**Heatherwood Hospital, Ascot,
Berkshire**

Archaeological Evaluation phase 2

**Site Code: HHA16/141
(SU 9138 6867)**

Report 16/141c

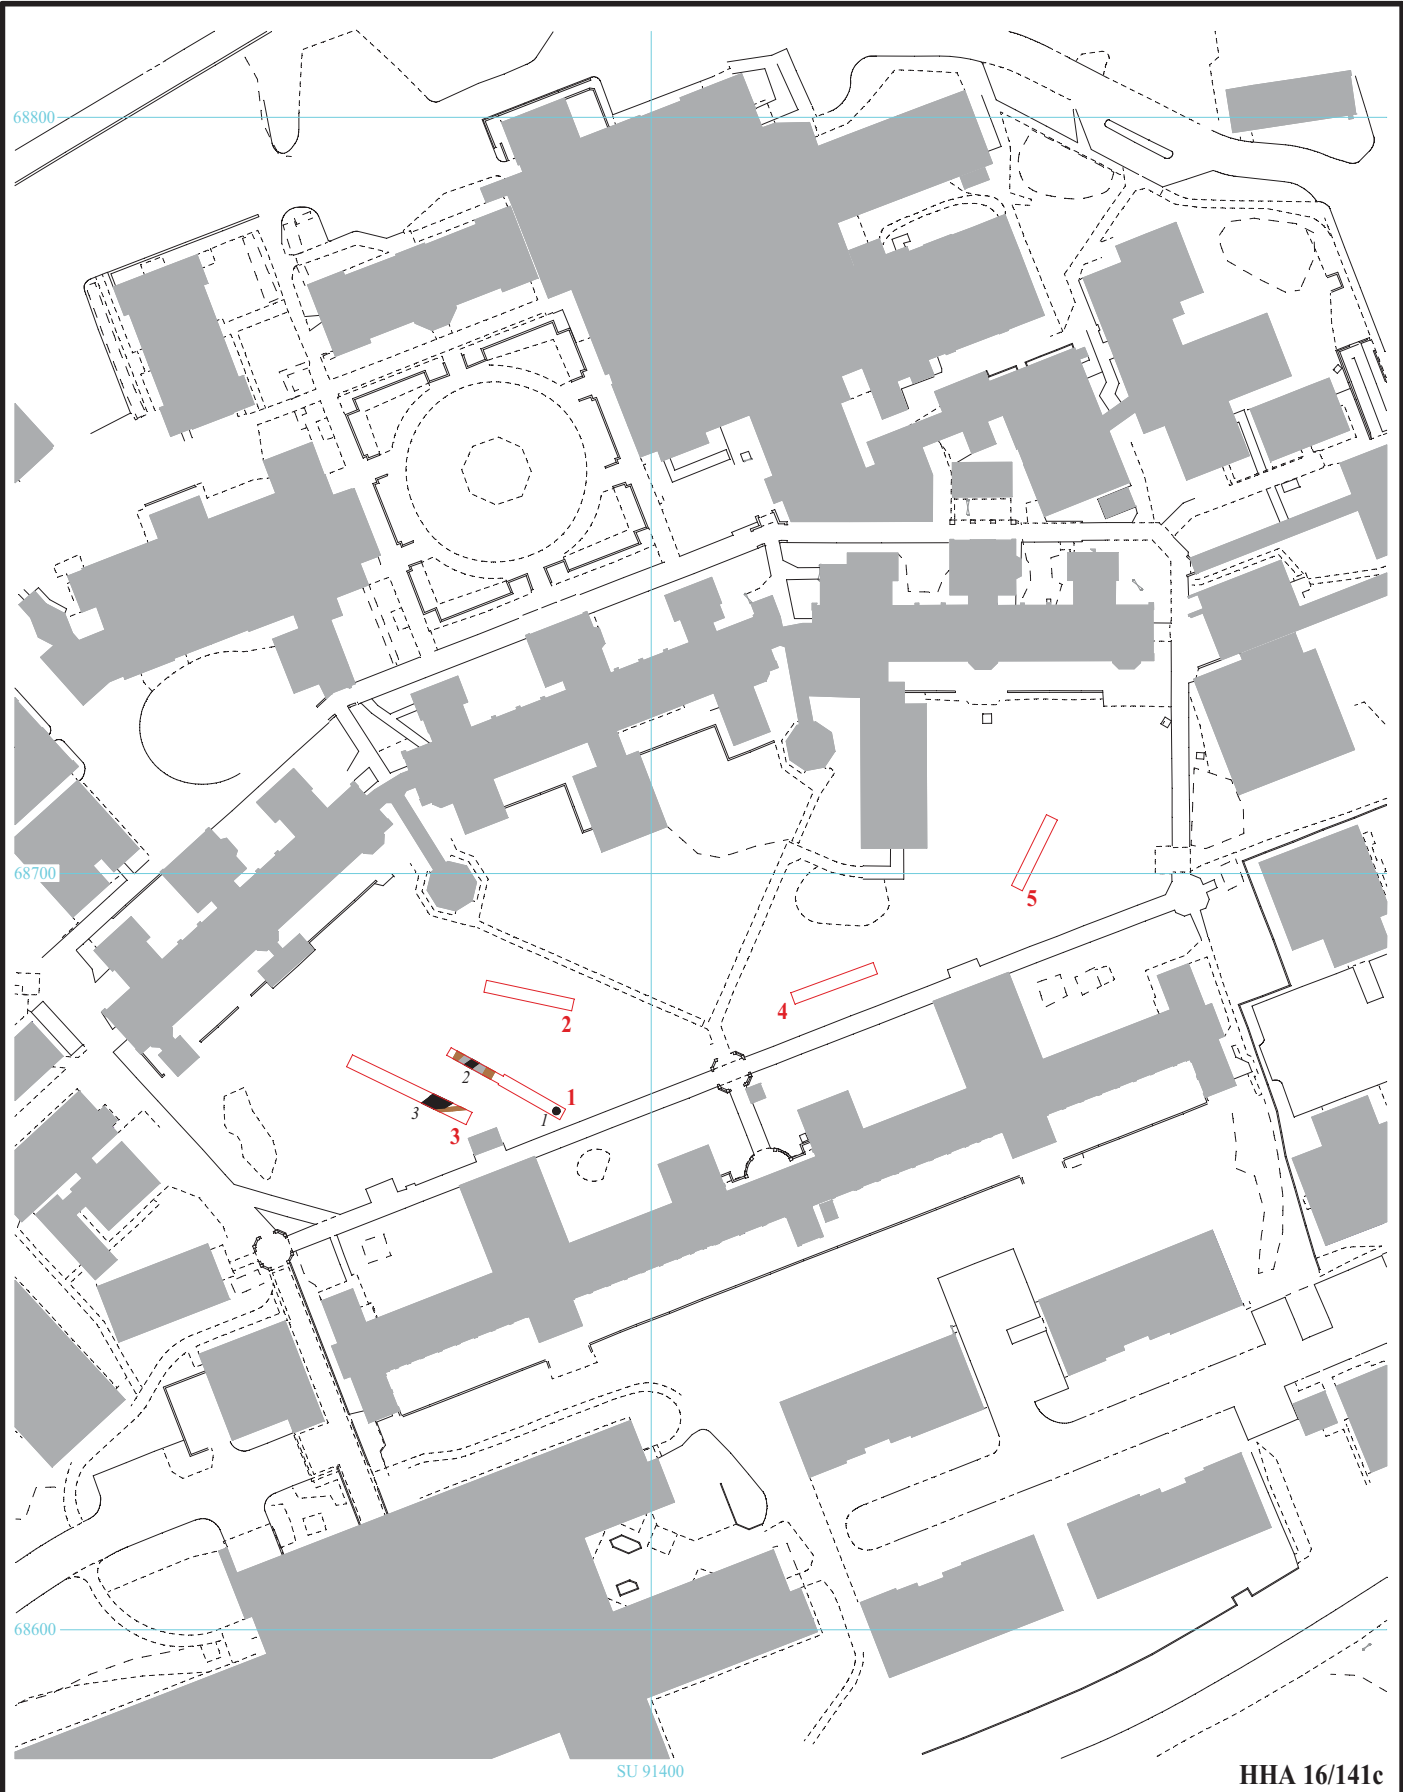
Figure 3. Trench layout.

Trench 2 (Fig. 3; Pl. 4)

Trench 2 was aligned south east – north west and was 11.5m long and 0.48m deep. The stratigraphy consisted of 0.14m of topsoil, overlying 0.21m of subsoil, overlying 0.13m of subsoil with gravel inclusions, overlying natural geology of brown orange gravel with mottled light grey sand.

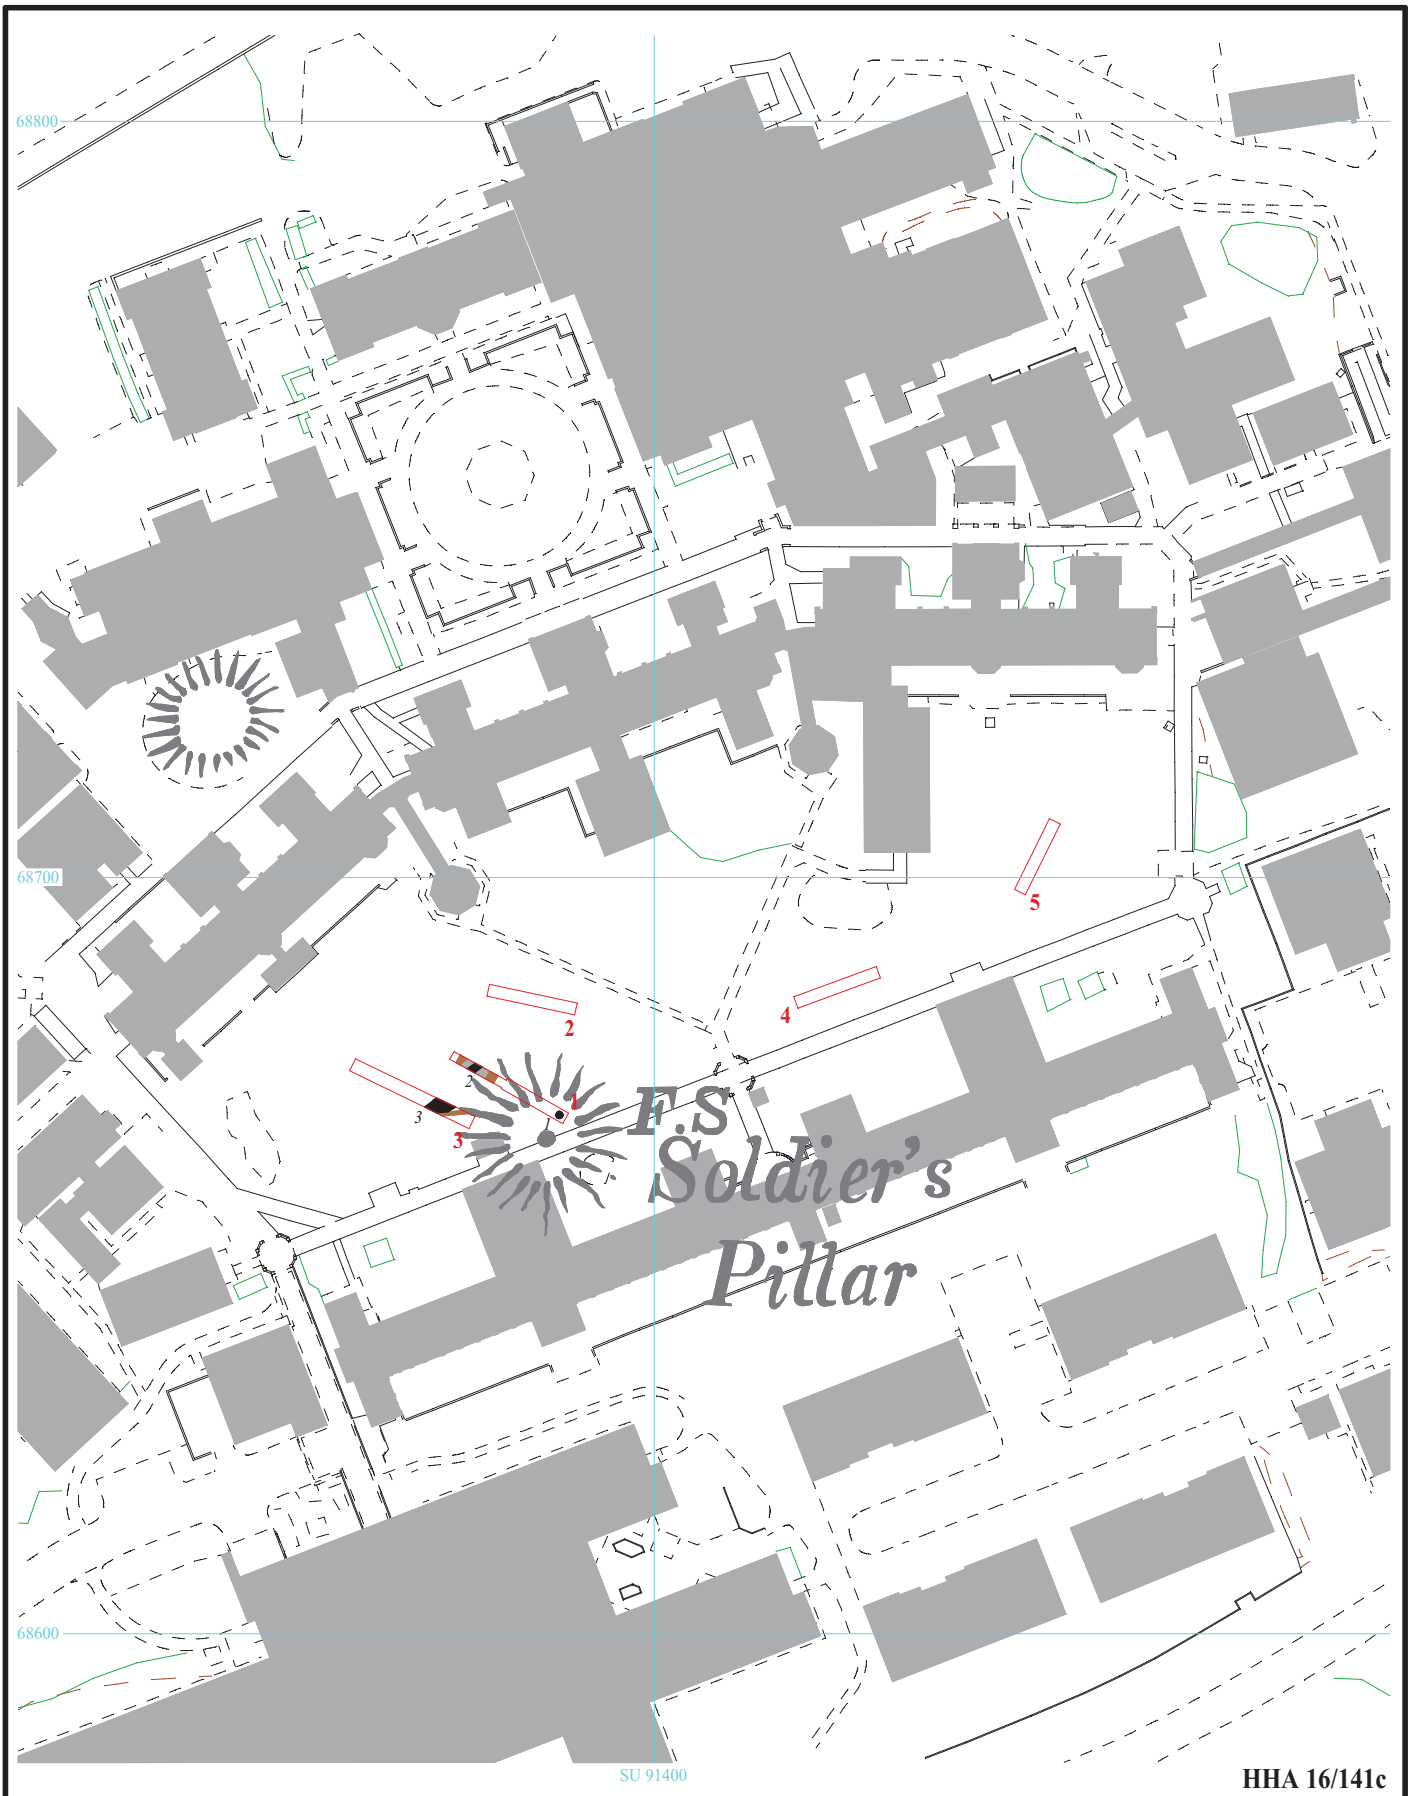
Figure 4. Trench layout with barrow locations from Ordnance Survey revision of 1932 superimposed.

The surface of the ground at the trench location rises almost imperceptibly to the south-east where the barrow mound is predicted to have stood. It is not clear if this rise is a by-product of root growth and tree planting or does reflect the former presence of the mound. It is considered that the latter is the more likely scenario and it was the presence of the mound that has led to the survival of the leached white sand in this location. The presence of the white sand here contrasts with the stratigraphic sequence of the other trenches (except in trench 5) where topsoil/subsoil directly overlays the mineral horizon. It is thought that this indicates a

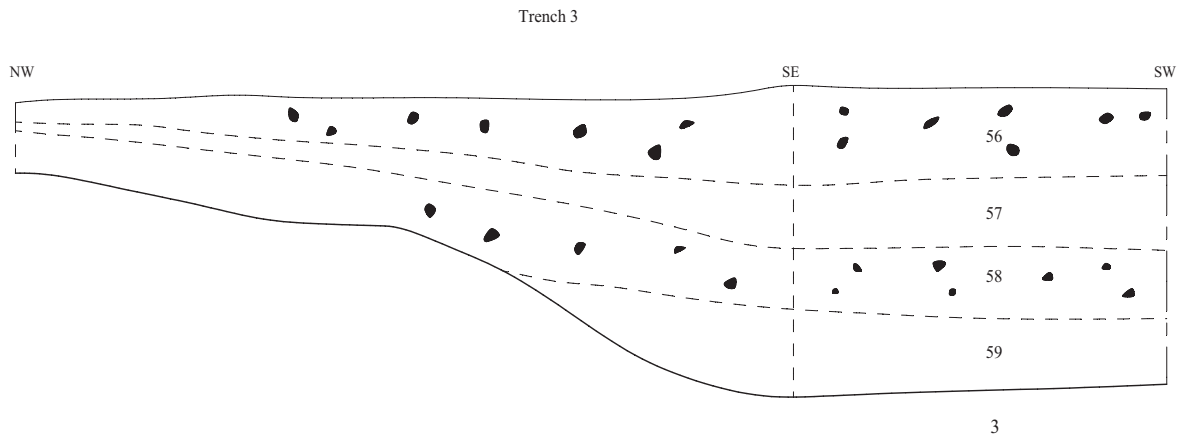
Figure 6. Sections.

Trench 3 was aligned north west – south east and was 17.6m long and 0.29m deep. The stratigraphy consisted of 0.04m of topsoil, overlying 0.16m of subsoil, overlying natural geology of brown orange gravel with mottled light grey sand. Ditch 3 was aligned north east–south west across the trench and measured more than 2.10m wide by 0.84m deep, the southeast side of the ditch was rendered inaccessible by a modern pipe. The ditch had gently sloping sides, a rounded base and contained four fills (numbered 56–59). Context 56 was mottled light grey and brown sand, overlying a dark grey black sand (context 57), overlying a light brown silty sand (context 58) overlying a darker brown silty sand (context 59) only found in the base of the ditch. There were no finds.

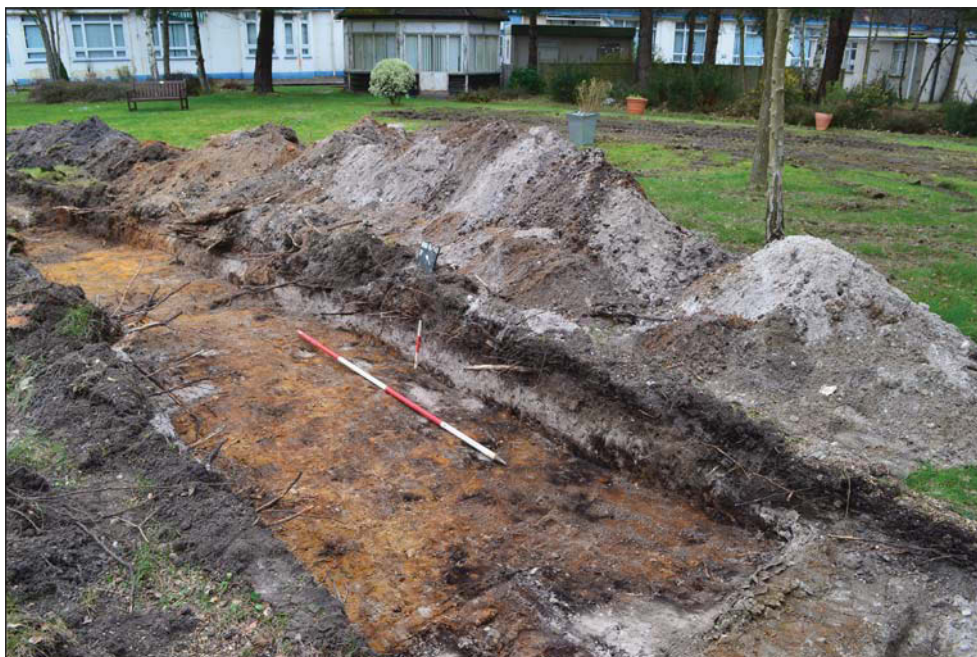
The anticipated undisturbed profile of the site in the predicted position of the barrow mound was that recorded in the nearby barrow excavation (Bradley and Keith-Lucas 1975). There, the lowest layer of clearly defined turves which had formed from a podsol soil profile overlay an intact buried podsol comprising a thin organic horizon above a leached white sand horizon above a brown/black mineralised horizon. In trench 1 however, the upper sequence of this profile was missing with rooty topsoil/subsoil directly overlying uniform leached white sand (Pls 1-3). It is considered that the whole of the mound make up for the barrow has been removed.

Plate 1. Trench 1, looking north, Scales: 2m and 0.3m.

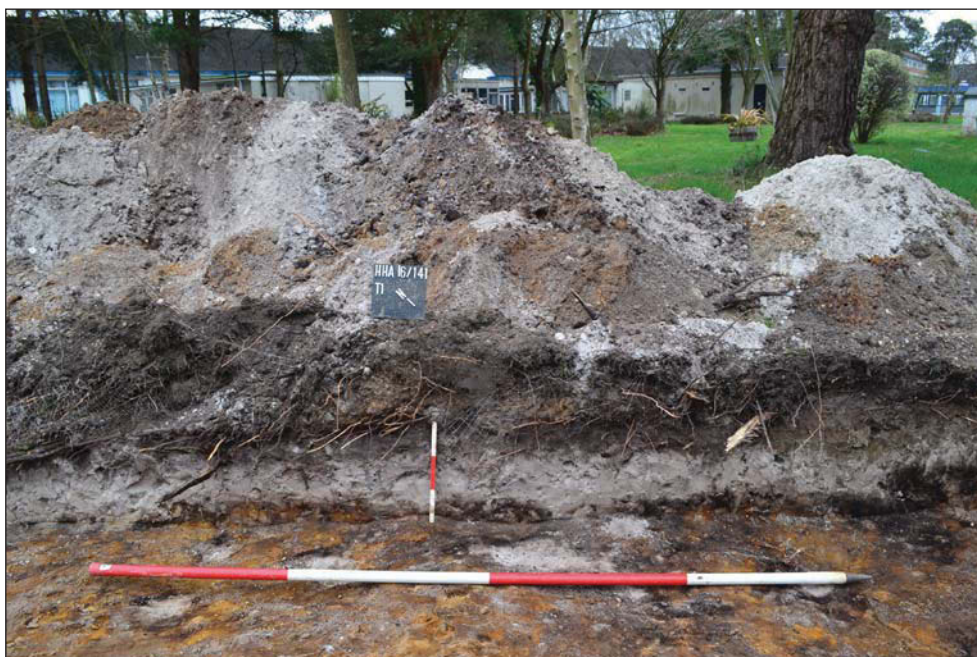
Plate 2. Trench 1 section, looking north-east, Scales: 2m and 0.3m.

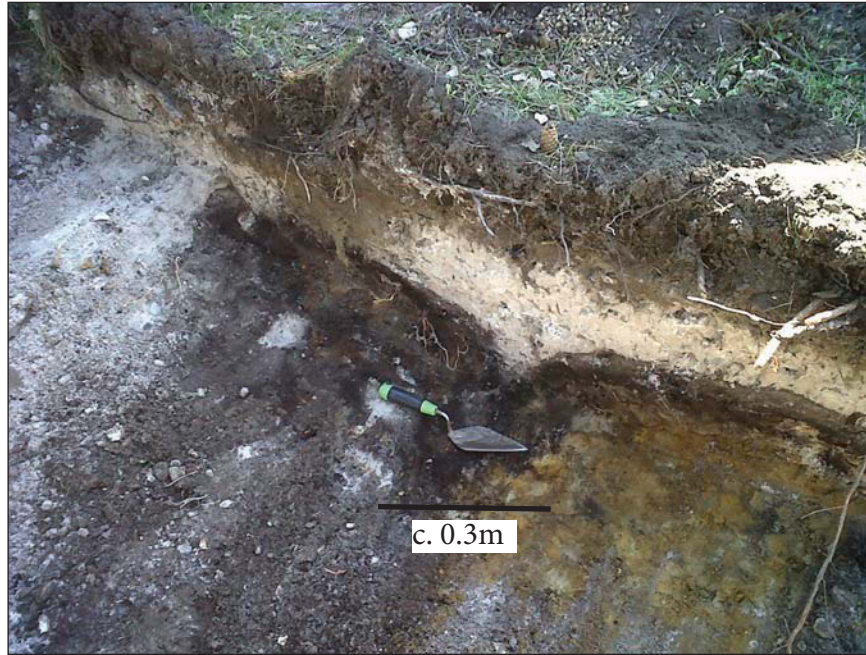
It is unclear if a marked v-shaped cut beneath the white sand (Pl. 3) is evidence for pre-barrow cultivation or a tree root.

Plate 3. Trench 1, detailed section looking south

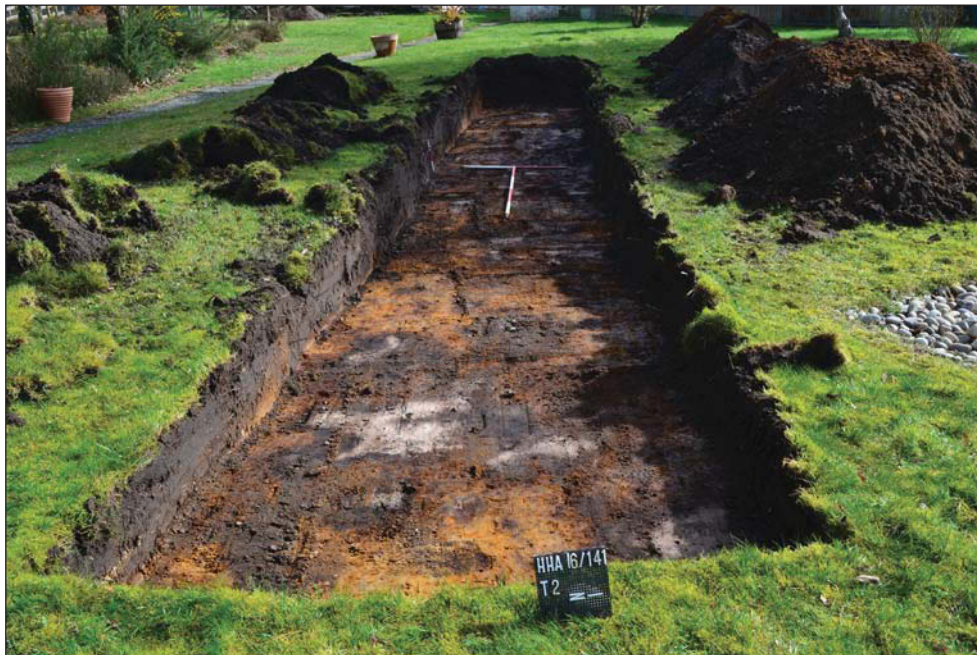
Plate 4 Trench 2, looking east, Scales: 2m, 1m and 0.3m.

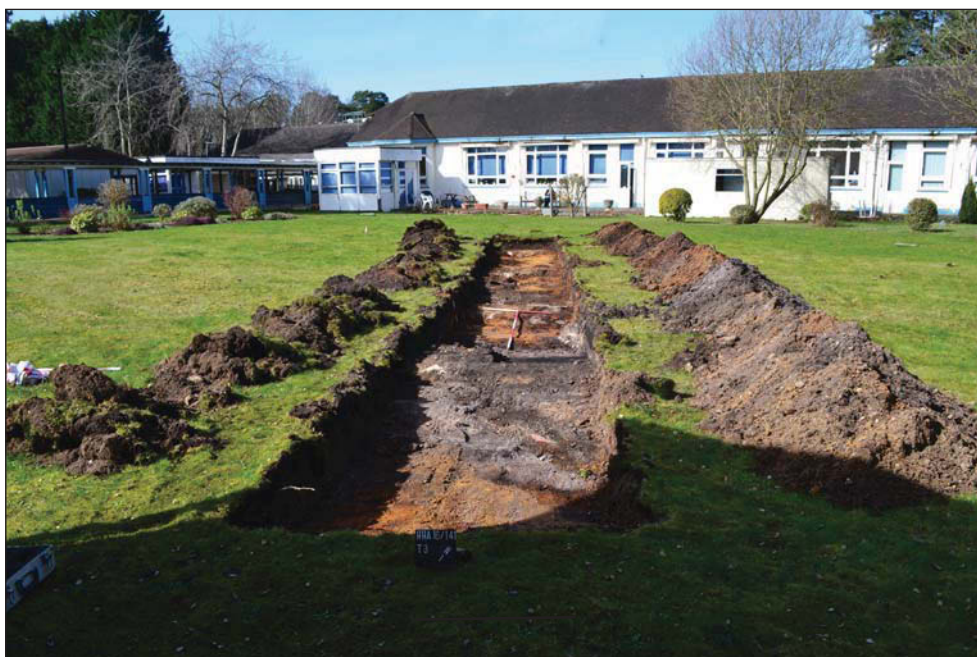
Plate 5. Trench 3, looking north west, Scales 2m, 1m and 0.3m

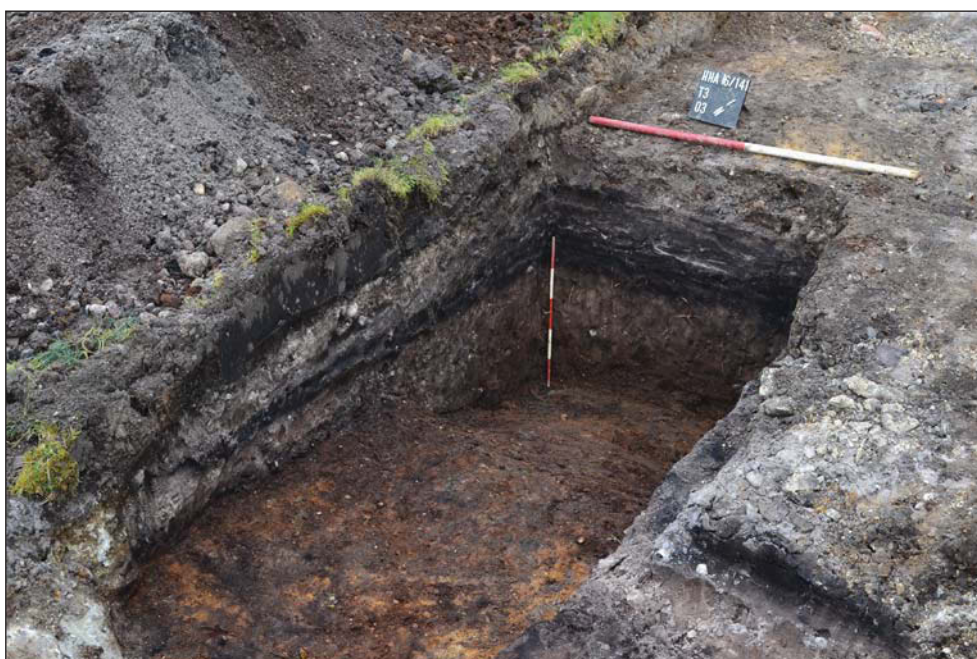
Plate 6. Trench 3, ditch 3 looking south east, Scales: 1m and 0.5m.

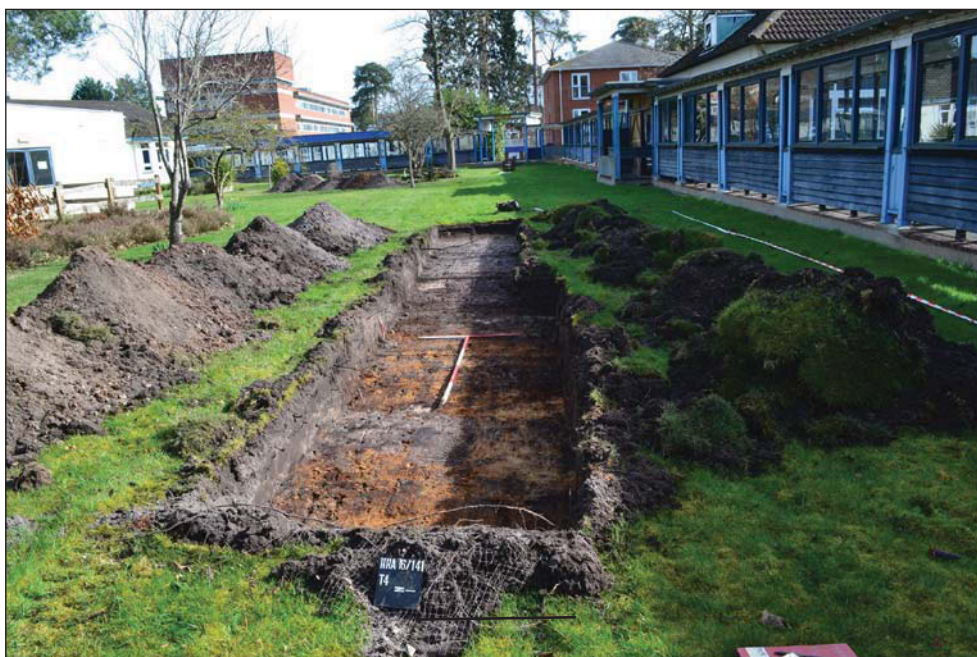
Trench 4 was aligned north east –south west and was 12.0m long and 0.45m deep. The stratigraphy consisted of 0.17m of topsoil, overlying 0.18m of subsoil, overlying 0.10m of subsoil with gravel inclusions, overlying natural geology of brown orange gravel with mottled light grey sand changing to light grey sand at the northeast end of the trench.

Plate 7. Trench 4, looking east, Scales 2m, 1m and 0.3m

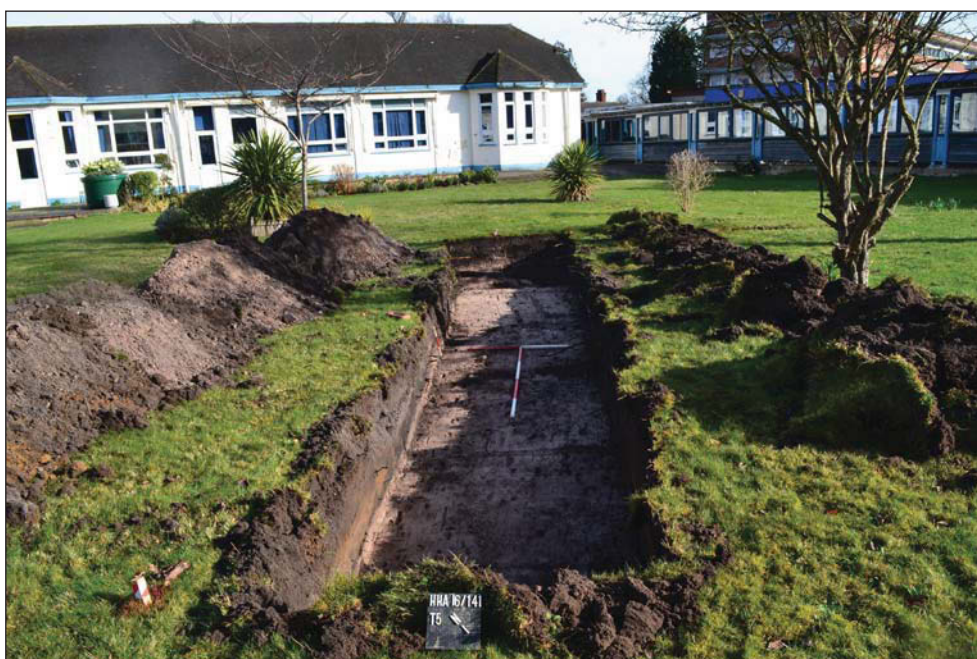
Trench 5 was aligned north east –south west and was 10.6m long and 0.40m deep. The stratigraphy consisted of 0.13m of topsoil, overlying 0.11m of subsoil, overlying 0.36m of mid yellow brown sand, overlying natural geology of very light brown grey sand at the south east end of the trench and 0.10m of topsoil overlying 0.19m of dark grey brown silty sand subsoil overlying natural geology at the north west end of the trench.

Plate 8. Trench 5, looking north east, Scales: 1m and 0.5m.
