**Land at Thame Road, Warborough,
Oxfordshire**

Archaeological Evaluation

Site Code: TRW16/134

An Archaeological Evaluation for Rectory Homes

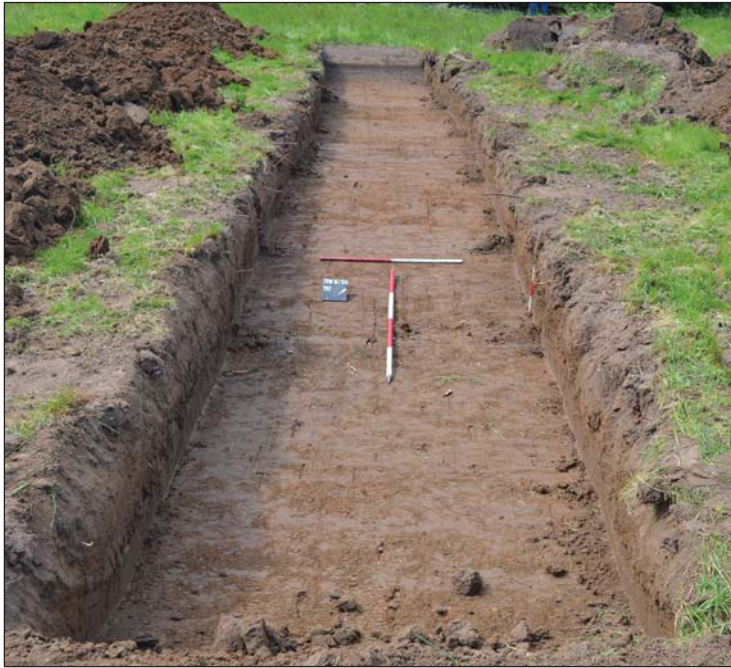
Plate 1. Trench 2, looking north west, Scales: horizontal 2m and 1m, vertical 0.3m.

Trench 2 was aligned SE - NW and was 20m long and 0.54m deep. The stratigraphy consisted of 0.22m of topsoil and 0.09m of mid grey brown sandy silt subsoil overlying a mid grey orange silty clay natural geology. No archaeological features were encountered.

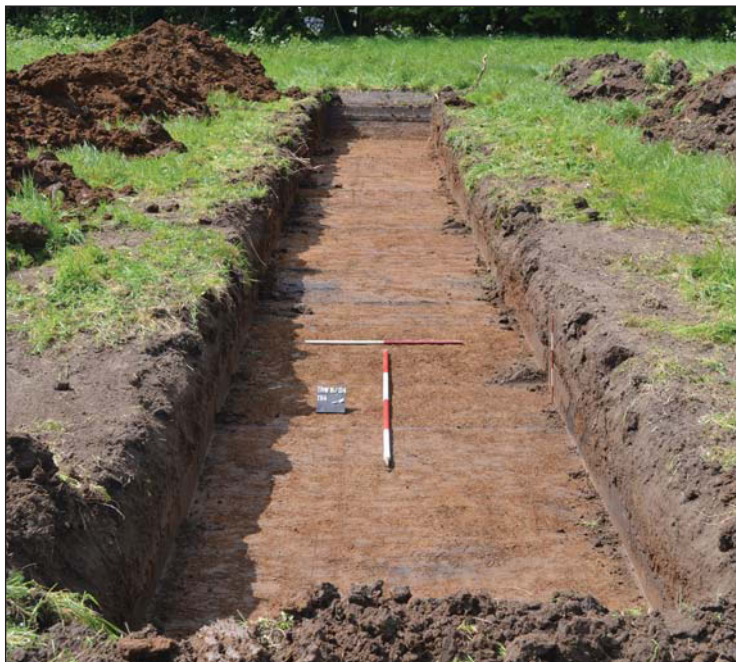
Plate 2. Trench 4, looking west, Scales: horizontal 2m and 1m, vertical 0.5m.

Trench 4 was aligned SE - NW and was 20m long and 0.6m deep. The stratigraphy consisted of 0.24m of topsoil and 0.11m of mid grey brown sandy silt subsoil overlying an orange brown silty clay with occasional gravel natural geology. No archaeological features were encountered.

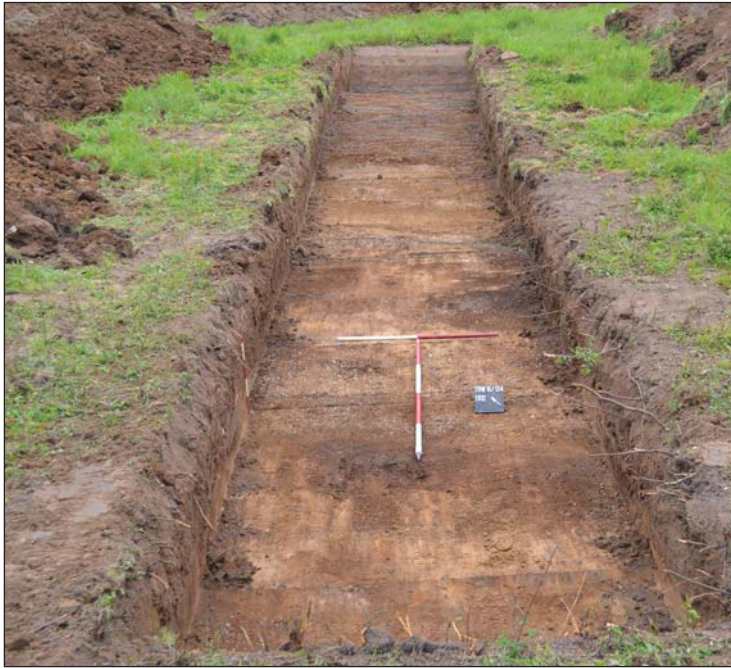
Plate 3. Trench 12, looking north east, Scales: horizontal 2m and 1m, vertical 0.5m.

Trench 12 was aligned SW - NE and was 20m long and 0.66m deep. The stratigraphy consisted of 0.31m of topsoil and 0.2m of mid grey brown sandy silt subsoil overlying a patchy orange brown silty clay with gravel and sand natural geology. A test pit was dug in the SW end, 0.99m deep showing a yellow orange sand. No archaeological features were encountered.

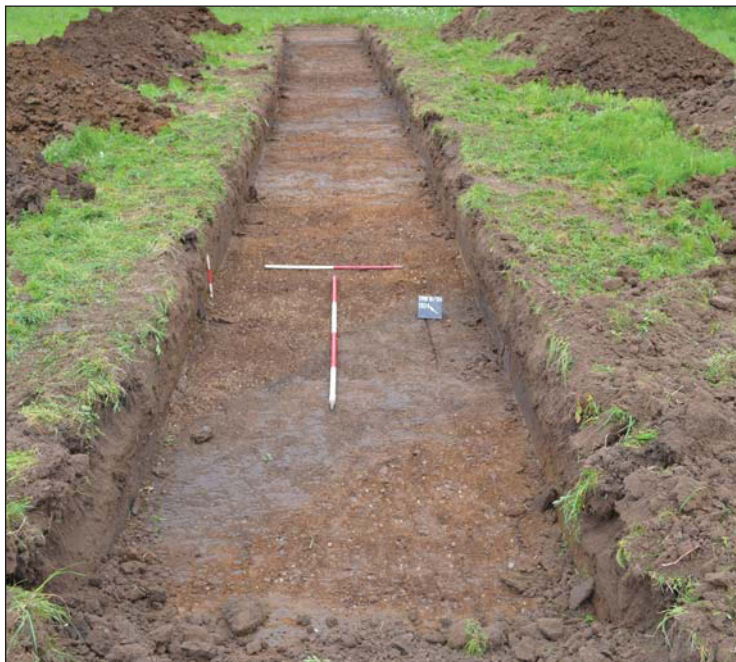
Plate 4. Trench 24, looking north east, Scales: horizontal 2m and 1m, vertical 0.3m.

Trench 24 was aligned SW - NE and was 20m long and 0.54m deep. The stratigraphy consisted of 0.37m of topsoil and 0.05m of mid grey brown sandy silt subsoil overlying a orange brown silty clay with gravel natural geology. Two ditches were investigated. The first (3) was 1.3m wide and 0.23m deep with a single fill (54) of mid grey brown sandy silt. The second (4) was 1.3m wide and 0.5m deep with a single fill (55) of light grey brown sandy silt. No dating evidence was encountered in either of the features.

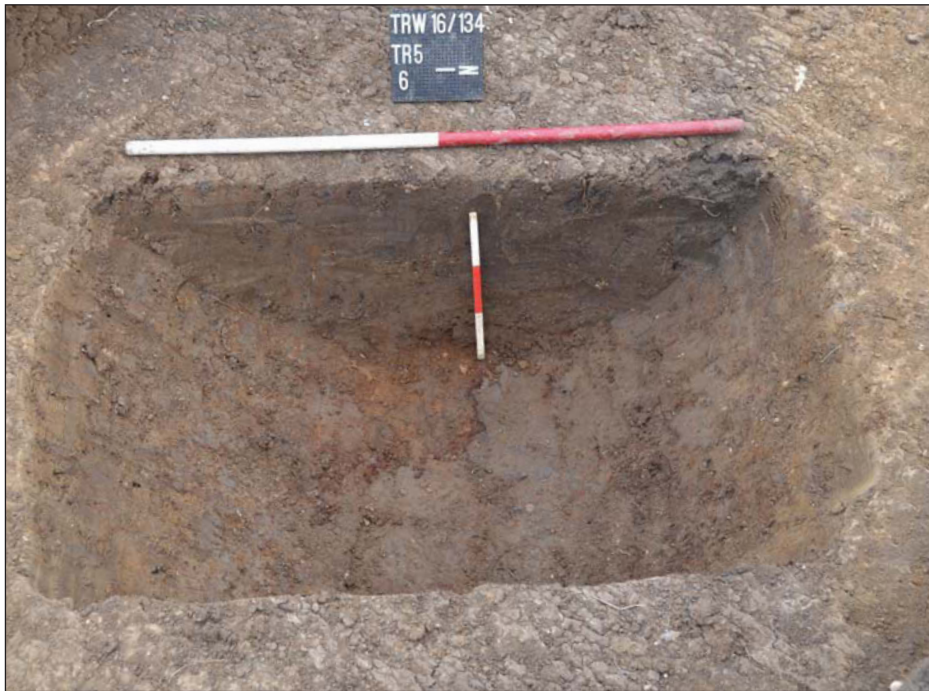
Plate 5. Trench 5, ditch 6, looking west, Scales: 1m and 0.3m.

Trench 5 was aligned SE - NW and was 20m long and 0.61m deep. The stratigraphy consisted of 0.35m of topsoil and 0.12m of mid grey brown sandy silt subsoil overlying an orange brown silty clay with gravel natural geology. A ditch was investigated where a slot (6) was dug with 1.1m wide and 0.38m deep with a single fill (57) of light orange grey sandy clay. No dating evidence was encountered.

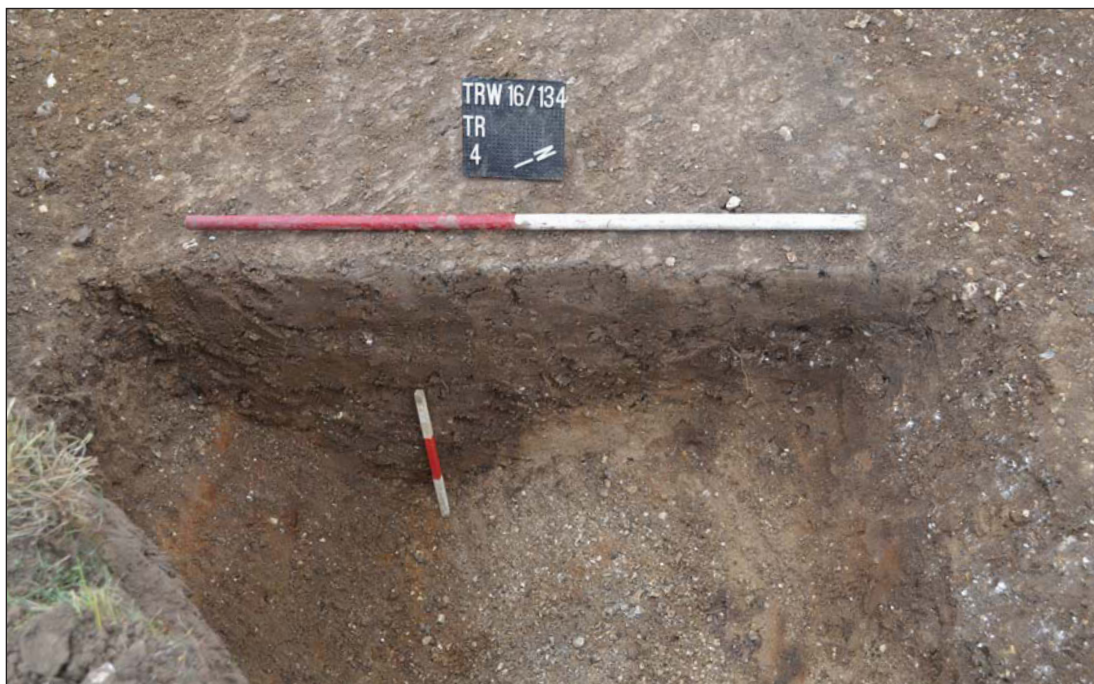
Plate 6. Trench 24, ditch 4, looking north west, Scales: 1m and 0.3m.

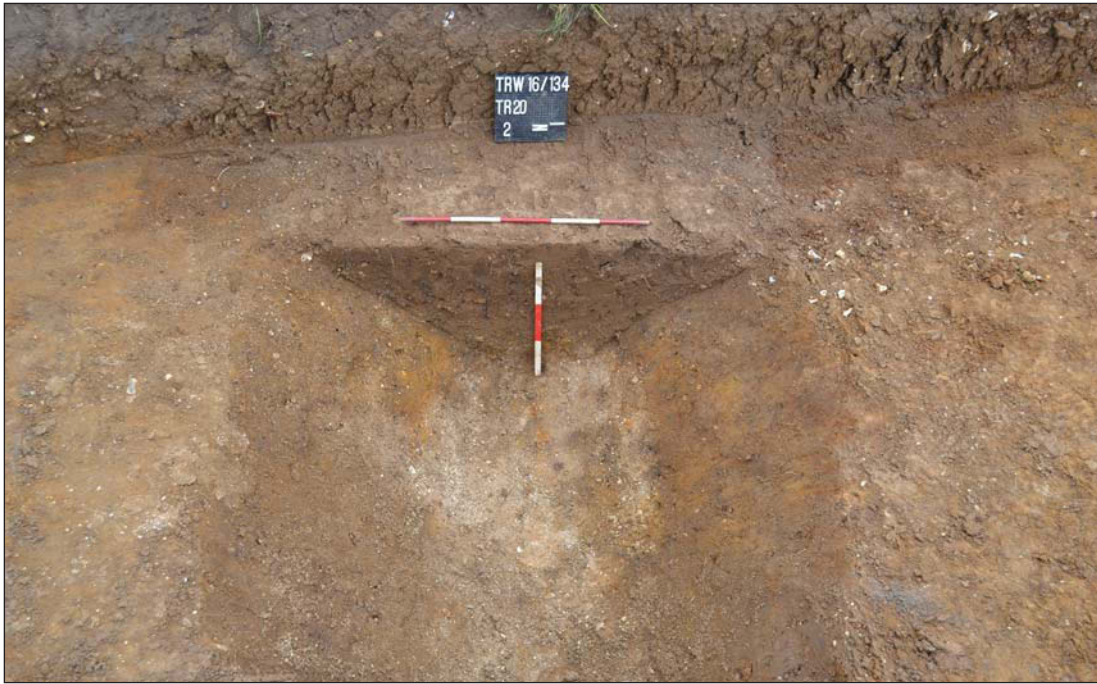
Plate 7. Trench 20, ditch 2, looking east, Scales: 0.5m and 0.3m.

A slot (2) was excavated through a ditch with sloping sides and a v-shaped profile. The slot measured 1m long, 0.9m wide and 0.36m deep with a single fill (53) of light orange brown sandy clay. No dating evidence was encountered.

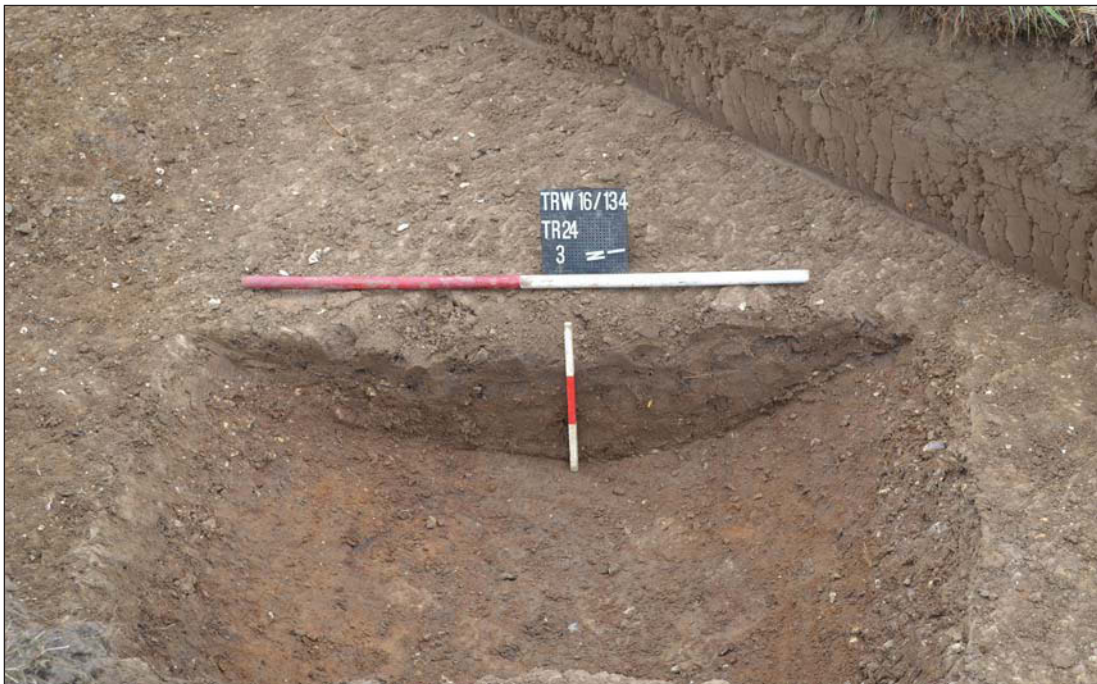
Plate 8. Trench 24, ditch 3, looking east, Scales: 1m and 0.3m.
