**The former Flag Cutters public house, 360 Holt Road,  
Horsford, Norfolk**

**Building Recording**

**Site Code: HRH17/03**

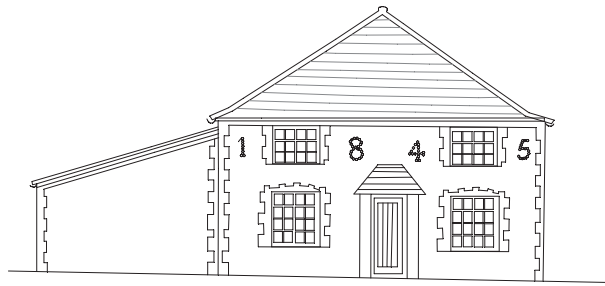
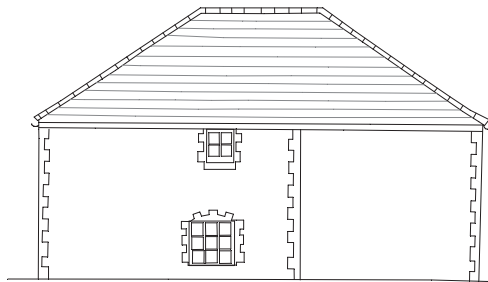
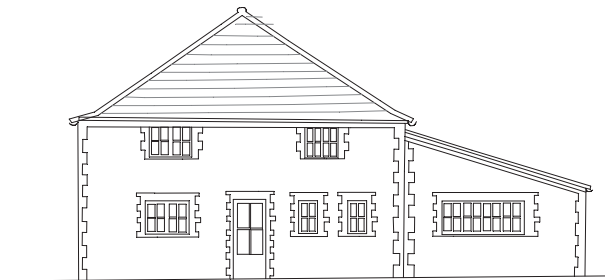
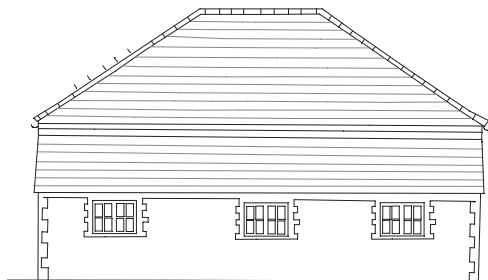
Figure 3. Elevations.

The building is rectangular in plan with a lean-to extension on the north-west. It is constructed of flint cobbles with brick quoins around the doors, windows and corners of the building. The roof is hipped in plan form and covered in modern pantiles. The lean-to extension is of the same construction with dentilated brickwork following the slope of the roof. The windows are of casement type and appear to be modern replacements.

*South-west (front) elevation*

*South-east (side) elevation*

*North-east (rear) elevation*

*North-west (side) elevation*

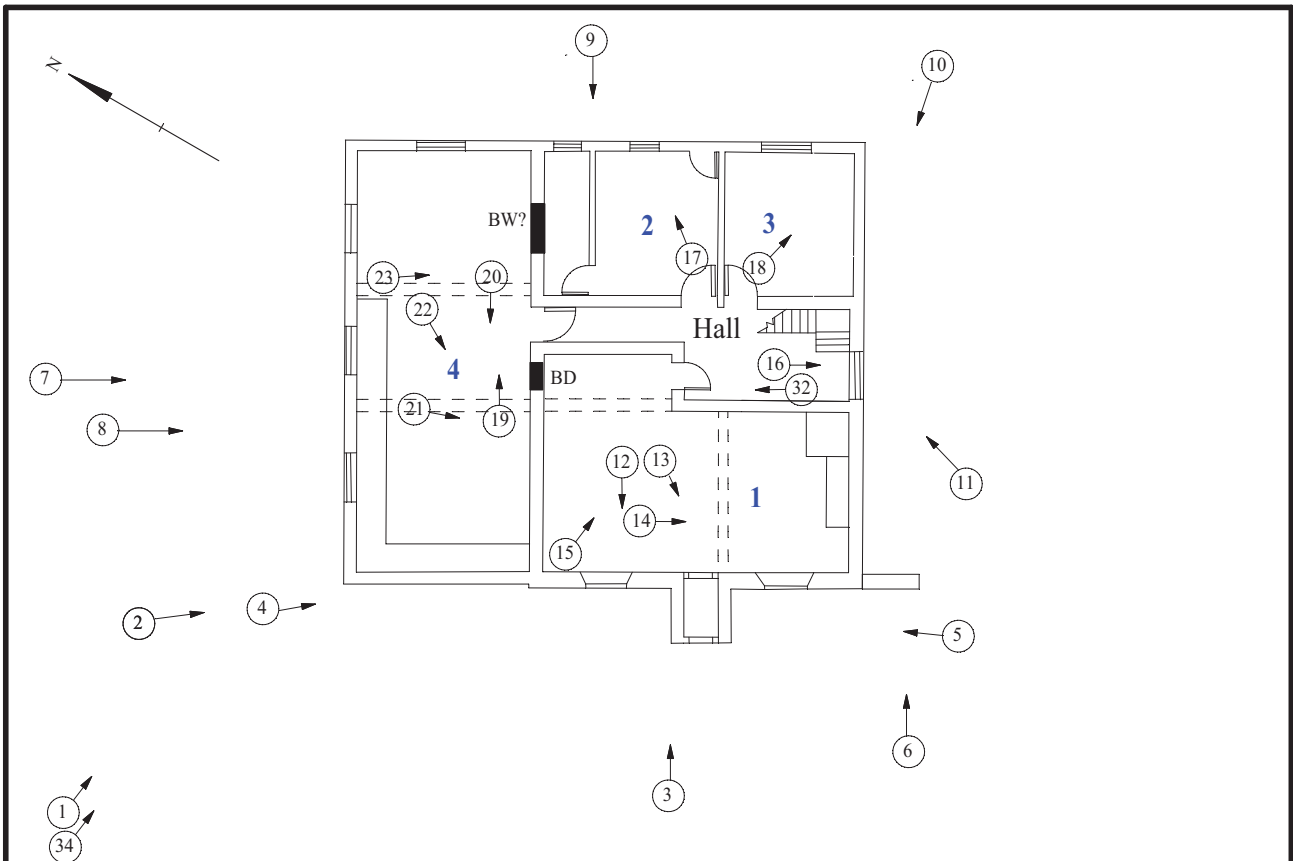
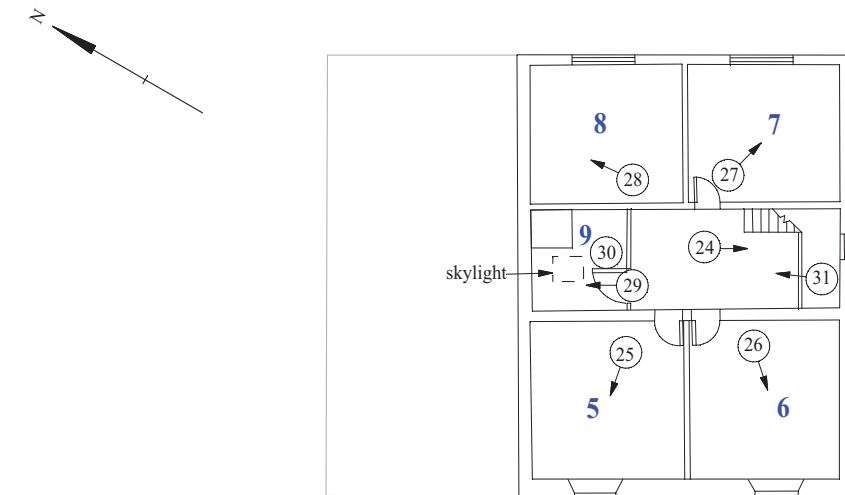
Figure 4. Detail floor plans of Ground and First floor, showing locations and directions of photographs (see Appendix 1).

Internally the walls are a combination of plastered and exposed flint. The floors are a combination of wooden boards and tiles.

Internally the ground floor is sub-divided into four rooms and a hallway. The front porch steps down into room 1; the living room (Pl. 6), which is 'L-shaped' in plan. In the south-east wall is a brick fireplace with a wooden lintel (Pl. 7). Slightly off-centre within the room is an exposed wooden beam spanning the width of the room and supported on a post at either end. A second beam is present where the earlier wall has been removed at the north-east end of the room.

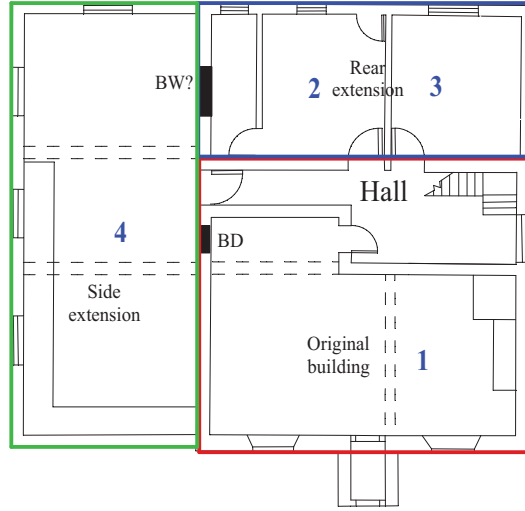
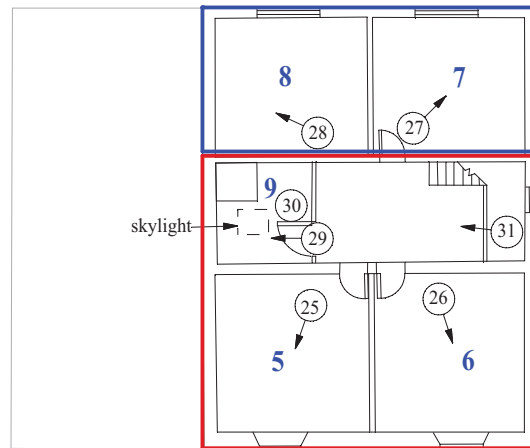
Figure 5. Block Plan showing suggested phasing

Earlier plans show that much of the alteration was carried out around 2002; the lean-to extension (room 4), the rear extension encompassing rooms 2, 3, 7 and 8 and the raising of the roof. Internally it was also substantially altered at this time with the layout redesigned and the original chimney within room 1 removed.

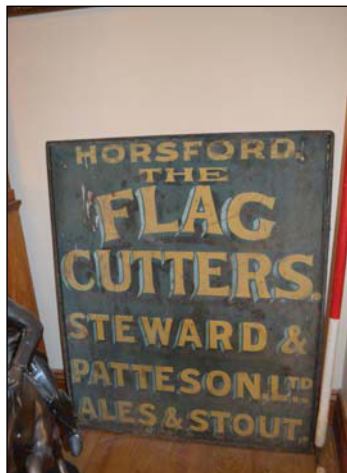
flags (Wells 2000). According to a sign retained within the house (Pl. 1), the Flag Cutters was formerly owned by Steward and Patteson Ltd Brewery which operated between 1793 and 1970 ([http://breweryhistory.com/wiki/index.php?title=Steward\\_%26\\_Patteson\\_Ltd](http://breweryhistory.com/wiki/index.php?title=Steward_%26_Patteson_Ltd)).

Plate 1. Flag Cutters Sign, Scales: 1m.

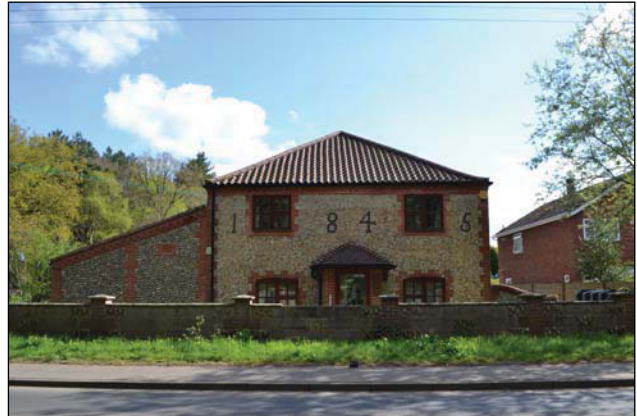
On the front (south-west) façade of the building (Pl. 2) is a central porch with a pitched roof and a window on either side. The first floor contains two windows above the ground floor ones. Picked out in black flint cobbles is the date 1845. A small boundary wall is present butted up against the south-east corner of the building. The south-east façade (Pl. 3) shows two phases of building with slightly different flint cobbles and the brick quoins within the centre of the wall. Within the older part of the building there are windows in the ground and first floors. The brickwork above the ground floor window is arched rather than flat and beneath the window is further brickwork suggesting this was a former door. At the top of the wall are four rows of bricks laid in stretcher bond, above which is a dentilled brick cornice. This brickwork spans the entire length of the wall and appears to be later than the original part of the building, probably added when the building was re-roofed to

Plate 2. Exterior, front elevation, looking northeast, Scales: 2m.

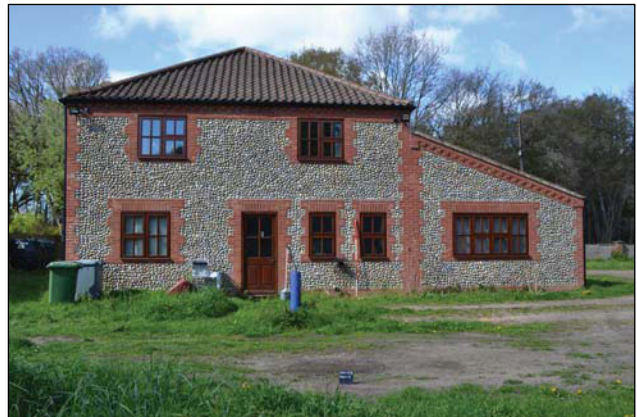
cover the later part of the building. The rear of the building (Pl. 4) contains a central door with a window to the southeast and a pair of windows to the northwest. On the first floor are a further two windows, slightly off-set from those on the ground floor. Within the lean-to is a further window. Only the lean-to can be seen within the north-west façade (Pl. 5). Three windows are placed within the wall. Within the roof of the main building is a skylight. From the style of the stonework in the wall it would appear that the lean-to was built at the same time as the rear extension.

Plate 4. Exterior, rear elevation, looking southwest, Scales: 2m.

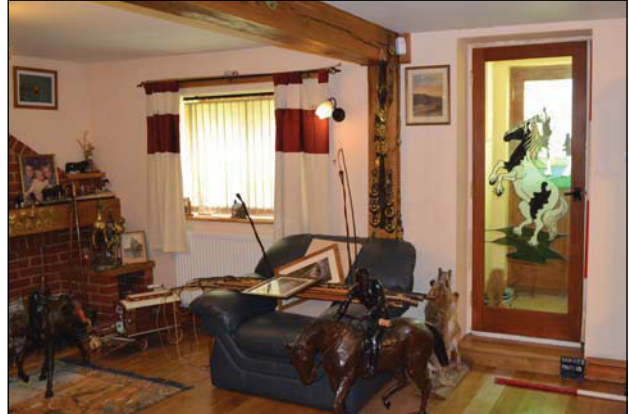
Plate 6. Interior, room 1, looking southwest,  
Scales: 1m.

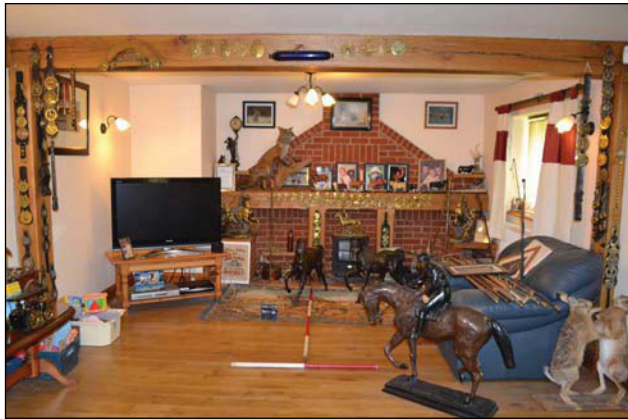
Plate 7. Interior, room 1 fireplace, looking southeast,  
Scales: 2m and 1m.

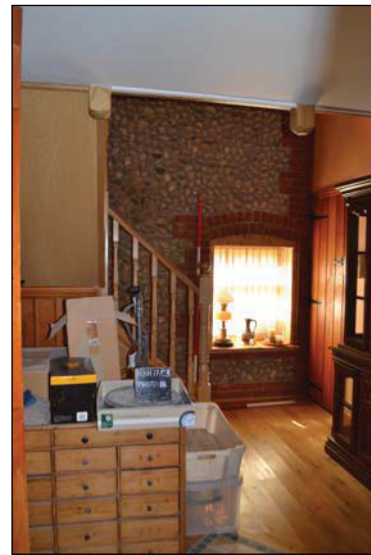
Accessed from the lounge is the hallway (Pl. 8), which has a window within the south-east wall adjacent to the stairs to the first floor. The window is set within a panel of exposed flint work. On the other side of the window is access to a small cupboard. Externally the window appears to be a former door, but internally there is flint work beneath the window. Accessed from the hallway is the utility room (room 2, Pl. 9) containing an external door to the rear of the building and a window and the bathroom (room 3, Pl. 10), containing a single larger window. At the far end of the hallway, down a corridor is access to the kitchen/diner (room 4, Pl. 11) housed within the lean-to extension.

Plate 8. Interior, ground floor hallway,  
looking southeast, Scales: 2m and 1m.

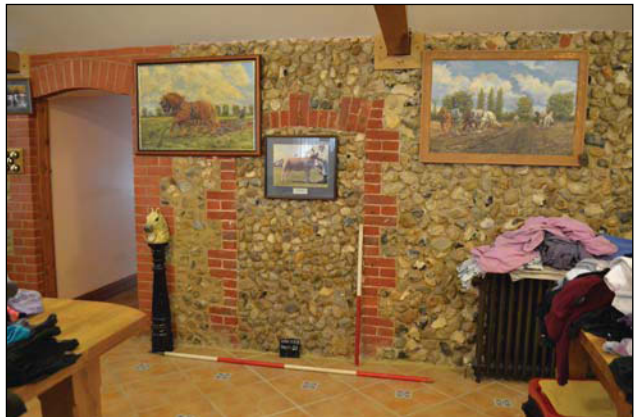
Within the roof space there are two partially exposed trusses of raking queen-strut or queen-post construction and the ceiling gives the impression of a pitched roof, although externally it is a lean-to style roof. Within the former external wall is a blocked door (Pl. 12) and possible window (Pl. 13) either side of the existing access to the kitchen which is via a more recent insertion.

Plate 12. Interior, room 4, blocked door,  
looking southeast, Scales: 2m and 1m.

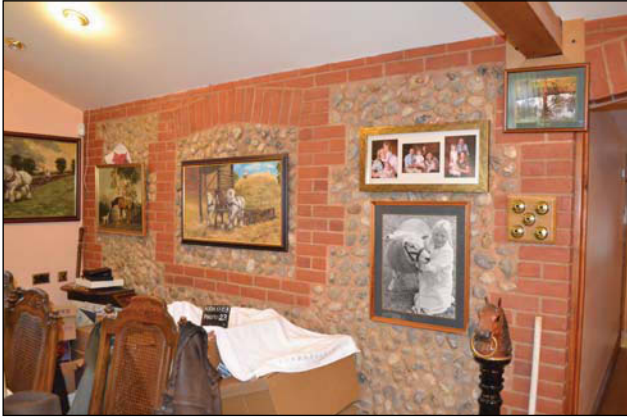
Plate 13. Interior, room 4, blocked window, looking southeast, Scales: 1m.

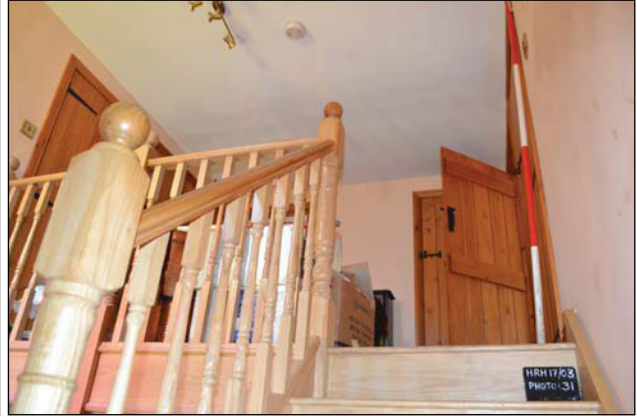
The first floor consists of a central hallway off which are located five rooms; four bedrooms and a bathroom. The hallway is lit by a window above the stairs. The stairs themselves are of straight flight type with turned wooden newel posts and balusters (Pl. 14). Opposite the stairs is the bathroom (room 9, Pl. 15) which is lit by a skylight in the roof. The other four bedrooms (rooms 5-8, Pls. 16-19) are arranged two on either side of the house and are approximately equal in size. Each has a window; two overlooking the front and two overlooking the rear.

Plate 14. Interior, hallway, looking northwest, Scales: 2m.

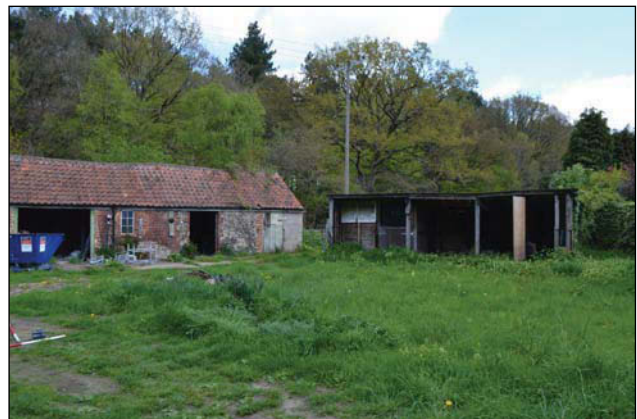
To the rear of the building, along the Green Lane frontage are a set of outbuildings. These consist of a former stable block and shed. Both are in a dilapidated state. The stable block is constructed of a combination of brick and flint, similar to the house with a pan tile, gable end roof. Many changes are apparent, with different types of brick and brick bonding styles used as well as concrete blockwork. The shed is built of concrete blockwork with a corrugated steel roof.

Plate 20. Exterior, outbuildings, looking northeast,  
Scales: 2m and 1m.
