**Cowleaze Farm, Eysey Manor Quarry Phase 7,
Cricklade, Swindon, Wiltshire**

Building Recording

Site Code: EMC14/184

July 2017

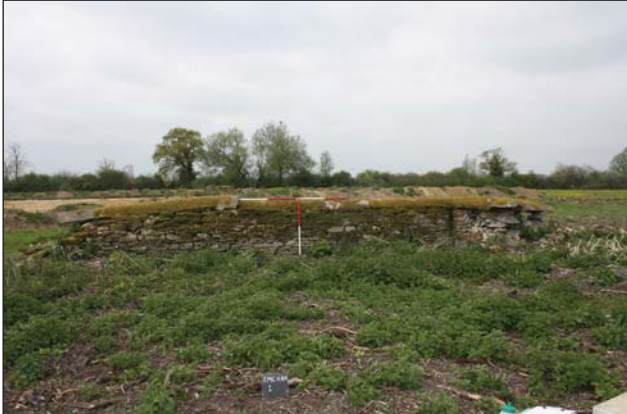
Plate 1. View to east wall, looking south west,
Scales: 2m and 1m.

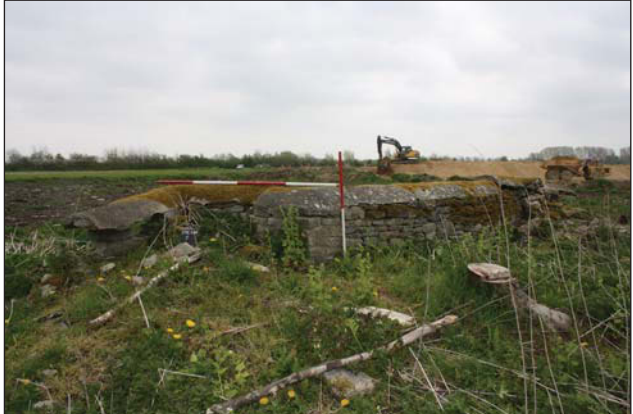
Little of the building remains, and not in any recognisable form. A total of three walls were present; east, west and south walls with the north wall missing. The east wall contained a small dog-leg to the east before continuing to the north. What remained consisted of a maximum height of 1.48m on the west wall, with other walls being considerably lower. There was no evidence remaining of the roof.

Plate 2. Internal face of east wall showing dog-leg,
looking east, Scales: 2m and 1m.

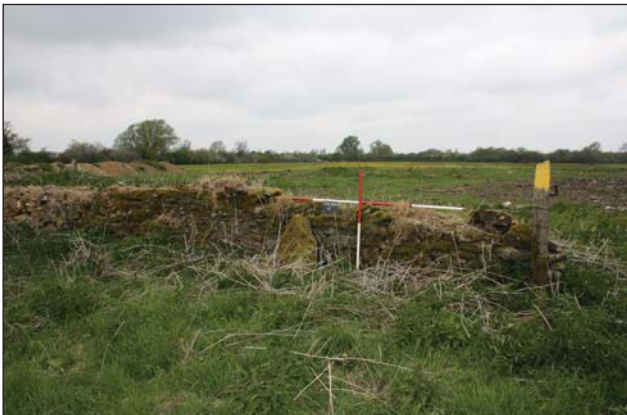
Some consolidation and preservation had been undertaken on the walls including the addition of a concrete cap on top of the walls, though this had also deteriorated and was no longer present on the southern wall. Within the southern wall were a few bricks, measuring 260mm x 130mm x 52mm and stamped *Stonehouse Brick and Tile Co. Ltd.* These were bonded in a hard, white, pebbly mortar. Three wooden posts also appeared to be a part of the building; these were located, two at the centre of the west wall and one at the eastern end of the north wall.

The posts had a square profile and were probably of pine. The posts in the southern wall measured 120mm square by 0.98m and 1.25m high; the westernmost one also had two hinges in it. The post in the western wall measured 95mm square by 1.25m high and had a single hinge in it.

Plate 3. External face of south wall, looking north west,
Scales: 2m and 1m.

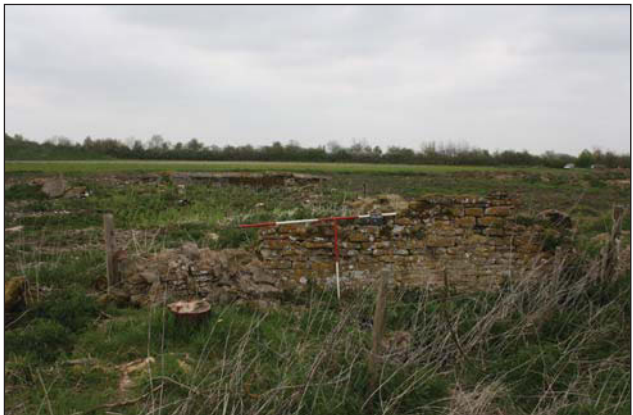
Plate 4. External face of west wall, looking north east,
Scales: 2m and 1m.
