**Church of St Michael and All Angels,
Waddesdon, Buckinghamshire**

Archaeological Watching Brief

Site Code: WCB17/52

May 2017

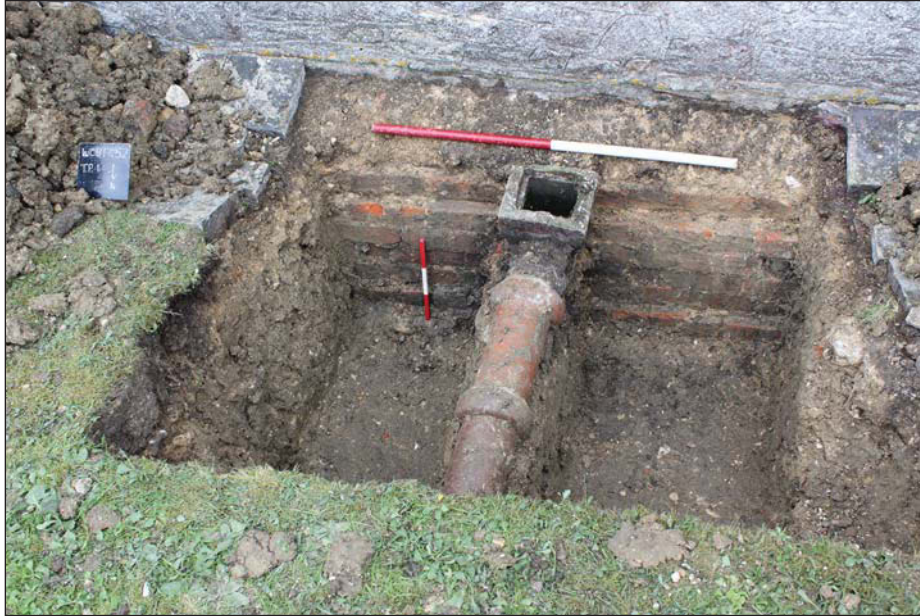
This test pit was 1.6m long by 1.3m wide, and 0.9m deep. Once the bricks for the drainage channel had been taken out, the concrete setting needed to be broken through. Turf and topsoil (0.1m deep) was removed from the

south side of the test pit. This covered a firm, light brown silty clay deposit (50) with was present across the extent of the excavated area, up to the brick foundation. It was 0.36m at its thickest at the south of the test pit. A small quantity of disarticulated human bone was recovered from this deposit. No pottery was recovered to indicate date of the deposits, though tile was present, and metalwork recovered included an identifiable portion of a coffin handle.

This deposit in turn overlay a light brown grey silty clay with occasional brick and limestone inclusions (51), up to 0.44m thick. A small quantity of disarticulated human bone was recovered from this deposit. No pottery was recovered to indicate date of the deposit, though again tile was recorded. A brick foundation had been built parallel with the original foundation and the base was encountered in the base of the test pit. It was covered with a sloped cap of mortar, and sat 0.25m from the exterior wall. The top of the capping was directly beneath the mortar of the drainage. Perpendicular drainage, that led away from the drain run northwards, was not removed. It was noted that the drainage cut the exterior brick foundation, therefore making the foundation older than the drain.

Plate 1. Exterior, test pit 1, looking south, Scales: 1m and 0.3m.

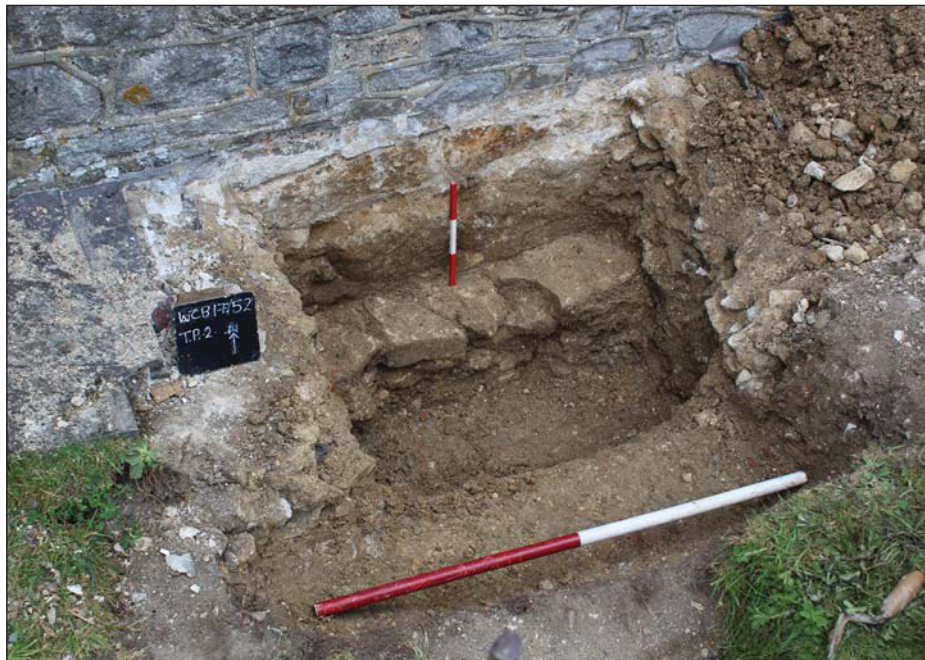
This test pit was 1.3m long by 1.07m wide, and was 0.75m deep. Once the bricks for the drainage channel had been taken out, the concrete setting needed to be broken out by mechanical means. Directly under the concrete was a 0.37m strip of disturbed mixed fill of tile and brick with grey brown sandy silt that appeared modern. In the south of the test pit, under turf, topsoil reached a depth of 0.22m. This in turn overlay a light grey sandy silty clay with frequent limestone fragments, up to 0.26m deep. Two fragments of tile were recovered from this fill, one a fragment of medieval glazed floor tile.

A step was created in the base of the test pit, to expose the lower limestone foundation step, which was course and not faced. The top of this step was 0.42m deep and stepped out 0.2m from the base of the exterior wall. The lowest fill of this test pit covered this foundation, and was firm, light brown sandy silty clay with occasional brick crumb in the fill. This deposit was excavated to a depth of 0.29m thick but extended beyond the base of excavation. No finds were recovered from this fill.

Plate 2. Exterior, test pit 2, looking north, Scales: 1m and 0.3m.

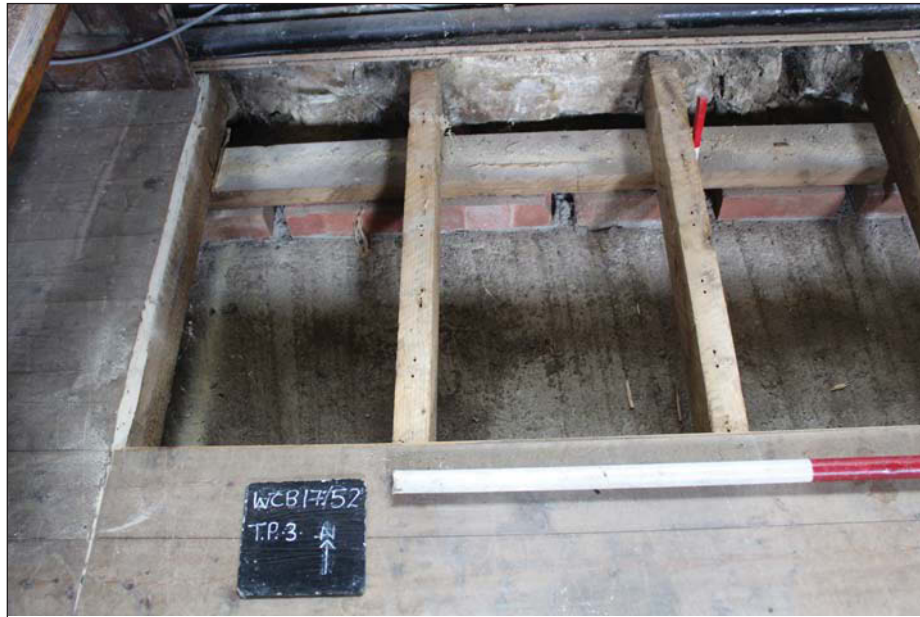
This test pit was positioned in the north aisle, east of the north aisle access. The area exposed removed boarding from the interior wall, 1.5m long and 1m wide. Once the pews and floor had been removed, it was noted that a modern concrete slab was under the suspended floor. Two other small points of investigation were undertaken in the north aisle suspended floor, and concrete was found throughout. A relatively modern wooden joist utilised the old joist holes visible at the base of the existing wall.

Plate 3. Interior, test pit 3, looking north, Scales: 1m and 0.3m.

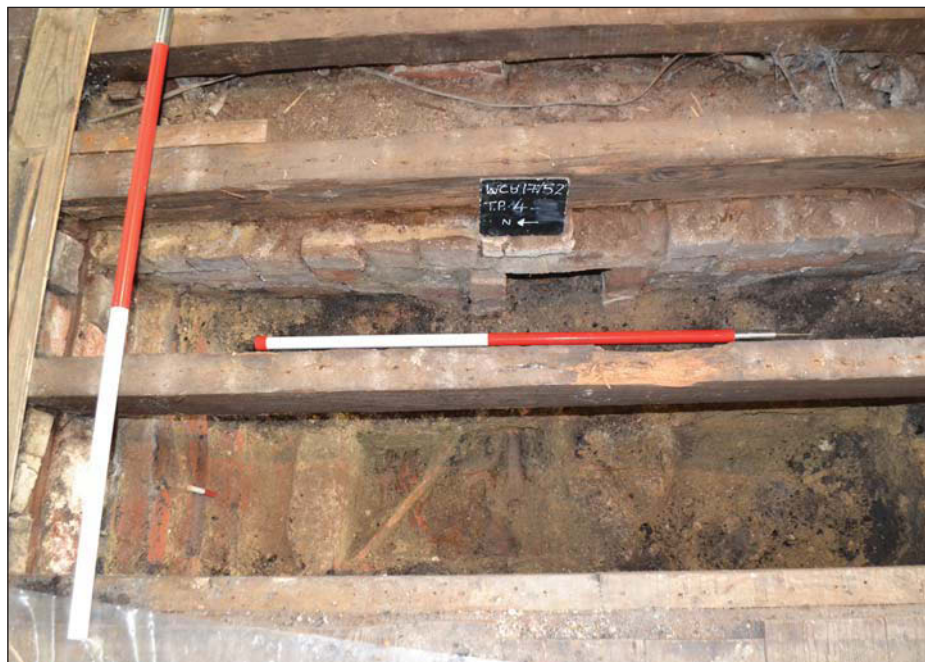
This test pit was positioned in the nave, on the suspended floor directly to the west of the marble pulpit. This measured 1.75m by 0.9m. Below the flooring, part of a brick support was visible under the eastern joist, but the western side of the area exposed soil. A slot 1.47m long by 0.4m wide was hand excavated through dark brown sandy silt, 0.1m thick which contained 19th-century pottery, metalwork and four clay tobacco pipe stems and bowls.

This overlay a compact earth surface, which was light yellow sandy clay and contained crushed mortar (54). This in turn overlay two areas of softer fill. The fill of the south was a light brown yellow sandy clayey silt with frequent crushed red plaster and limestone inclusions (58). The base of this fill was not reached at the base of excavation at 0.35m. In the north of this test pit, a limestone-edged grave (1) was discovered on a W-E axis. The pelvic area of one *in situ* individual was encountered (sk56), with a second individual present directly over the top of the lower remains. The bones that were present of Sk56 were either side of the pelvic bone, both parts of the forearms and bones of both hands. Both of the top portions of the femurs were present. The second individual was represented by one femur and one side of the pelvis. The limestone blocks were 0.15m high (57) forming very different facings of the grave with a probably carved slab on the northern edge and unworked rounded stones making its southern edge. The upper parts of the skeleton were 0.28m deep.

No finds were recovered from the fill of the grave (55) which was a soft, light brown yellow sandy clay silt and contained frequent limestone pieces. The bones were left *in situ*.

Plate 4. Interior, test pit 4, looking north, Scales: 1m x2.

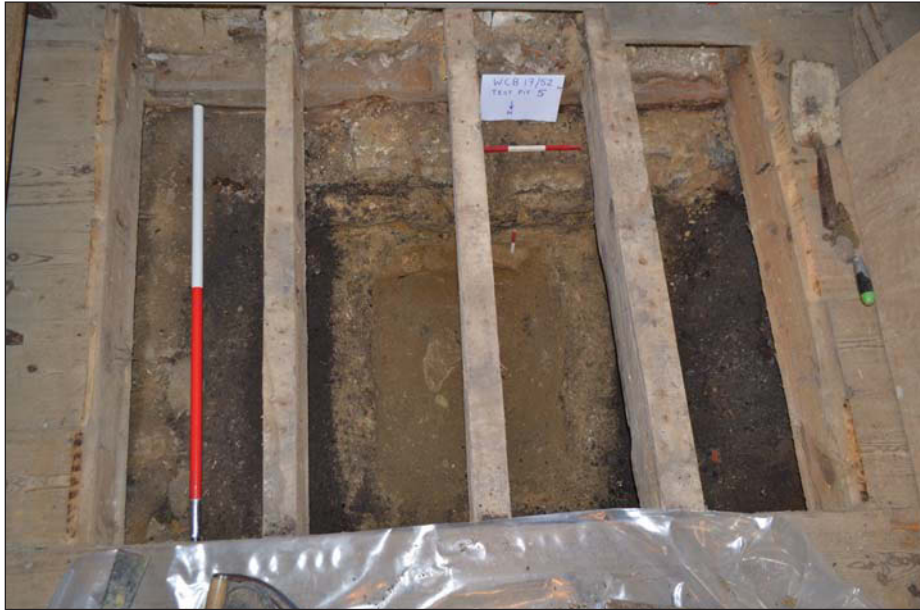
This test pit was excavated in the south aisle to the east of the main south doorway. This pit measured 1.6m by 1.2m. The excavated area of the soil that was exposed under the suspended floor was 1m by 0.7m. The top layer

was a soft dark brown black silty ash (61), 0.28m deep, similar to test pit 4. Pottery and metal finds were recovered from this fill, all suggesting a 19th-century date. Underlying this was a firm, light brown sandy chalky clay (62). Two pieces of disarticulated human infant bone were recovered from this fill. A small area of compact chalky clay was noted in the north-eastern part of the test pit at the base of excavation (63).

Three courses of interior stone foundation were exposed in section, which were roughly faced, but the current joist did not use the original joist holes created in the upper part of the foundation.

Plate 5. Interior, test pit 5, looking south, Scales: 1m and 0.3m.

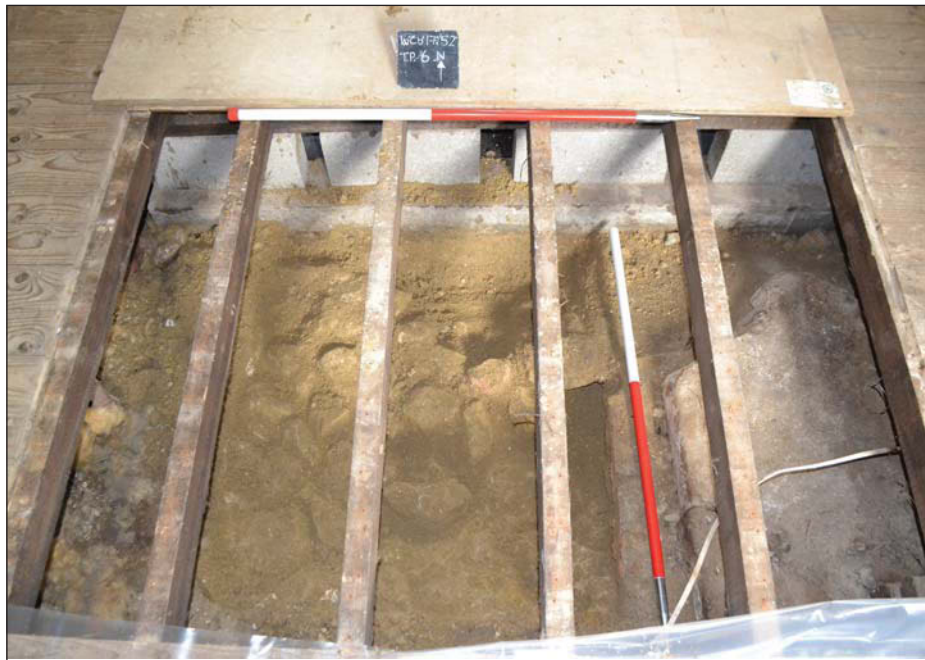
This test pit was 1.6m by 1.4m, on exposed flooring in the south-west of the church to the north of the modern vestry. An excavated hole was dug 1.1m by 0.9m. The top of a crypt tomb was present in the east and was left undisturbed. The top deposit excavated was a soft brownish yellow sandy clay with occasional limestone fragments (59), reaching a depth just 0.06m and is interpreted as a trample layer. This overlay a course of unbonded limestone rubble within a soft light brown yellow sandy clay loam mixed with occasional coarse mortar (60). No identifiable edge of this material was discovered. The surface was extremely uneven and there appeared to be more than a single course. The crypt to the east would have cut through this layer. This deposit appears too massive to be a wall base and too uneven to be a floor: possibly it was the base of the original (late 14th century) tower. The excavation did not exceed 0.22m. No finds were uncovered in this excavation.

Plate 6. Interior, test pit 6, looking north, Scales: 1m x2.
