**Church of St Michael and All Angels,
Waddesdon, Buckinghamshire**

Archaeological Watching Brief

Site Code: WCB17/52

May 2017

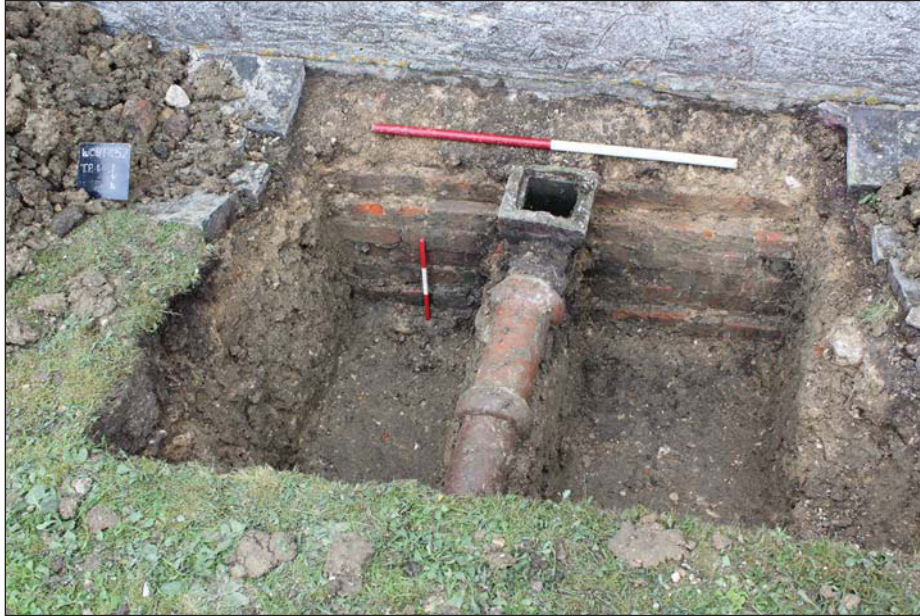
This test pit was 1.6m long by 1.3m wide, and 0.9m deep. Once the bricks for the drainage channel had been taken out, the concrete setting needed to be broken through. Turf and topsoil (0.1m deep) was removed from the south side of the test pit. This covered a firm, light brown silty clay deposit (50) with was present across the extent of the excavated area, up to the brick foundation. It was 0.36m at its thickest at the south of the test pit. A small quantity of disarticulated human bone was recovered from this deposit. No pottery was recovered to indicate date of the deposits, though tile was present, and metalwork recovered included an identifiable portion of a coffin handle.

This deposit in turn overlay a light brown grey silty clay with occasional brick and limestone inclusions (51), up to 0.44m thick. A small quantity of disarticulated human bone was recovered from this deposit. No pottery was recovered to indicate date of the deposit, though again tile was recorded. A brick foundation had been built parallel with the original foundation and the base was encountered in the base of the test pit. It was covered with a sloped cap of mortar, and sat 0.25m from the exterior wall. The top of the capping was directly beneath the mortar of the drainage. Perpendicular drainage, that led away from the drain run northwards, was not removed. It was noted that the drainage cut the exterior brick foundation, therefore making the foundation older than the drain.

Plate 1. Exterior, test pit 1, looking south, Scales: 1m and 0.3m.

Of the exterior Test pits, Test Pit 1 on the north side of the church is against an originally 1320's wall, but exposed a single thickness coursing of brickwork stepped in front of the original foundation. It was most likely a 20th century installation to try to initially control water ingress against this wall into the interior of the church coming from the top of the churchyard to the north, though the clay soil. Test Pit 2 on the south side of the nave wall, up against the western extension wall of the nave, during the time the tower was original built in the 14th century. Here, the ground conditions were different; more sandy and freely draining, with this foundation unmodified.

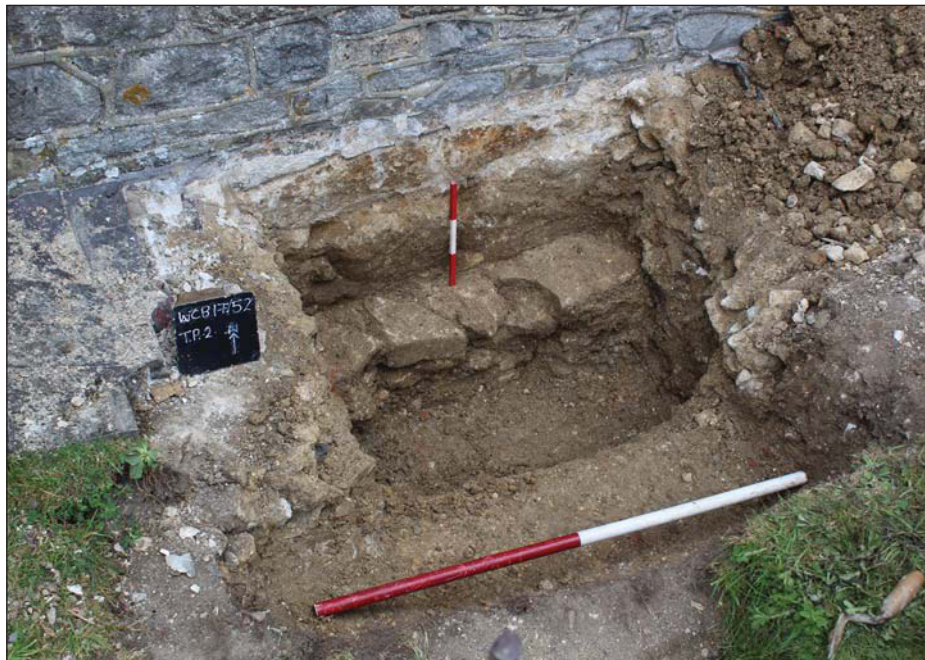
This test pit was 1.3m long by 1.07m wide, and was 0.75m deep. Once the bricks for the drainage channel had been taken out, the concrete setting needed to be broken out by mechanical means. Directly under the concrete

was a 0.37m strip of disturbed mixed fill of tile and brick with grey brown sandy silt that appeared modern. In the south of the test pit, under turf, topsoil reached a depth of 0.22m. This in turn overlay a light grey sandy silty clay with frequent limestone fragments, up to 0.26m deep. Two fragments of tile were recovered from this fill, one a fragment of medieval glazed floor tile.

A step was created in the base of the test pit, to expose the lower limestone foundation step, which was course and not faced. The top of this step was 0.42m deep and stepped out 0.2m from the base of the exterior wall. The lowest fill of this test pit covered this foundation, and was firm, light brown sandy silty clay with occasional brick crumb in the fill. This deposit was excavated to a depth of 0.29m thick but extended beyond the base of excavation. No finds were recovered from this fill.

Plate 2. Exterior, test pit 2, looking north, Scales: 1m and 0.3m.

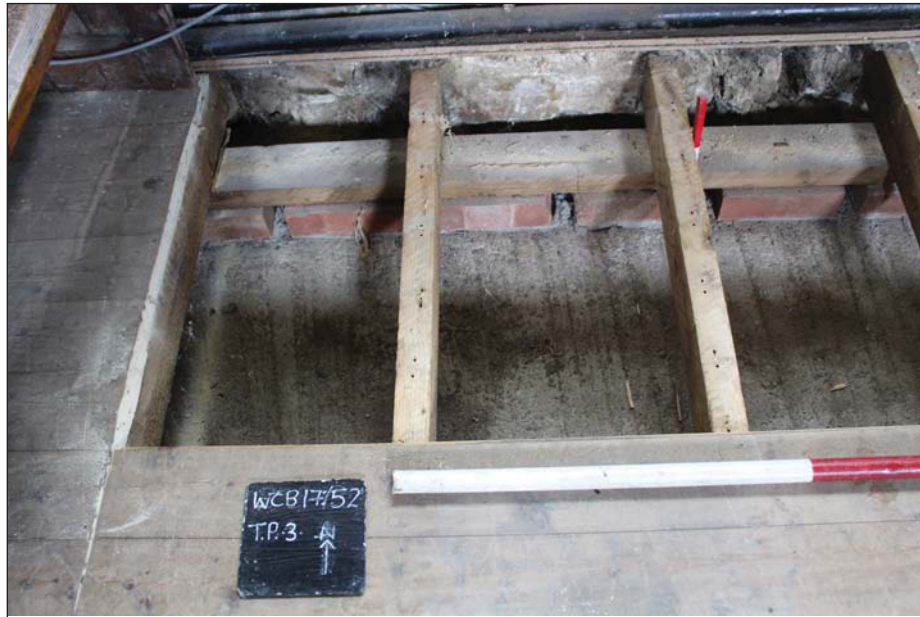
This test pit was positioned in the north aisle, east of the north aisle access. The area exposed removed boarding from the interior wall, 1.5m long and 1m wide. Once the pews and floor had been removed, it was noted that a modern concrete slab was under the suspended floor. Two other small points of investigation were undertaken in the north aisle suspended floor, and concrete was found throughout. A relatively modern wooden joist utilised the old joist holes visible at the base of the existing wall.

Plate 3. Interior, test pit 3, looking north, Scales: 1m and 0.3m.

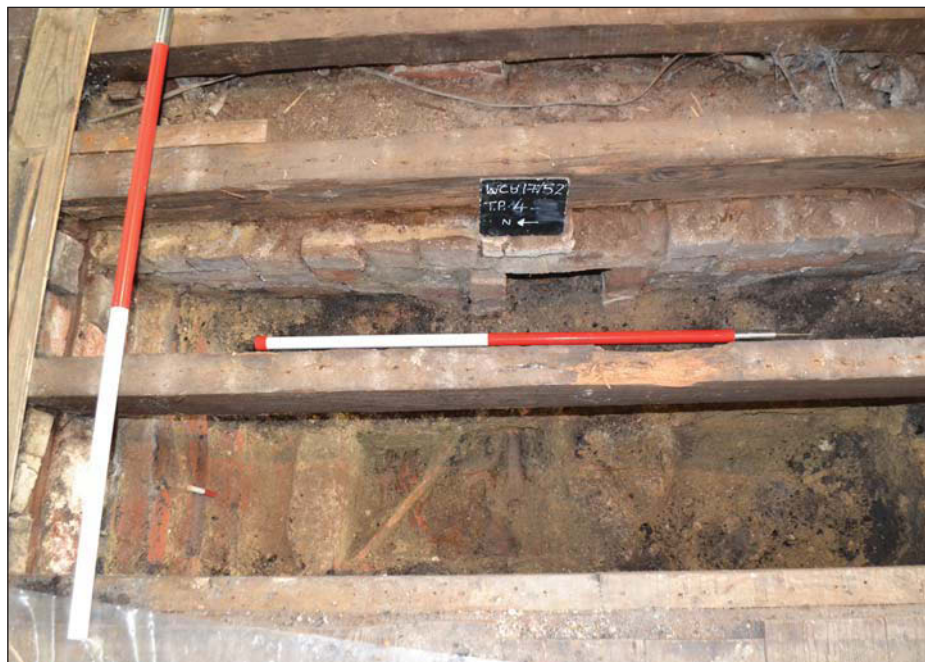
This test pit was positioned in the nave, on the suspended floor directly to the west of the marble pulpit. This measured 1.75m by 0.9m. Below the flooring, part of a brick support was visible under the eastern joist, but the western side of the area exposed soil. A slot 1.47m long by 0.4m wide was hand excavated through dark brown sandy silt, 0.1m thick which contained 19th-century pottery, metalwork and four clay tobacco pipe stems and bowls.

This overlay a compact earth surface, which was light yellow sandy clay and contained crushed mortar (54). This in turn overlay two areas of softer fill. The fill of the south was a light brown yellow sandy clayey silt with frequent crushed red plaster and limestone inclusions (58). The base of this fill was not reached at the base of excavation at 0.35m. In the north of this test pit, a limestone-edged grave (1) was discovered on a W-E axis.

The pelvic area of one *in situ* individual was encountered (sk56), with a second individual present directly over the top of the lower remains. The bones that were present of Sk56 were either side of the pelvic bone, both parts of the forearms and bones of both hands. Both of the top portions of the femurs were present. The second individual was represented by one femur and one side of the pelvis. The limestone blocks were 0.15m high (57) forming very different facings of the grave with a probably carved slab on the northern edge and unworked rounded stones making its southern edge. The upper parts of the skeleton were 0.28m deep.

No finds were recovered from the fill of the grave (55) which was a soft, light brown yellow sandy clay silt and contained frequent limestone pieces. The bones were left *in situ*.

Plate 4. Interior, test pit 4, looking north, Scales: 1m x2.

Part of one *in situ* skeleton (Grave 1; sk 57) was uncovered in the church interior, within test pit 4, with a part of another presumably disturbed, within the same grave. No further disturbance of this burial was necessary at this time. No Medieval pottery was encountered, though the two pieces of pattern Medieval floor tile were, both of probable 14th century date. No deposits can firmly be dated as Medieval, although this would seem to be the most likely context for the limestone layer at the base of test pit 6, and the burial in Test Pit 4 is of at least Post-Medieval in date. The nave is known to have been extended westwards in the mid-14th century and a tower added in the latter part of that century (VCH 1927, 117–18). There is no indication of burial in Test Pit 5, even though documentary evidence describes a significant Medieval burial for the church somewhere close to this location (VCH 1927).

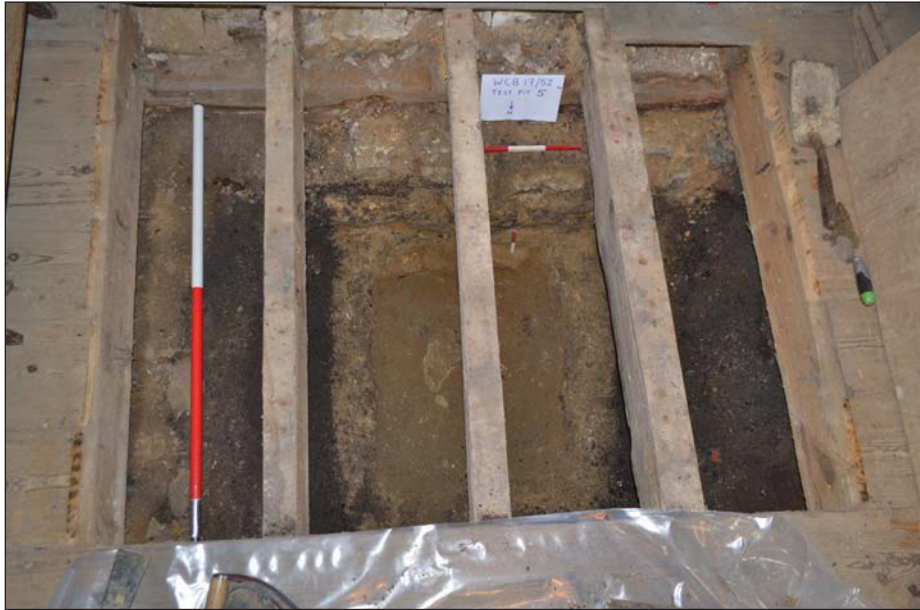
This test pit was excavated in the south aisle to the east of the main south doorway. This pit measured 1.6m by 1.2m. The excavated area of the soil that was exposed under the suspended floor was 1m by 0.7m. The top layer was a soft dark brown black silty ash (61), 0.28m deep, similar to test pit 4. Pottery and metal finds were recovered from this fill, all suggesting a 19th-century date. Underlying this was a firm, light brown sandy chalky clay (62). Two pieces of disarticulated human infant bone were recovered from this fill. A small area of compact chalky clay was noted in the north-eastern part of the test pit at the base of excavation (63).

Three courses of interior stone foundation were exposed in section, which were roughly faced, but the current joist did not use the original joist holes created in the upper part of the foundation.

Plate 5. Interior, test pit 5, looking south, Scales: 1m and 0.3m.

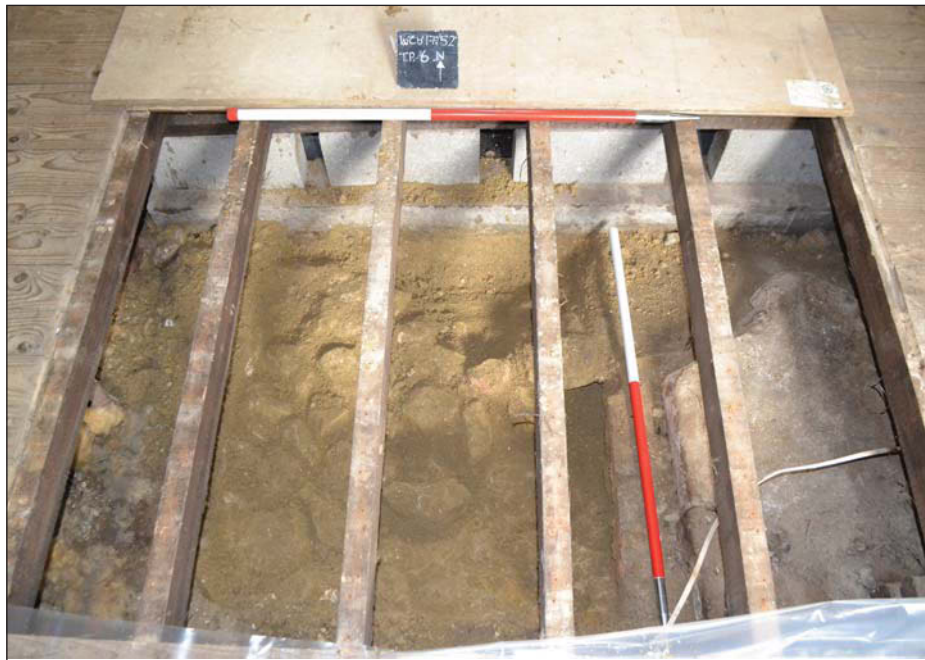
This test pit was 1.6m by 1.4m, on exposed flooring in the south-west of the church to the north of the modern vestry. An excavated hole was dug 1.1m by 0.9m. The top of a crypt tomb was present in the east and was left undisturbed. The top deposit excavated was a soft brownish yellow sandy clay 0.06m thick, with occasional limestone fragments (59), and is interpreted as a trample layer. This overlay a layer of unbonded limestone rubble within a soft light brown yellow sandy clay loam mixed with occasional coarse mortar (60). No identifiable edge of this material was discovered. The surface was extremely uneven and there appeared to be more than a single course. The crypt to the east appears to truncate this layer. This deposit appears too large in plan to be a wall base and too uneven to be a floor: possibly it was the base of the original (late 14th century) tower. The excavation did not exceed 0.22m. No finds were uncovered in this excavation.

Plate 6. Interior, test pit 6, looking north, Scales: 1m x2.
