**The White Swan Public House, 243 Golders Green Road,
London Borough of Barnet**

Building Recording

Site Code: GOG17/165

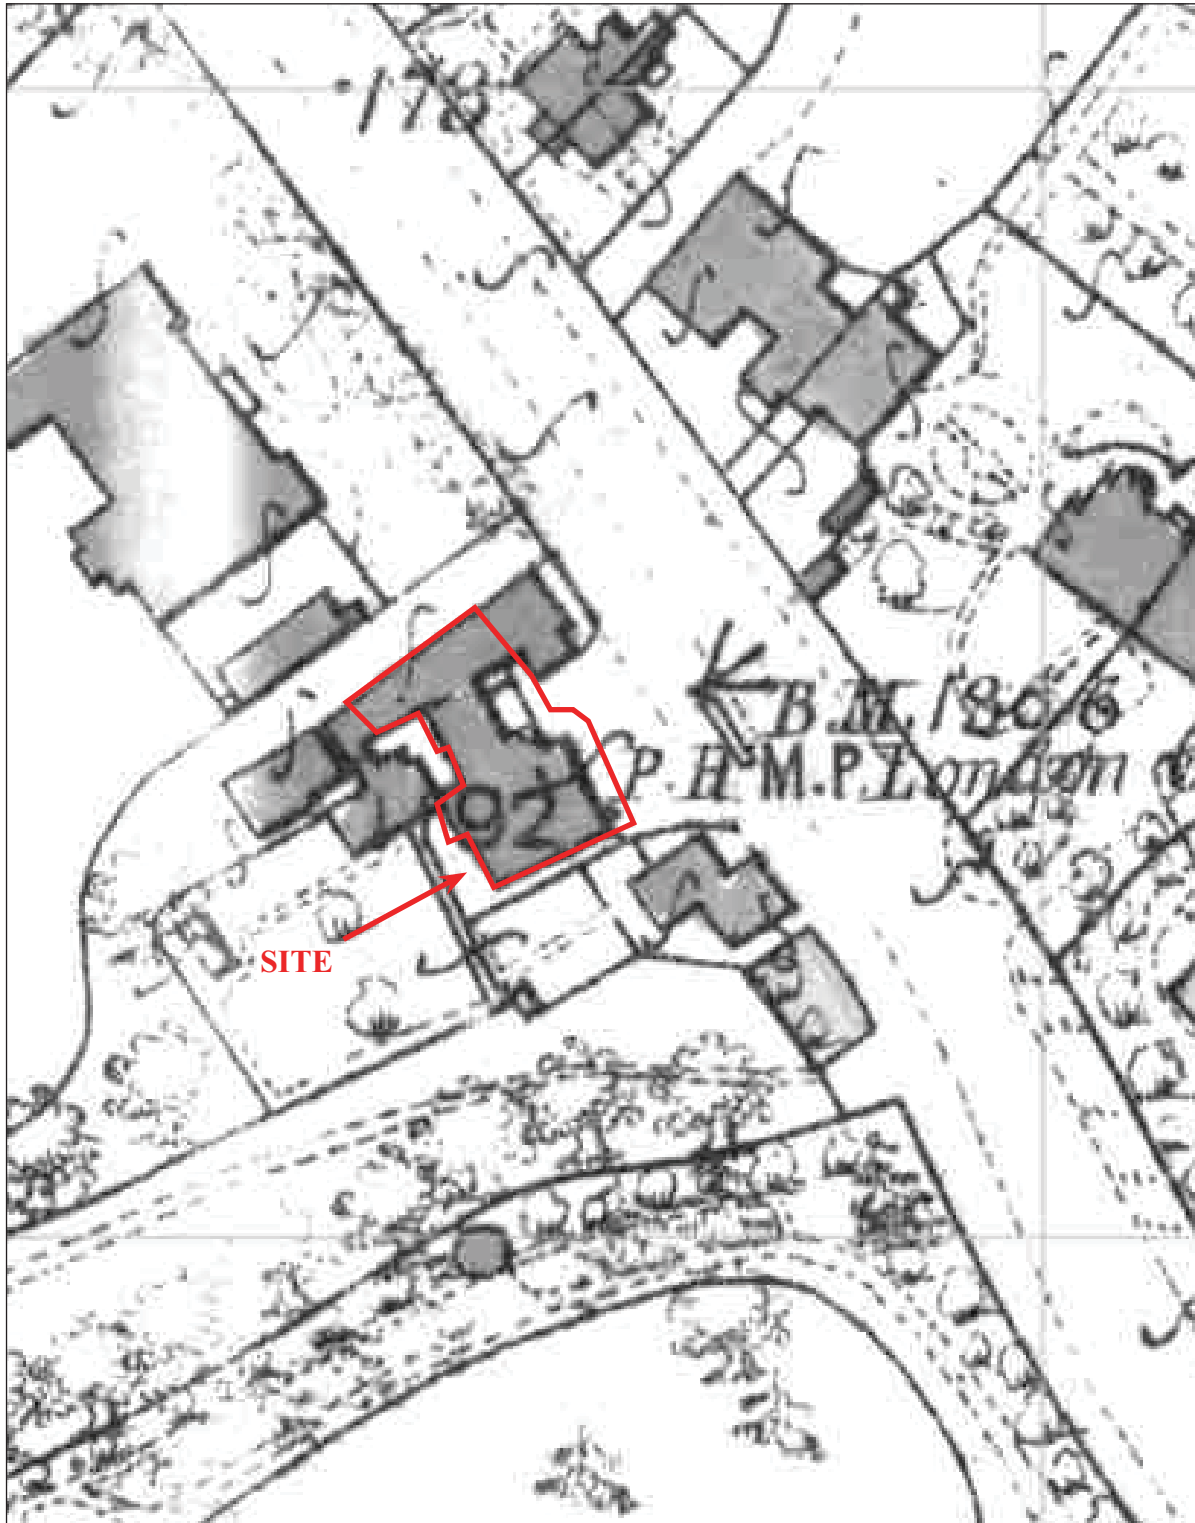
Figure 6. First Edition Ordnance Survey, 1864

The first map to show the buildings in detail is the First Edition Ordnance Survey map of 1864 (Fig. 6). Here it is possible to see how the current building has been extended from its earlier form. The building shown includes phases 1, 2 and 3 and is likely to be the same as that seen on the tithe map. It is annotated as a public house and the milepost is also noted (6 miles to London). A new building is present to the north-west, later labelled as 'Highfield'. The Second Edition Ordnance Survey map of 1896 (Fig. 7) shows changes to the front of the building with the addition of a bay window, seen in contemporary photographs (phase 4). Further buildings are now present to the rear of the site and to the north-west including a new cart entrance with a room above.

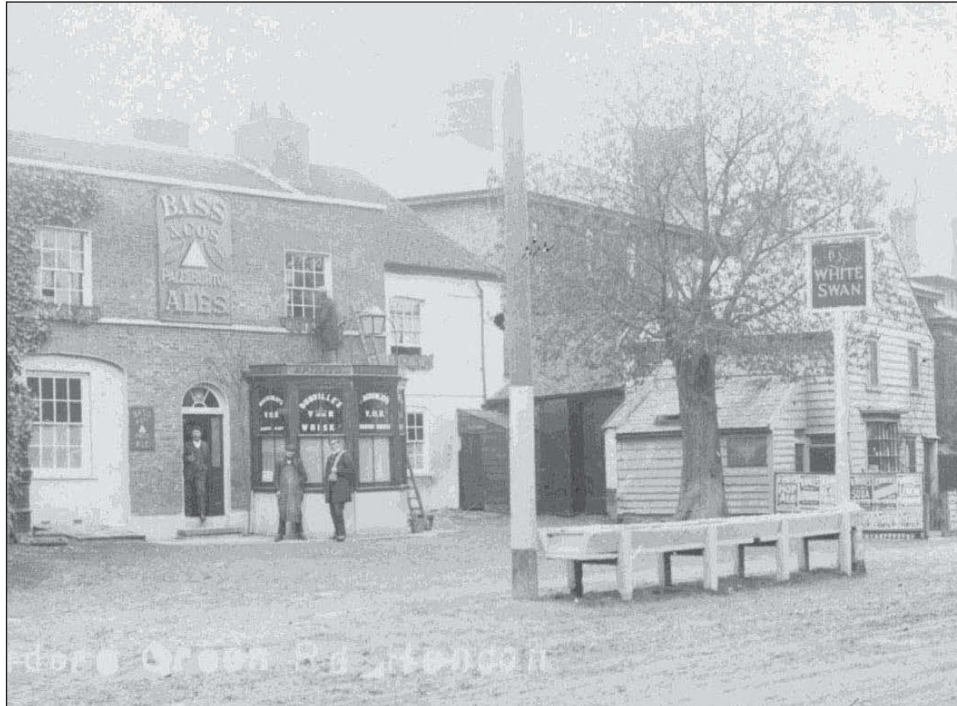
Photographs from the late 19th century (Pl. 1) show the building prior to the front extension, when it was in the hands of Bass and Co. The photographs focus on the main entrance (phase 2) with only a glimpse of the phase 1 building to the north-west. The phase 2 building has a central doorway with a semi-circular window above. Windows are present either side; to the south-east is an 8-over-8 sash window set within a former arched opening and to the north-west is a 5-sided bay window (phase 4). Above a string course, on the first floor are a further two 8-over-8 sash windows set above those of the ground floor. The roofline is hidden behind a parapet. Of the phase 1 building to the north-west, only two windows can be seen, set one above the other, and again consisting of 8-over-8 sash windows. The building is either painted or plastered in a pale colour.

Plate 1. Late 19th century photo of The White Swan showing the former cart entrance and bay window

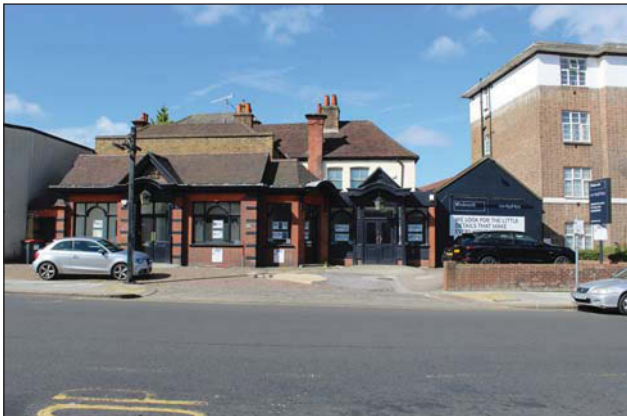
Externally only the parapet could be seen from street level, though there were two windows present at first floor height concealed behind the ridge line of the ground floor phase 5 front extension (Pl. 2). The windows appeared to be of sash type of 2-over-1 pane. No further detail could be discerned as they had been boarded up internally. To the rear the first and second floors could be seen; the ground floor being obscured by large shrubs (Pl. 3). The ground floor contained two doors and three windows. The doors were modern and the windows, where seen, were of casement type with frosted glass. Within the first floor were two sash windows with horns; one narrow window consisting of two over two panes and the other of three over three panes. A third window had been converted to a fire escape with a narrow slit window remaining beside it. Above this window was a flat segmental arch. A cast iron spiral staircase, painted black, gave access to the ground (planning permission C00539V showed this dated to 1998). A single sash window of three over three panes beneath a flat segmental arch was present on the second floor.

Plate 2. The White Swan, looking southwest,
Scales: 2 x 1m.

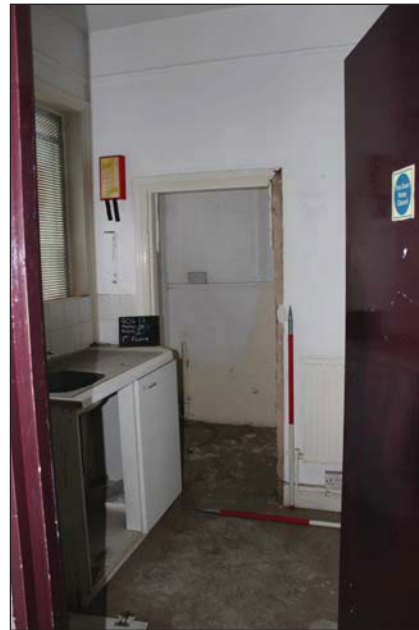
To the rear (south-west) side of the building was a small kitchen (6) with a window to the rear (Pl. 7). Off this room was a small 'pantry' against the side of the chimney breast with a small window lighting it. Room 7 was an internal room, formerly used as an office (Pl. 8). Both rooms had white plastered walls. The kitchen was also partially tiled and contained a picture rail. The wall within the pantry dividing rooms 6 and 9 could be seen to be of lath and plaster construction.

Plate 7. Room 6, looking northwest, Scales: 2 x 1m.

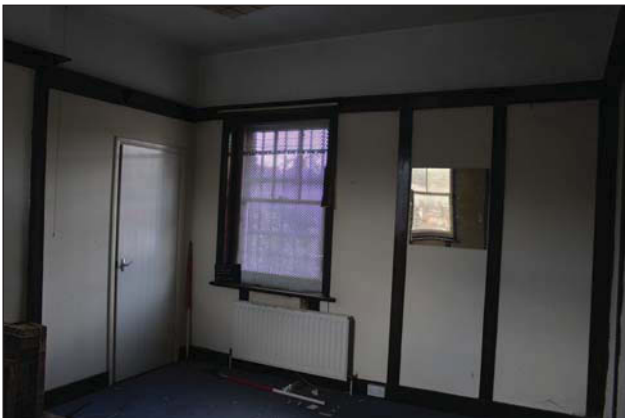
Room 9 was located at the end of the corridor and stretched across the width of the building. There was a window in both the front and rear walls (Pl. 10). In the south-east wall was a fireplace (Pl. 11). This was tiled with a shallow arched mantle and a split level tiled hearth. It probably dated to the 1950s. On the far side of the chimney breast was a small toilet built up against the side of the chimney. The room was plastered white with faux-timber framing consisting of the skirting board, picture rail and posts in between, all stained dark brown.

Plate 10. Room 9, looking southwest, Scales: 2 x 1m.

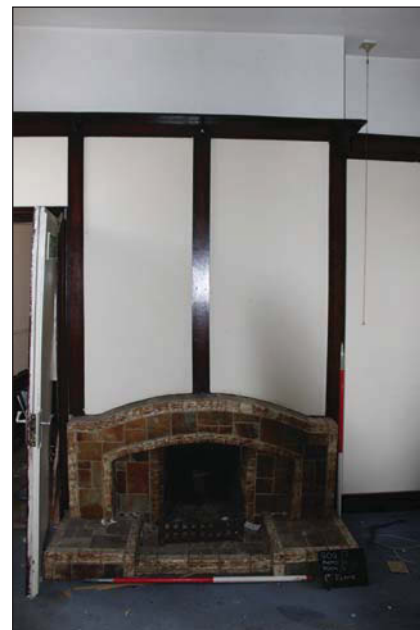
Plate 11. Room, fireplace detail, looking southeast, Scales: 2 x 1m.

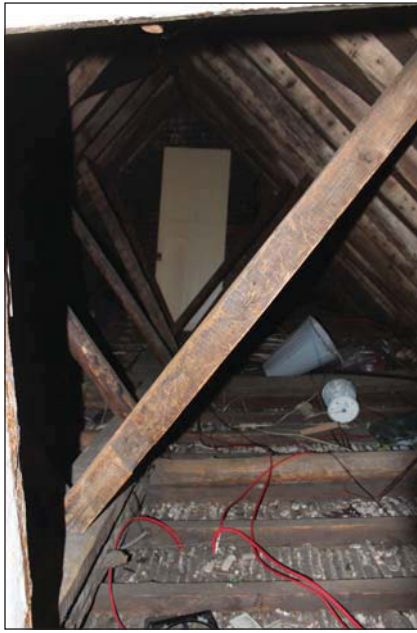
Access to the loft area was via a small door on the second floor landing outside room 1. The roof structure consisted of a central ridge plank with pine rafters laid on edge. The rafters were then supported by raking struts from the central beam which were tied into small planks of wood acting as the purlin (Pl. 12).

Plate 12. Phase 1 roof detail, looking northwest.

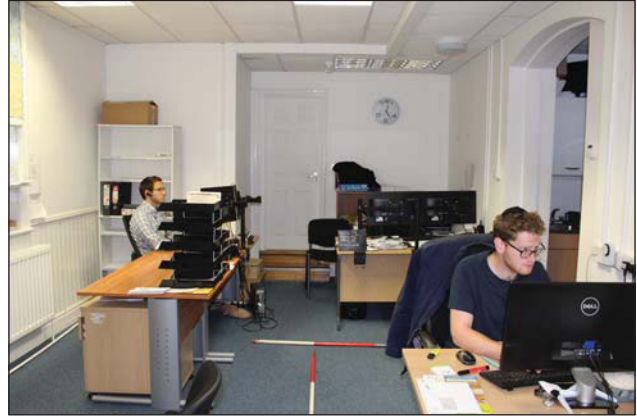
Room 23 (Pl. 15) had been recently renovated to accommodate an office area. Wooden panelling was present beneath the dado rail and there was a window in the external wall to the south-east. The floor had been carpeted, the original ceiling obscured by a modern suspended ceiling and the fireplace boxed in. A modern door at the south-west end of the room gave access to corridor 25, up a set of two steps. In the north-west wall was an archway opening into room 24.

Plate 15. Room 23, looking southwest,
Scales: 2 x 1m.

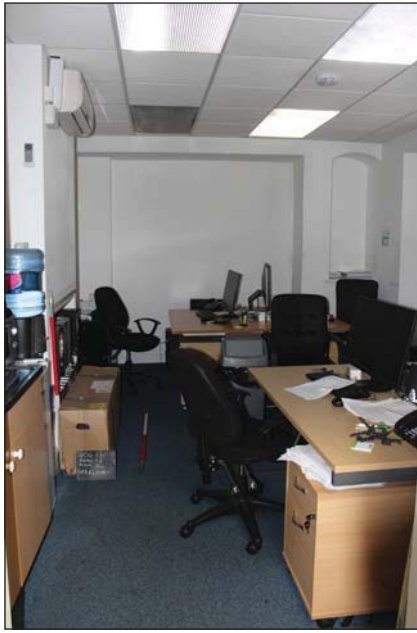
Room 24 (Pl. 16) predominantly encompassed the bar area, though this had been removed by the time of the building survey and converted into an office. The north-west wall of the original room 24 had been removed to create a longer serving area, extending into the phase 5 extension. This wall and the small 'window' created by the remaining pillars had been subsequently enclosed again in phase 7. The original room had a central fireplace within the south-west wall, the opening of which had been converted to a bookcase. Like room 23, room 24 had modern carpet and a suspended ceiling. Immediately to the north-west of the fireplace was a door giving access to corridor 13 within the phase 1 building.

Plate 16. Room 24, looking northwest,
Scales: 2 x 1m.

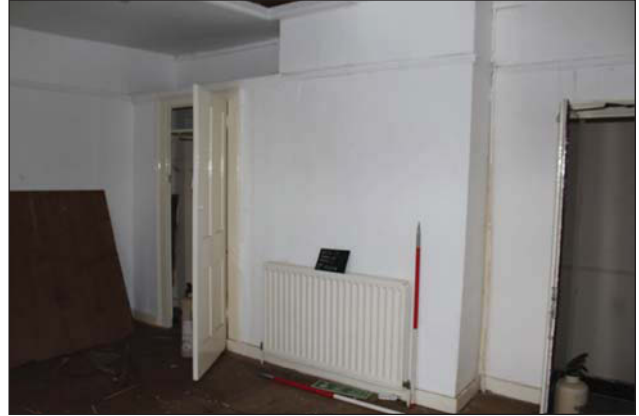
Room 10 (Pl. 17) was located off corridor 8 from phase 1. The walls and ceilings were plastered and painted white; a picture rail was present around the wall. Within the north-east wall was a window, located slightly off centre. Within the south-west wall was a chimney breast. To the south-east of the chimney breast was a built in cupboard with a Victorian style four-panel door. Contained within the cupboard was evidence for a blocked doorway, set at a slightly higher level to the room itself, requiring a step down (Pl. 18).

Plate 17. Room 10, looking southwest,
Scales: 2 x 1m.

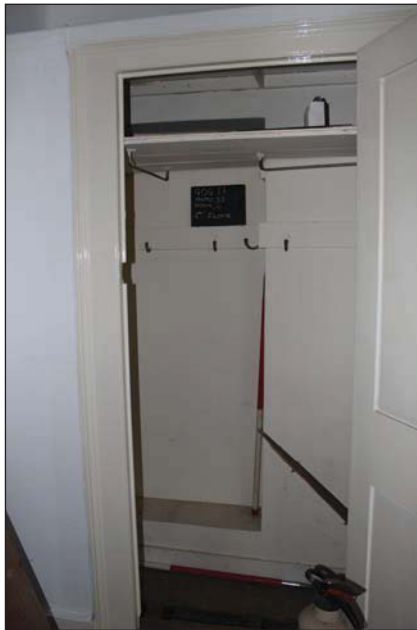
Plate 18. Room 10, blocked door, looking southwest,
Scales: 2 x 1m.

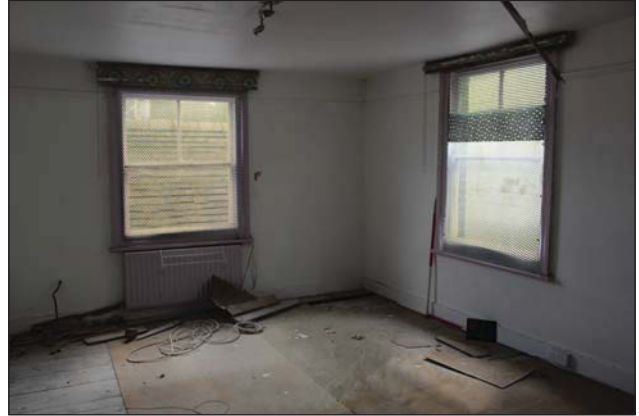
Room 2 (Pl. 19) was accessed off the stairs up to the second floor. The room contained windows in the north-east and south-east walls. The walls and ceiling were of white painted plaster with a picture rail, whilst the floor was a combination of wooden planks and hardboard. In the south-west corner was a blocked fireplace (Pl. 20). Within the ceiling a structural beam had been boxed in. This beam was in line with the end of the roof.

Plate 19. Room 2 looking east,
Scales: 2 x 1m.

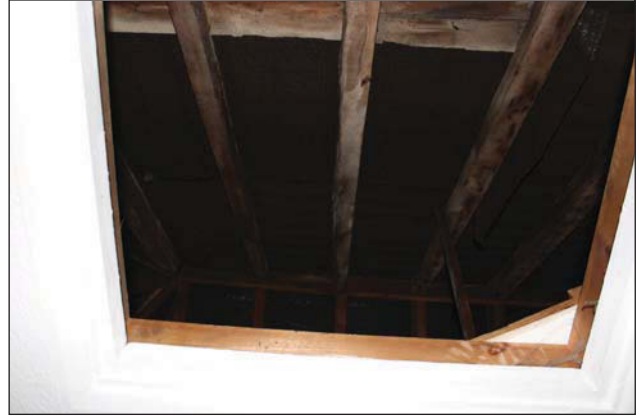
The loft access was located within the ceiling of room 10. The roof construction appeared to be of common rafter type with a central ridge plank. The wood appeared to be pine (Pl. 21).

Plate 21. Room 10, roof space, looking east.

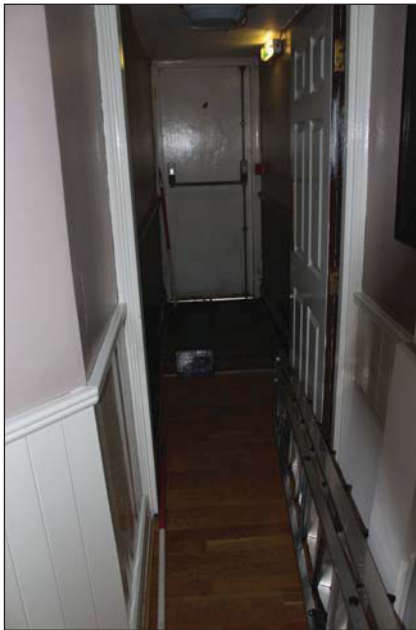
Corridor 25 (Pl. 22) had, like rooms 23 and 24, been modernized with plastered and painted walls and ceiling and laminate flooring. Beneath a dado rail was wooden plank panelling. At the end of the corridor, up a step was a fire exit. Located off the corridor were rooms 31 to the south-east and room 26 to the north-west. Both were toilets; room 31 the gents toilet to which there was no access and room 26 the ladies toilet. Within room 26 (Pl. 23) a small corridor opened into the toilets proper. These were entirely tiled with green tiles beneath a torus band at dado-rail height and cream above. In the south-west wall was a casement type window with frosted glass. The floor was a combination of stripped pine boards in the wash area and tiled with the cubicles. The two cubicles were located along the north-west wall. In the easternmost one was a storage cupboard whilst in the westernmost one was evidence for a blocked door into room 11.

Plate 22. Room 25, looking southwest,
Scales: 2 x 1m.

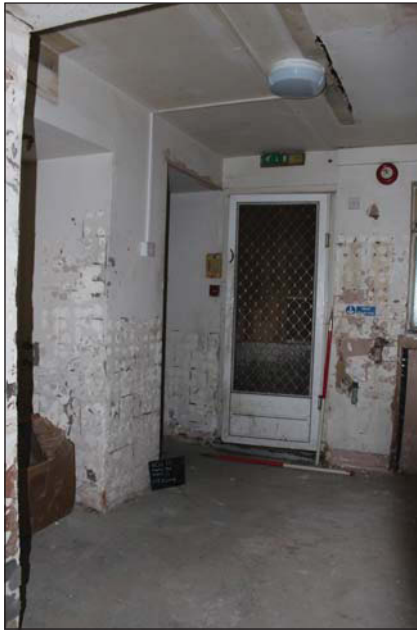
Room 11 (Pl. 24) was located off room 12 (phase 1) and accessed up a step. Like room 12 the room had been stripped back to bare walls and floor. It appeared to be an extension to the kitchen with the walls formerly covered in tiles. Within the rear wall was a modern door and a frosted, casement window.

Plate 24. Room 11, looking southwest, Scales: 2 x 1m.

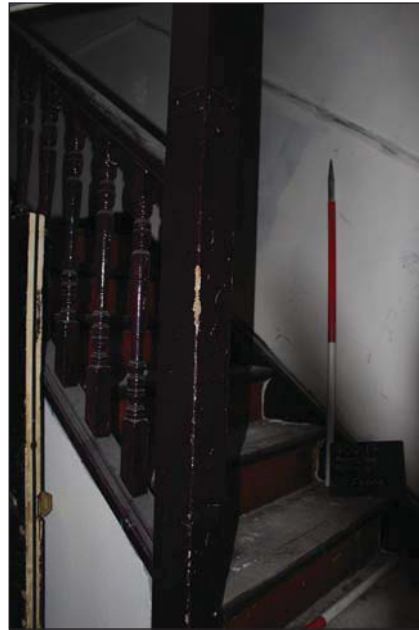
The stairs (Pl. 25) were located at the south-west end of corridor 13 (phase 1) and were of straight flight with winder type and continued in the same style up to the second floor. The newel post had a simple square profile, whilst the balusters were turned and the banister rail curved. The steps were of closed tread style.

Plate 25. Room 8, stair detail, looking northwest, Scales: 2 x 1m.

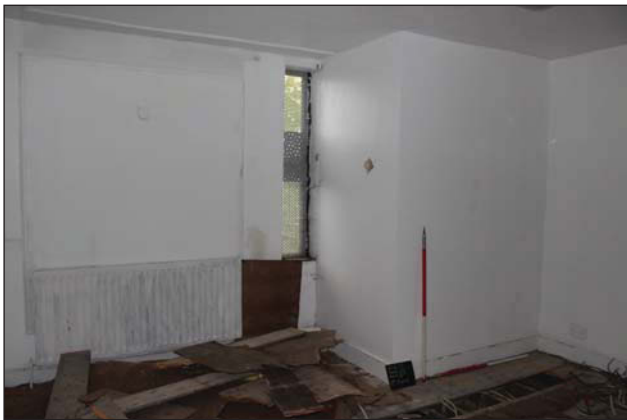
corridor to the fire escape seen to the rear of the building. The fire escape was cut through a former window, the remainder of which was located within room 3. Room 3 (Pl. 26) was originally approximately square in shape with a single window in the south-west (rear) wall. The floor was covered in floorboards. The walls and ceiling were of painted plaster. Within each of the walls was a large panel with a cavetto-type moulded edge. A similar style panel was also present in the ceiling (Pl. 27). The door to the room was four-panelled Victorian style and the only older style room door within the building, albeit not in an original location.

Plate 26. Room 3, looking northwest, Scales: 2 x 1m.

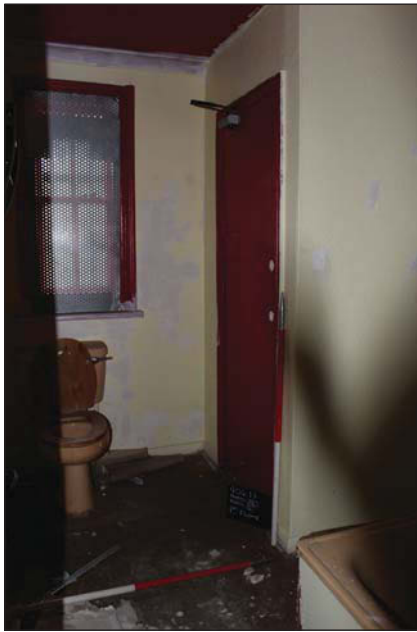
Room 5 was located up a shallow step from corridor 4 and was latterly used as the bathroom. The walls and ceiling were of painted plaster and in the rear wall was a small window. A larger window was located within a cupboard in the corner of the room, to which there was no access (Pl. 28).

Plate 28. Room 5, looking west, Scales: 2 x 1m.

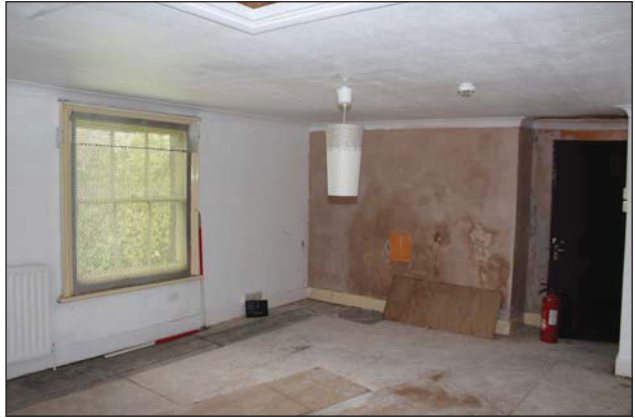
On the second floor there was a single room, 1. The walls and ceiling had been plastered and painted. Around the ceiling was cavetto shaped coving. In the rear wall was a single window. A chimney breast was located in the north-west corner of the room (Pl. 29).

Plate 29. Room 1, looking northwest, Scales: 2 x 1m.
