**Fairlawn, 17 Lawns Avenue,
Eastbourne, East Sussex**

Archaeological Watching Brief

Site Code: LAE127/201

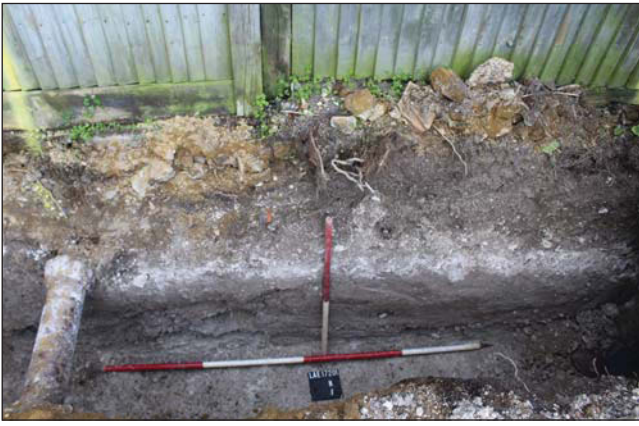
Plate 1. Footings of rear extension, looking North.
Scales: 2m and 1m.

The stratigraphy recorded in the footings for the rear (east) extension consisted of 0.30m of concrete and its associated bedding layer, above 0.60m to 0.95m of made ground containing modern material including concrete and plastic fragments (not retained). The made ground was recorded immediately above the natural geology, indicating that the area had been significantly disturbed in the recent past (Fig. 4; Pls 1 and 2).

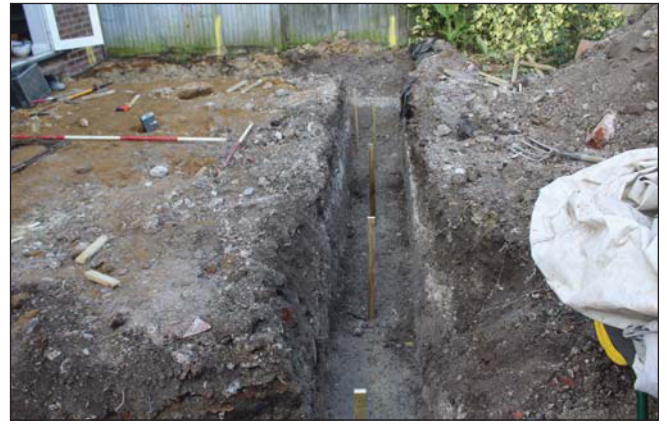
Plate 2. Footings of rear extension, looking North.
Scales: 2m and 1m.

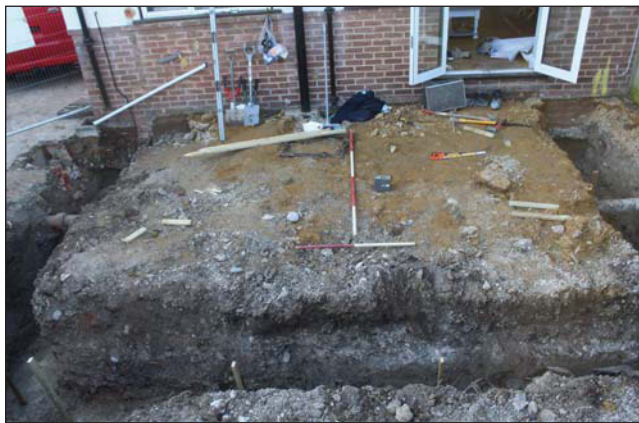
Plate 3. General view of site, looking West.

Prior to the footing trenches being excavated, the existing patio to the rear of the property had been removed. The footings were then dug under constant archaeological supervision. All the footing trenches were about 0.60m wide, and between 1.0m and 1.30m deep (Fig. 3; Pl. 3).

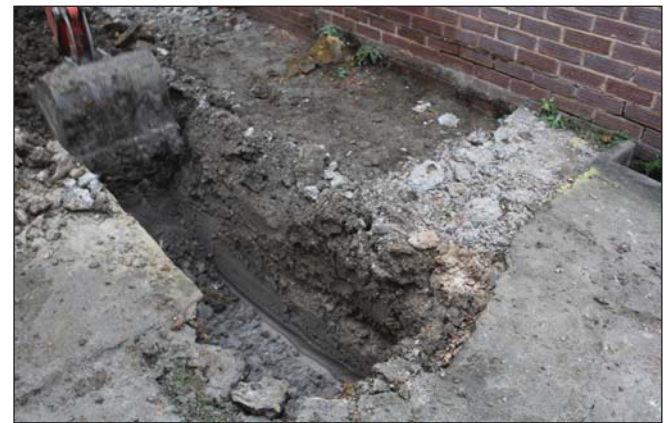
Plate 4. Footings of side extension, looking North-west.

The footings for the side (south) extension showed that the stratigraphy above the natural geology generally consisted of 0.10m of concrete, above 0.60m of modern made ground and 0.30m of sterile mid grey silty clay (Fig. 4; Pls 4 and 5).

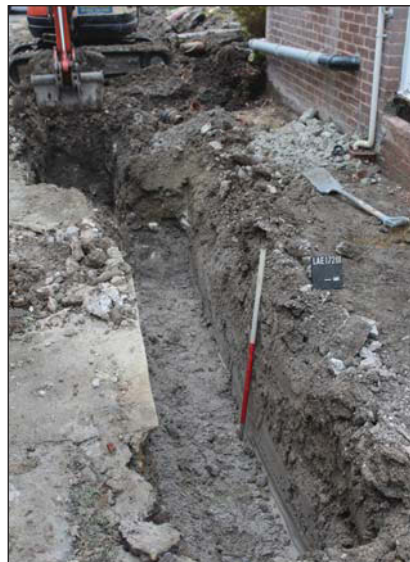
Plate 5. Footings of side extension, looking West.
Scale: 1m.
