**St Michaels Church Hall, Vicarage Drive,
Bray, Maidenhead, Berkshire**

Archaeological Watching Brief

Site Code: SMB16/170

December 2017

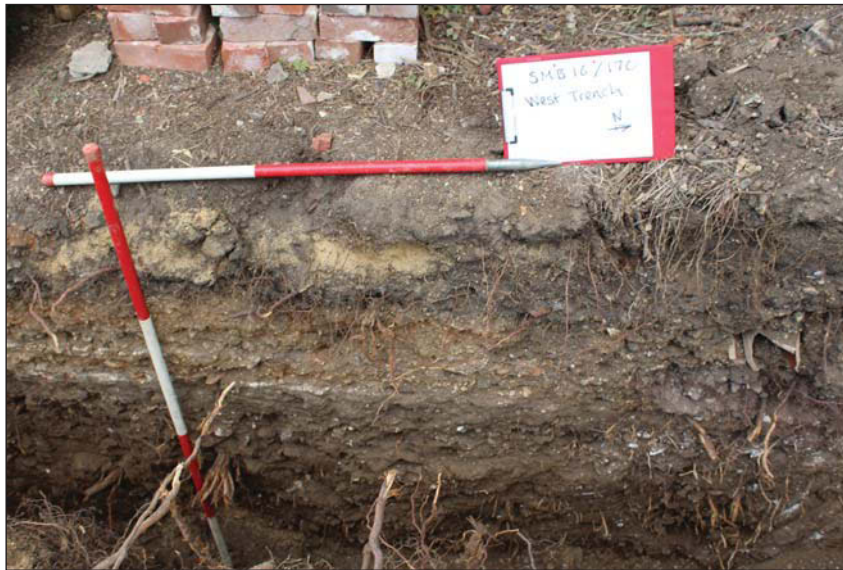
The stratigraphy varied only in the uppermost levels. In the east and south trench were two layers of concrete (0.23m deep) above 0.31m of made ground consisting of concrete and brick rubble overlying a dark brown grey sandy silt disturbed grave soil (50) to the full depth of the trench (Fig. 4; Pl. 1). In the north and west trenches a single concrete spread (0.10m deep) overlay a thin topsoil spread (0.05m deep) above the disturbed grave soil (50). This was found to contain disarticulated human bone, animal bone, 'china' pottery fragments, nails and occasional coffin handles and a "Golden Wonder" crisp packet. No articulated burials were observed and none of the finds were removed from the site. The concentration of human bone was particularly high in the west trench.

Plate 1. West trench, looking south west, Scales: horizontal 1m, vertical 2m.

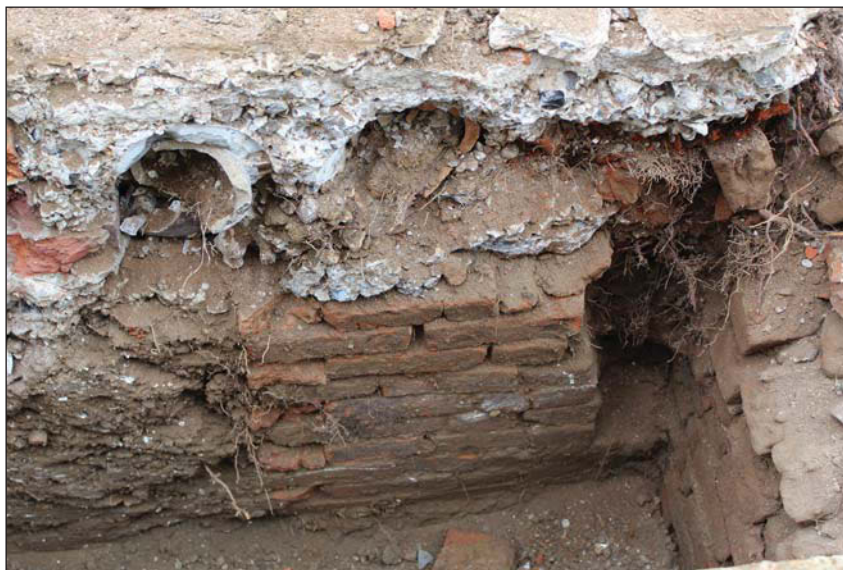
In the south-eastern corner of the southern trench was part of a brick wall (Pl. 2). This may be the end of a tomb and from the observed bricks could be late medieval, although more likely early post-medieval. It survived ten courses high (it deep not appear to extend below the base of the trench but this was not definitely established) and was only very loosely bonded. An unrelated return wall along the south corner of the west trench was clearly later.

Plate 2. End of wall in south trench, looking south-east.
