**Golding's Yard, Bullington Lane,
Barton Stacey, Hampshire**

Building Recording

Site Code: GYBS18/46

**Building Recording
For Irongate Developments Ltd**

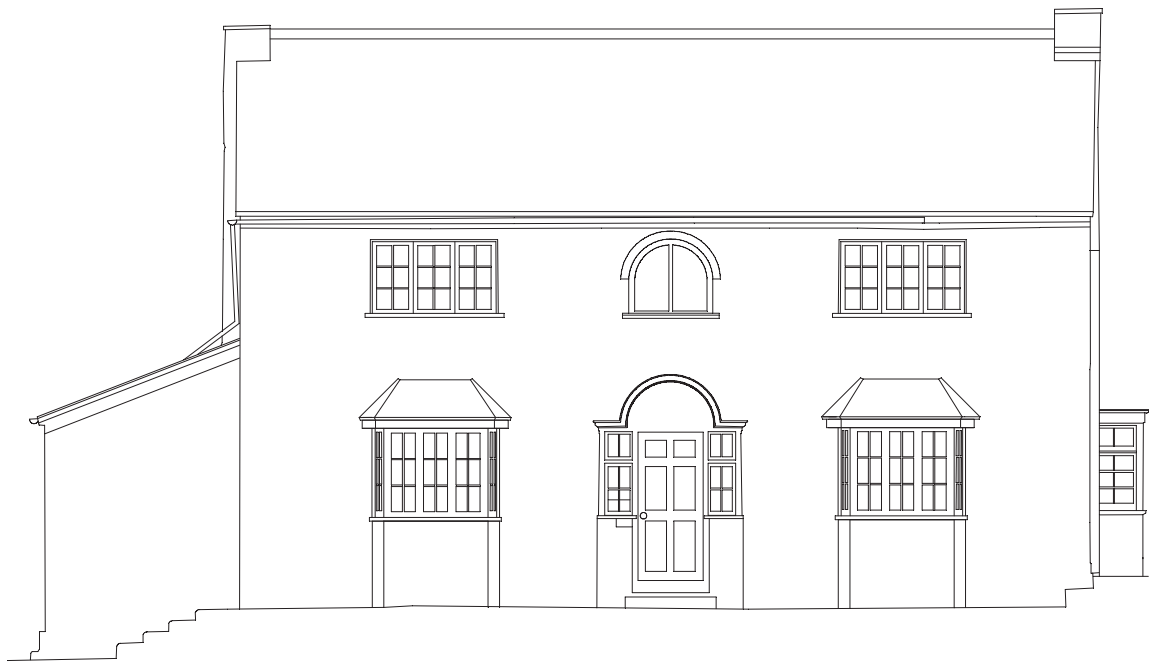
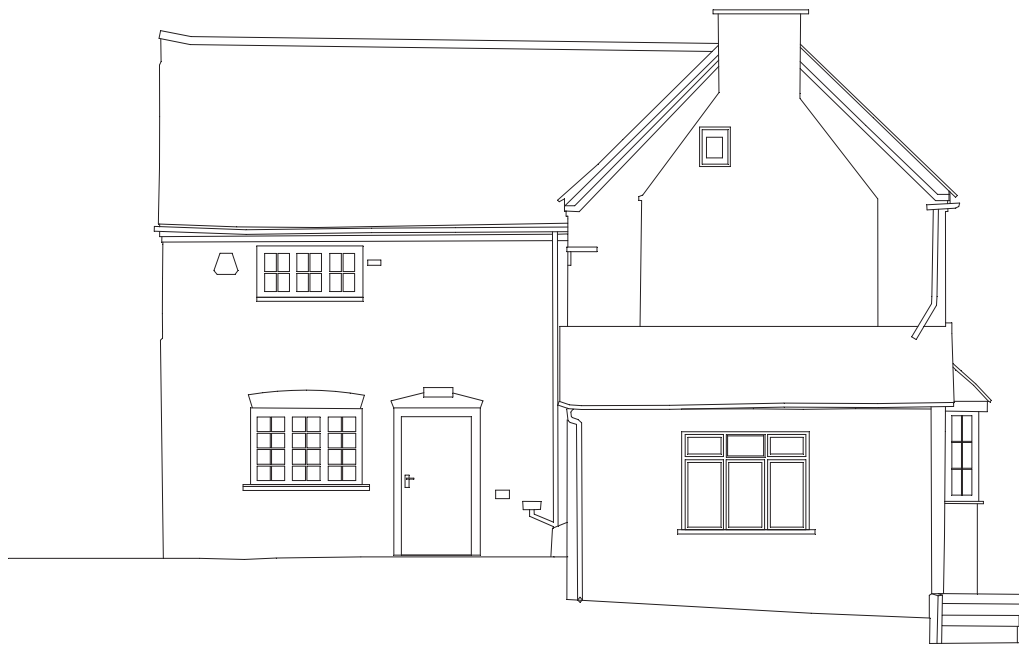
WEST ELEVATION

NORTH ELEVATION

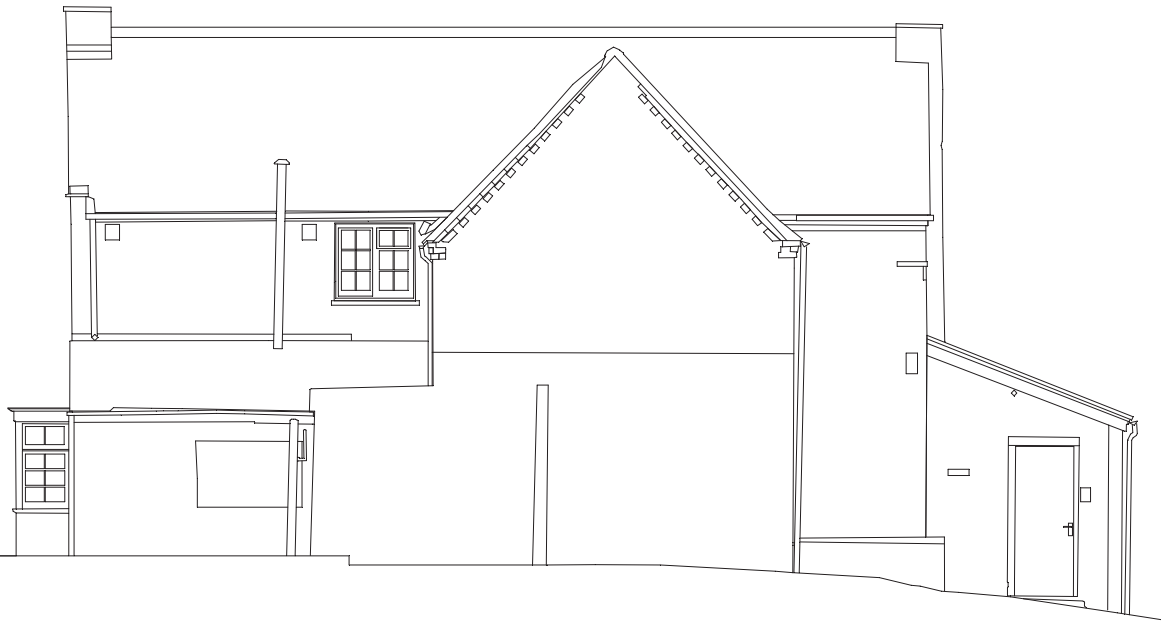
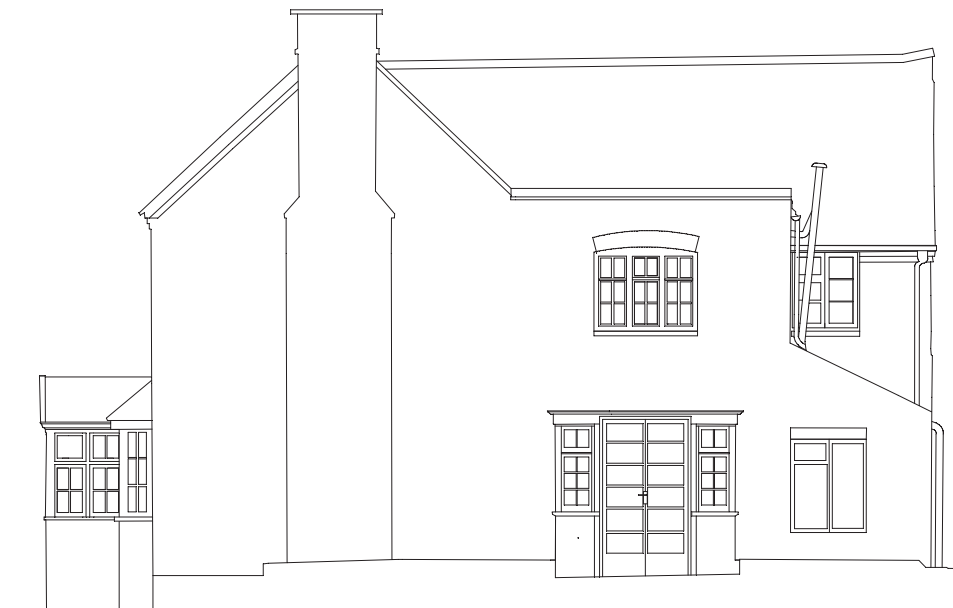
EAST ELEVATION

SOUTH ELEVATION

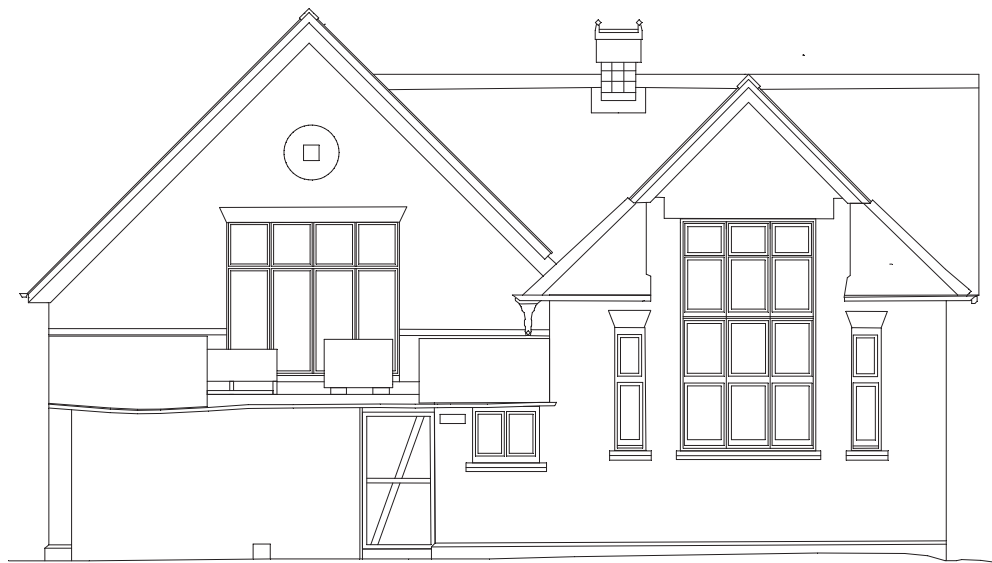
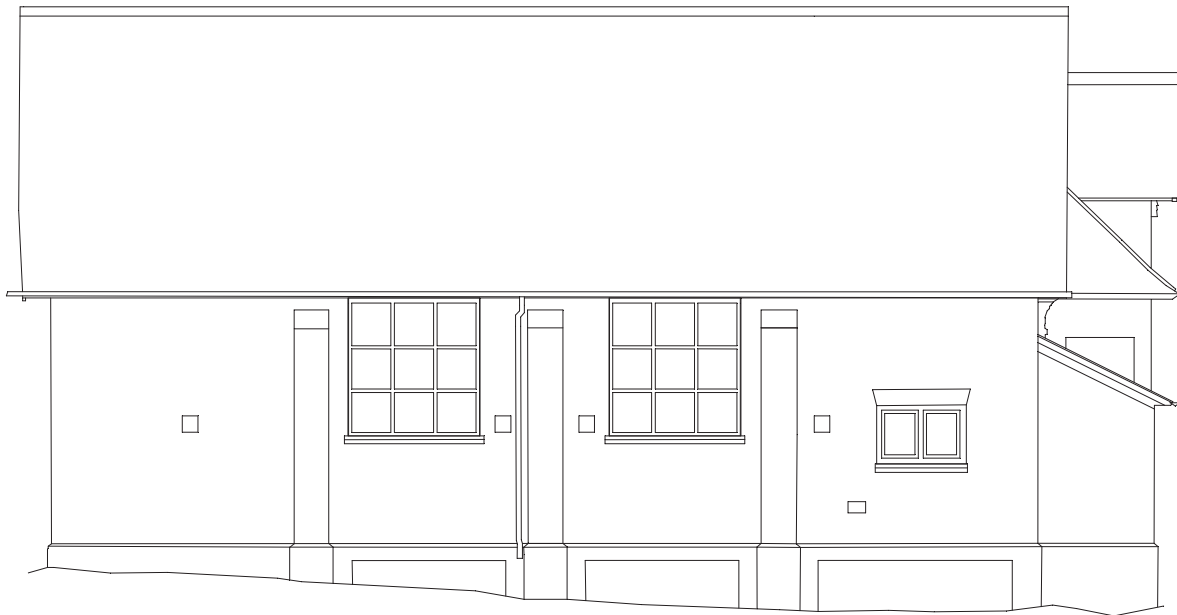
NORTH WEST ELEVATION

NORTH EAST ELEVATION

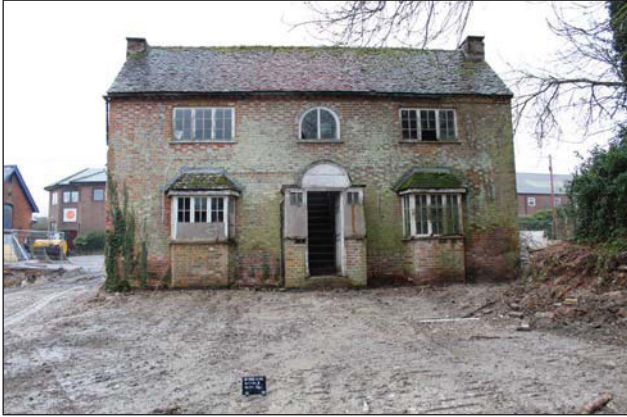
The north-west facing elevation (Pl. 1) is the main front of the building, fronting onto The Street, but set well back from the street itself. The wall is brick built in Flemish bond with blue headers, bonded with lime mortar. The bricks measure 210mm x 100mm x 60mm (8 1/4" x 4" x 2 3/8"). Dentilated brickwork is present at the eaves. The elevation is symmetrical with a central, six-panel door set within a barrel-vaulted porch. The porch itself is brick built on the lower half with timber framed casement windows above. Above the door is a white rendered semi-circle. On either side of the door is a shallow, slightly canted bay window, three casements wide and one casement deep. These are set beneath a hipped roof covered in red clay tiles. On the first floor are a further three windows; the central one being an arched window set beneath blue bricks in rowlock bond and containing a fixed two-pane window shaped to fit the opening, whilst on either side is a three casement window set beneath a row of red brick header bond.

Plate 1. Old School House, Northwest elevation, looking SE.

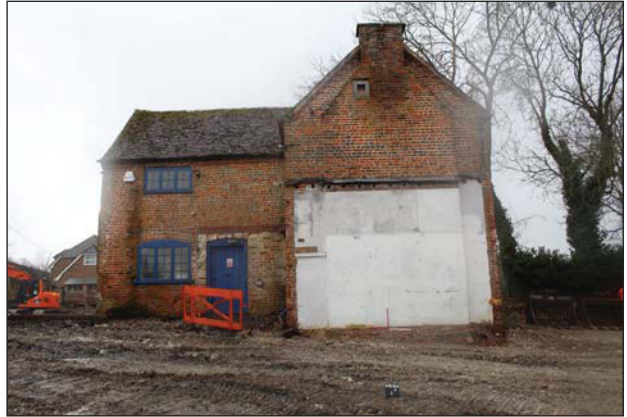
The north-east elevation (Pl. 2) is more complex, with three different planes. Foremost is the large chimney stack, taking up the majority of the gable end. The brickwork is laid in English bond in lime mortar, although the lower part is rendered where the former lean-to was located. Near the top of the stack, on the east side is a small window. Set slightly further back from the chimney is the gable end proper, much of which is obscured by the chimney stack itself and the render where the lean-to was. The upper, visible sections show that the brickwork is also laid in English bond with lime mortar. On the east side is a vertical scar, some 19 courses in height suggesting that the building may have been re-fronted. Dentilated brickwork is present at the eaves of the house and it is possible that this also dates to the re-fronting of the house. Furthest back is the rear wing of the house, constructed of irregular bond brickwork, containing many headers. Part of the east end of the building may have been rebuilt, suggested by the presence of blue headers and some attempt at Flemish bond being present. Beneath the eaves is dentilated brickwork. On the ground floor is a door to the west and a three casement window to the east. Both the door and window are set beneath a gently curved brick arch. The door is of simple plank construction and appears to have once been located within an extension based on the patchy remains of white paint on the brickwork. At first-floor level is a further three casement window located directly above the ground floor window. This window is shorter than that of the ground floor, each casement consisting of two over two window panes rather than two over four.

Plate 2. Old School House, Northeast elevation, looking SW, Scales: 2 x 1m.

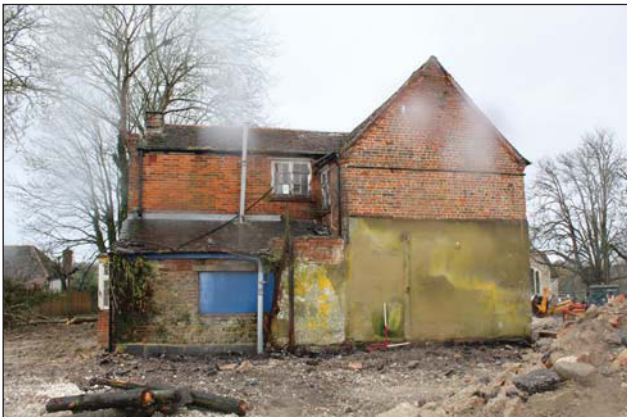
The south-east elevation (Pl. 3) is also complex incorporating the rear of the front range, the gable end of the rear extension, a two-storey flat roof extension and a single storey lean-to extension. The rear of the front range is of English bond brickwork at the east end with dentilated eaves. Within the brickwork end it is possible to see the remains of the mono-pitched roof of the lean-to that enclosed the door within the north elevation. The rear gable end is of mixed bond with dentilated eaves. The lower half of the gable has been rendered. The two-storey extension is only viable above the height of the lean-to extension and is constructed of stretcher bond with plain eaves. Within the wall is a two-casement window two by six panes high. The single storey lean-to is also of stretcher bond with a mono-pitched roof covered in slate tiles. A single, boarded up window is present beneath a concrete lintel.

Plate 3. Old School House, Southeast elevation, looking NW, Scales: 2 x 1m.

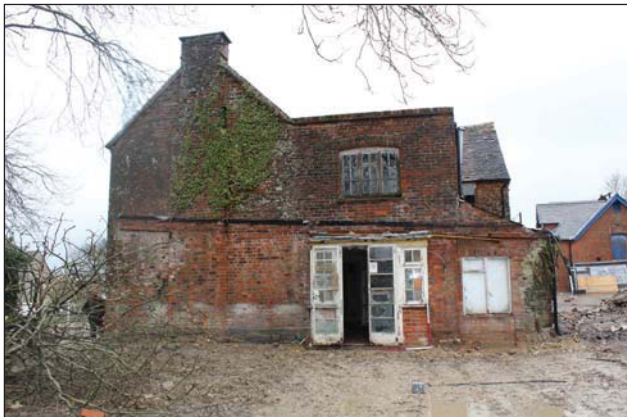
The south-west elevation (Pl. 4) shows the relationship between all the modern extensions. The south gable end of the front range is of mixed bond as is the chimney stack, set beneath dentilated eaves. The upper part of the wall is covered in ivy but it does appear that a small blocked window is present to the east of the chimney, set beneath a flat arch. On the west side, a similar vertical scar is present to that on the north gable end. This can be seen within the upper *c.* 15 courses of brickwork where the bricks are set at a different level to those on the rest

of the gable end. To the west is the two-storey rear extension with a flat roof concealed behind a parapet. The brickwork has been tied in, though the bonding pattern changes to stretcher bond. At ground floor level is a central door, set within a porch similar to that present on the main, west elevation, but with a flat roof. Set within the porch is a pair of glass and steel frame doors with a wooden casement window on either side. Above this, on the first floor, is a three casement window set beneath a curved arch. The single storey lean-to is also of stretcher bond that has been tied in. A two casement metal window is set within the wall. Set further back from the plane is the upper floor of the rear extension which contains a two casement wooden window at the junction with the two-storey extension.

Plate 4. Old School House, Southwest elevation, looking NE, Scales: 2 x 1m.

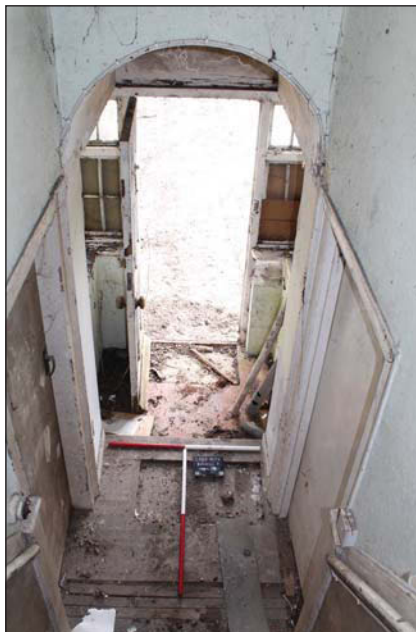
The building is entered through the main door on the west elevation into a small porch area set a step down from the rest of the building (Pl. 7). A window is set within the walls on either side and the ceiling is barrel vaulted, leading directly into the entrance hallway. The walls are plain plastered. The floor within the porch is of quarry tiles with a sunken rectangle left for a doormat. Within the small entrance hallway was access to the stairs

Plate 7. Old School House, hall, View to porch, looking NW, Scales: 2 x 1m.

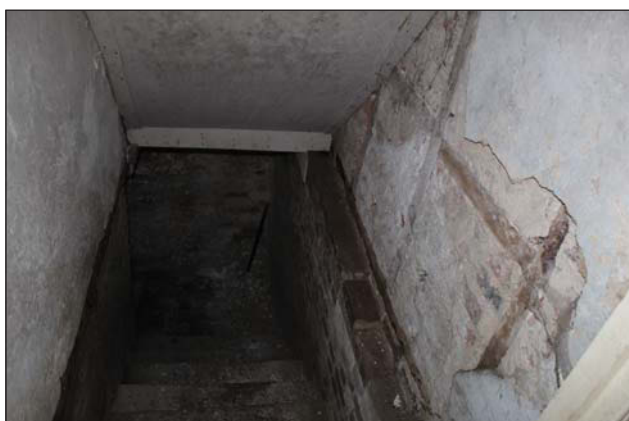
The central circulation space is a small, irregularly shaped area with access to rooms 1-4 and steps to the basement. Where some of the plaster had been removed on the north side of the basement steps it was possible to see the wall constructed of timber box framing, in-filled with brick (Pl. 14).

Plate 14. Old School House, Room 11, Timber box framing and cellar stairs, looking NW.

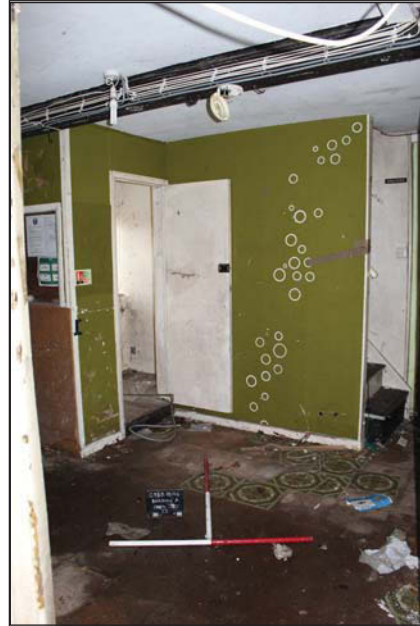
Room 4 (Pl. 16) is located on the north side of the building, accessed via an angled door in the south-west corner of the room. The walls are plastered with no dado rail or cornice. The floor is tiled. Within the ceiling is a transverse beam with chamfers and run-out stops. At the southern end is a deep chamfer possibly suggestive of the original location of a set of stairs. Within the north wall is a simple plank door with a small electrical cupboard to the west and a newly partitioned room (4a) to the east, which is located up a slight step and contains a window within the north wall. A set of stairs to the first floor is located towards the east side of the room with a moulded banister rail attached to the wall. A blocked door is located in the east wall proper. In the southern wall, at the east end is access to room 5.

Plate 16. Old School House, Room 4, View to stairs, looking NE, Scales: 2x 1m.

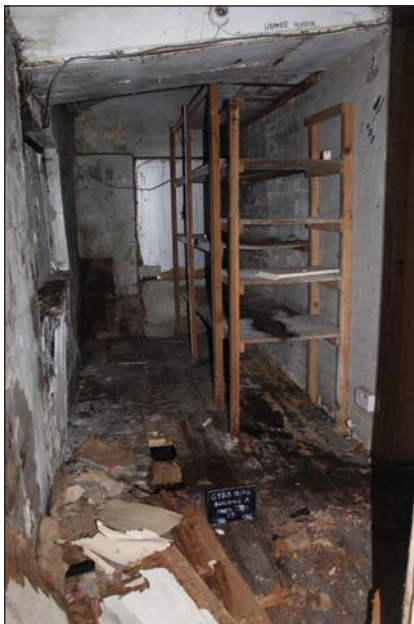
Room 5 is a narrow room (Pl. 17), located in the south-east corner of the building with whitewashed brick walls and timber plank flooring. Within the east wall is a blocked window. A further window is present in the south wall and there is access to room 3 in the west wall.

Plate 17. Old School House, Room 5, General view, looking SW.

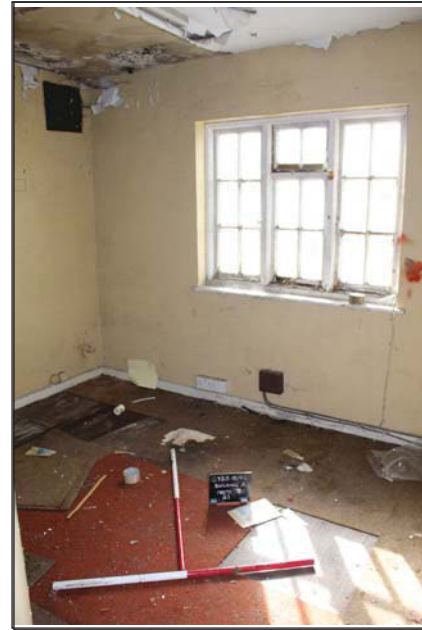
Room 8 (Pl. 20) has been sub-divided to accommodate a bathroom (room 9) and is subsequently located off a short corridor. The room is plastered with a window in the southern wall.

Plate 20. Old School House, Room 8, View to window, looking SE, Scales: 2x 1m.

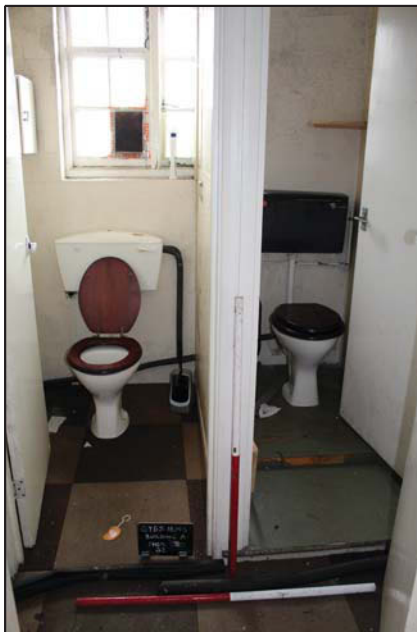
Bathroom 9 (Pl. 21) is also located off short corridor, to the east, and contains two toilets and a sink. The division for the toilets cuts unequally through the window in the eastern wall.

Plate 21. Old School House, Room 9, Toilets, looking SE, Scales: 2x 1m.

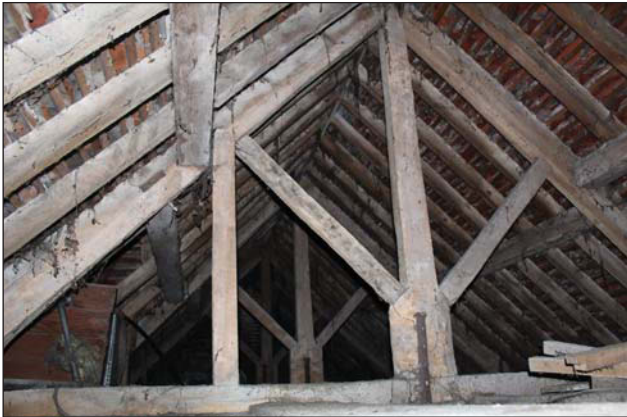
The roof (Pl.23) is constructed of four king trusses of softwood supporting a ridge plank. Staggered butt purlins support the common rafters. At the north and south ends is a small blocked window.

Plate 23. Old School House, loft, Roof truss detail, looking SW.

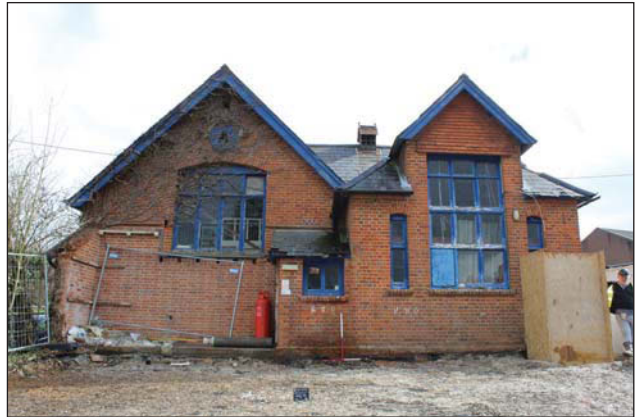
The north-west elevation (Pl. 24) is the main, front elevation which would have originally opened out onto the playground. It is a complex frontage consisting of a gable end, hipped roof and a porch area. Part of the roof structure to the former verandah had been removed prior to the survey and consisted of a pitched roof, shaped to fit around the large window in the northern gable end. The northern gable end contained a single, large window

beneath a curved arch, above which is a roundel set beneath a stone hood mould. At the southern end of the gable is the projecting porch area set beneath a projecting tile plat band. The porch contains a pair of casement windows with a brick sill. The south end of the elevation consists of a projecting wing with a hipped roof (in line with the porch) with a tall window that cuts through the roof line and has a small gabled roof. Either side of the large, nine-paned window is a tall, narrow window, two panes high beneath a curved arch. The gable end above the large window is tile hung.

Plate 24. Former School, Northwest elevation, looking SE, Scales: 2x 1m.

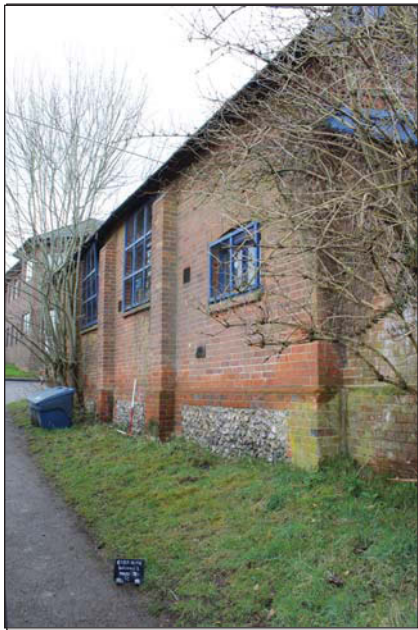
The north-east elevation (Pl. 25) fronts onto Bullington Lane and consists of the main building and the side of the former verandah at the south end. The verandah wall is slightly set back from the plane with the highest set of bricks against the side of the building to accommodate a mono-pitch roof. The main building is a combination of brick and uncoursed flint walling. The flint walls being present at ground level, beneath the plat band. It is best seen at the western end of the building where the ground slopes down. The wall itself is sub-divided into four sections by three brick pillars, each, with the exception of the easternmost panel, containing a window. The window in the panel at the west end consists of two casement windows set beneath a curved arch. The next two panels contain a larger nine pane window extending up to the roof line.

Plate 25. Former School, Oblique of northeast elevation, looking SE, Scales: 2x 1m.

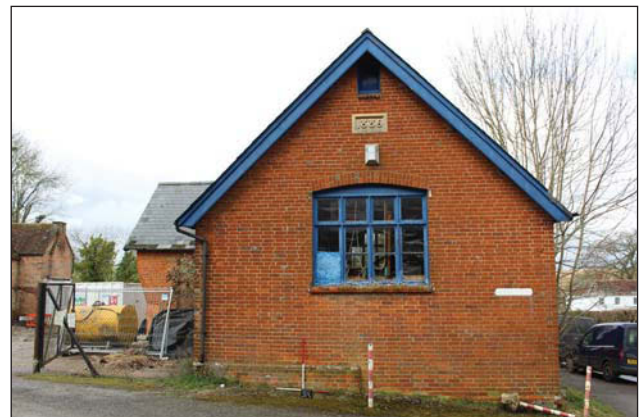
The south-east elevation (Pl. 26) fronts onto Gravel Lane and consists of the gable end of the main building and the side of the south facing gable end, set back from the plane. The main gable end, at the north end of the building is located on a north to south slope resulting in a change of height of the string course, with that at the east end being higher than that at the south end. Located centrally within the gable is a large four by three pane high window set beneath a curved arch. Above this is a rectangular date stone – 1886, above which is a small, rectangular window in the apex of the gable. The south end of the elevation is set back and consists of a plain brick wall, sub-divided into three by two brick pillars. The southern corner has been chamfered in brick.

Plate 26. Former School, Southeast elevation, looking NW, Scales: 2x 1m.

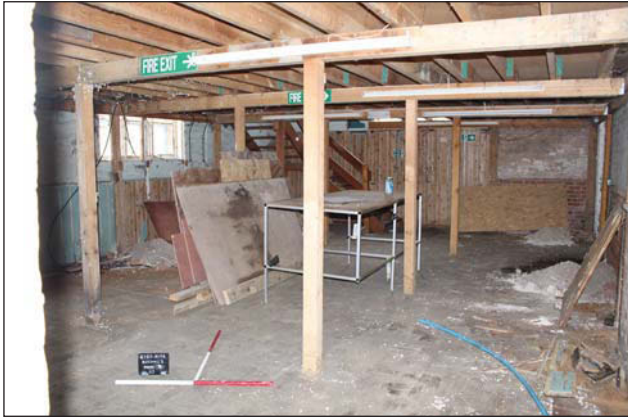
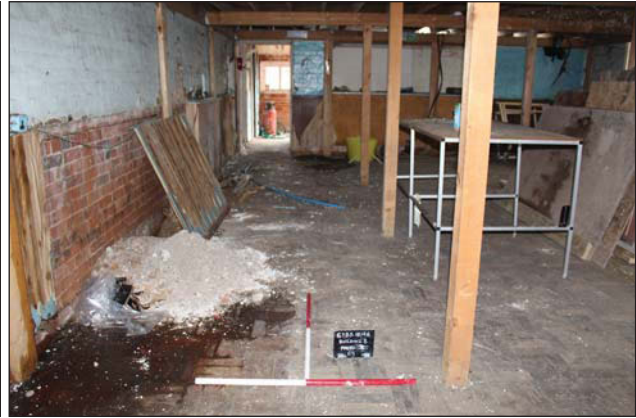
Room 2 (Pls. 31, 32) is the main school room and this has been converted to accommodate a first floor using a pair of posts to support the main floor joists. A total of five joists support the upper floor. The room itself has a wooden block floor laid in square basket pattern. The walls are clad in tongue and groove panelling on the lower half and remain as white-washed brick above. Within the south wall, at the west end is a small, square window into room 3 (Pl. 33).

Plate 31. Former School, Room 2, General view to stairs, looking E, Scales: 2x 1m.

Plate 32. Former School, Room 2, General view, looking W, Scales: 2x 1m.

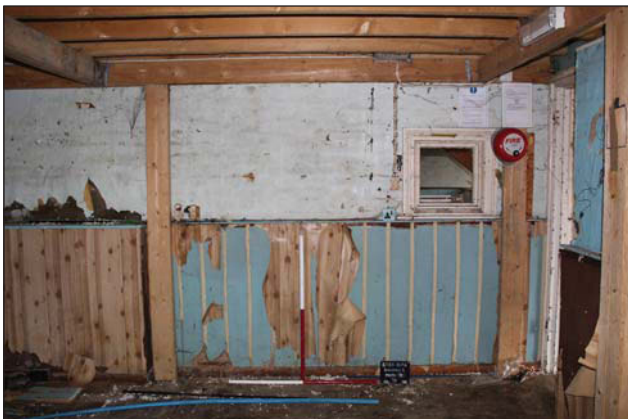
Plate 33. Former School, Room 2, View to internal window, looking SW, Scales: 2x 1m.

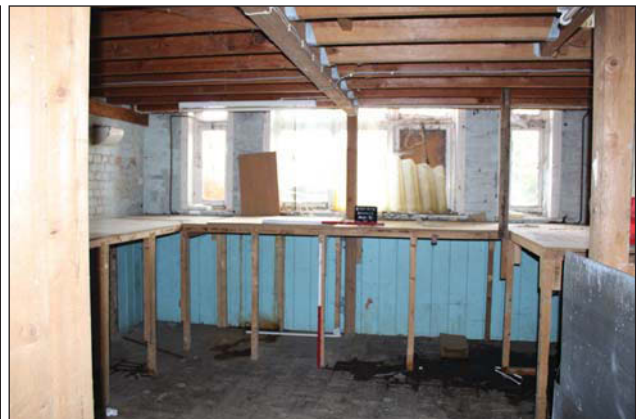
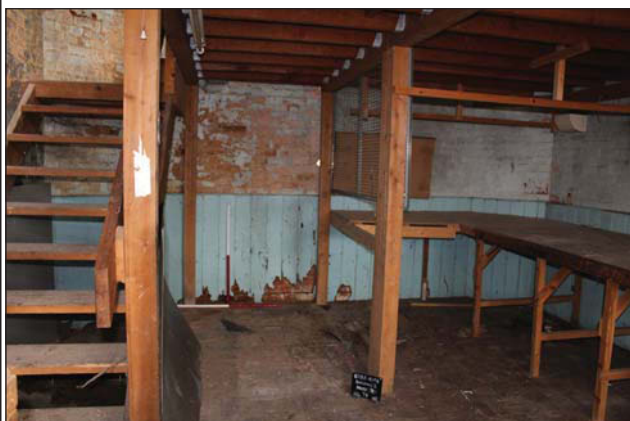
Room 3 (Pls. 34, 35) is the smaller classroom and is similar in style to room 2 with the same wood block floor, tongue and groove panelling and white-washed brickwork. Within the south wall are three corbels of unknown function. The former chimney in the northeast corner has been covered over with the tongue and groove panelling. Like room 2 a modern, upper floor has been inserted with a set of stairs along the north wall.

Plate 34. Former School, Room 3, View to window, looking W, Scales: 2x 1m.

Plate 35. Former School, Room 3, General view, looking S, Scales: 2x 1m.

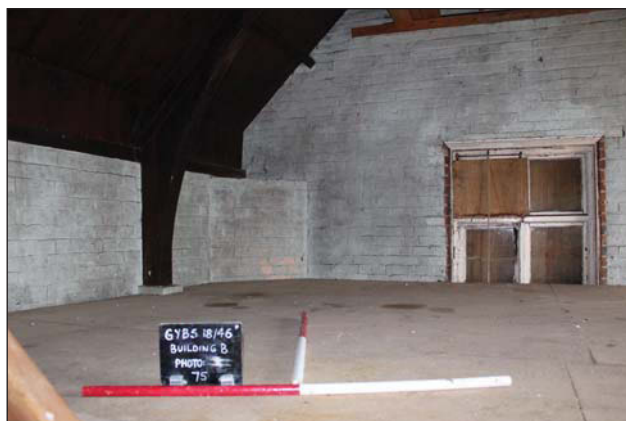
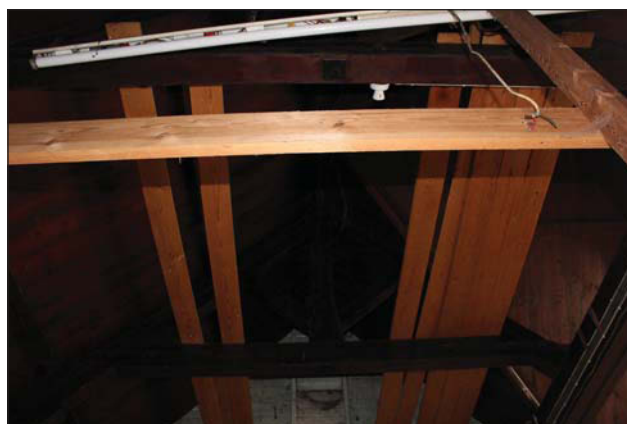
The roof structure (Pls. 36, 37) consists of principal rafters supported on a curved bracket which rests on a support projecting from the wall. These trusses have a raised collar supporting a king post. Trenched purlins support the boarding of the roof.

Plate 36. Former School, loft, View to angled corner showing roof truss, looking S, Scales: 2x 1m.

Plate 37. Former School, loft, Roof truss, looking NW.
