**Barn House, Park Wall Lane, Lower Basildon,
West Berkshire**

Building Recording

Site Code: BHLB16/65

June 2018

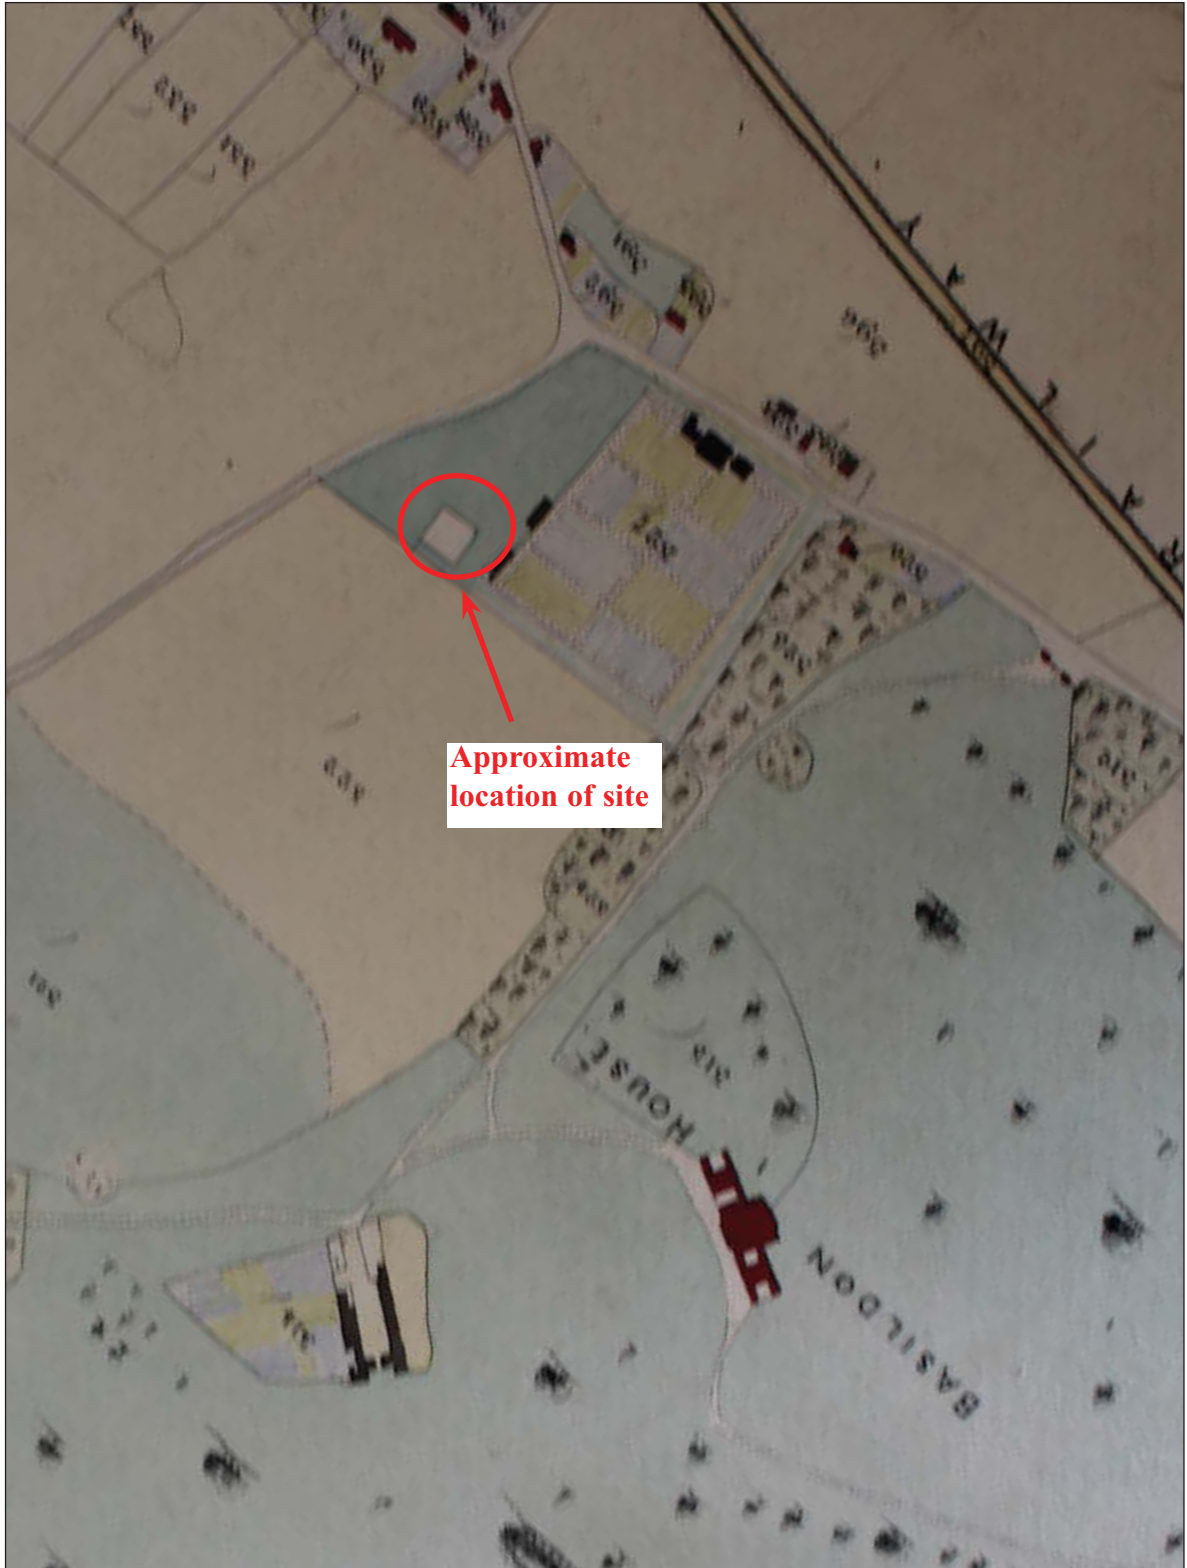
**Barn House, Lower Basildon,
West Berkshire, 2018
Building Recording**
Figure 3. Basildon Tithe Map, 1840.

of 1840 (Fig. 3) shows two buildings present along the south-east boundary and an area of, presumably, hard standing at the southern end of the site. At this time Basildon Park was owned by James Morrison and remained in his family until it was requisitioned by the government in 1914.

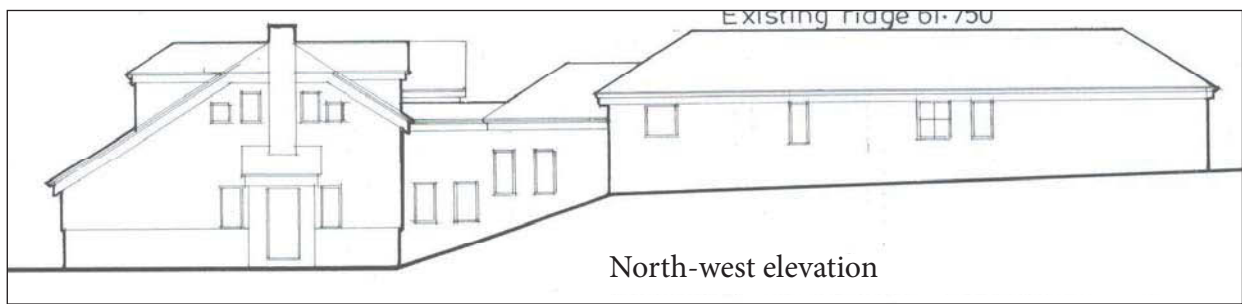
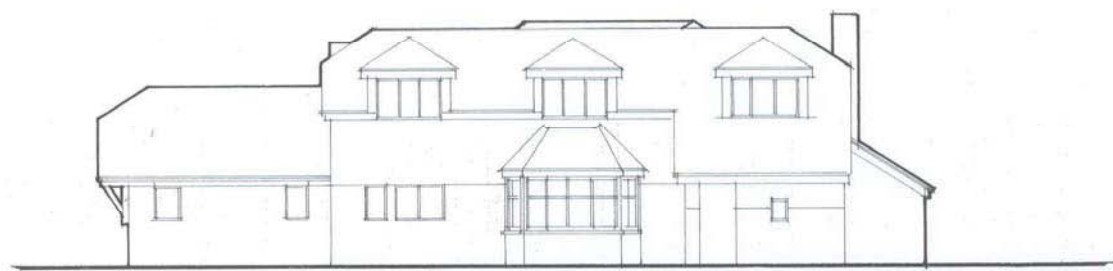
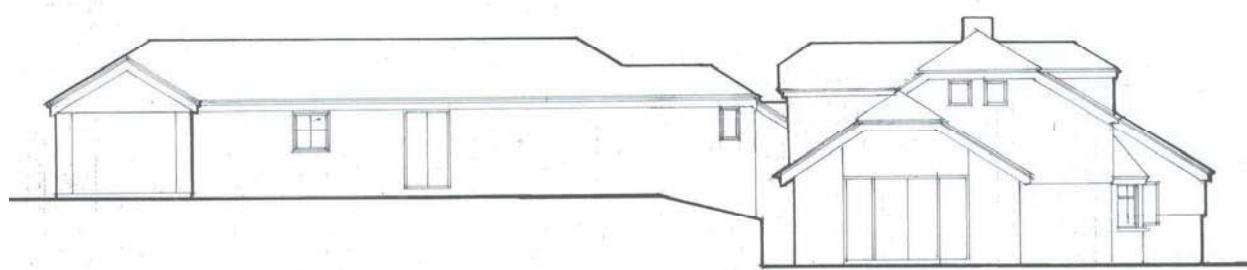
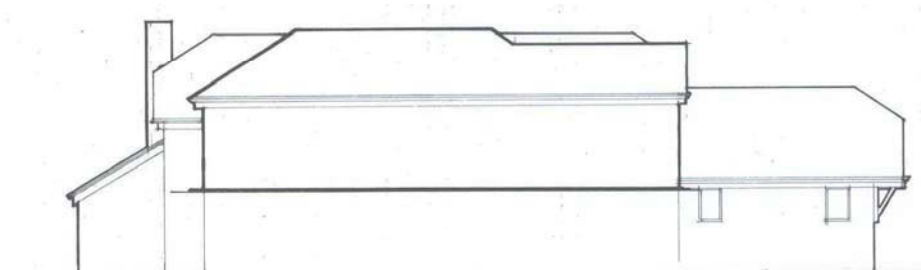
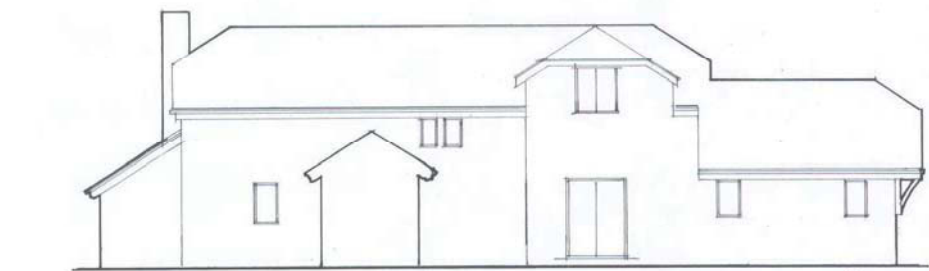
**Barn House, Lower Basildon,
West Berkshire, 2018**
Building Recording
 Figure 8. Elevations.

The main (north-east facing) elevation (Pl. 1; Fig. 8) consists of not only the main part of the building but also an additional bay window and large entrance porch beneath a catslide roof. The ground floor consists of, from the south-east (Pl. 2), a small square window of four lights beside a more substantial three light window. Beneath both is evidence for a former opening which has been bricked up using bricks laid in stretcher bond. To the north-west is a large, angled bay window, four lights wide, with two lights in each of the angled sides: the brickwork beneath is laid in stretcher bond. At the far north-west end of the building (Pl. 3) is a large porch beneath a catslide roof. The brickwork is laid in English garden wall bond with weatherboarding above. Within the porch area the door is at the south-east end with a squared timber post on either side set on a shaped concrete block (Pl. 4). To the north-west is a small window. Within the roofline are three dormer windows, three lights wide, set beneath a pitched roof.

The south-east elevation (Pl. 29; Fig. 8) faces onto the internal courtyard and would originally have been the principal elevation fronting onto the yard area. The existing elevation is of modern construction with the brick walls laid in stretcher bond and cement mortar. The original roofline has been extended down to meet this new wall. Within the wall is a central pair of French doors with a window on either side.

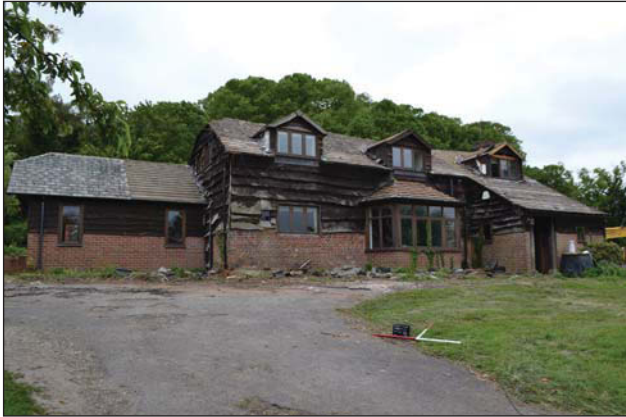
Plate 1. Exterior, general view, front, looking west.

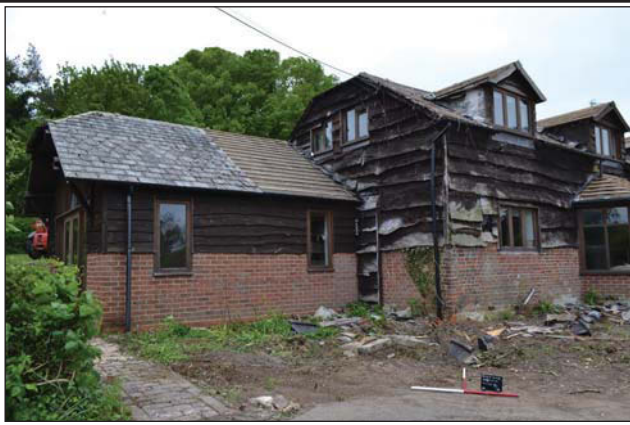
The south-east elevation (Pl. 5) is partially obscured by the block C extension, which is partially set back from the main elevation. Within the centre of the elevation, the weatherboarding continues down to the ground and the presence of king closer and queen closer bricks are indicative of a former doorway. Within the apex of the gable end was a pair of windows, each two lights wide.

Plate 5. Front elevation, south-east end, looking west,
Scales: 1m.

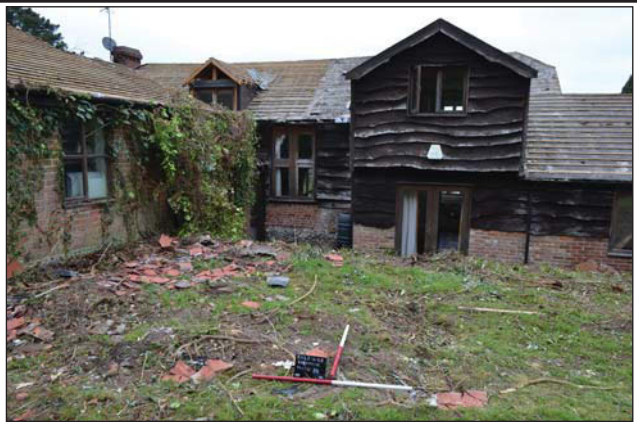
Only two small sections of the south-west elevation are visible. At the south-east end of the building (Pl. 6) is a window, two lights wide and two lights high, reaching to the roof line. Beneath the window is an area of brickwork above flintwork. Within the roof is a further dormer window. The flintwork continues at the north-west end of the building with brickwork above (Pl. 7). Within the elevation is a single, small window, two lights wide. The weatherboarding has a vertical joint in it, where it changes from wider to narrower boards.

Plate 6. Blocks A, B and C, oblique, looking north-east,
Scales: 1m.

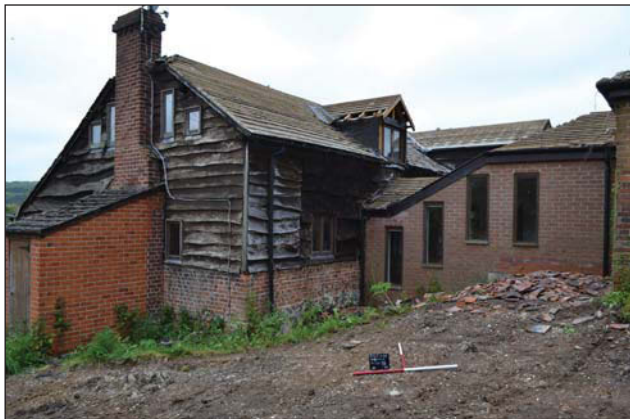
On the north-west side (Pl. 7) the ground slopes upwards and four windows are present within the elevation with the upper two being at the same level.

Plate 7. Blocks A and E, oblique, looking east, Scales:
1m.

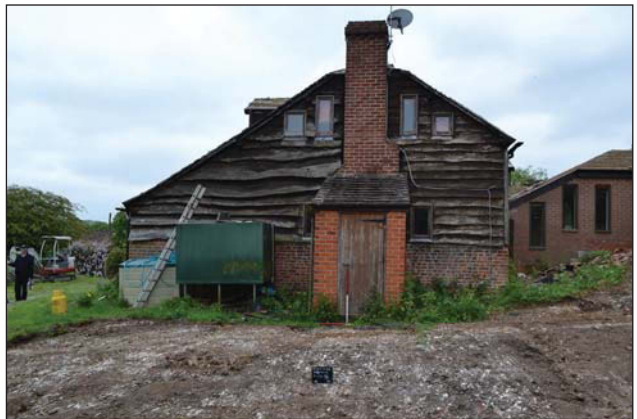
The north-west elevation (Pl. 8) contains the catslide roof over the porch at the north-east end and a central cupboard in front of a chimney. The north-east end was also partially obscured by an oil tank. Both the cupboard and the chimney are brick built in stretcher bond. The cupboard has a central, wooden plank door, beneath a mono-pitched roof. On either side of the chimney is a single window at ground floor level and two single windows at first floor level.

Plate 8. Block A gable, looking south-east, Scales: 1m.

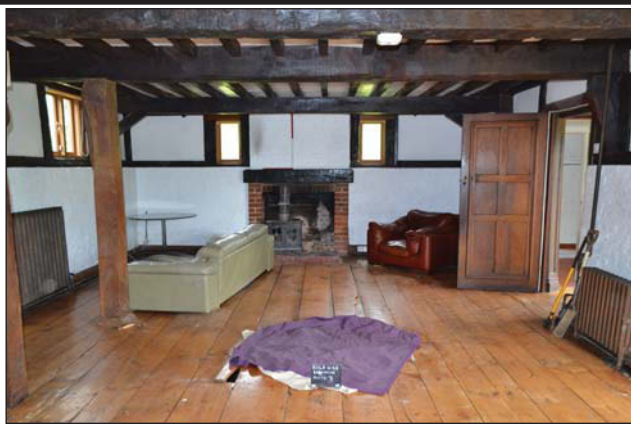
Room 2 (Pl. 11) is the main room of the block with timber plank floors, exposed beams in the ceiling, fireplace, bay window and stairs to the first floor, as well as access to room 8. The room is entered via a wooden panel door into a large open space. The lower walls are of painted brickwork above which is a wall plate on which sit the windows and posts to support the main beams. The upper parts of the wall are plastered and painted white. The fireplace (Pl. 12) in the north-west wall has a brick chimney breast laid in an irregular bonding pattern, the upper part, above the mantel piece has been painted white, whilst the lower part is exposed brickwork bonded with cement mortar. The hearth is constructed of bricks laid on edge. The mantelpiece is

The ceiling is formed of four tie-beams (numbered 1-4, from north-west to south-east Pl. 11) aligned north-east to south-west, resting on a combination of full-size wooden posts (beams 3 and 4) and quarter-sized wooden posts resting on the wall plate (beams 1 and 2), all with a jowled head on the north-east side. Beam 1 also has a wind brace (Pl. 15). On the south-west side beams 1 and 2 rest on a quarter post with jowled head upon the wall plate, whilst beams 3 and 4 are supported on posts within the room. A post is also present beneath beam 2 and all have jowled heads. The posts are all machine-cut wood (Pl. 13).

Plate 11. Room 2, looking north-west, Scales: 1m.

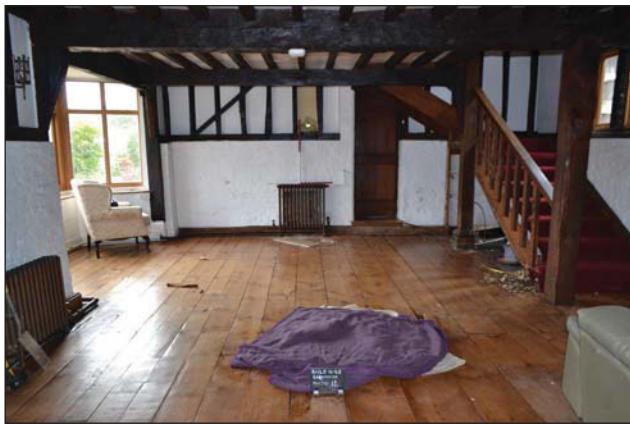
Within the south-east wall are a number of timber posts and a diagonal brace above the wall plate. The stairs also dog-leg round to this wall from the south-west wall. The stairs are a later insertion, constructed of wood with a closed string, fitted between two vertical wooden posts. The balusters and bannister rail are of plain, square-cut wood (Pl. 13).

Plate 13. Room 2, looking south-east, Scales: 1m.

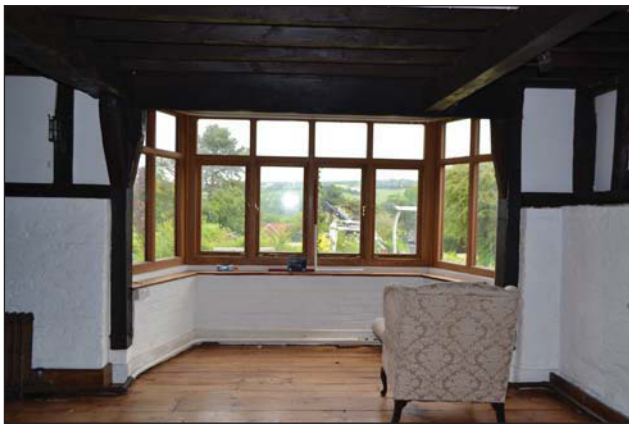
Within the north-east wall is a modern bay window. Timber posts on either side of the opening support the lintel on a jowled head (Pl. 14)

Plate 14. Room 2, looking north-east, Scales: 1m.

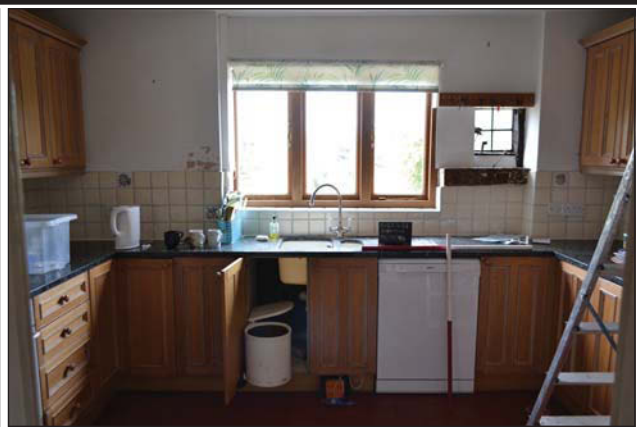
Room 9 (Pl. 18) was in use as a kitchen and has been modernized. In the north-east wall is an approximately central alcove containing two windows; the smaller of which is set above a small section of wood. The timber again shows signs of reuse with empty mortices and pegholes.

Plate 18. Room 9, looking north-east, Scales: 1m.

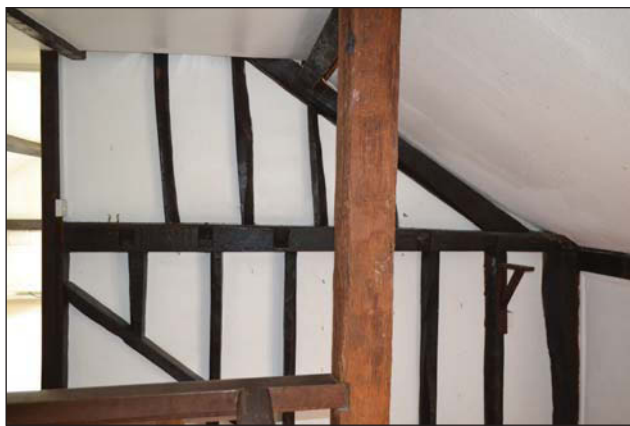
The timber framing in the south-east wall adjacent to the stairs continues upwards to a tie-beam sat on top of a jowled post (Pl. 19). The tie-beam contains a number of empty mortices, most likely for the former floor joists that have been removed to accommodate the stairs. Above the tie-beam are a further three posts and a principal rafter. The beam is cut by the door into room 16. The rest of the corridor is plastered and painted white. The newel post at the top of the stairs is also a piece of re-used timber with a unusual shaped top and an empty mortice in one side, though it appears to have been machine- rather than hand cut (Pl. 20).

Plate 19. Hallway timber detail, looking south-east.

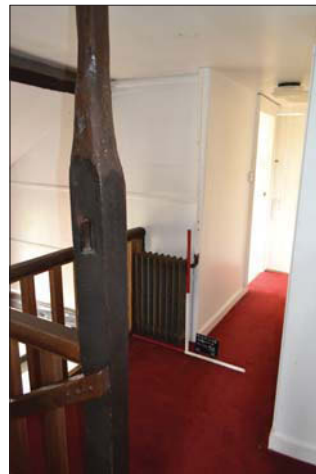
Plate 20. Hallway timber detail, looking north-west, Scales: 1m.

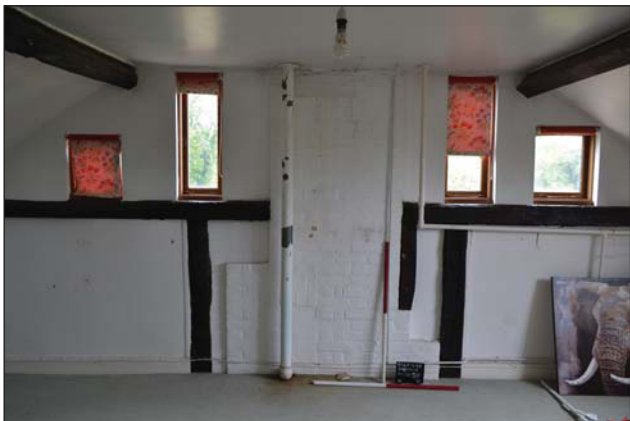
Room 13 is at the north-west end of the house and runs across the width of the building. Centrally, within the end wall is the brickwork for the later chimney (Pl. 21). It cuts through the timber wall plate which has subsequently been supported by a timber post on either side. An additional piece of timber post is set on the brickwork itself. Within the brickwork is a brick soldier course indicating the presence of a former, small fireplace. A steel pipe is now present in front of it, which continues through to the roof. On either side of the chimney breast are two windows. In the north-east wall is a dormer window and in the south-west wall is the timber wall plate supported on a post with a large empty mortice within it. Within the ceiling the purlins are visible; the north-eastern one being supported on a post adjacent to the internal wall.

Plate 21. Room 13, looking north-west, Scales: 1m.

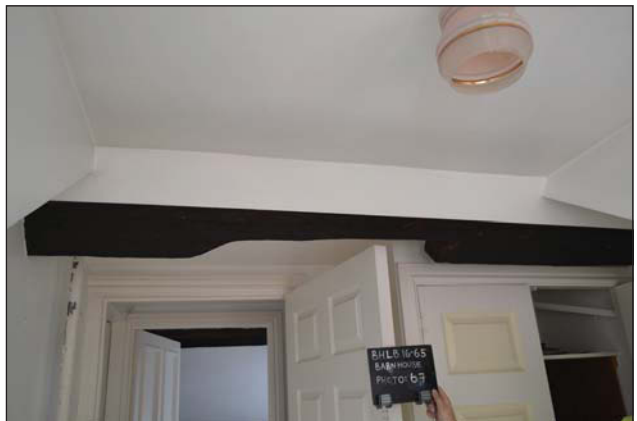
Room 14 is located to the rear of the building and has a dormer window in the south-west wall set on a timber wall plate with a post containing an empty mortice beneath. Within the ceiling is the purlin which has a large slot cut into it (Pl. 22).

Plate 22. Room 14, purlin detail.

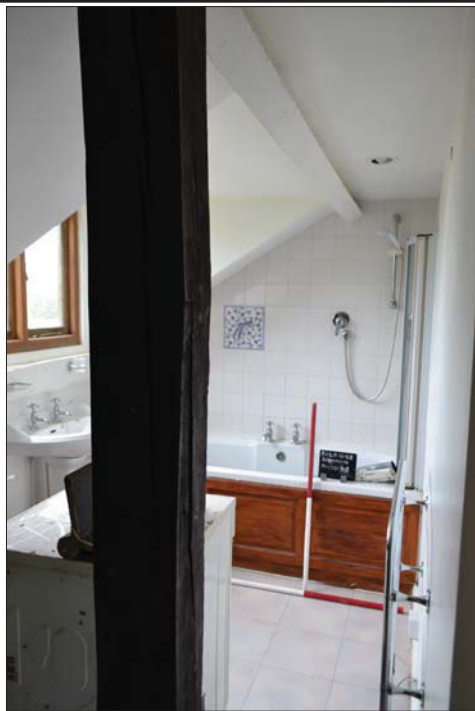
Room 15 (Pl. 23) is located to the front of the building and has a dormer window in the north-east wall. It is in use as a bathroom/utility room and much of the woodwork has been painted white to blend into the white walls. The dormer window is sat on a timber wall plate and the purlin continues through the room, supported on a timber post within the room. Adjacent to the bathroom is a small cupboard.

Plate 23. Room 15, looking south-east, Scales: 1m.

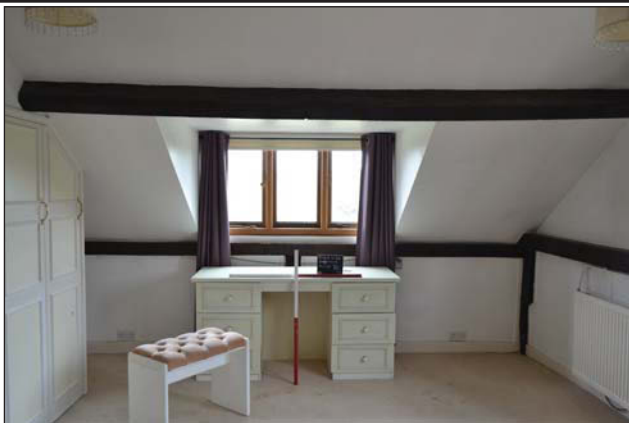
Room 16 (Pl. 24) is located at the south-east end of the building. In the north-east wall is a dormer window, above the wall plate. In the south-east wall are a further four windows arranged into two groups of two, set above the truss. In the east corner of the room can be seen the top of the jowled post on which the truss is resting. The south end of the truss is located within a small cupboard in which can also be seen a jowled post supporting it. The two purlins continue within the room.

Plate 24. Room 16, looking north-east, Scales: 1m.

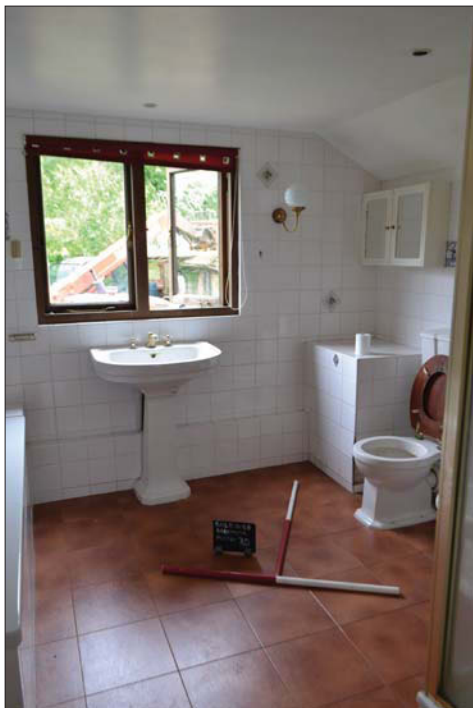
Room 17 (Pl. 25) is located to the south-west of room 16 in a later extension, above block C. The original end wall of the building has been removed to accommodate this bathroom. The bathroom itself is entirely modern with a window in the south-west gable end.

Plate 25. Room 17, looking west, Scales: 1m.

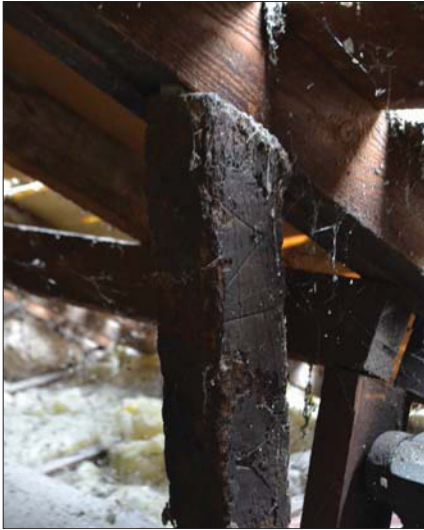
Access was available to the roof above the front porch from room 13. The roofline continued down from the main roof and was formed from trusses supporting raking struts which in turn supported the purlin on which the common rafters were laid (Pl. 26). A further support had been added, propping up one of the rafters. This was a reused piece of timber with the carpenters mark 'IV' scratched into it (Pl. 27).

Plate 27. Room 13, carpenter's mark.

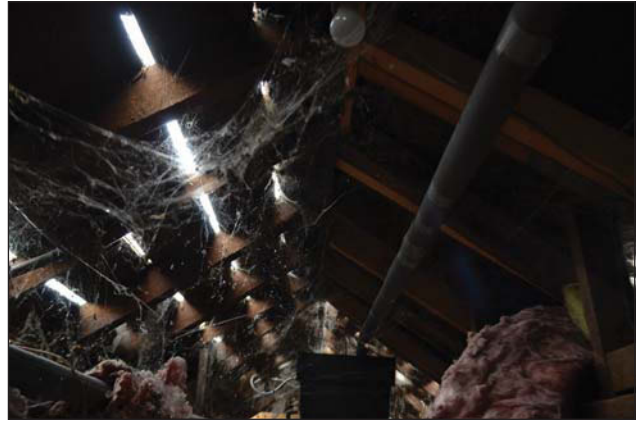
The roof above main part of the building consisted of common rafters meeting at a ridge plank (Pl. 28). The rafters on the south-west side have been replaced with modern pine whilst those of the north-east side appear to be original.

Plate 28. Block A, roof detail, looking south-east.

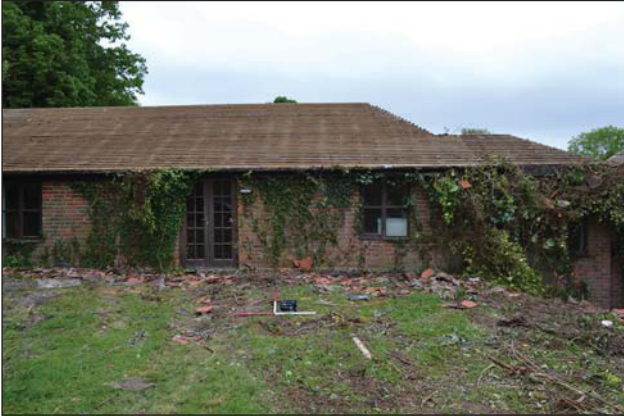
Only two elevations are present; the south-east and the north-west. The south-east elevation (Pl. 29) is partially obscured by ivy and other plant growth. This is the more complex elevation with the dog-leg in the wall to accommodate the terracing that has occurred to accommodate block C. At the lower level, at the north-east end of the elevation is a door with two windows adjacent to it. At the higher level is a further window.

Plate 29. Block B, south-east elevation looking north-west, Scales: 1m.

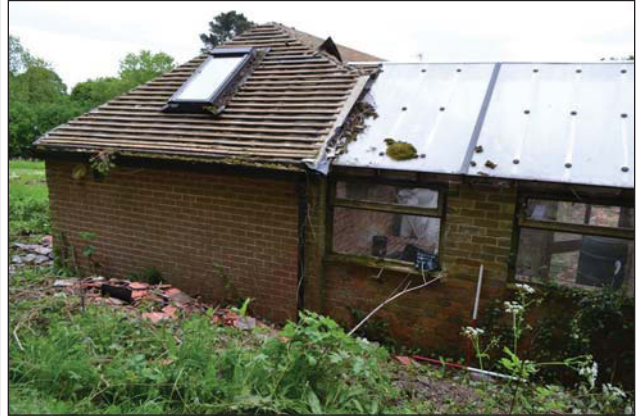
The south-west gable end has been rebuilt in brick laid in stretcher bond with cement mortar. The roof has been altered to accommodate the block D extension roof (Pl. 30).

Internally it is possible to see both the north-west and south-east walls. The north-west wall (Pl. 30) is of brick construction laid in English bond, whilst the south-east wall (Pl. 43) is a combination of brick walling and timber weatherboarding above. The brick built section is laid in English bond with a top course capped in half round coping bricks above which is the timber weatherboarding.

Plate 30. Block D, rear, looking north, Scales: 1m.

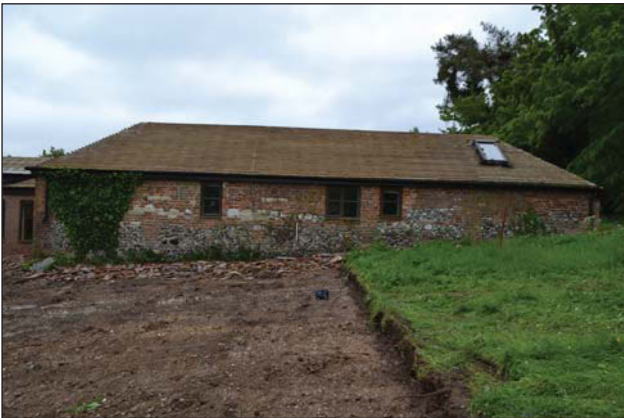
The north-west wall (Pl. 31) is original and of complex construction, utilizing a combination of brick, flint and stone. The lower parts of the wall are predominantly of very roughly coursed flint, interspaced with brick 'pillars'. The brickwork then continues above the height of the flint walling, in patches laid in an approximation of English bond whilst elsewhere there is no clear bonding pattern. Within the brickwork are areas of flintwork and stone blocks as well as four windows.

Plate 31. Block B, north-west elevation, looking south-east, Scales: 1m.

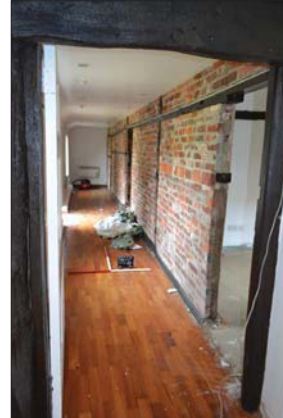
Internally there are three rooms (4-6) located off the south-east corridor with a further room (7) located off room 6 at the south-west end of the building. The corridor (Pl. 32) runs the length of rooms 4-6 finishing at a dead end

where room 11 of block D is located. The floor is of timber strips whilst the external wall and ceiling are plastered white. The internal wall between the corridor and rooms is exposed brickwork predominantly laid in stretcher bond with some timber framing. The bricks measure 220mm x 110mm x 80mm ($8\frac{5}{8}$ " x 4" x $3\frac{1}{8}$ "). At floor level is a timber cill, upon which the posts are set. The timber post between rooms 4 and 5 contains the remains of bolt type hinges for a gate (Pl. 33) along with a chiselled carpenters mark 'IIII' where it meets the rail / wall plate (Pl. 34). A mid-rail is present within room 4 which has been obscured in the corridor by later, large bricks. A further post is present immediately to the south-west of the entrance to room 5 and additional posts either side of the doorway to room 6 (Pl. 35), though these are possibly later insertions to form the door frame. Between the posts is a mid-rail with a further mid-rail to the south-west of the doorway to room 6. The post to the north-east of the room 6 door is from a reused piece of wood as evidenced by the empty mortice. Above the posts and doorways is the wall plate running the length of the corridor. A number of empty mortices were present along its length. Above the wall plate are a further three courses of brick and short sections of timber post possibly suggesting the roof has been raised. Where visible, the timber has regular, slightly bowed striations suggesting it had been cut using a band saw.

Plate 32. Corridor, looking south-west, Scales: 1m.

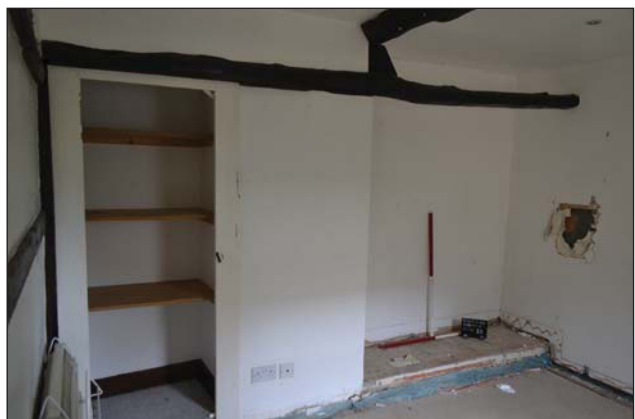
Room 4 is located at the north-east end of the building. There is a window in both the north-east and north-west walls. The walls are plastered white and the floor is of concrete. Within the south-east wall can be seen the mid-rail and wall plate along with a post at the location of the cupboard (Pl. 36). Within the south-west wall, above the height of the cupboard door, is what appears to be a beam sat on the post. Above the beam is a block of wood supporting a further timber running south-west to north-east along the length of the room (Pl. 36).

Plate 36. Room 4, looking west, Scales: 1m.

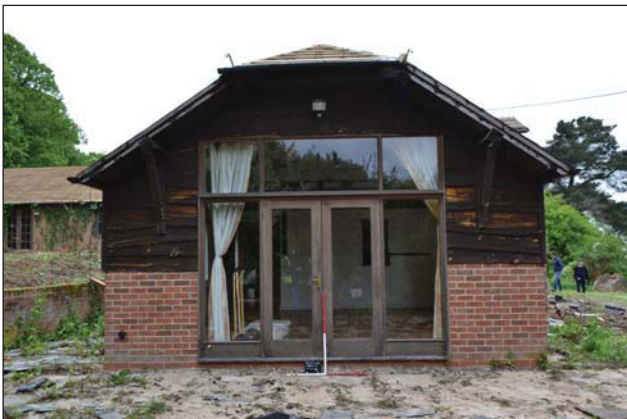
The north-east elevation (Pls 1, 5) is the front elevation of the building and contains two casement windows. The south-east gable end (Pl. 39) is more complex with the overhanging eaves and a large set of French doors / window combination located centrally within the wall. This consists of a central pair of doors with a large plate glass window on either side and a further three windows above the height of the door. The south-west elevation (Pl. 40) contains two windows, opposite to those on the front elevation and a further pair of doors at the north-west end where the building wraps around block A. These are located beneath the first floor extension to block A. Very little is present of the north-west elevation and it contains no features.

Plate 39. Block C gable end, looking north-west, Scales: 1m.

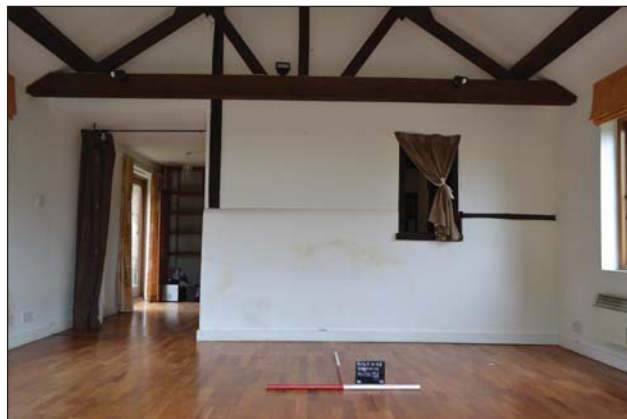
The internal wall is the former rear wall of the block A building and has a wider base with a narrower wall above the wall plate (Pl. 41). The wall plate is exposed to the north-east of the window. The rest of the wall has been plastered over and painted white.

Plate 41. Room 10, looking north-west, Scales: 1m.

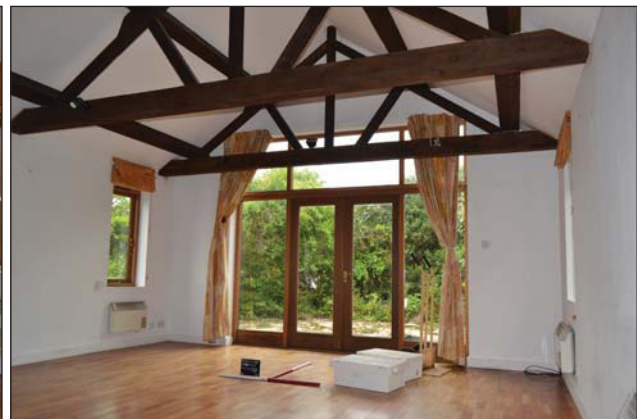
The roof structure (Pl. 42) is formed of three King post trusses. The common rafters above the purlins have been plastered over to form the ceiling.

Plate 42. Room 10, looking south-east, Scales: 1m.

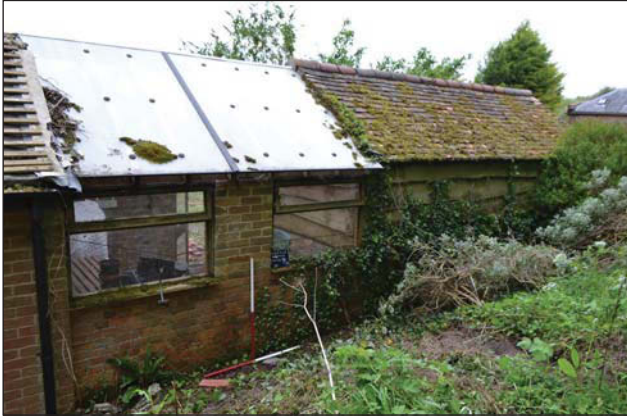
Block D is located at the south-west end of the building, adjacent to block B and consists of two rooms including a garage. An extension in this location is first present on the 1966 Ordnance Survey map, and remains until the 1994 map, but does not match the plan of the current block, which must therefore be later than 1994, plausibly added at the same time as block E. It is a single-storey building, a combination of brick built and weather boarded with two different roof types / coverings. The south-west building consisted of a garage which is entirely covered in weatherboarding with a pitched roof covered in red clay tiles. The north-west room is a potting shed / greenhouse and is brick built, with the lower walls laid in English bond and a pitched roof covered in polycarbonate sheets (Pl. 43).

Plate 43. Block D, rear, looking east, Scales: 1m.

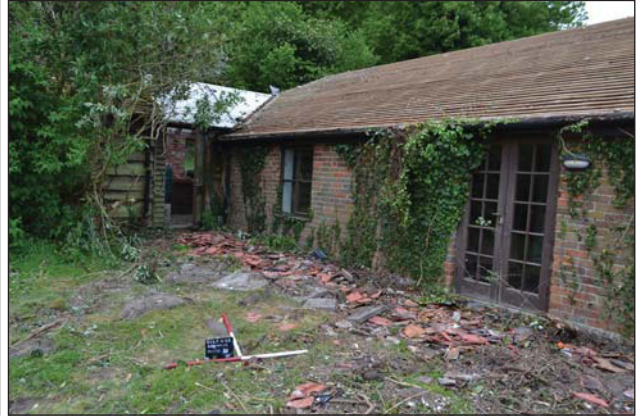
Only two external elevations are visible; the north-east and south-west. The north-east elevation (Pl. 44) is minimal and contains the main door into the room (numbered 11). This is a modern glass door. The south-west elevation (Pl. 43) is more complex. A pair of modern windows are set upon the brick walling laid in English bond. The brickwork between them is more recent of a different type of brick, laid in stretcher bond. It is possible that an earlier wall has been utilized.

Plate 44. Blocks B and D oblique, looking west, Scales: 1m.

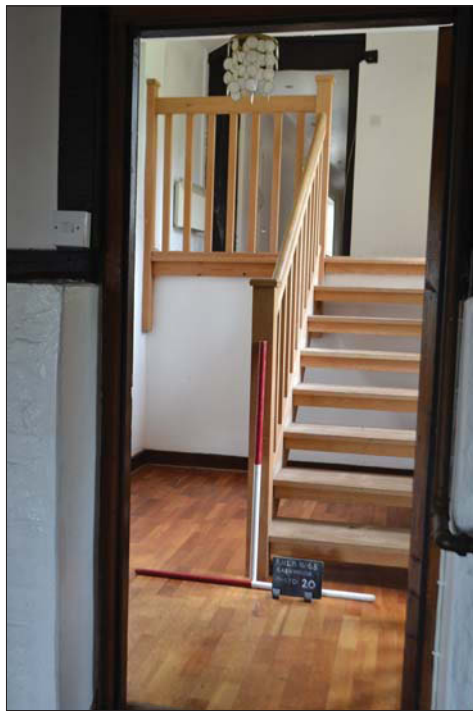
Internally the block consists of a single room (3) split over two levels (Pl. 45). The lower level is adjacent to block A, which contains a modern door through the rear wall. Within the wall is a lower band of flintwork, painted white, a middle band of exposed brickwork and plaster at the top (Pl. 46). All other walls are of plaster. The flooring is of timber strips.

Plate 45. Room 3, looking south-west, Scales: 1m.
