**Lower Northbrook Farm, Titnore Lane, West Durrington,
Worthing, West Sussex**

An archaeological excavation

**An Archaeological Excavation
For Wilmington Homes and Bloor Homes**

Site Code LNF 12/182

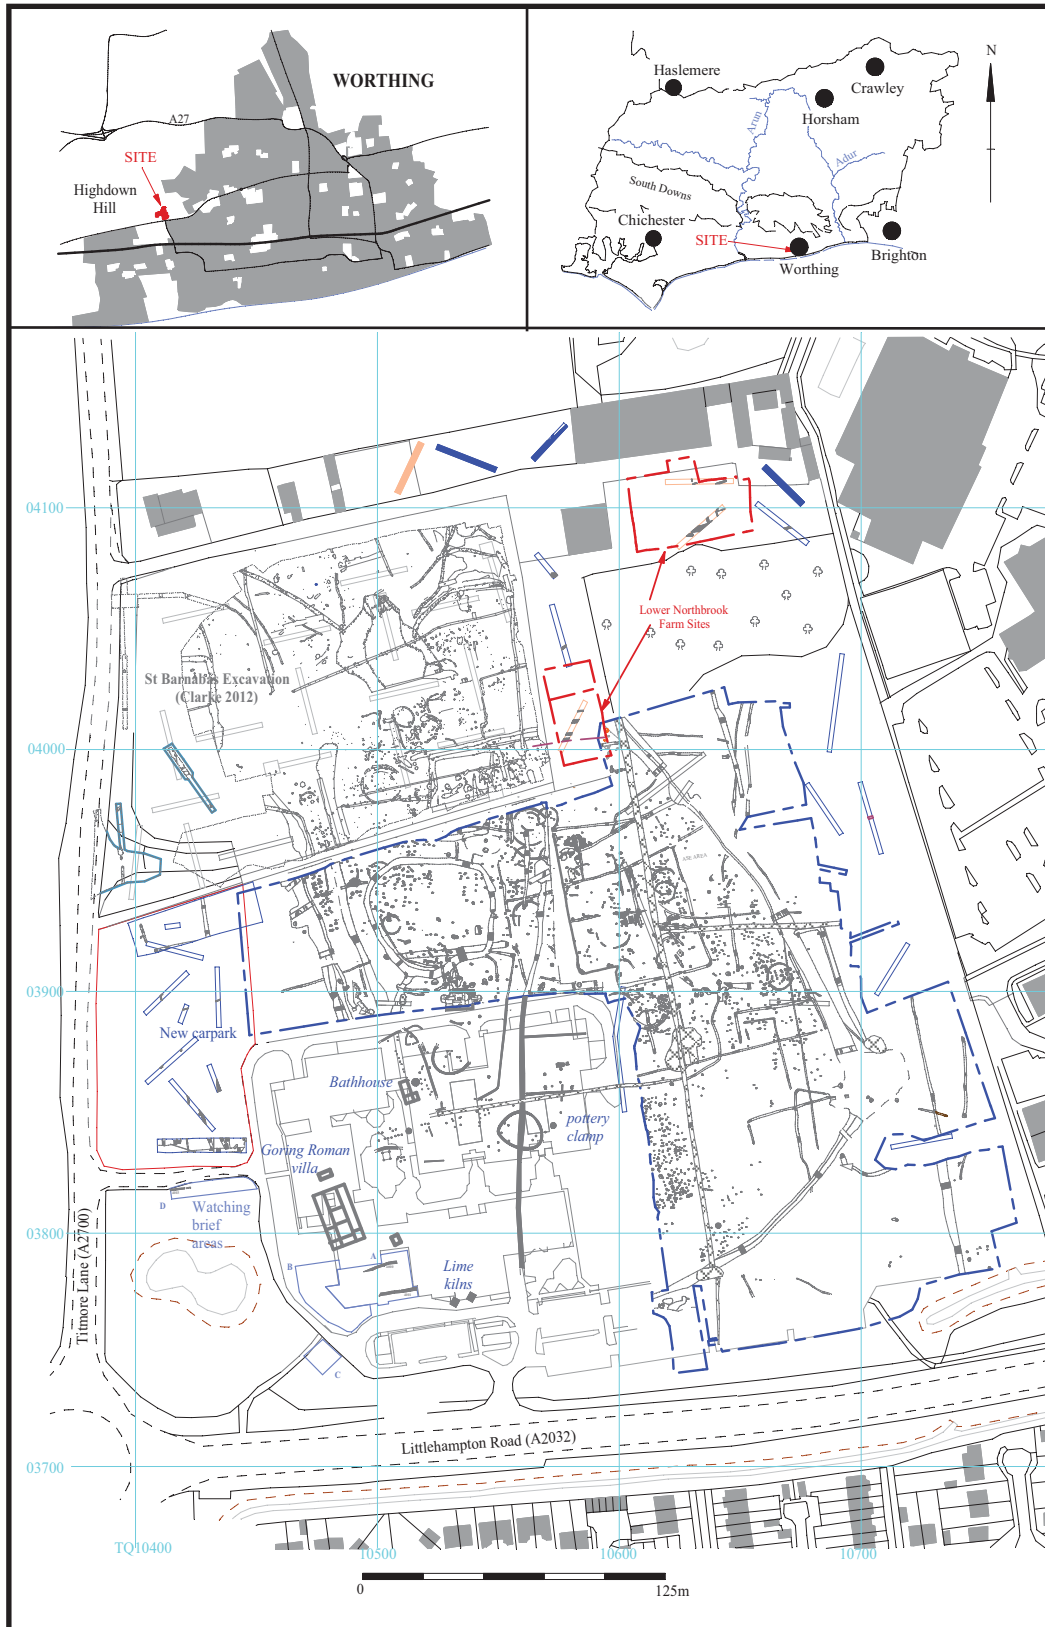
LNF 12/182

Figure 1. Location of site in West Sussex and Durrington

Thames Valley Archaeological Services (TVAS) carried out three phases of investigation including archaeological evaluation, building recording and follow-up excavation at Lower Northbrook Farm, Titnore Lane, West Durrington, Worthing, West Sussex (TQ 1060 0410) (Fig. 1) in January 2015 on behalf of Wilmington Homes and Bloor Homes.

The site lies to the north of Littlehampton Road and east of Titnore Lane, approximately 4km north-west of the historic core of Worthing (Fig. 1). The western part of the site was occupied by several residential properties and their associated gardens, whilst the eastern part of the site consisted of a number of former agricultural buildings and associated areas of hard standing. An access road leads into the site from Titnore Lane. The site is generally flat, at a height of approximately 11m above Ordnance Datum. According to the British Geological Survey the

Ten trenches were dug across the site ranging in length from 22-26m (Fig. 1). In the immediate vicinity of the farmyard, these mainly revealed the foundations of structures that matched those present on the 1839 tithe map, with some later developments. Elsewhere a number of linear features were revealed, some of Iron Age and/or Roman date (Wallis 2012).

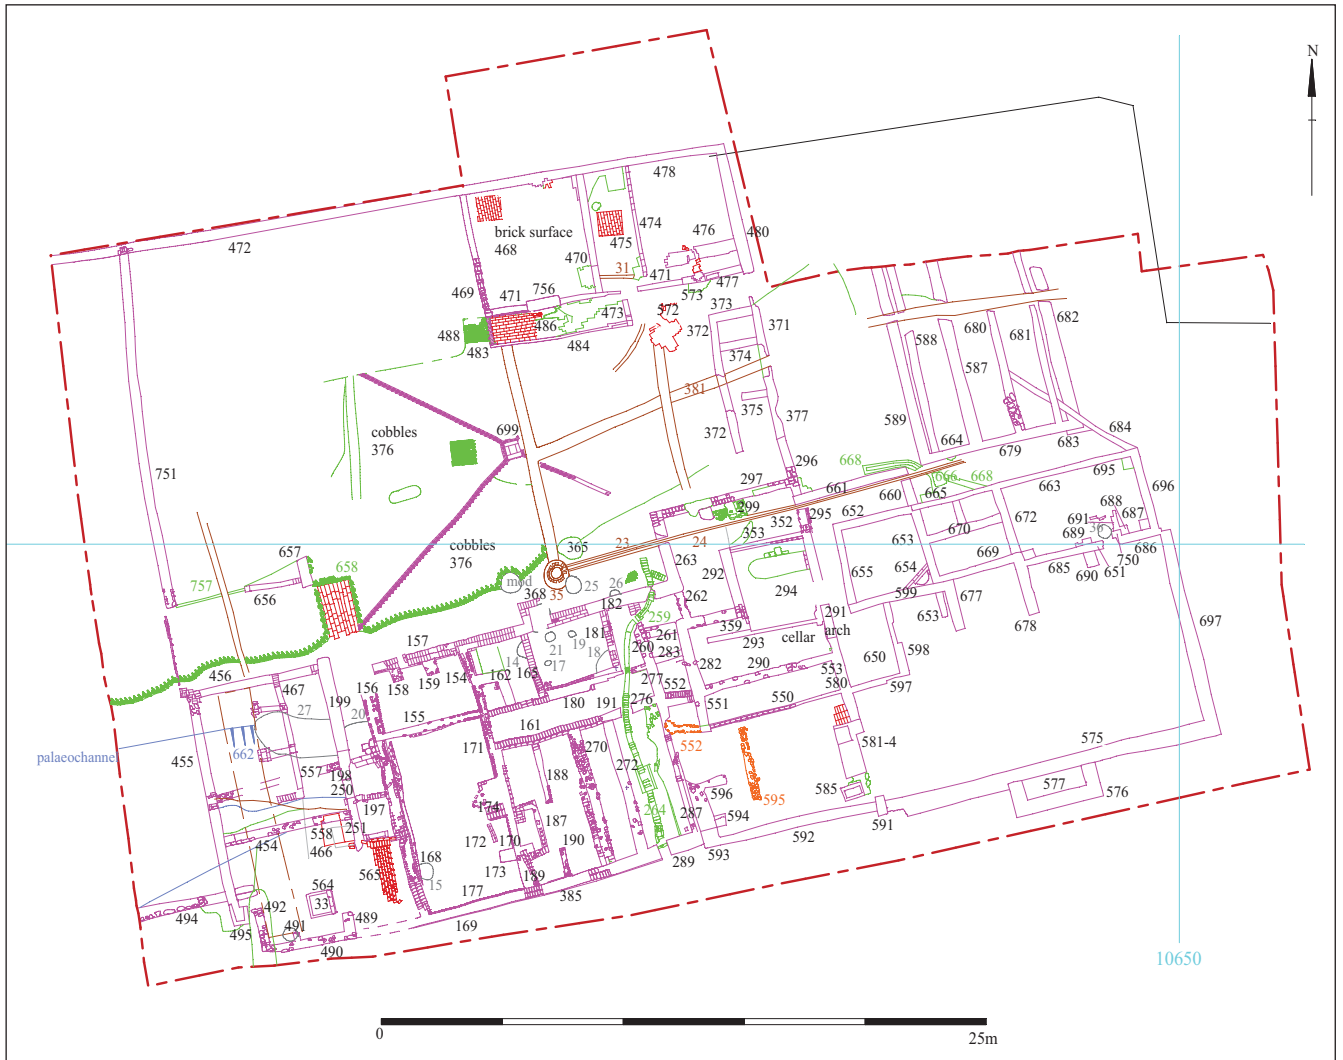
Lower Northbrook Farm, Titnore Lane,
 Worthing, West Sussex
 Archaeological Excavation
 Figure 8. Detailed plan of Area A.

Area A (Fig. 8)

Area A mainly revealed the remains of post-medieval brick-built buildings with a small volume of earlier cut features. The brick-built remains largely coincide with the ground plans of two buildings depicted on the 1839 tithe map and which can be confidently identified with Northbrook Mansion. As detailed above the house may date from before 1778 but was demolished in the 1850s. However, the Ordnance Survey map of 1875 suggests the western outbuilding was not demolished, nor the northernmost building. Interpretation of the internal layout of the buildings is hampered by the depth of demolition which seems to have been deeper than original floor levels and thus it is mostly foundations and not walls and doorways that have survived.

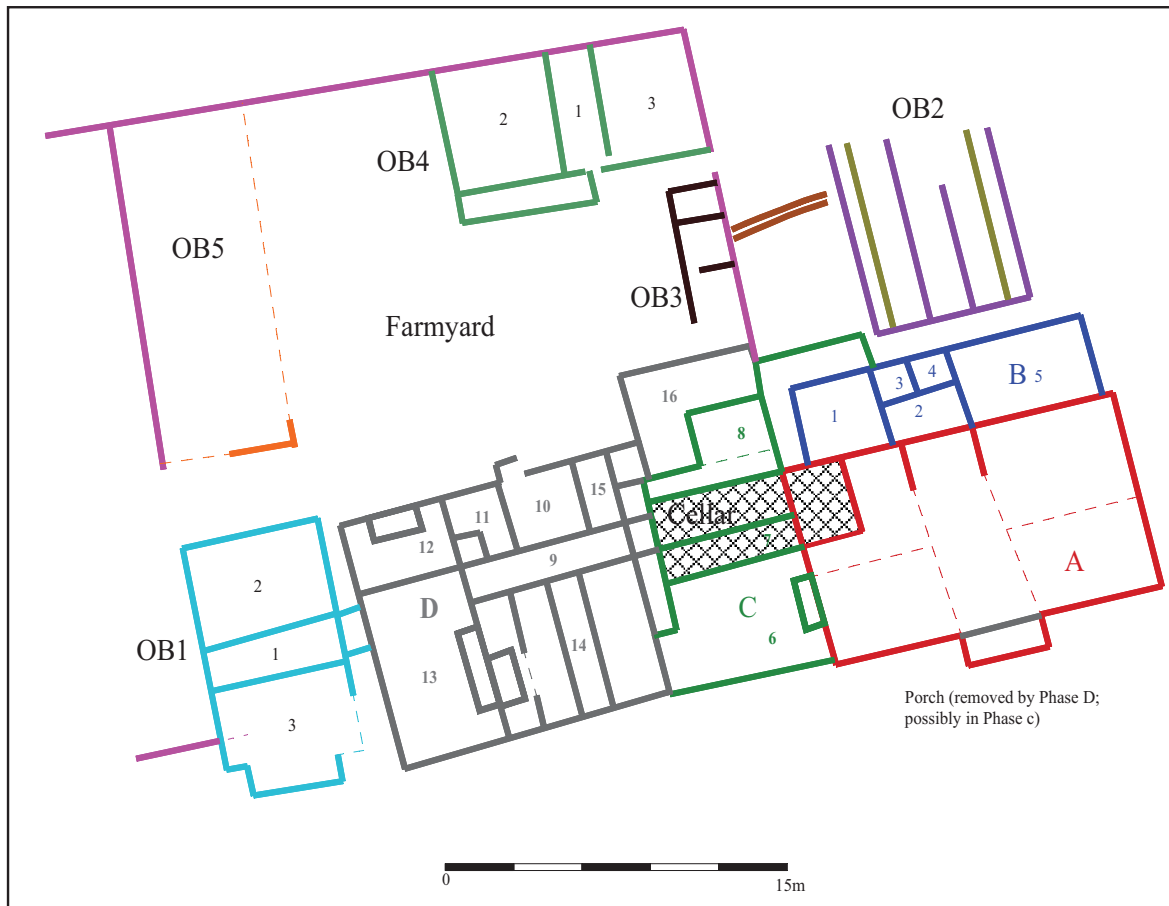
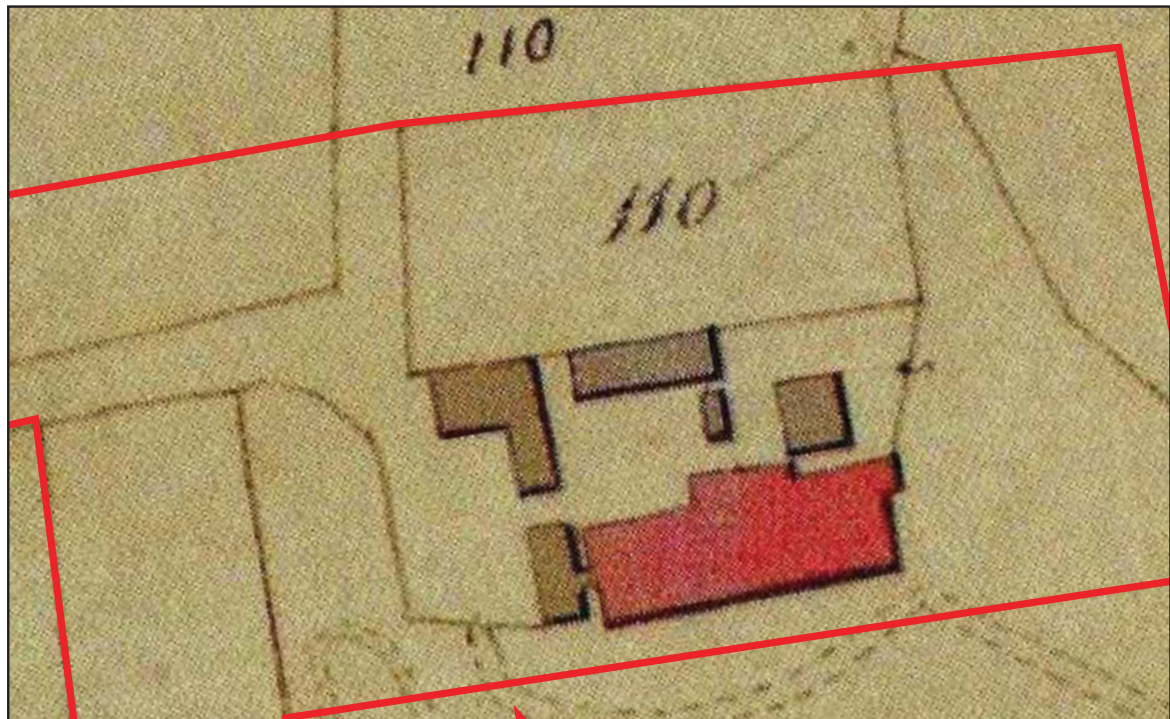
Figure 11. Interpretation plan of buildings in Area A (schematic) compared to the Goring tithe map of 1839 (below).

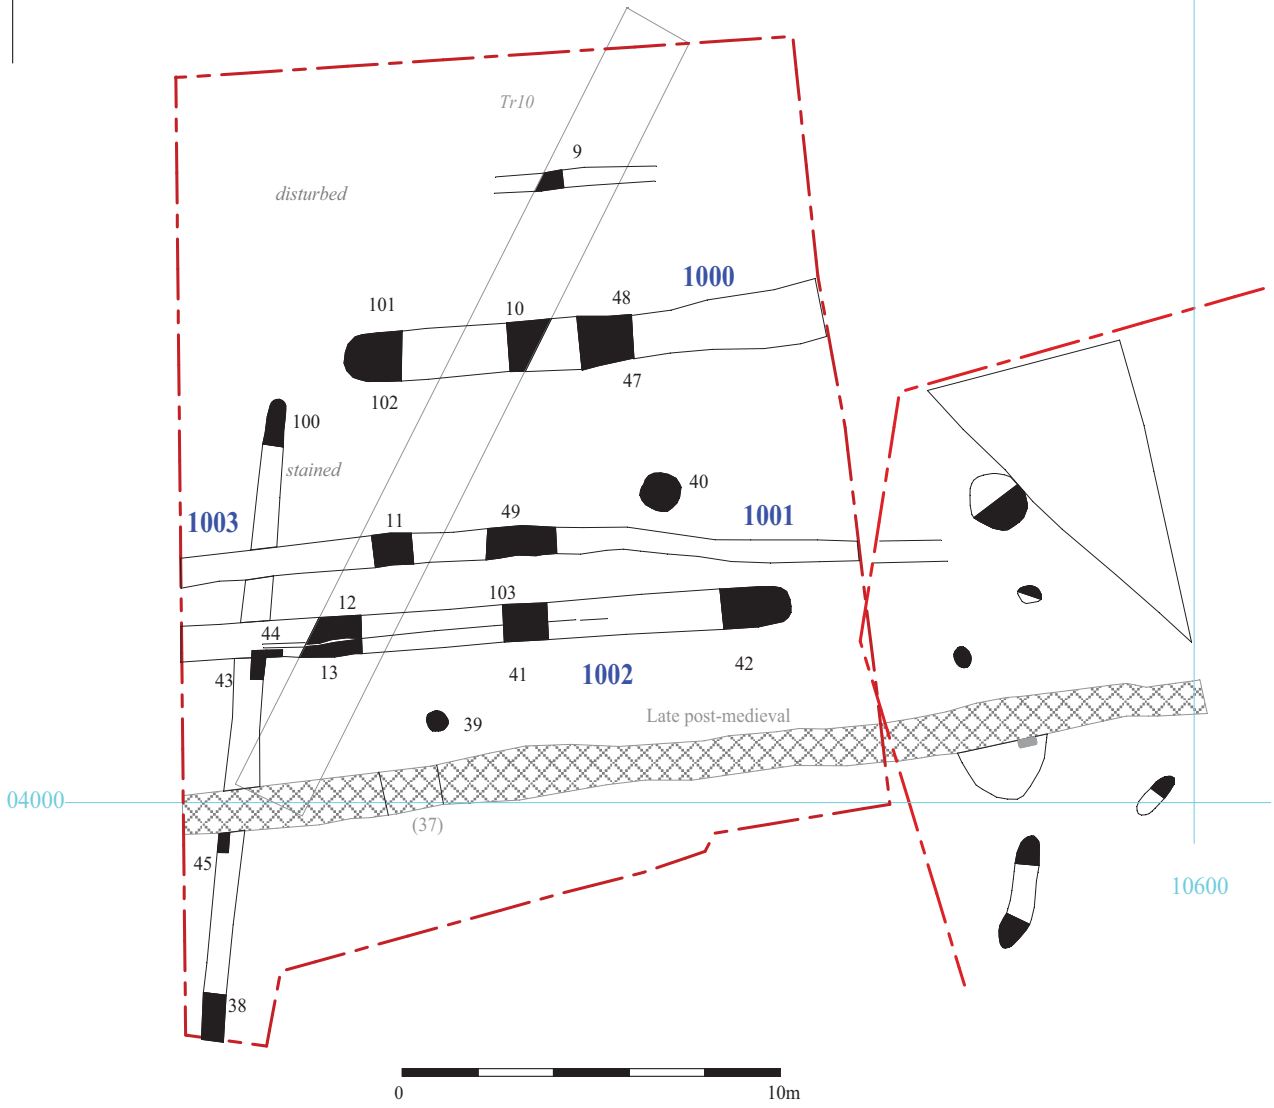
Lower Northbrook Farm, Titnore Lane,
Worthing, West Sussex
Archaeological Excavation
Figure 12. Plan of features in Area B.

Ditch 1001 was also aligned east-west and was 0.94m wide and up to 0.40m deep. It traversed the whole trench and was investigated by two slots (11, 49). It originally continued 50m further to the east as ditch 10009 as seen in the larger Northbrook College excavation to the east/south (Wallis and Ford 2018) but had been truncated by the Late Iron Age/Roman boundary ditch which was a major feature in the college excavations. It in turn cut gully 1003. The upper fill contained burnt flint along with two sherds Late Bronze Age/Iron Age pottery (including one from the evaluation phase). Ditch 10009 had been tentatively assigned to the later Bronze Age in previous work and this evidence does nothing to contradict that.

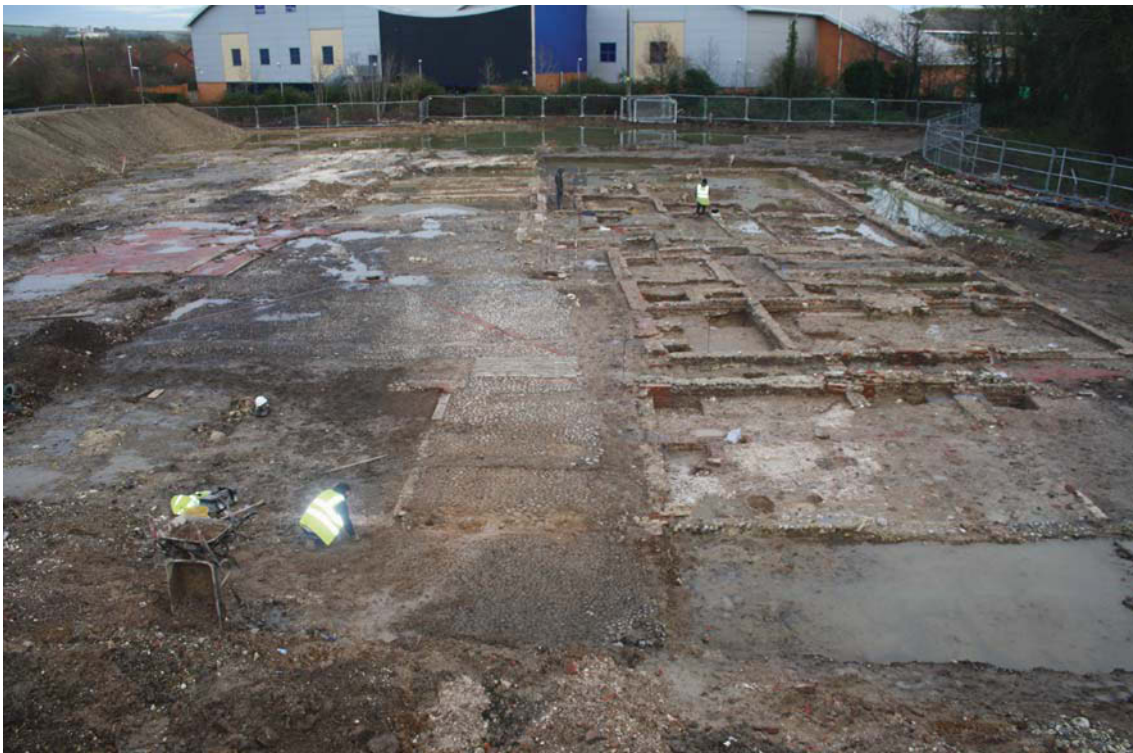
Plate 1. Site overview, Area A, looking east.

The excavation comprised the digging of two areas of the site: A and B of 1400 sq m and 400 sq m respectively (Fig. 7; Pl. 1).

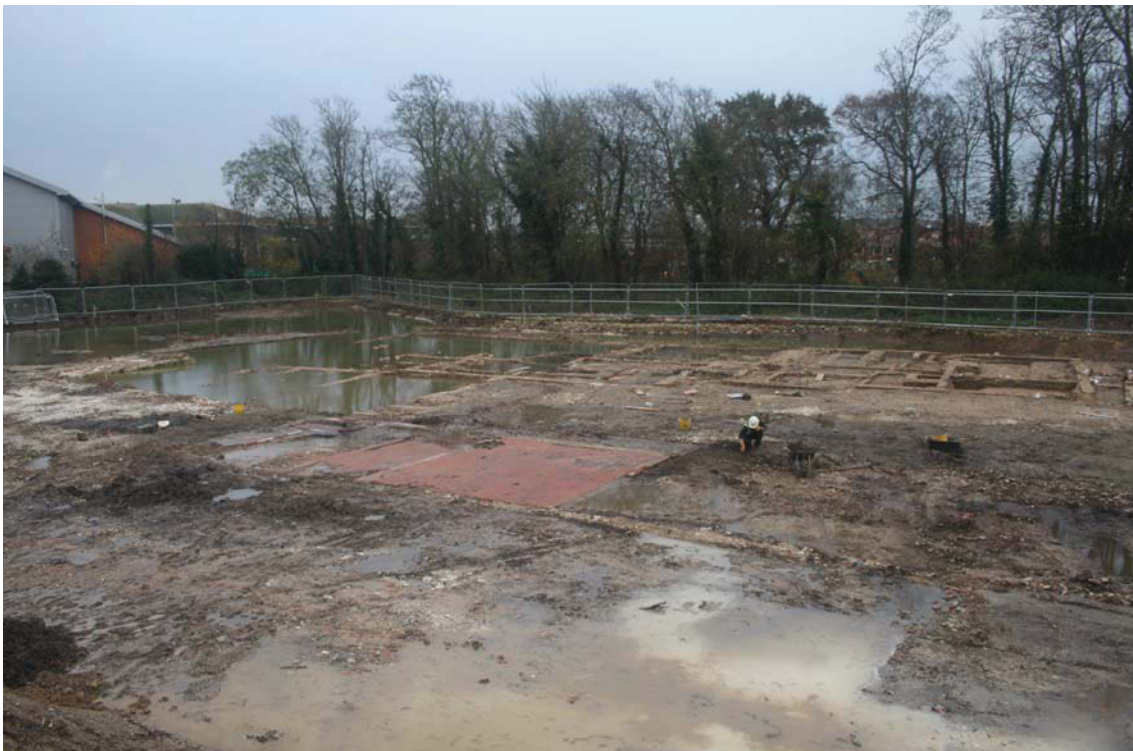
Plate 2. Excavation conditions, looking south-east.

The site was extremely wet and at least partially under water during the excavation, so that not all features could be fully bottomed (Pl. 2).

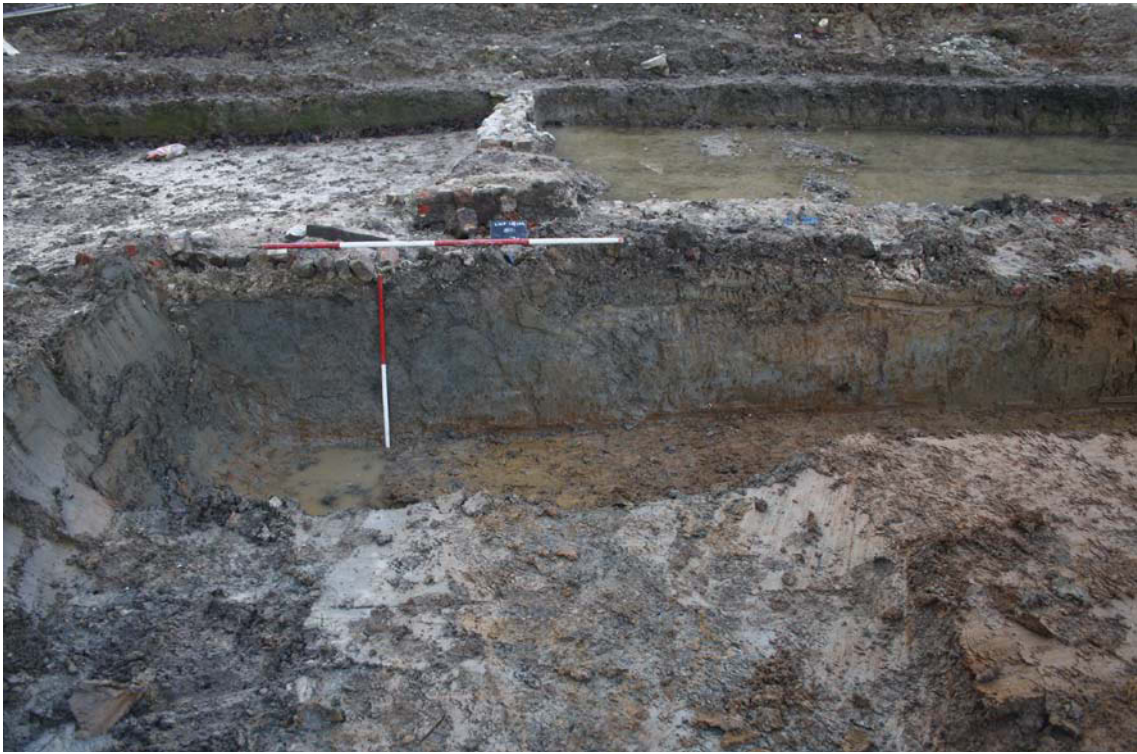
Plate 3. Slot through palaeochannel 662, looking west; scales 2m, 1m.

An area of alluvium underlay outbuilding 1 at the east end of the site and is considered to be a possible palaeochannel. It was investigated by a machine-excavated slot through this revealed only the north edge. It was

at least 0.95m deep, with a varied but essentially mid-grey-blue clay or silty clay fill (Pl. 3), with occasional burnt flint. One prehistoric flint flake and a sherd of medieval pottery were also recovered.

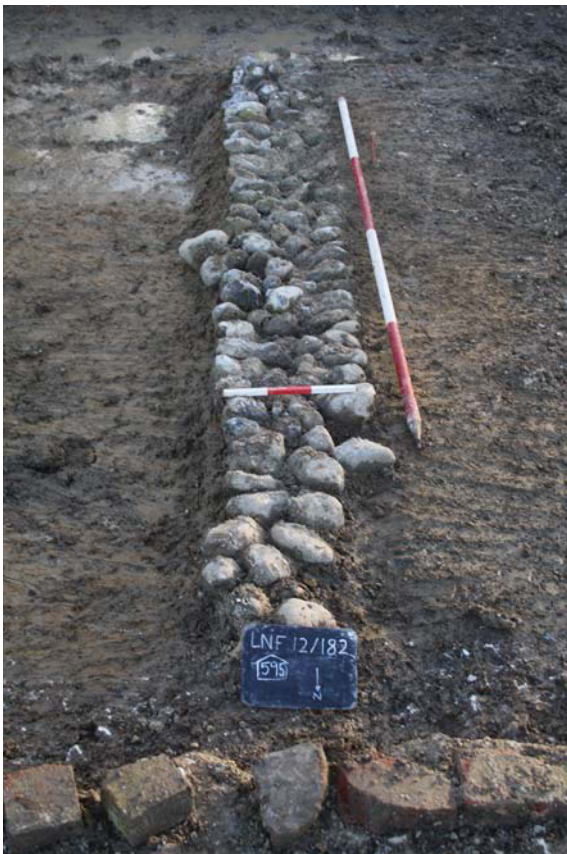
Plate 4. Early wall 595, looking south; scales 2m, 0.3m.

Two walls (552 and 595) did not appear to relate to the main building construction in either plan or construction style. Wall 552 runs approximately east-west and is of flint construction, bonded in lime mortar. It is only 1.25m long and is situated between walls 287 and 551, underlying the former. Wall 595 is aligned north-south, located to the east of wall 552. It measures approximately 3.1m long by 0.36m wide and has no relationships with any other walls. It is constructed of flint cobbles in lime mortar (Pl. 4). Too little of this potential building remains for further interpretation except that it predates Phase C of the main farmhouse but it is possible it is contemporary with Phase A. It is, however, too speculative to suggest that it might be the western of the two buildings shown on Yeakell and Gardner's 1778 map. The crudeness of construction, however, suggests it should be earlier.

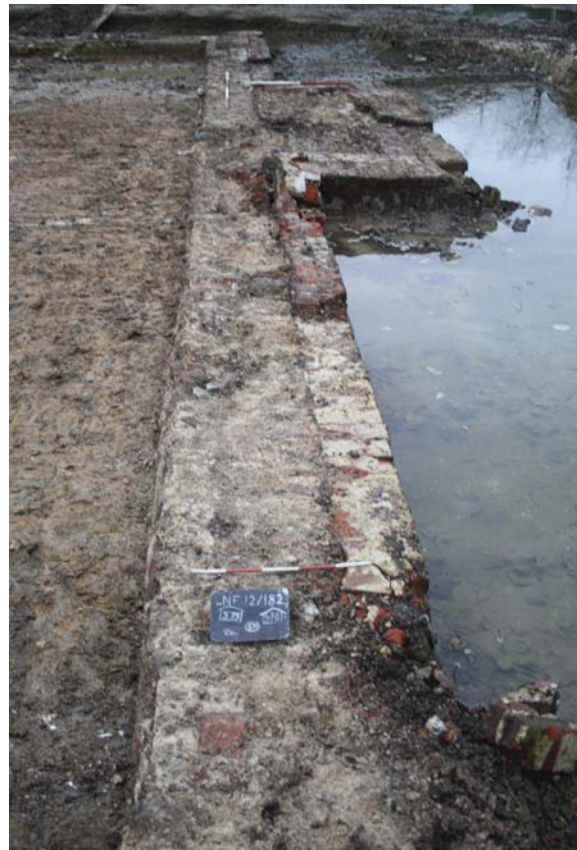
Plate 5. Phase A south wall 575, looking west; scales 2m, 1m (distance), 0.5m (foreground).

The southern (575) and eastern (697) external walls survive the most intact (Pl. 5). Wall 575 was constructed in two parts: an internal rubble construction of a combination of bricks, cobbles and chalk in lime mortar; and an external brick face, 230mm wide. The bricks themselves are red and measured 230mm x 110mm x 70mm (9" x 4 1/4" x 2 3/4"). To the south of this wall is an approximately central, rectangular base, 3.75m long by 1.4m wide (576). It had the same rubble core as wall 575 and external brick facing. The location is suggestive of a porch and main entrance rather than a chimney stack. Wall 575 turned though 90° to the north

where it was numbered 697. Wall 697 is constructed of a combination of brick and flint cobbles in lime mortar. The bricks vary with a combination of red and yellow bricks visible internally. The space within wall 576 was surfaced with flint and mortar, presumably providing a threshold. The porch is not shown on the 1839 map, whose details otherwise appear reliable, but by this time the main entrance would have been from the farmyard to the north (this also possibly reinforces the case for its not being a chimney stack, which would be more likely to have survived the remodellings).

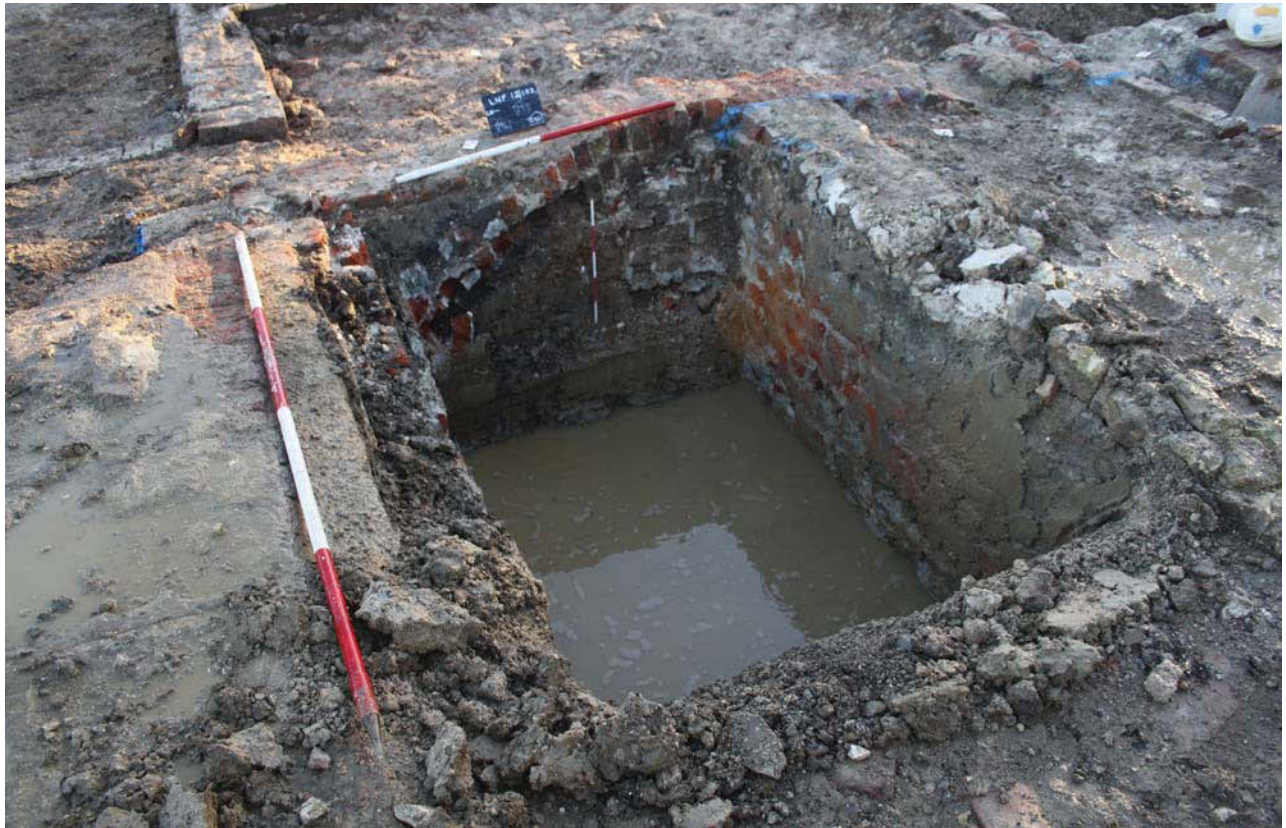
Plate 6. Cellar arch 291 and associated walls, looking west. Scales: horizontal 2m, 1m; vertical 0.5m.

The west wall is numbered 291 and 580 at its northern end and appears to be missing at its southern end with the exception of a small section numbered 591. Section of wall 291 consists of the top of an arch, spanning some 2.90m in width and at least 1.2m deep (the full depth could not be established). The arch itself is of brick construction, laid in two courses of rowlock bond in lime mortar (Pl. 6). The keystone brick extends laterally slightly from the rest of the arch to the west; this was not apparent to the east (but possibly due to truncation). The underside of the arch appears to be a combination of a small amount of brickwork and soil infill. A deposit of fragmentary brick, slate and (mostly) cement (294) may be the cellar roof.

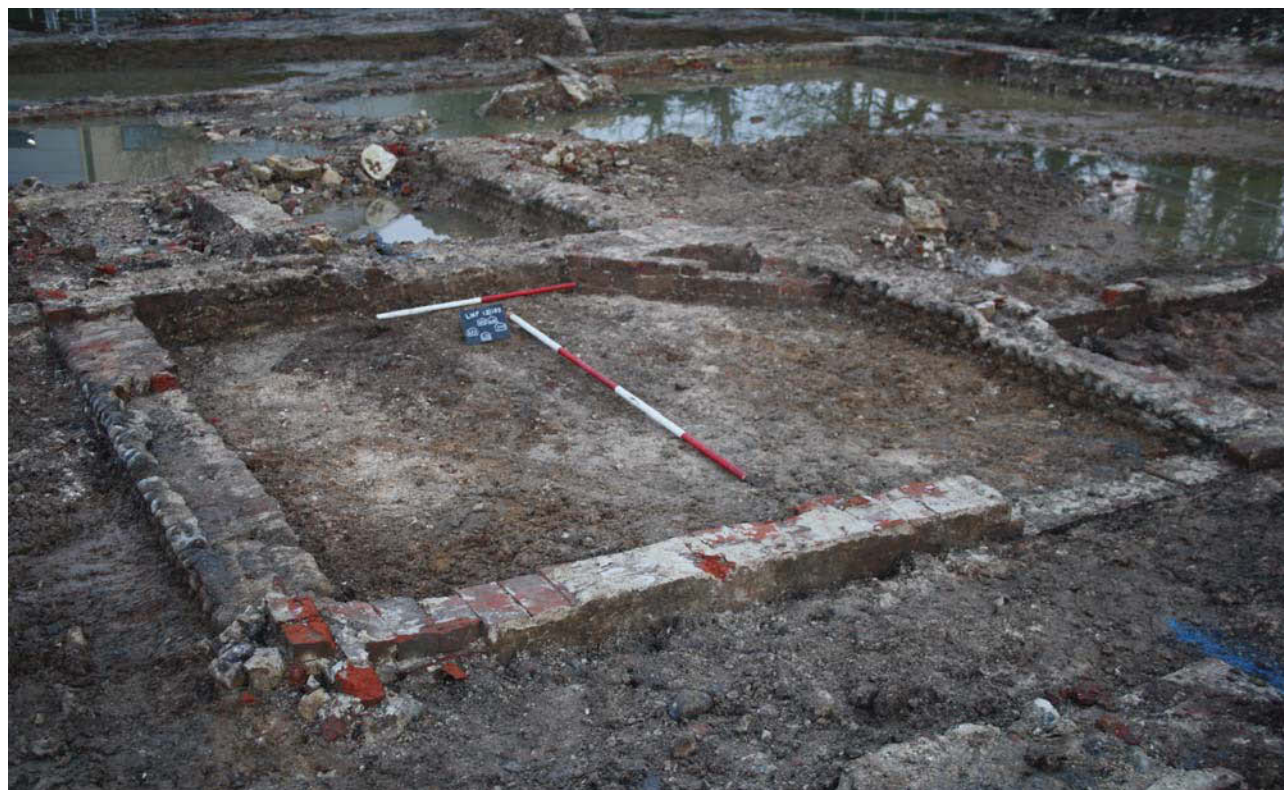
Plate 7. Phase B, room 1, looking south-east; scales 2m, 0.3m.

With no obvious access, room 2 would appear to be the most likely contender for a corridor, having a relationship with each of the four other rooms; 1 to the west, 3 and 4 to the north and 5 to the east, as well as butting the presumed central corridor of the original building. Room 1 measured approximately 3m square and

contained brick feature 654 in the south-west corner (Pl. 7). Depending on what this structure is it could potentially impact upon the location of the door, though a remaining width of 0.75m would leave just enough space for a door. Feature 654 is brick built in lime mortar using bricks measuring 230mm x 110mm x 70mm (9" x 4 1/4" x 2 3/4"). It appears to butt walls 599 and 653, forming a triangular shape in the corner of the room. Centrally within the feature is an open semi-circle. It is possible that this is the base of a chimney. Rooms 3 and 4 measure approximately 1.35m x 1.05m and based on the size would seem best suited as cupboards accessed from below the stairs (Pl. 8), though it is possible they were privies, perhaps with access from the exterior. Room 5 is the largest room measuring 5.34m x 3m. Its function is unknown.

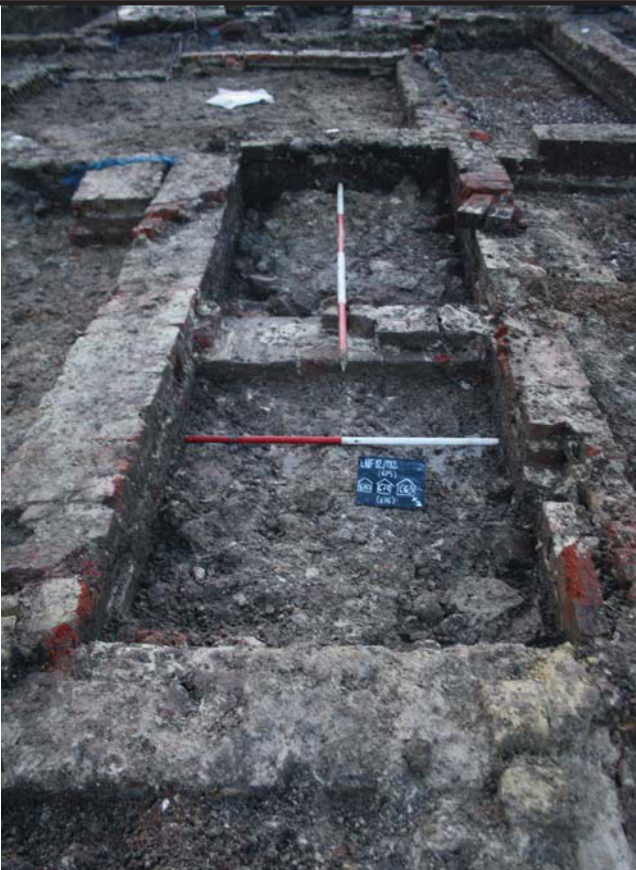
Plate 8. Phase B rooms 3 and 4, looking south-west.
Scales: 2m, 1m.

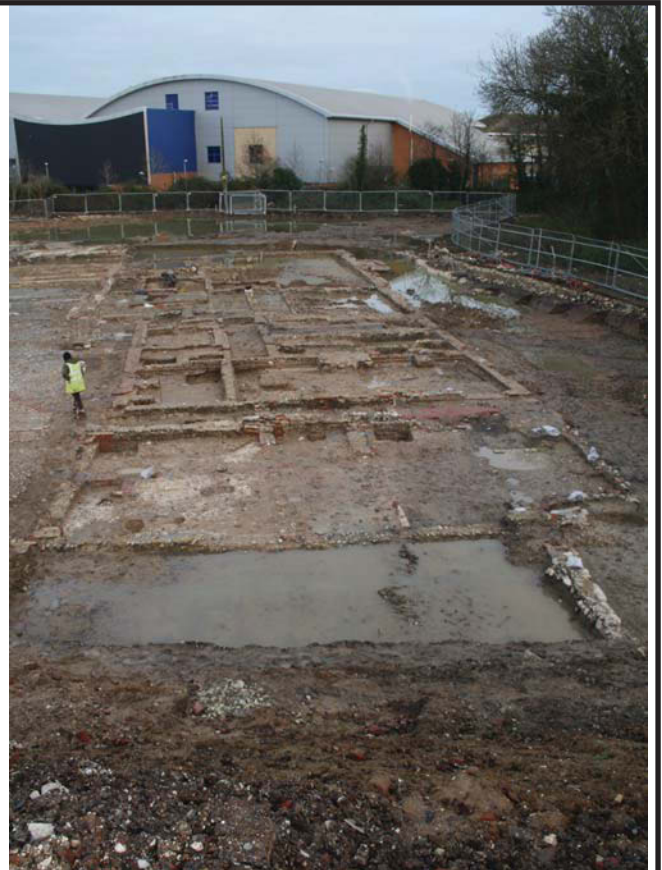
Plate 9. Overview of west end of main building (Phase D)
and outbuilding 1, looking east.

Due to the irregular phase C extension it would appear that this phase of construction has four main external walls with additional ones for the northern extension. The main walls are numbered 169/289 (south), 156/167/168/195 (west), 157/182 (north) and 260/277/287 (east) with the smaller northern extension external walls numbered 263, 297 and 368 (Pl. 9).

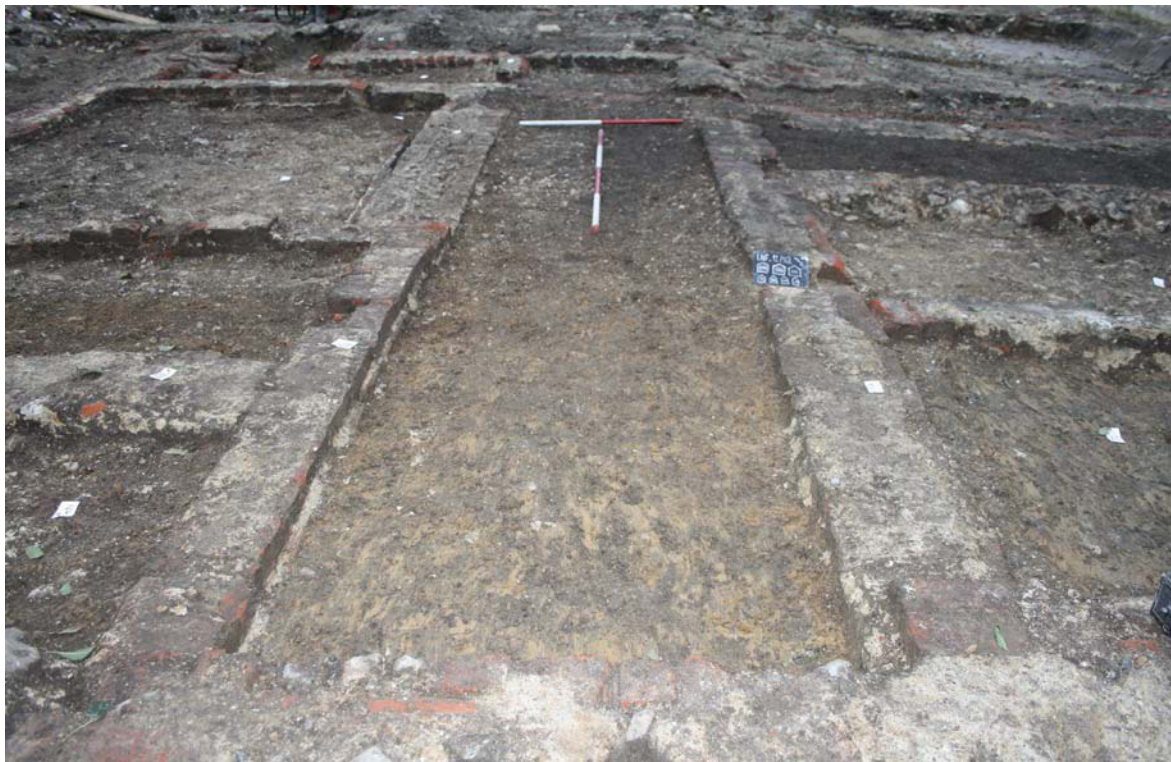
Plate 10. Interior of Phase D (corridor 9 and adjacent rooms) looking east. Scales: 2m, 1m.

Room 9 appears to be an east-west aligned corridor, approximately 1.25m wide by 6.85m long and has a relationship with rooms 10, 11, 13 and 14 (Pl. 10). Its eastern end is less clear; it may turn to the north through room 15 or continue to the east beyond the eastern wall of this phase of extension between walls 281 and 283 which appear to be in line with the corridor walls. The main corridor walls were numbered 161/180/259 on the north side and 191/276 on the south side. Both were cut by drain 264 and were constructed of bricks bonded with lime mortar and measuring 230mm x 110mm x 65mm (9" x 4 ¼" x 2 ½") and were approximately 0.35m thick, though the north wall had some variation. Walls 281 and 283 were of slightly different construction; 281 was a combination of brick and flint cobbles in lime mortar whilst 283 was purely of flint construction in lime mortar.

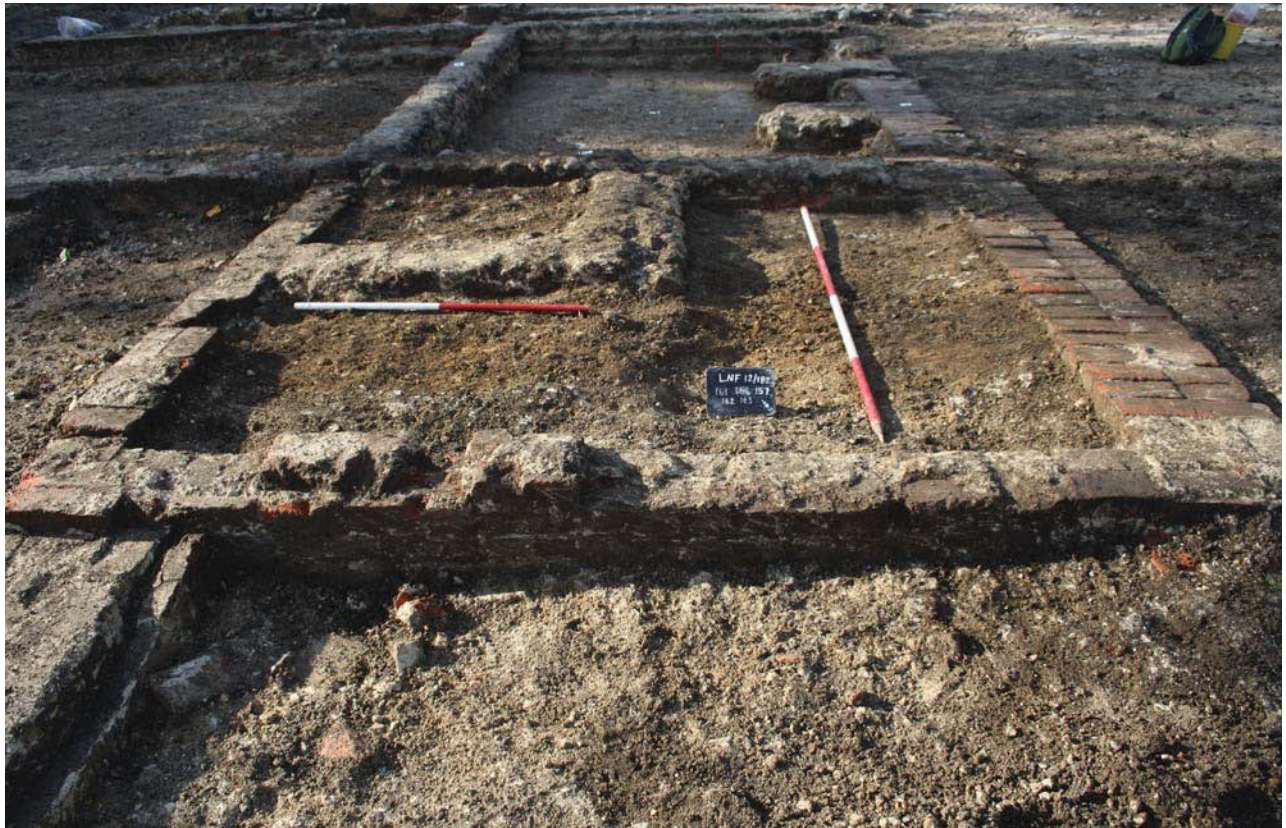
Plate 11. Phase D room 11 with 12 beyond, looking south-west. Scales: 2m, 1m.

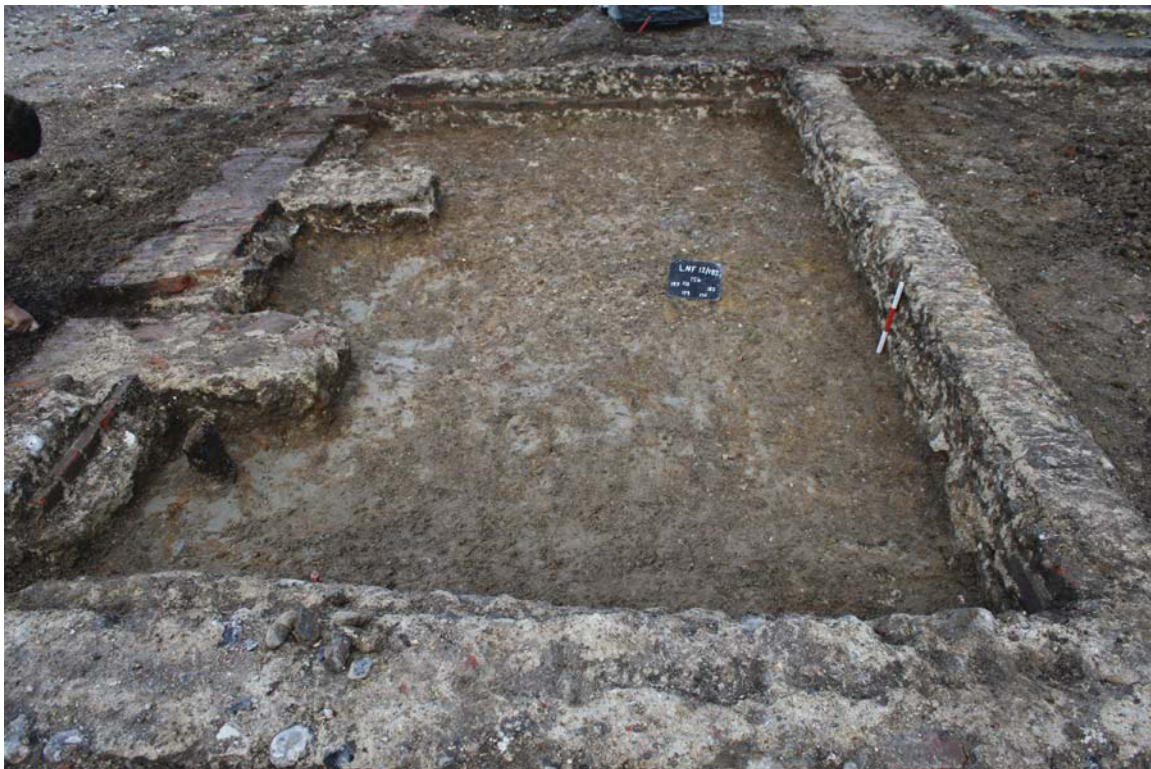
Plate 12. Phase D, room 12, looking east; vertical scale 0.3m.

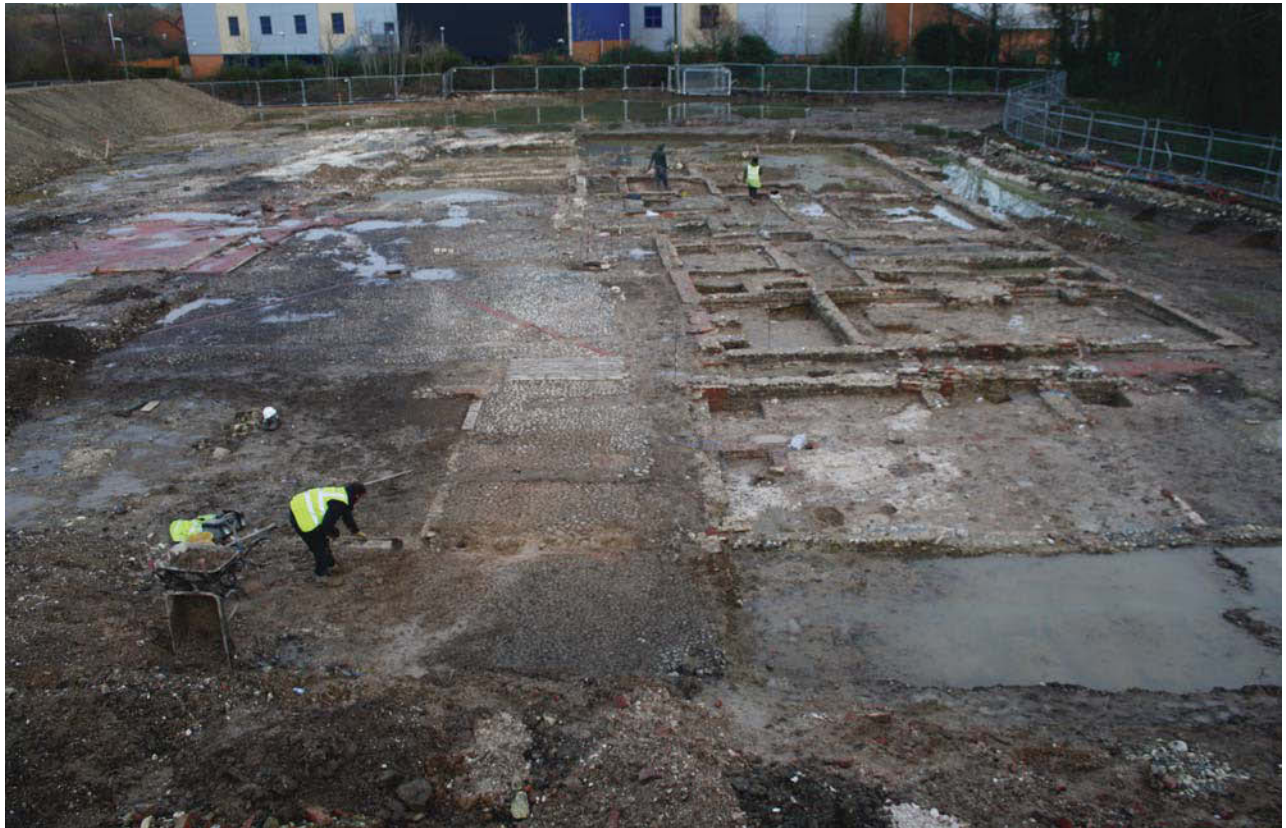
Plate 13. Overview of farmyard in relation to main range of buildings, looking east.

The farmyard lay in the north-west corner of the site and appeared to be a loose courtyard formed by the main house and outbuilding 1 to the south, outbuilding 3 to the east, outbuilding 4 to the north and a further outbuilding in the north-west corner (outbuilding 5), present on the 1839 map but not found during the excavation in any meaningful form, to the west. Incorporated into these buildings were continuous stretches of walling forming not only the farmyard boundary but also the property boundary.

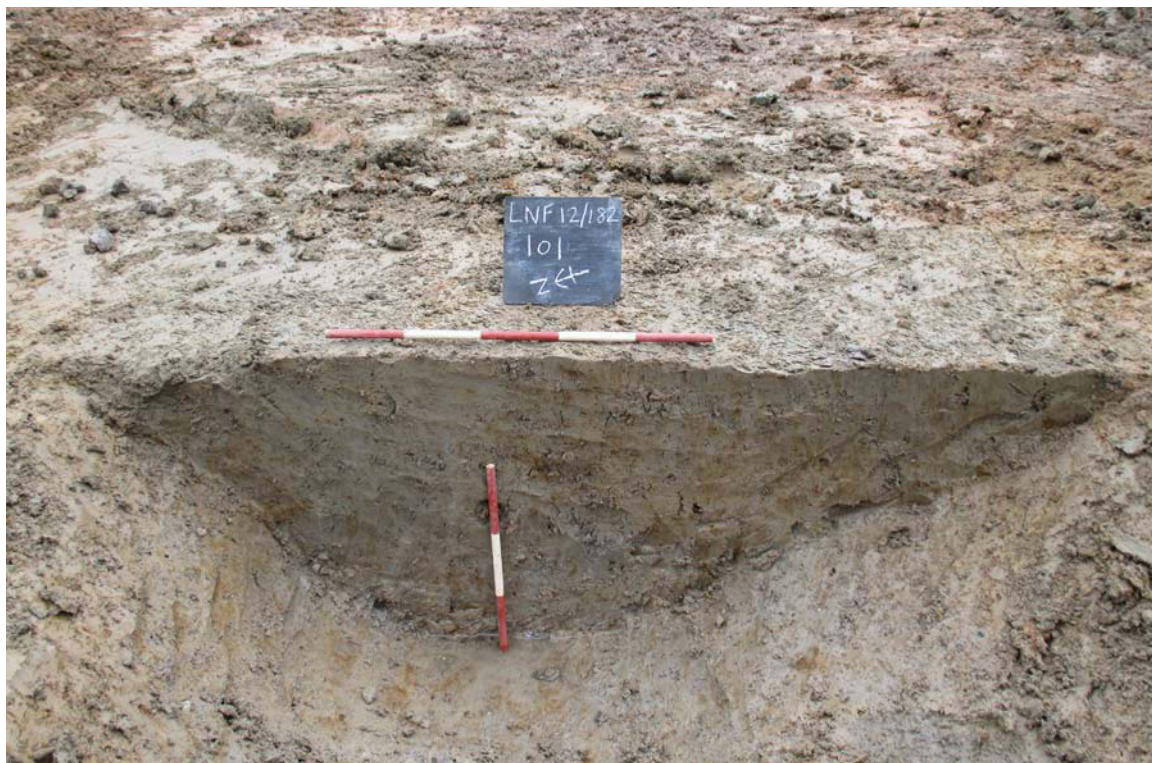
Plate 14. Area B, ditch 1000, slot 101, looking east; scales horizontal 0.5m, vertical 0.3m.
