**St Edburg's Church, Church Street,
Bicester, Oxfordshire**

Archaeological Watching Brief

**An Archaeological Watching Brief
for The Incumbent and Church Wardens**

July 2018

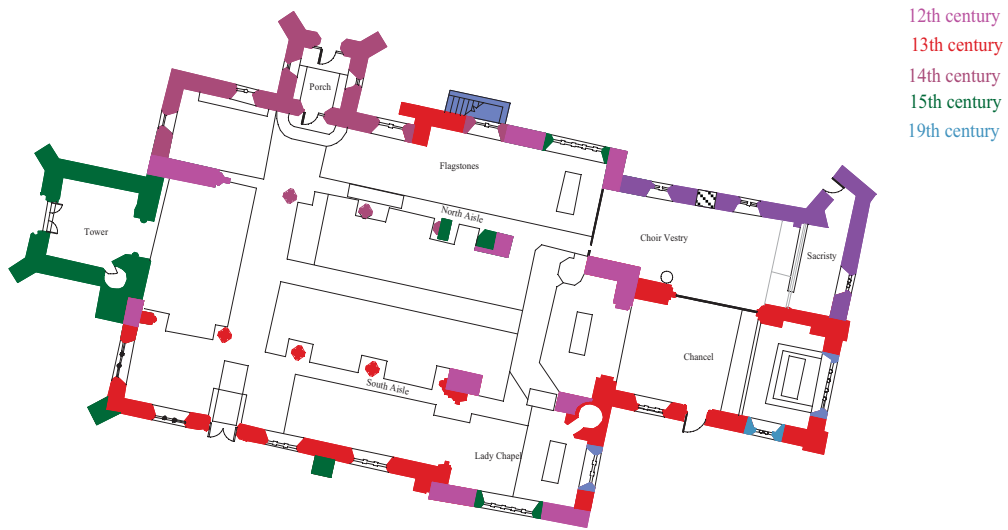
Figure 4. Summary of foundation condition and age.
(phase plan modified from VCH, 1959)

The foundation of the chancel was photographically recorded, to add to the information gained from the other observations from around the church (Fig. 4). The south and east wall of the chancel foundation stonework was in fair state, more so than the 12th-century foundation stonework of the Lady chapel, which had some spalled facing. Missing stones were evident, especially at key points in the upper foundation of the south-east corner buttress (Pl. 2). The east foundation of the sacristy wall was in good condition (Pl. 3), and so was the doorway wall on the north-east corner. Soil from behind several gravestones, in close proximity to the exterior of the church, was reduced to the rear of the stones and stabilized, with a small step of mortar below ground level, to secure them (Pl. 4). Most stones required no disturbance, other than a broken gravestone that had fallen over and was leaning against the exterior wall of the sacristy and needed to be lifted.

The investigation of the foundation of the church found a better state of preservation of the chancel and sacristy walls than the 12th-century foundation of the Lady chapel. There were some holes, missing stones, on the SE chancel corner buttress and occasional missing stones out of the top courses of the foundation. In 2015, damp had created the level of spalling seen on the 12th-century wall of the southern transept wall and had caused the stone of the later 15th-century southern aisle buttress to the 13th-century south aisle, to deteriorate to a point it was offering little support at foundation level (Fig. 4). The south aisle foundation was in fair condition,

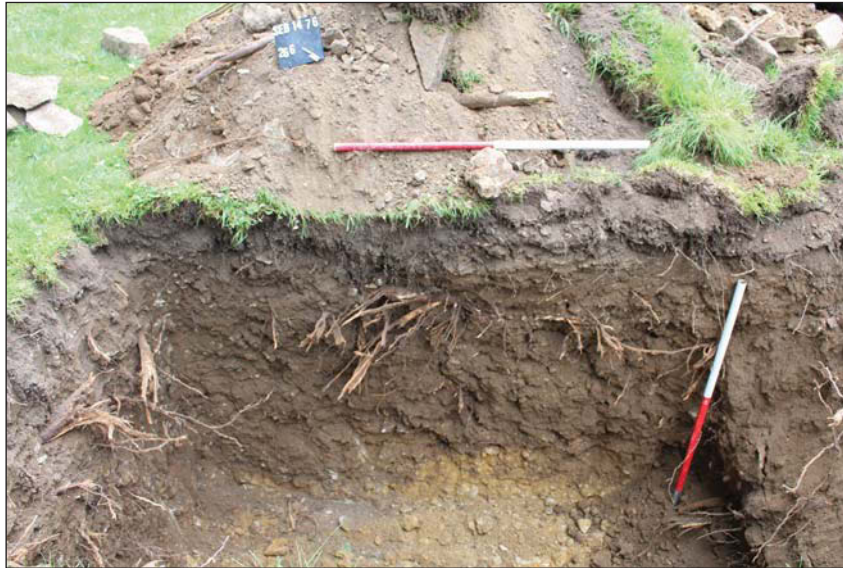
A location 5.4m south-east of the south-east chancel corner was excavated for a storm-water soakaway. The excavation was 2.4m long by 1.3m wide and 1.55m deep (Pl. 1). It was aligned to the corner of the church on a WNW-ESE axis, with the linking trench joining a new junction at the SE corner chancel buttress (Fig. 3, Pl. 2). This junction was 0.35m deep. The machine excavation of the soakaway was positioned through a 2m wide gap between two gravestones. It was anticipated this would avoid any remains associated with the marked headstones. The pit was dug through the topsoil turf, 0.15m deep and encountered limestone pieces of rubble, some with dressed facing on one or two sides. In the south-west side this was no deeper than 0.3m (264). This rubble was loosely infilled with a light brown sandy silt. The densest layer of rubble was on the north-east face of the excavation, reaching a thickness of 0.45m. None of these remains formed an *in situ* buried structure. Below 0.3m was a homogenous light brown sandy silt with limestone and brick rubble to a depth of 0.6m (265). From 0.6m deep, the highest layer of buried graveyard soil was encountered, which was 0.28m thick to a total depth of 0.88m. This loose, light brown sandy silt with occasional sub-angular limestone fragment inclusions (266) contained disarticulated human bone, with one area of a fragmentary, partial skull. This skull had been previously disturbed and was smashed. No parts of the cranium could be excavated *in situ*. The only diagnostic piece recovered from this location was the mandible, indicating it belonged to a child of 7 years (+/- 24 months), with milk teeth present. The two lower front adult incisor teeth were erupting within the jawline. Though other long bones were recovered from this context, none were associated with the remains of this skull. No grave cut could be defined.

At 0.88m, a secondary layer of grave soil (267) was encountered. This reached a depth of 1.23m where the top of the natural was encountered. The second grave soil layer was a light brown clayey silt with frequent sub-rounded limestone fragments. Human bone was recovered, but again, none of the remains encountered were considered to be *in situ*. A single, discrete area indicated the location of the back part of a skull, though no other

The base of excavation was dug 0.28m into the natural Cornbrash geology to reach a final depth of 1.55m. No structural remains were encountered. Finds from the layers were sparse, almost no pottery was encountered throughout the excavation, other than a brown-glazed redware sherd in the first layer of grave soil (266). A single stem of clay tobacco pipe of thick stem but narrow bore was recovered close to the skull fragment, which would be of 17th- or more likely 18th-century date. The only find of Medieval date was a piece of red and yellow patterned floor tile, with patchy of orange-brown glaze, found in the secondary lower layer of grave soil (267). Other sparse fragments of floor tile have been identified in previous works at the church, notably of Medieval date, in interior test pitting and in the exterior works to the south-west and north-west.

Plate 1. Soakaway section, looking south-west, Scales: horizontal 1m, vertical 1m.

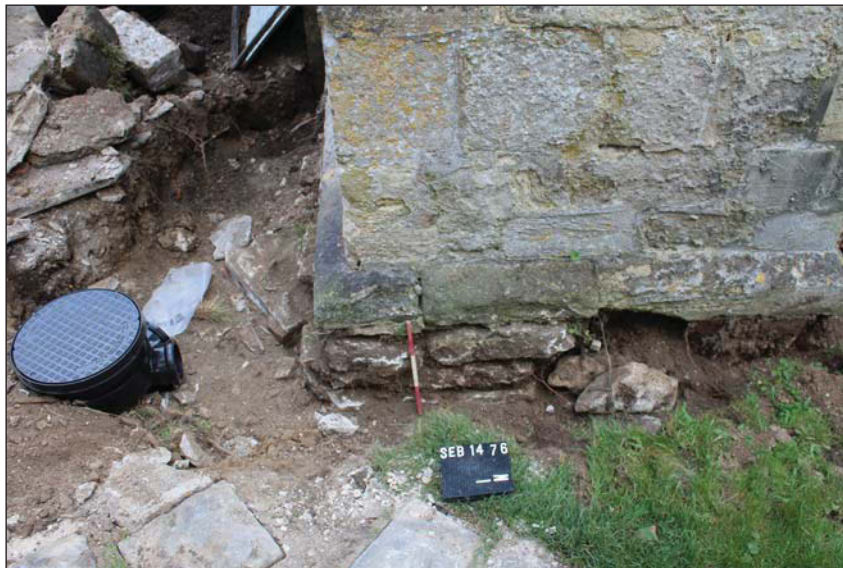
Plate 2. South-east corner buttress foundation of 13th-century chancel, looking west, Scale: 0.3m.

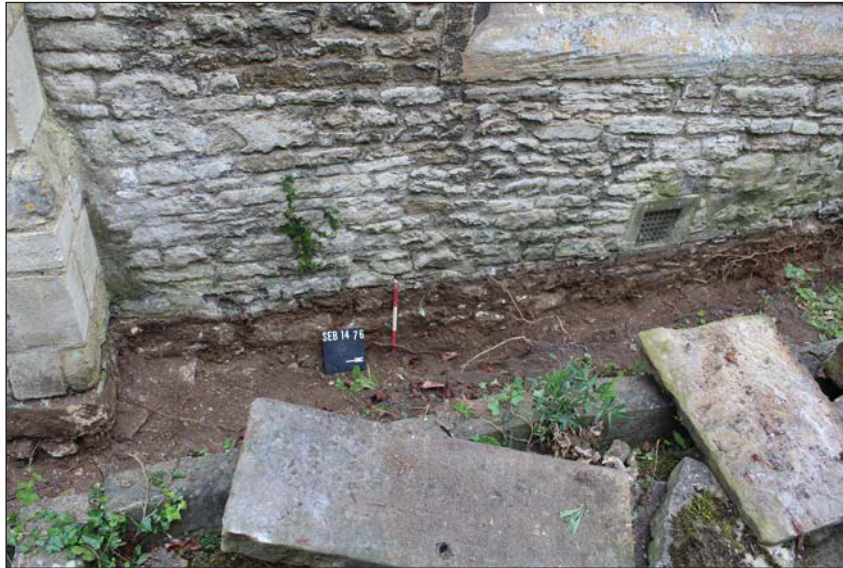
Plate 3. East Sacristy wall foundation, looking west-north-west, Scale: 0.3m.

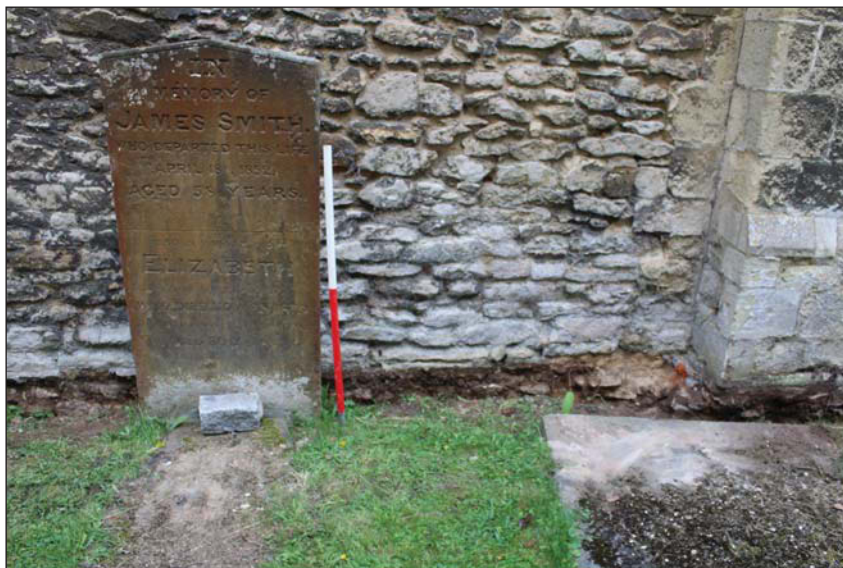
Plate 4. Gravestone in proximity to east chancel wall, looking west, Scale: 1m.
