**36 - 38 High Street, Whitchurch,
Shropshire**

Building Recording

HSW18/104

**Building Recording
For New Park Commercial Limited**

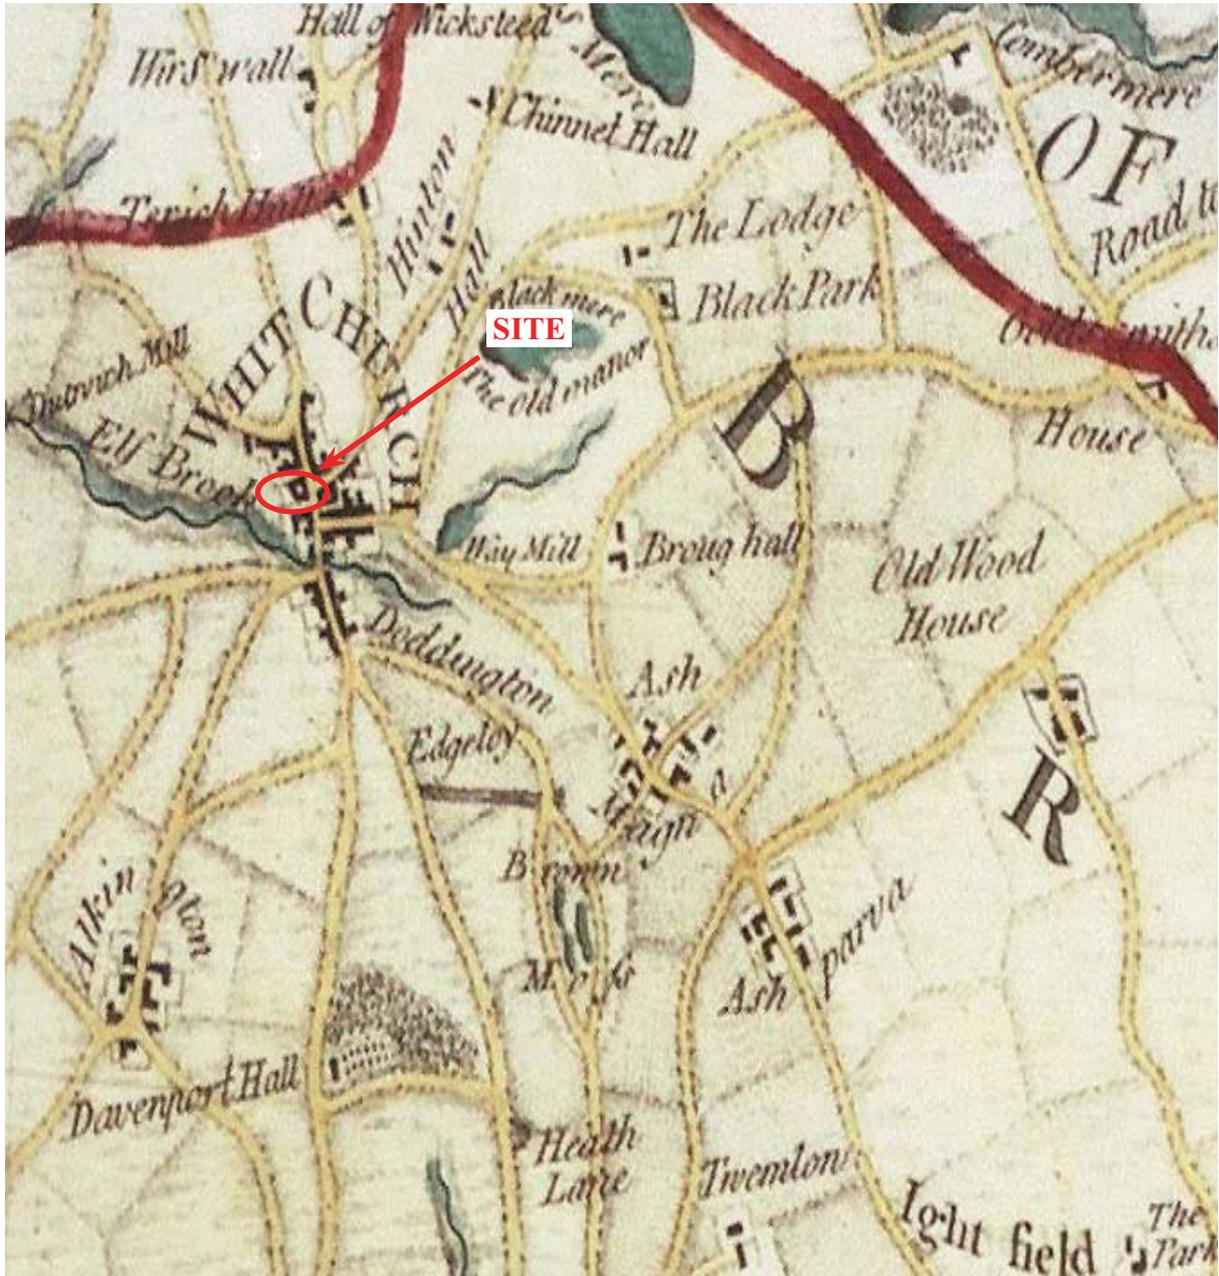
36-38 High Street,
Whitchurch, Shropshire, 2018
Building Recording
Figure 3. Roque's map of Shropshire, 1752.

The later history of the site can be traced through contemporary maps. The earliest map to show buildings in the vicinity of the site is Roque's map of Shropshire (1752) (Fig 3) which shows a continuous line of buildings on the west side of the High Street between Pepper Street and Yardington. This is support by the Stevens map of Wem (1829).

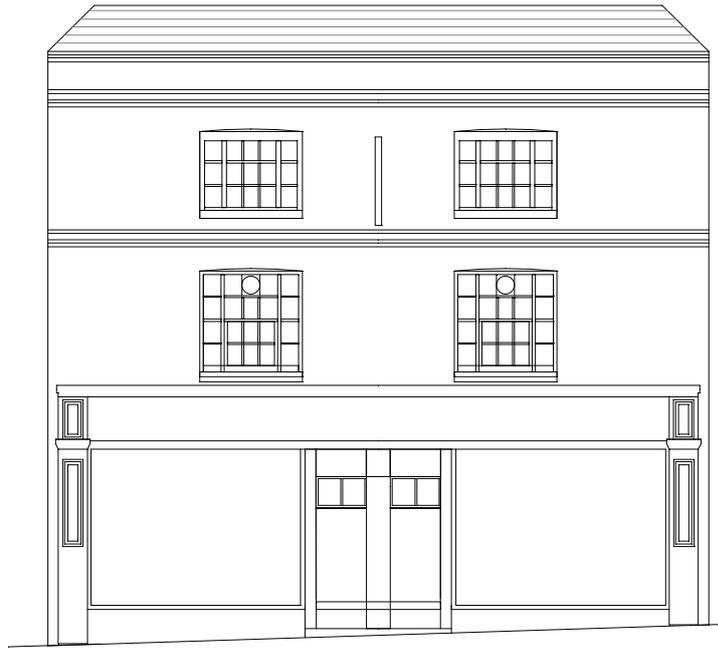
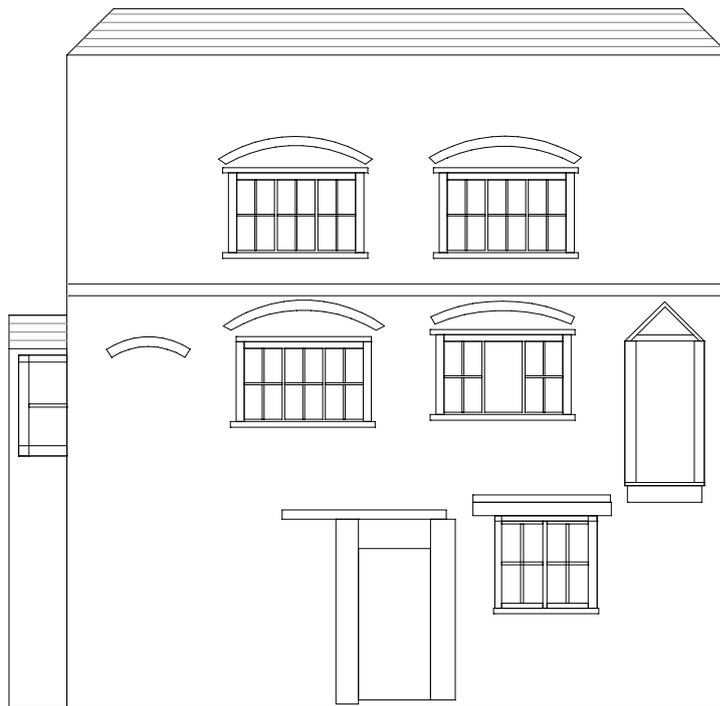
Figure 4. Elevations.
(prior to the rebuild of the rear wall)

North-east (front) elevation

South-west (rear) elevation

The front (northeast) elevation (Pl. 1) consists of a traditional shop frontage on the ground floor with a central recessed door and a pair of plate glass windows on either side. This is surrounded by a wooden façade with pilasters at either end. Above the height of the ground floor the building is rendered. The first floor contains a pair of tri-partite windows set beneath a segmental arch within a wooden frame. The central section of window may be a sash window of six-over-six panes. Between the first and second floor is a moulded string course. The second floor contains a further two windows set immediately above the first floor ones, also set beneath a segmental arch. The window itself is the same tri-partite style with a central sash window but only three-over-

The rear (southwest) elevation has been entirely rebuilt in 2017 with a ground floor extension and the entire thing rendered (Pl. 2). The date stone is now present bearing the date 1677 and the letters E, B?, E. The windows are modern replacements set beneath a brick segmental arch. Beneath the eaves is a line of dentilated brickwork.

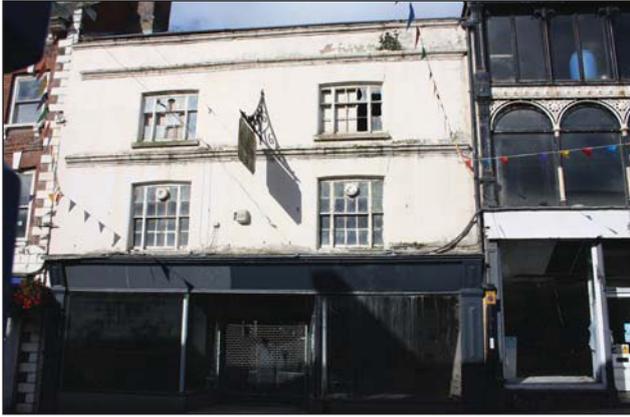
Plate 1. Front elevation, looking southwest.

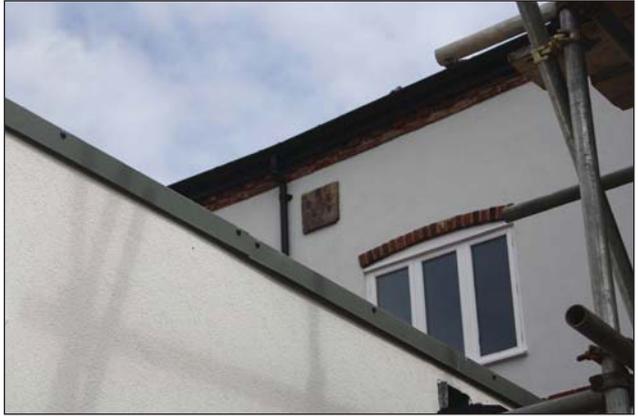
Plate 2. New, rear elevation showing date stone, looking north

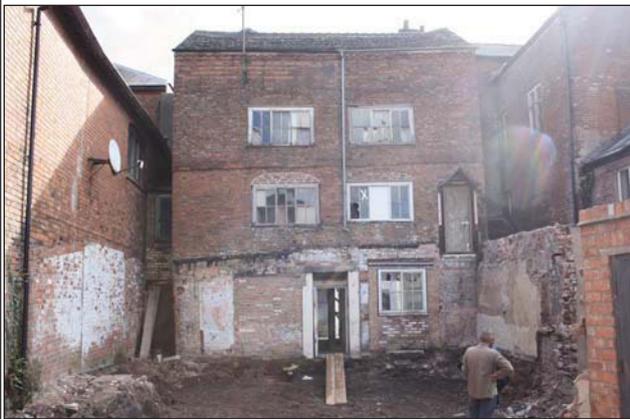
Plate 3. Original rear elevation, looking northeast.

The former rear elevation, observed in 2017, was complex with a number of blocked openings and alterations, very little, if any, of which was probably original (Pl. 3). The ground floor consisted of a central door with a side-hung sash window to the southeast set within a wooden frame. Both the door and window are set beneath replacement wooden lintels. Within the rest of the elevation, from the northwest to the southeast, is a blocked doorway, probably beneath a segmental arch though this is partially obscured, a blocked window, a segmental arch above the existing doorway but relating to an earlier opening due to misalignment, the side-hung sash window beneath which may be evidence for a former larger opening lie a doorway. The far southeast end maybe a former doorway but it is not clear whether the newer brickwork to the northwest relates to the window or this section. It is possible that the southeast end is the earliest section of brickwork at ground floor level. Above the door and window was traces of a former roofline to a ground floor extension.

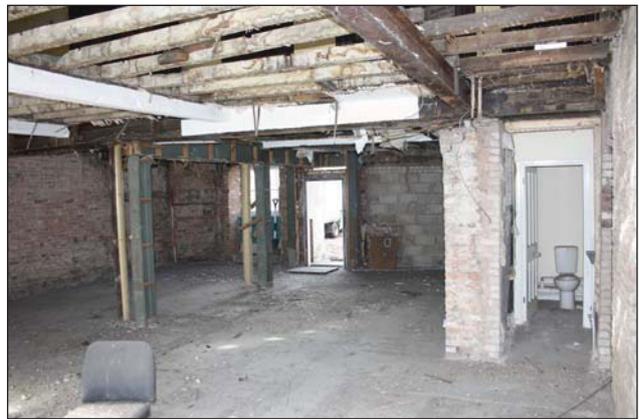
Plate 4. Ground floor, looking south, Scales: 2m.

In summary, during the 2017 visit, the ground floor was in the process of being renovated and consisted of a large open space with no internal divisions (Pl. 4). The walls were visible and could be seen to have no identifiable bonding pattern, consisting of a mixture of headers and stretchers with concrete blockwork present in the rear wall. The floor had been replaced with concrete screed and the ceilings removed. Where former divisions had been removed a steel frame had been inserted.

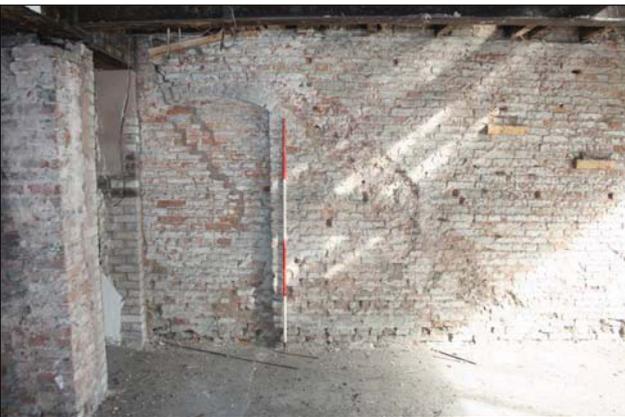
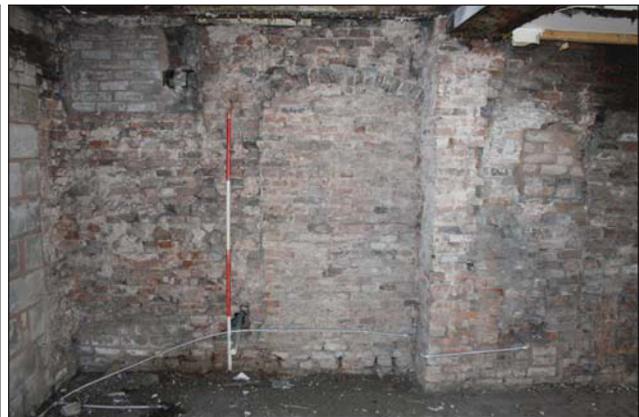
Plate 5. Ground floor, blocked doorway, looking northwest, Scales: 2m.

Plate 6. Ground floor, blocked doorway, looking northwest, Scales: 2m.

Within the northwestern wall there was evidence for two former doorways beneath segmental arches and a straight staircase (Pls. 5, 6). The doorways would have given access to the passageway between buildings 38 and 40, seen on the 1880 town plan. In the southern corner of the room was a probable former fireplace beneath a brick arch (Pl. 4). A chimney stack was present, adjacent to the rear blocked arch on the northwest wall (Pl. 6) and brick corbels were present on the southeastern wall supporting a chimney above (Pl. 7).

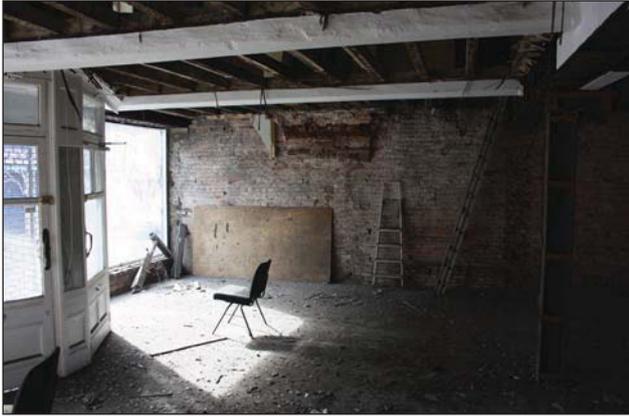
Plate 7. Ground floor, looking southeast.

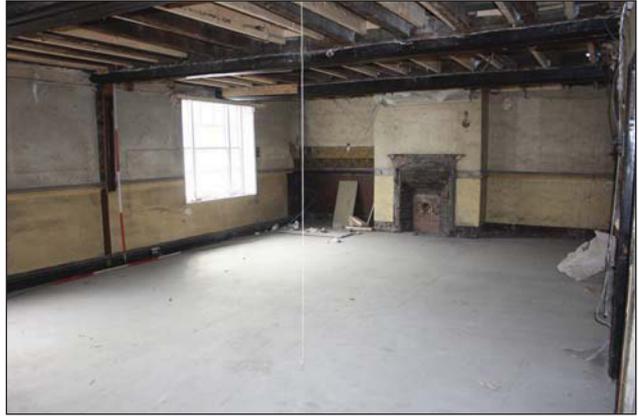
Plate 8. Room 1, looking east, Scales: 2m and 1m.

Across the entire width of the front of the building is a single large room (Room 1) which could be further sub-divided into two via a folding screen, now removed (Pls. 8, 9). Since 2017 a floor has been inserted allowing access into the room. The floor structure could be seen to consist of, probably three tie beams across the width of the room with joists tenoned into them. The room itself is accessed via a door from corridor 1 (now removed

Within the large room there are two fireplaces. One is located slightly off-centre within the southeastern wall and the other within the rear wall at the northeast end of the room. The fireplace surround has been removed from the southeast chimney exposing the brickwork behind. The opening is formed by a segmental arch with the bricks laid in as soldiers (Pl. 10). The surround was leant against a wall and is of bolection type in wood and recorded in the listing details as being of c. 1690 – 1700 in date (Pl. 11). The chimney in the rear wall consists only of the surround; the chimney breast itself located within room 3 to the rear. This surround is also wooden, though simpler in design but still in the style of the 17th century, but likely to date to c.1900 according to the listing detail (Pl. 12). The ceiling consists of three tie-beams with joists tenoned in, appearing to be of the same construction as the floor. The joists have been reinforced with modern timbers. The tie-beams themselves have an ovolo chamfer (Pl. 8).

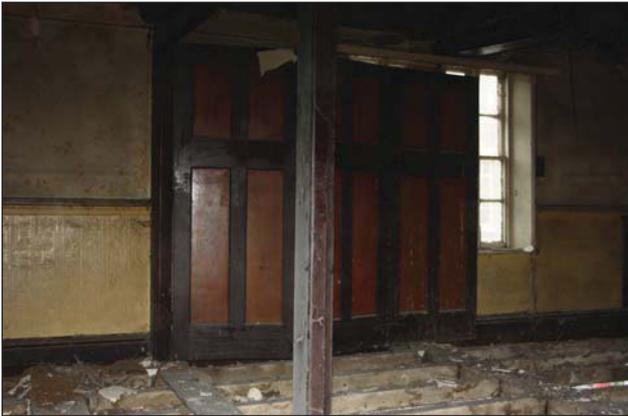
Plate 9. Room 1 showing dividing screen, looking east.

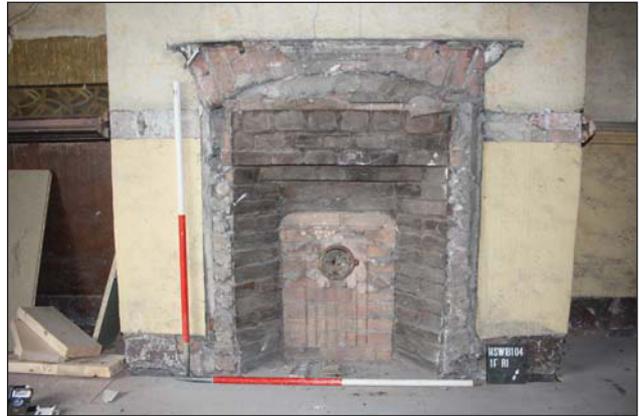
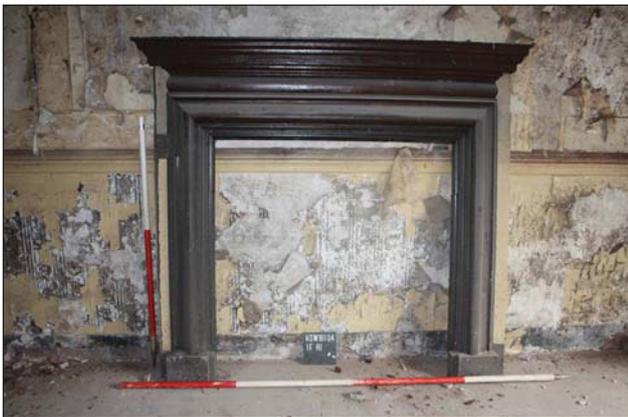
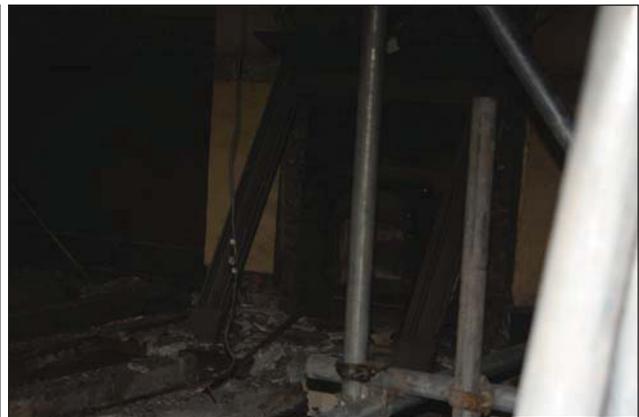
Plate 10. Room 1, fireplace detail, looking southeast, Scales: 2 x 1m.

Plate 11. Detail of fireplace surround, Scales: 2m and 1m.

Plate 12. Room 1, fireplace detail, looking west.

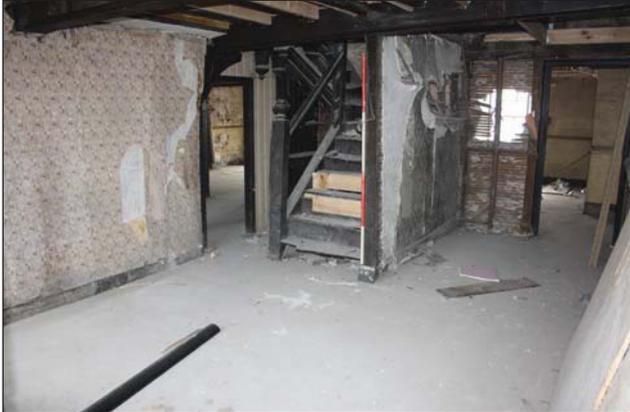
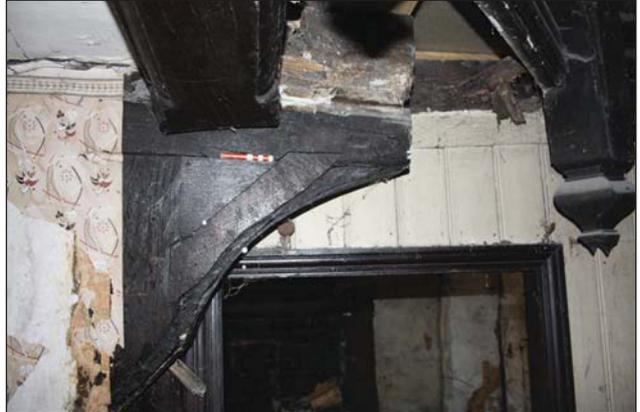
Plate 13. Room 2, looking north, Scales: 2m.

Plate 14. Room 2, post and beam detail, looking northwest.

Room 2 is located to the rear of the building on the southeast side and was formerly accessed from corridor 1 (now removed) with a second access from room 3. The dividing wall between corridor 1 and room 2 has been removed, opening the space up (Pl. 13). The room is partially clad in tongue and groove and the dividing wall between rooms 1 and 2 can be seen to be of timber frame construction with a lath and plaster finish. Within the ceiling are two tie-beams across the width of the room with joists tenoned in. The tie-beams have ovolo chamfers with ogee stops. The northeast beam, at the northwest end is tenoned into a wall plate, that itself is supported on a post with an infilled brace (Pl. 14).

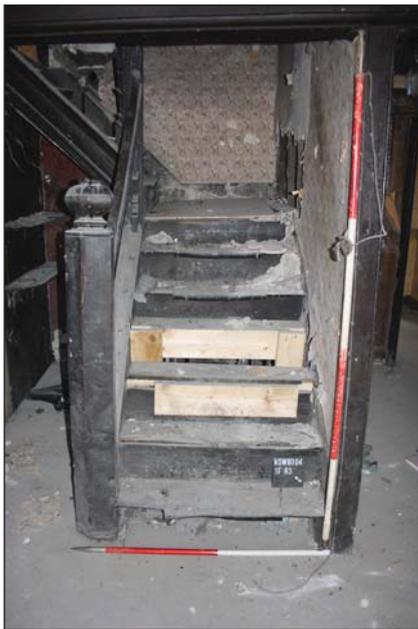
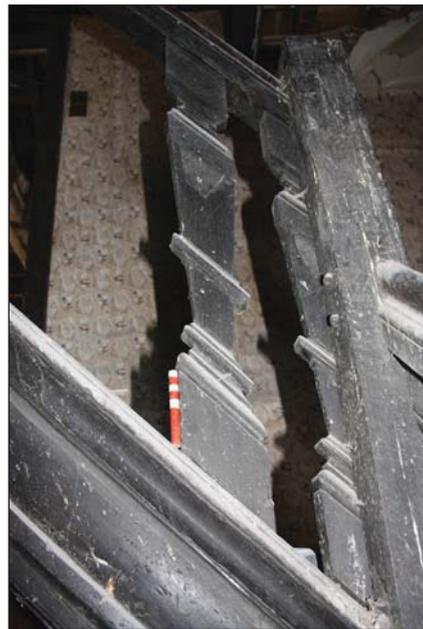
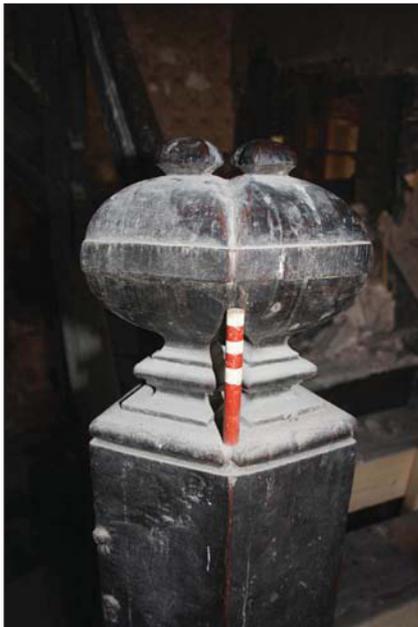
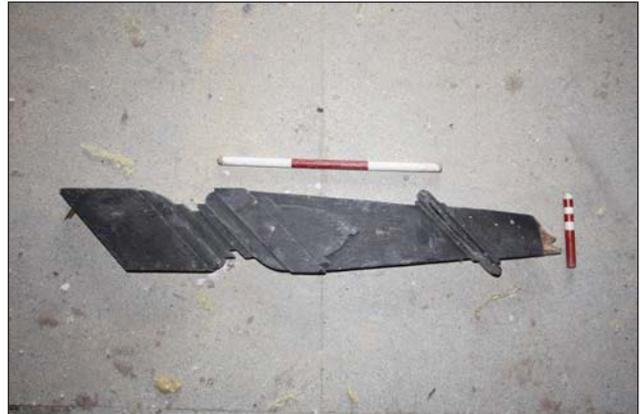
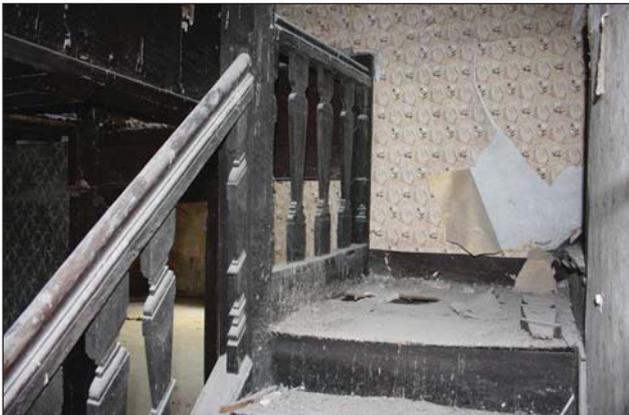
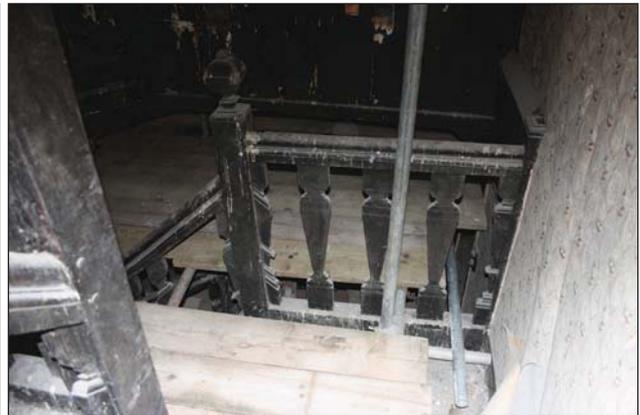
Plate 15. Rooms 2, stairs, looking northeast, Scales: 2m and 1m.

Plate 16. Rooms 2, stair detail looking southeast, Scales: 0.1m.

Plate 17. Newel post detail, Scales: 0.1m.

Plate 18. Baluster detail, Scales 0.3m, 0.1m.

Plate 19. Bannister rail detail, looking north.

Plate 20. Stair detail, showing newel post, looking northwest

The room is dominated by a staircase located against the dividing wall between rooms 1 and 2 (Pl. 15). It is 'L-shaped' in plan form with a half landing and continues up through the rest of the building. The section from the ground floor has previously been removed. The staircase is constructed of oak and consists of a closed string. It has been boxed in on the southeast side and is currently in a poor state of repair with missing risers, treads and balusters. The risers and treads are of plain planks of wood. The stringer is simply carved into three bands with a pulvinated profile (Pl. 16). At the southwest end of the staircase is a newel post with a pentagonal profile, topped with a bulbous finial with a pair of bulbous shapes on top (Pl. 17). The balusters are angled and flat with a fairly simple shape. They have raised banding and an oval shape on them (Pl. 18). The bannister rail has a broadly rectangular profile with circular top (Pl. 19). Elsewhere up the stairs the newel posts have a rectangular profile with a single bulbous finial with a smaller one sat on top (Pl. 20). Pendants are present beneath the newel posts and have a similar bulbous shape, but ending in a more pointed shape (Pl. 21).

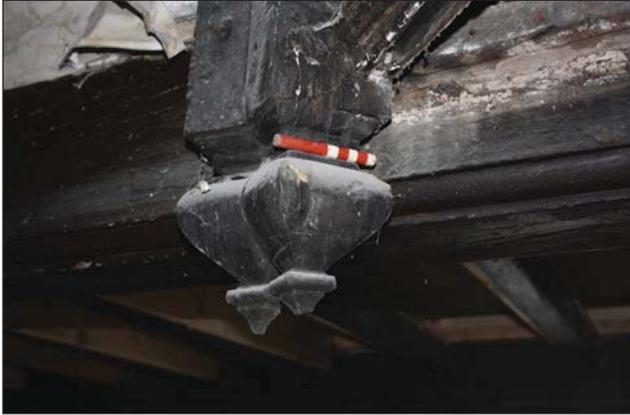
Plate 21. Pendant detail, Scales: 0.1m.

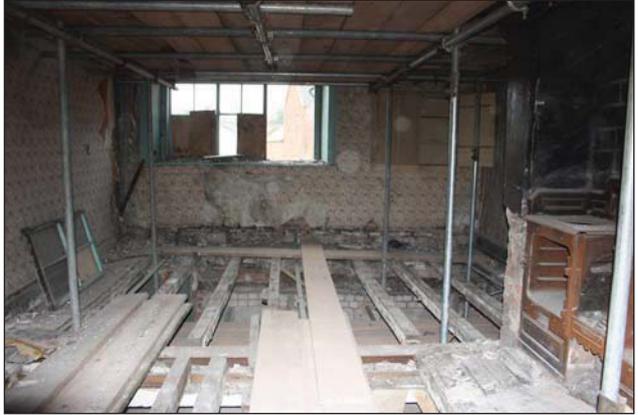
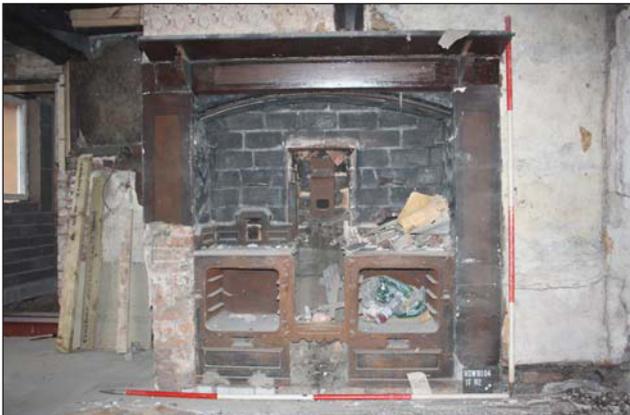
Plate 22. Room 3, looking southwest.

Plate 23. Room 3, fireplace detail, looking northwest,
Scales: 2 x 2m.

Room 3 is located in the western corner of the building and has access via rooms 1, 2 and corridor 2. The earlier visit revealed sections of the flooring to consist of a main beam running across the width of the room (southeast-northwest) with joists tenoned in and the original back wall containing a pair of windows; the northeastern one with a pair of shutters over it (Pl. 22). The latest visit showed the back wall to have been rebuilt in concrete blockwork. The room is dominated by a cast iron range in the north corner of the room. The range has a symmetrical design with oven space to the left and right and a single ring atop both side however the doors to the ovens and central piece are missing. It is set within a wooden surround with a mantle piece (Pl.23). A pair of beams are present across the width of the room, forming the ceiling structure. These both have ovolo chamfers with the northwestern beam supported by a bracket above the range.

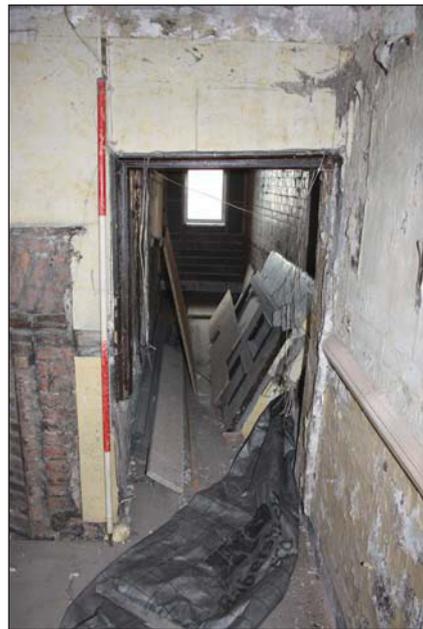
Plate 24. Corridor 2, looking southwest, Scales: 2m.

Corridor 2, located at the northwest end of the building gives an alternative access between rooms 1 and 3. No further access was available to this corridor on the most recent visit. The initial visit showed it to be of brick construction with a window to the rear, which was rebuilt by this visit (Pl. 24).

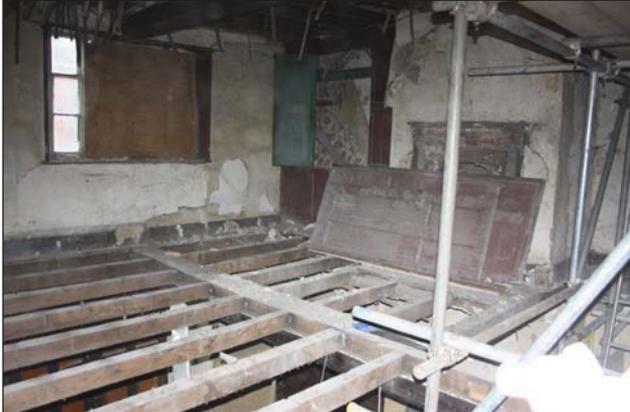
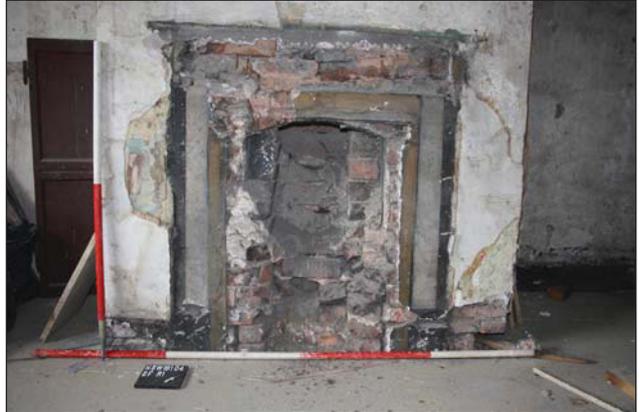
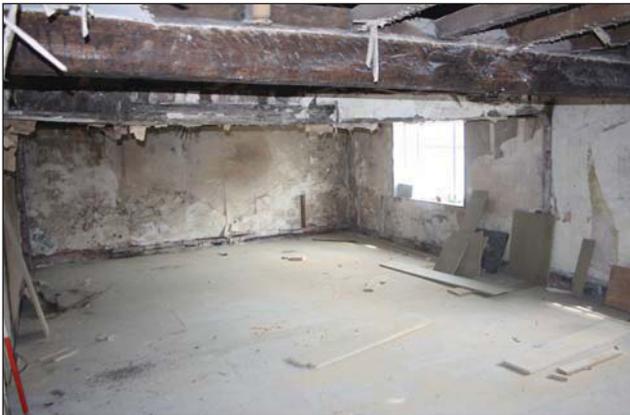
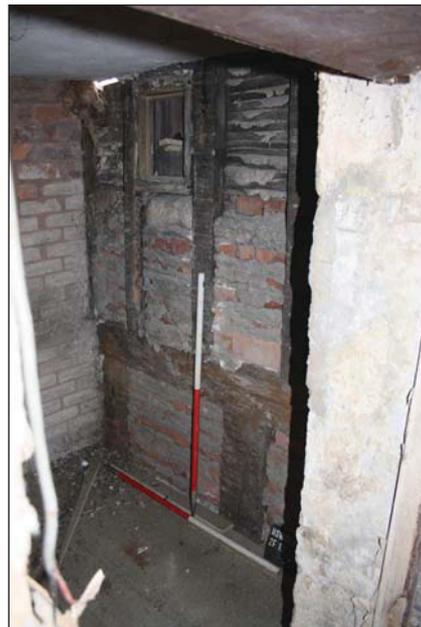
Plate 25. Room 4, looking east.

Plate 26. Room 4, fireplace detail, looking southeast,
Scales: 2m and 1m.

Plate 27. Rooms 4 and 5, looking north.

Plate 28. Room 5a, timber framing detail, looking west,
Scales: 2 x 1m.

Rooms 4 and 5 are located across the front of the building, above room 1. Room 4 is in the east corner of the building and is similar to the room below. On the initial visit there was no floor laid and it was possible to see that the beam for the ceiling was located directly above the main beam for the floor below (Pl. 25). Like the other beams within the building this one also has an ovolo chamfer. The fireplace in the southeast wall no longer has its fireplace or surround (Pl. 26). By the second visit the dividing wall had been removed along the line of the beam though it is still obscured by plaster. A further beam is present within the former room 5 and also has an ovolo chamfer (Pl. 27). The fireplace in the southwest wall has been completely removed leaving only evidence for a former log burning type fitment. A small cupboard (room 5a), located in the southwest corner of the room and behind the chimney breast in room 8 has a modern southwest wall with a timber framed northeast external wall. The small amount of wall visible consists of a sizeable rail with two posts below and three above. The lower two posts are more substantial than the upper ones and one contains an empty mortice. A small

window is present between two of the upper posts, now blocked up. The framing has been filled with a mixture of brick work and lath and plaster. The exposed wall was at one point also covered in lath and plaster (Pl. 28).

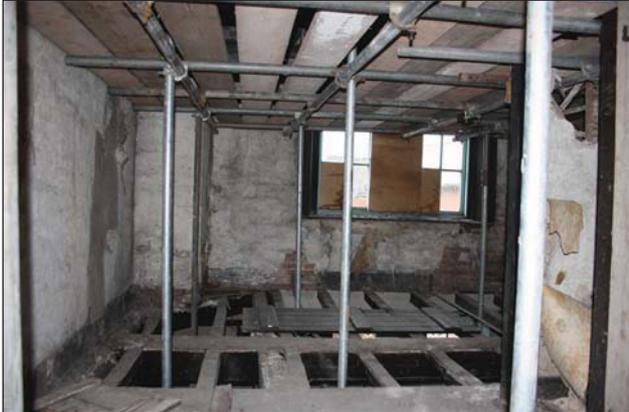
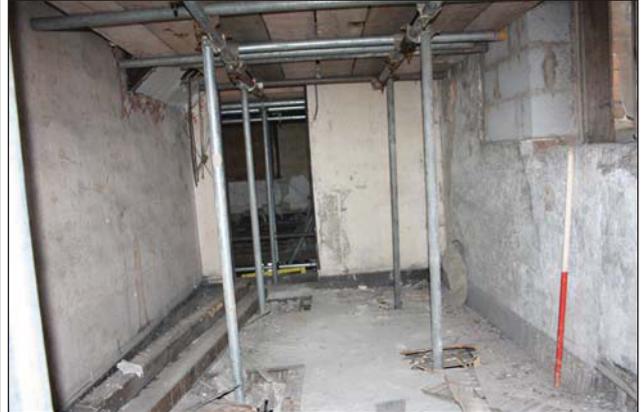
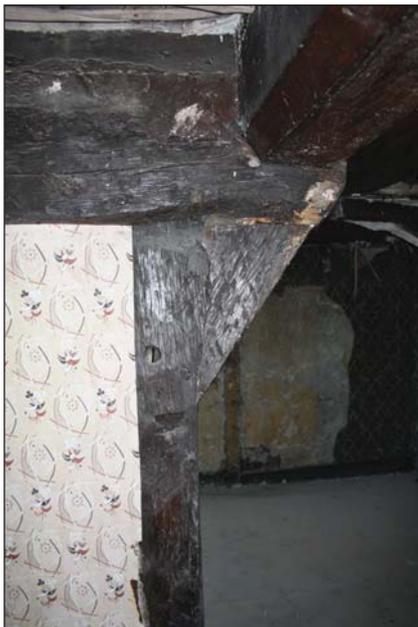
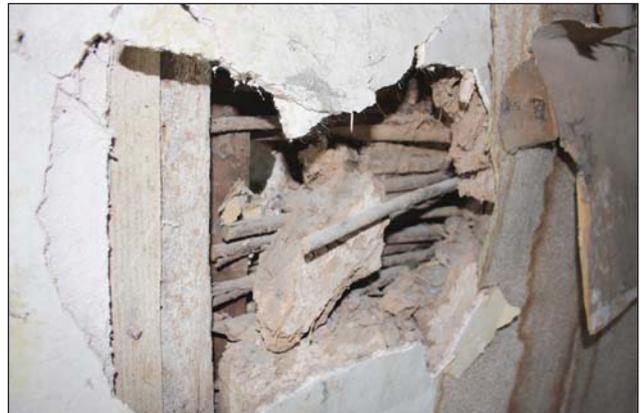
Plate 29. Room 6, looking southwest.

Plate 30. Room 6, showing blocked window, looking northeast, Scales: 1m.

Plate 31. Hallway, showing beam and post detail, looking northwest

Plate 32. Room 6, wall detail, looking north.

Room 6 is an 'L-shaped' room located in the south corner of the building (Pl. 29). Within the southeast wall is a window that has been reduced in size with concrete blocks (Pl. 30). The latest visit showed the dividing wall between the hallway and room 6 to have been removed and part of the floor opened up to accommodate the new stairs. The beam at the northeast end of the room has a chamfer and sits within a beam running northeast-southwest which rests on a braced post (Pl. 31). The brace is pegged to the post but there is also a much larger empty peghole present. The dividing wall between rooms 6 and 7 had been partially revealed showing the wall to consist of sticks, rather than laths, though it could not be seen if these were woven to create a wattle wall. It was then rendered in plaster containing hair (Pl. 32).

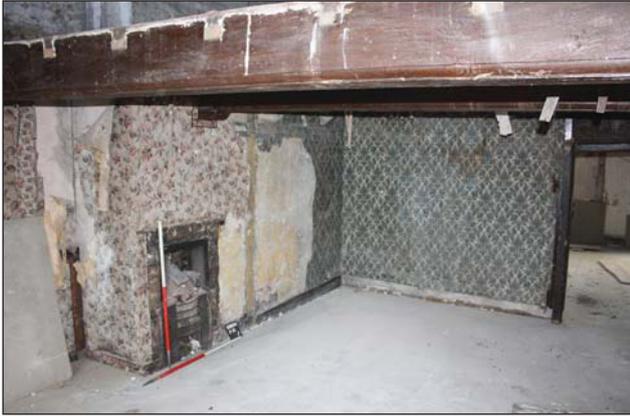
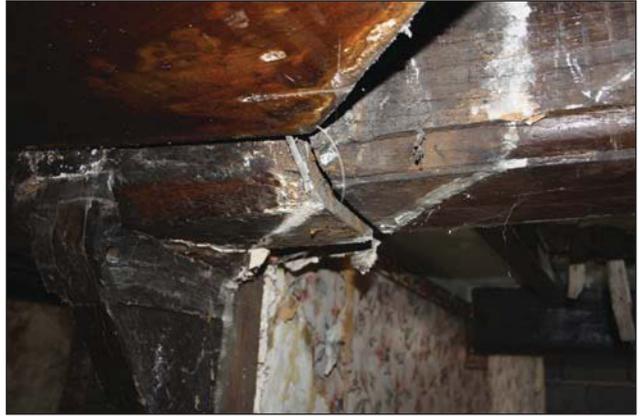
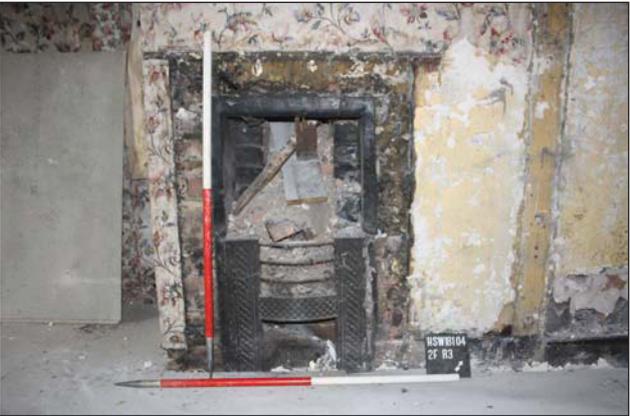
Plate 33. Room 7, looking north, Scales: 2 x 1m.

Plate 34. Room 7, beam detail, looking east.

Plate 35. Room 7, fireplace detail, looking northwest, Scales: 2 x 1m.

Room 7 is located in the west corner of the building and had been knocked through to room 8 by the time of the second visit. In the north corner of the room is a blocked fireplace. The later visit revealed the fireplace and the two beams within the ceiling with ovolo chamfers (Pl. 33). Within the room it could be seen that the northeast beam was in two parts with the joint just within room 7 (Pl. 34). It was not possible to see how they were joined together as the join was still partially obscured by plaster. The fireplace was small, designed to fit the space beside the room 7/8 dividing wall. The, presumably wooden, surround had been removed but the cast iron grate remained. It was narrow, standing on a pair of legs with three rounded bars. It was decorated with a beaded wavy line pattern (Pl. 35).

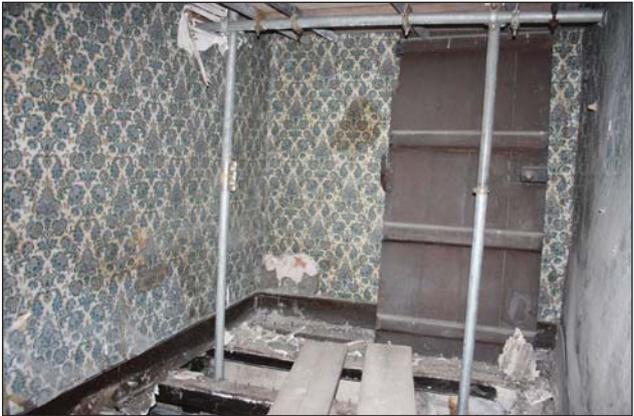
Plate 36. Room 8, showing a door, looking northwest.

Room 8 contained no features but on the first visit a four-plank and batten door was lent up against the wall (Pl. 36).

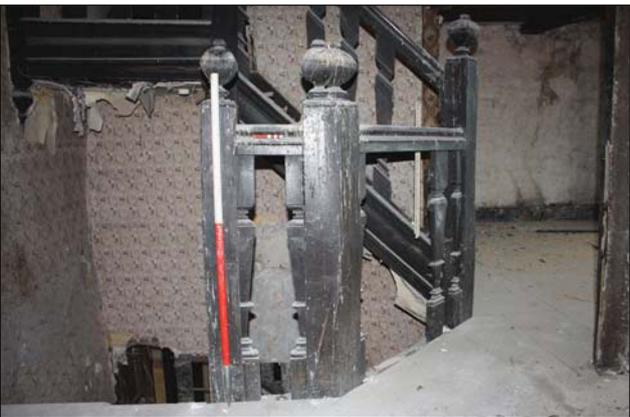
Plate 37. Hallway, showing stairs, looking southeast, Scales: 1m.

Within the hallway the staircase continued up to the third floor. The landing area was set at an angle before the staircase proper continued upwards, immediately above the one below (Pl. 37).

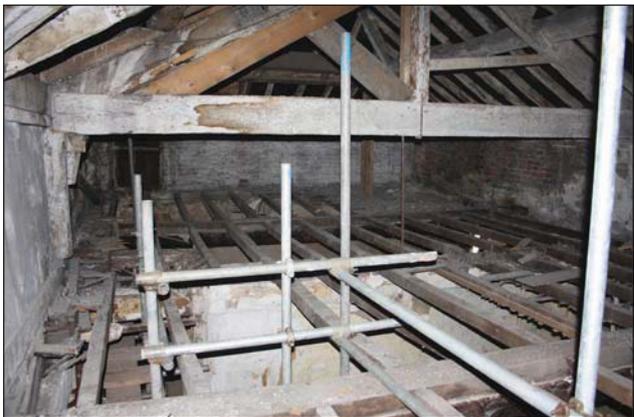
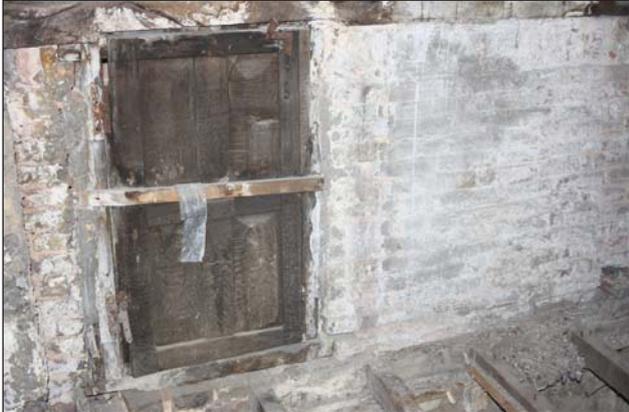
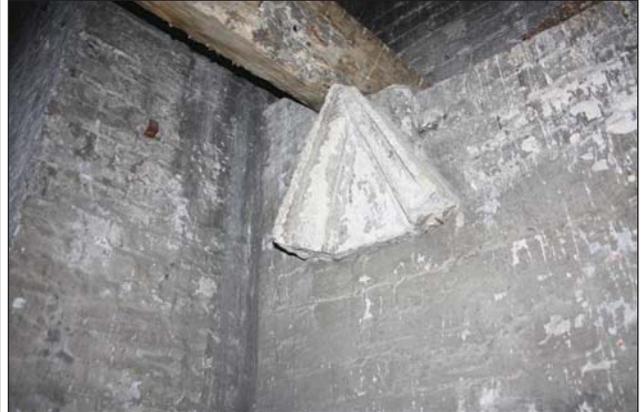
Plate 38. Room 9, looking northwest.

Plate 39. Room 9, door detail, looking northwest.

Plate 40. Room 9, purlin support detail, looking east.

Room 9 is a large open room located within the roof space over the front of the building (Pl. 38). Within the northwest wall is a simple plank door, presumably giving access to the roof space above 40 High Street (Pl. 39). The roof is supported by a central king post truss, which has been reinforced more recently. Both of the principal rafters show evidence of reuse; the southwest one containing an empty mortice and the northeast one containing empty lap joints, one of which is used to site the purlin. The northeast end of the truss sits on the wall, in front of the wall plate, whilst the southwest end is supported on a short timber post and appears to be tenoned into the wall plate. The common rafters rest on the wall plate and purlin. The northwest end of the roof is hipped. At the southeast end of the room the purlins rest on a pair of ornamental roll and hollow moulded stone pieces, most probably originating from an ecclesiastical building (Pl. 40).

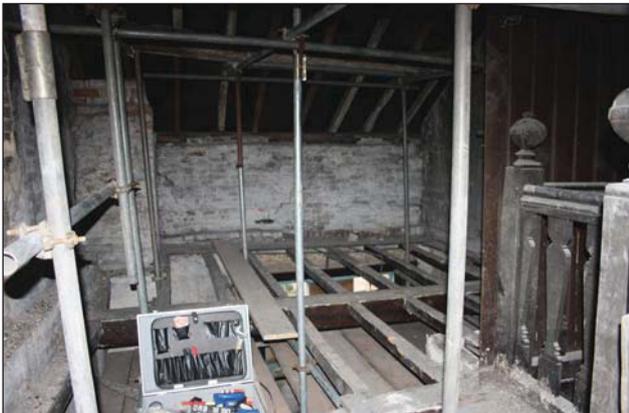
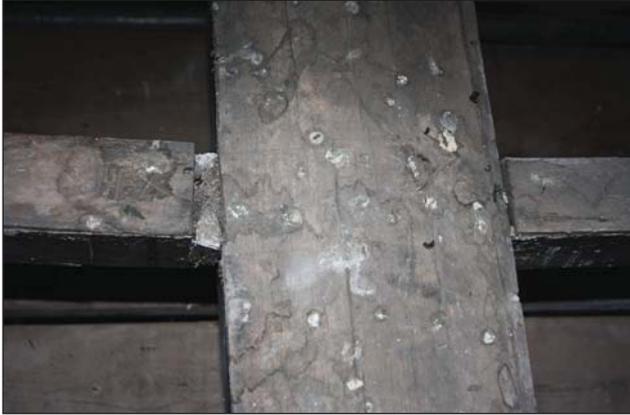
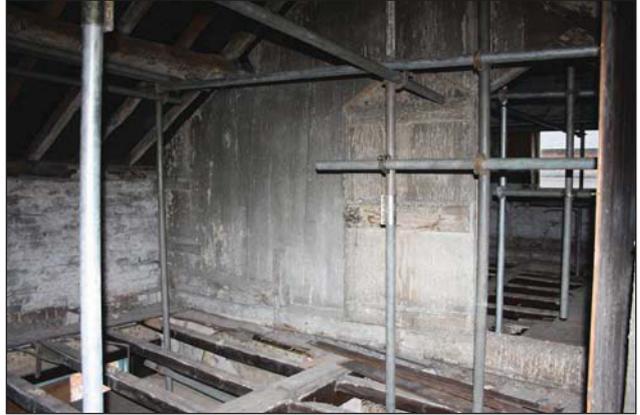
Plate 41. Room 10, looking southwest.

Plate 43. Room 10, carpenters marks on beam.

Plate 44. Room 10, dividing wall detail, looking west.

Room 10 is located in the south corner of the building, with the stairs giving direct access to this room (Pl. 41). It can be seen within room 11 that the staircase has been turned through 180° to its current position (Pl. 42). A number of carpenter's marks are evident on the joists supporting the former floor ('V' and XII') with the 'V' corresponding to the same number on the main beam. Additional marks include a 'V' and an 'X' on the main beam without corresponding marks on the joists (Pl. 43). All the marks appear to be gouged. Dividing rooms 10 and 11 is a plank wall, shaped to accommodate the shape of the roof and the purlin. At the northeast end, adjacent to the stairwell is a plank and batten door with a triangular head (Pl. 44).

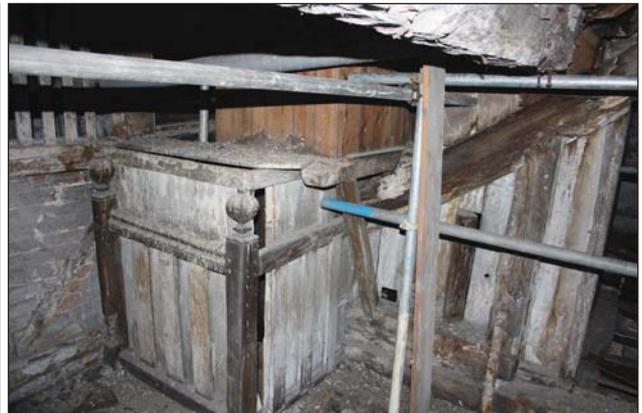
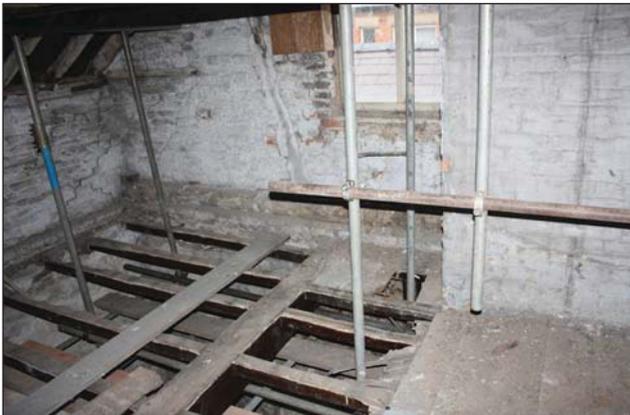
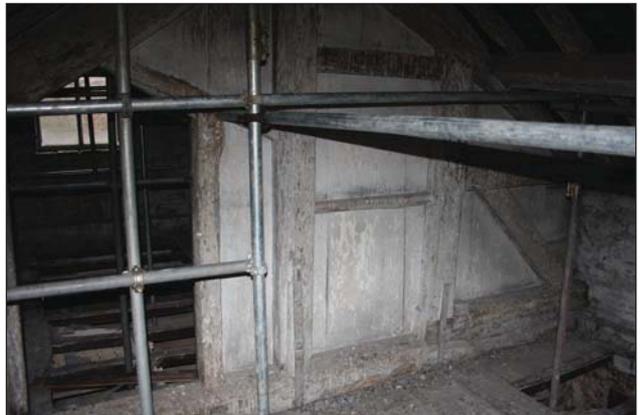
Plate 42. Room 11, altered staircase, looking east.

Plate 45. Room 11, looking northwest.

Plate 46. Room 11, truss / dividing wall detail, looking south.

Room 11 is located in the west corner of the building and has the original stairwell boxed in and located in the eastern corner of the room (Pl. 42). Within the northwest wall, adjacent to the chimney breast is a window (Pl. 45). Within this room it is possible to see the nature of the construction of the dividing wall between rooms 10 and 11 (Pl. 46). The wall is principally a king post truss with additional framing to support the plank wall, including posts, rails and diagonal braces to give the appearance of box framing. The northeast side of the door head is formed by the principal rafter within the truss structure whilst the southwest side is formed from a minor strut. The door jambs are formed from a post with a jowled head. The clasped purlin sits on the principal rafter and supports the common rafters forming the roof above rooms 10 and 11.
