**Queen Anne's Well, Cadbury Castle,
South Cadbury, Somerset**

Archaeological Watching Brief- Addendum

Site Code: QAW18/130

Report 18/130b

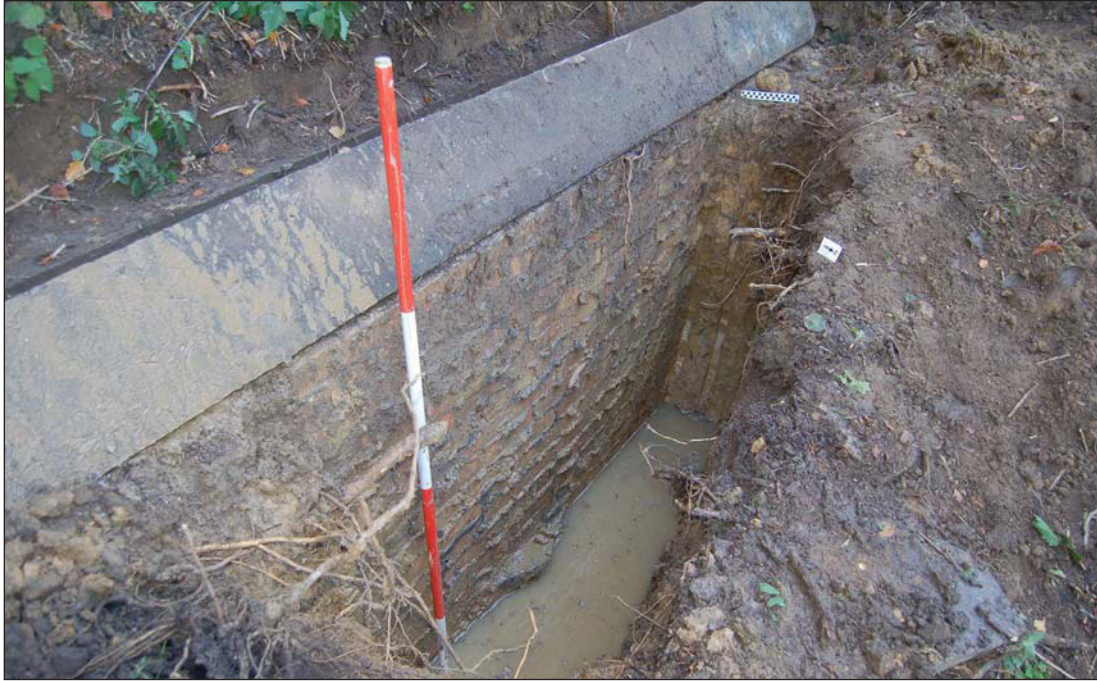
Plate 1. North-west facing wall of tank 58, looking south-south-west, Scales: 2m and 0.20m.

Excavation of a trench by removing re-deposited local silty sandy clay hillwash (64) butting against the north-west facing wall of the tank (58) revealed a minimum of 16 full or partial mortared brick courses laid in stretcher bond forming a single skin over natural yellow sandy limestone and stratigraphically lower yellowish blue silty sand (65) (Fig. 4; Pl. 1). An iron pipe was revealed briefly on first excavation but was quickly concealed by silty water filling the trench through cracks in the tank wall and from hillwash at the south-western end of the tank so that its location was identified only approximately. The tank was approximately 60% full of water at the time of excavation.

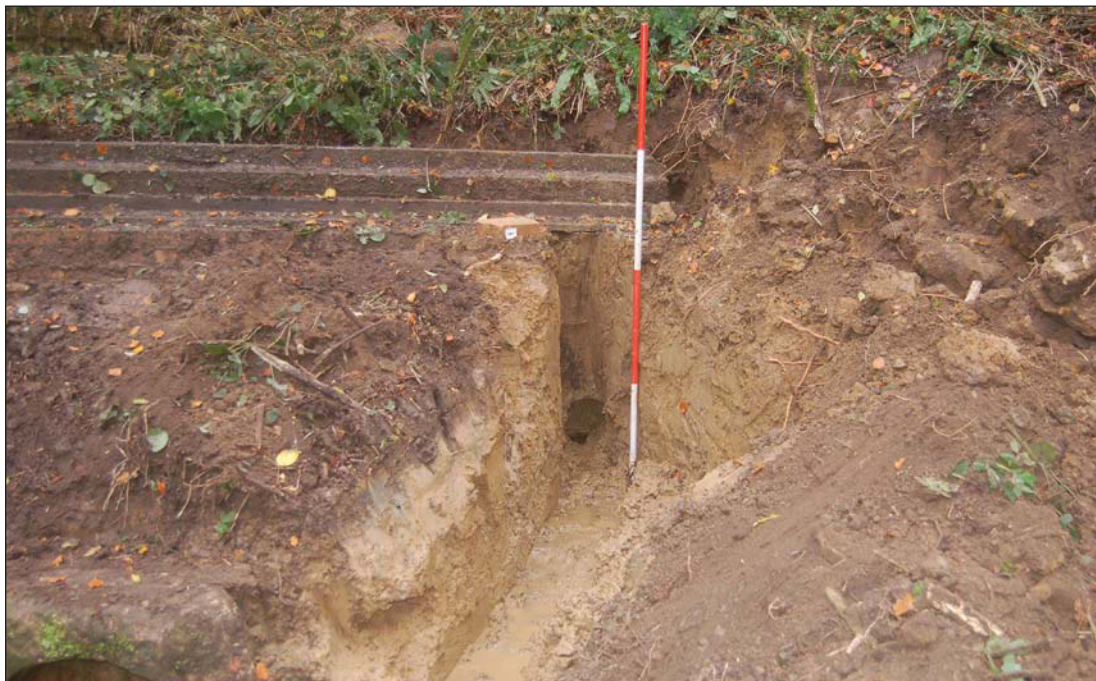
Plate 2. Area D, hillwash 65, looking south, Scale: 2m.

A narrow slot excavated beyond the tank's south-west corner revealed an isolated modern brick sealed by the redeposited hillwash (64) and a cavity caused by the rising of a spring (Fig. 4; Pls 2 and 3). No trace of the surrounding wall (52, 53) was found adjacent to the tank on either side and it must be concluded that the wall was partly destroyed when the tank was constructed and sealed by the re-deposition against it of locally available clayey hillwash (64). A spread of stones (67) set within and slightly below the recently formed topsoil and vegetation and over the re-deposited hillwash (64) was cleaned roughly to assess the character of the wall from which they had tumbled (Pl. 4). They were all of mainly sub-angular, occasionally sub-rounded, yellow sandy

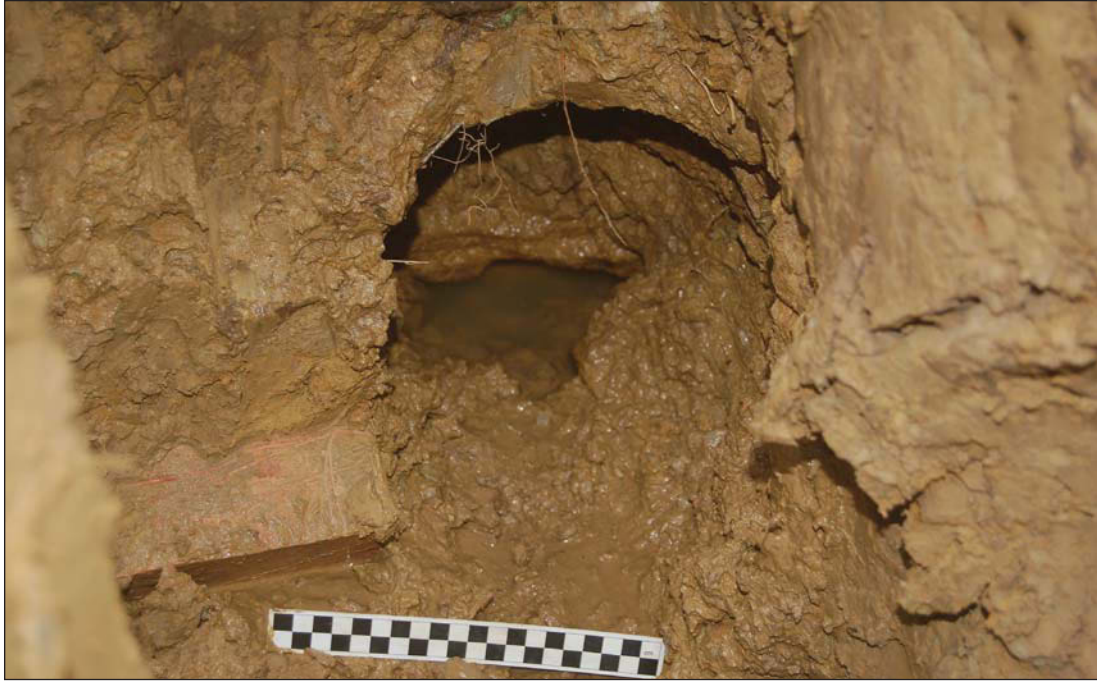
Plate 3. Area D, rising spring cavity 66 and in situ brick, looking south, Scale: 0.2m.

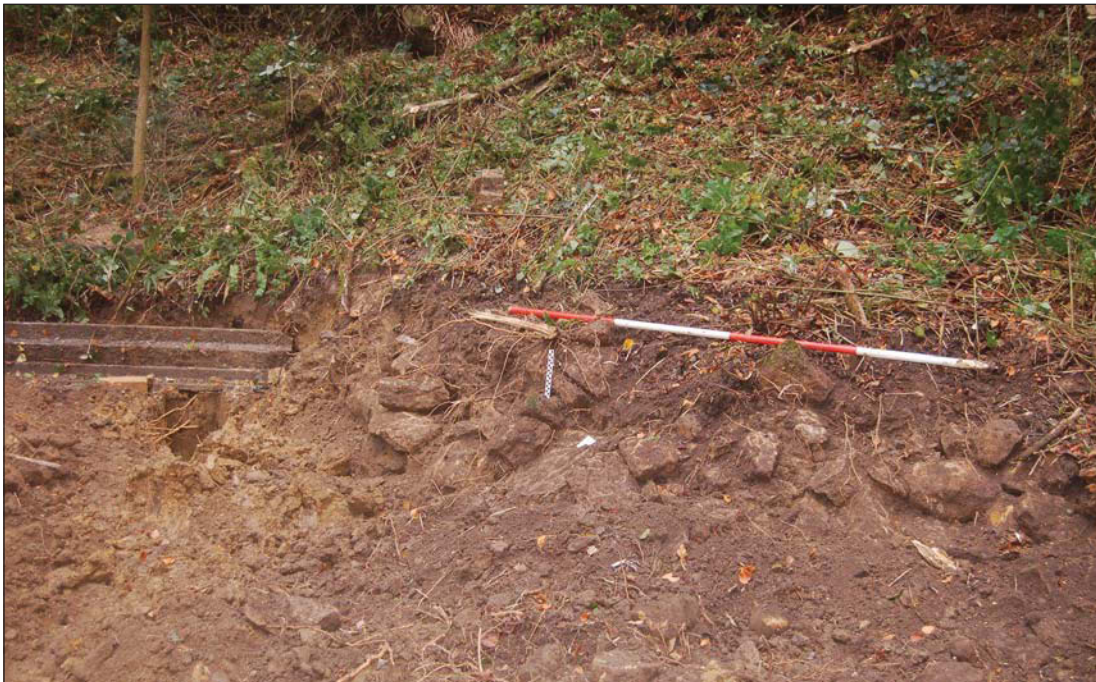
Plate 4. Wall-tumble 67, Scales: 2m and 0.20m.

limestone, typically with maximum dimensions of around 0.40m. Unexcavated traces of the wall suggest that it was approximately 1m wide so that the structure which it comprised would have been substantial.
