**Wadhurst Methodist Church, High Street,  
Wadhurst, East Sussex**

**Building Recording**

**Building Recording  
For Regents Bay Investments Ltd**

**September 2018**

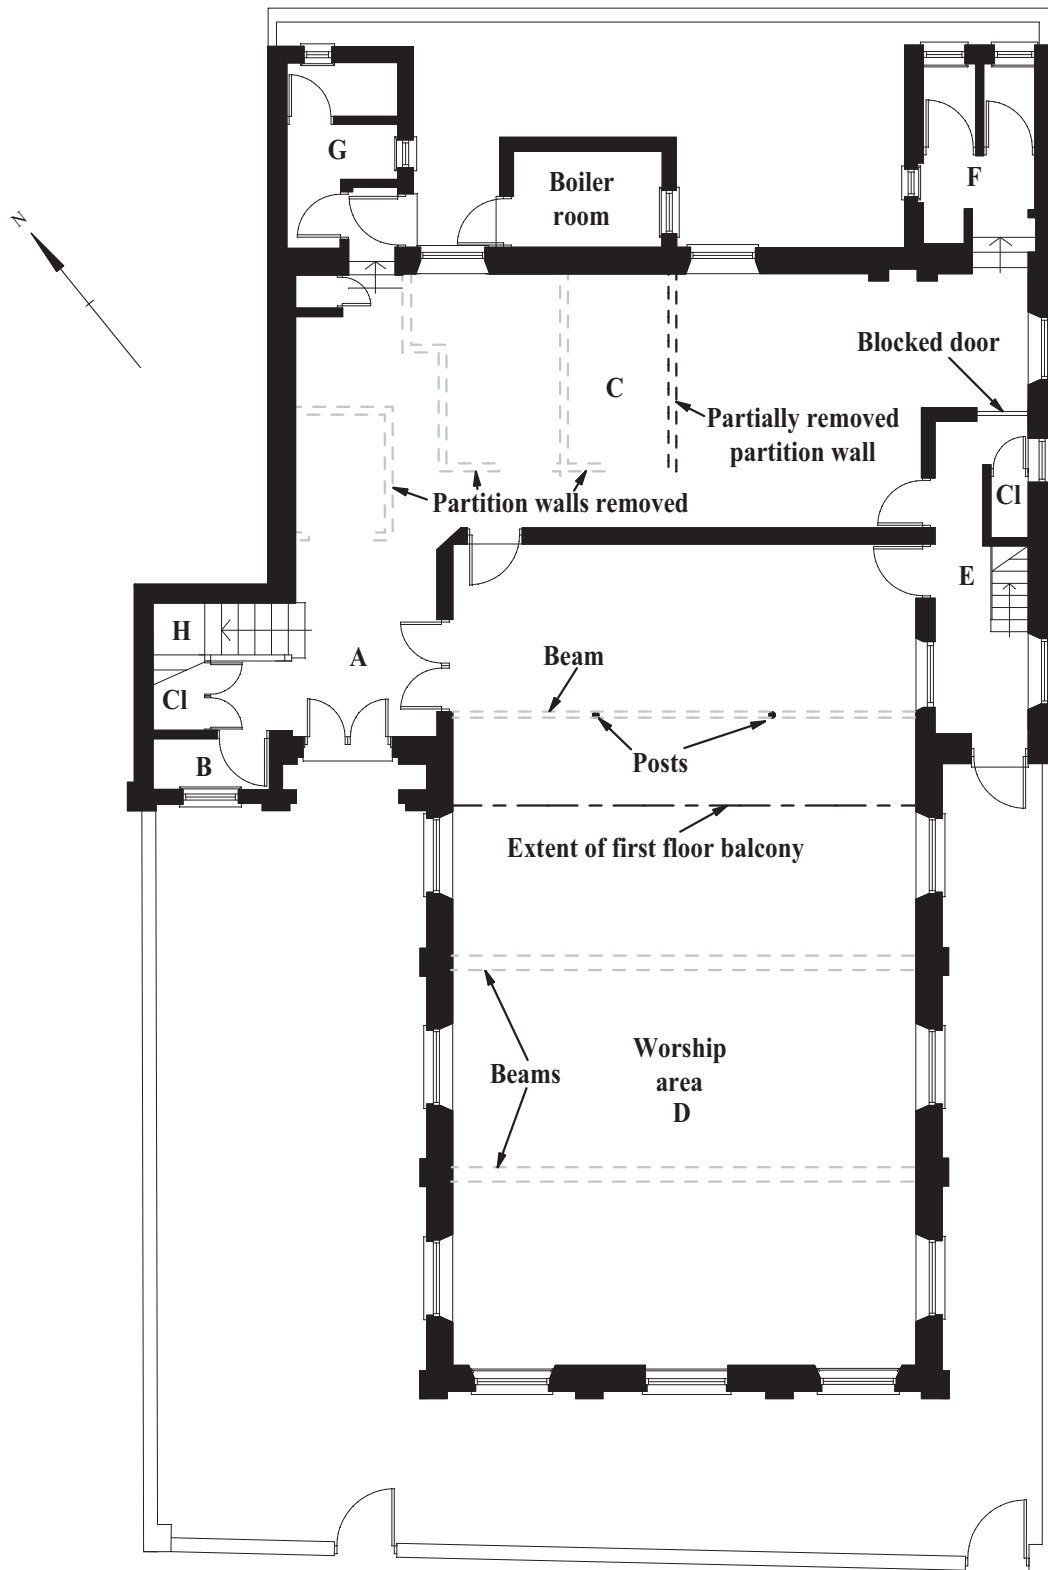
Figure 10. Plan of ground floor.

As mentioned above, the original front door was blocked up in 1959. The main entrance to the building is now through the staircase extension, which was built in 1920 to serve the Sunday school. There is a small lobby (A) immediately inside the entrance which provides access to a staircase to the first floor (H) (Pl. 10), the former vestry / schoolroom (C) (Pl. 11) and the main worship area (D) (Pl. 12). There is also a small closet (B) just inside the entrance, and another storage area under the stairs. The doorway into the worship area from the lobby does not appear to have been built as it was originally planned in 1920. The wooden staircase (H) appears to be original and it has carved newel posts with decorative finials (Pl. 10). There is a simple carved banister running up one side of the staircase, and the balustrade is comprised of alternating thin plain balusters and wider balusters with a carved decorative heart motif.

The entrance from the lobby (A) into the worship area (D) originally had double doors which have recently been removed, and there is a short ramp for wheelchair access. The worship area measures 13.60m by 7.65m, and the height from the floor to the ceiling is 5.54m. The pulpit had been moved to the southern end of the worship area when the original front door was blocked up in 1959. The pulpit and its raised dais had been removed by the Methodist Society, but its position could be determined due to the fact that the area was not carpeted. A photograph from 1966 showing this end of the church was available at the East Sussex Records Office (Pl. 27). The large organ shown in the photograph was sold to a Roman Catholic church in Bexhill in the late 20th century, whilst the wooden pews were removed and replaced by chairs in 1994. The removal of the pulpit area exposed the gas and electricity meters. The lower parts of the worship area's walls were originally timber panelled, but the wood had been removed by the Methodist Society exposing the bare brickwork. There is a first floor gallery at the northern end of the worship area (Pl. 13), which is supported by two decorative iron posts (Pl. 15). The gallery was screened from the worship area by moveable timber and glass panelling which was installed in 1960. Some of the few surviving decorative features of the building are the surrounds of the three air vents in the ceiling of the worship area (Pl. 14). Doorways at the northern end of the worship area lead into room C and corridor E, although the wooden doors had been removed prior to the survey. The 1920 plan of the proposed alterations indicates that the doorway to room C was to be blocked up, although this does not appear to have been achieved.

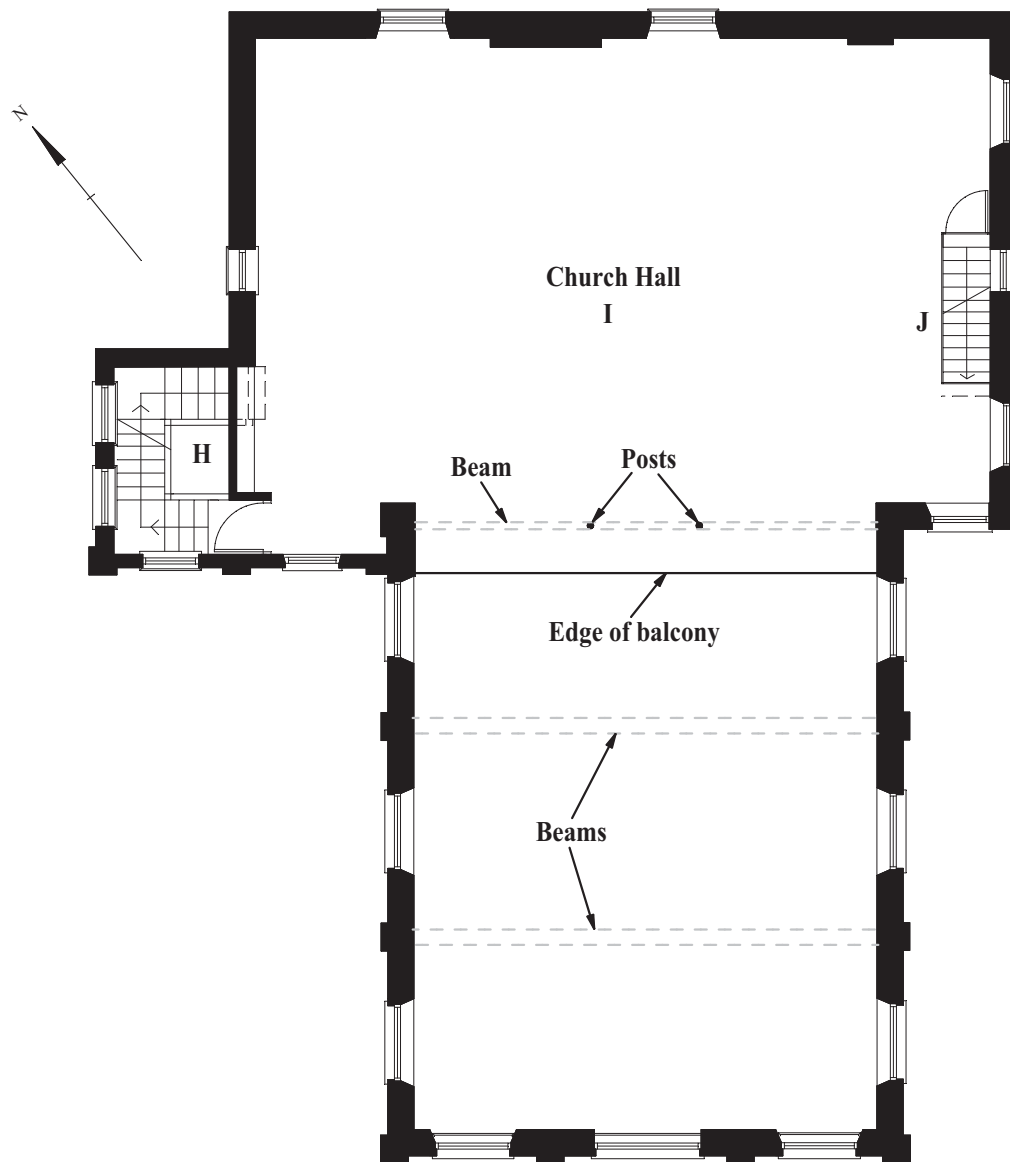
Figure 11. Plan of first floor.

The first floor can be accessed from entrance lobby A via the main staircase (H) in the 1920 extension, or from corridor E via staircase J. It is not clear where the original staircase may have been as it is not depicted on the 1920 plan which shows a proposed staircase that does not appear to have been built. It is therefore possible that

Apart from the small landing at the top of staircase H, the first floor consists of one large room (I) which was used as a church hall until recently, but had formerly been a schoolroom (Pls 22, 23). As with the rest of the building, the timber panelling which once covered the lower parts of the walls had been removed by the Methodist Society before the church was sold. The entire floor is covered with bare boards, some of which had recently been lifted. Part of the southern wall of the room is an open gallery overlooking the worship area (D) below (Pl. 24). The gallery could be screened off from the worship area by moveable wood and glass panels, which were installed in 1960 to replace the curtains which had previously been used. The ceiling above the gallery was supported by two cast iron posts. There is a fireplace in the north wall of the room, which appears to have been revealed when the timber panelling was removed recently. A large wooden structure along the eastern wall houses the upper part of staircase J (Pl. 25). The ceiling of the room may be original, and consists of timber planks in a decorative herringbone pattern. Apart from these features there was little of historic interest in the room, and certainly nothing to indicate its former use.

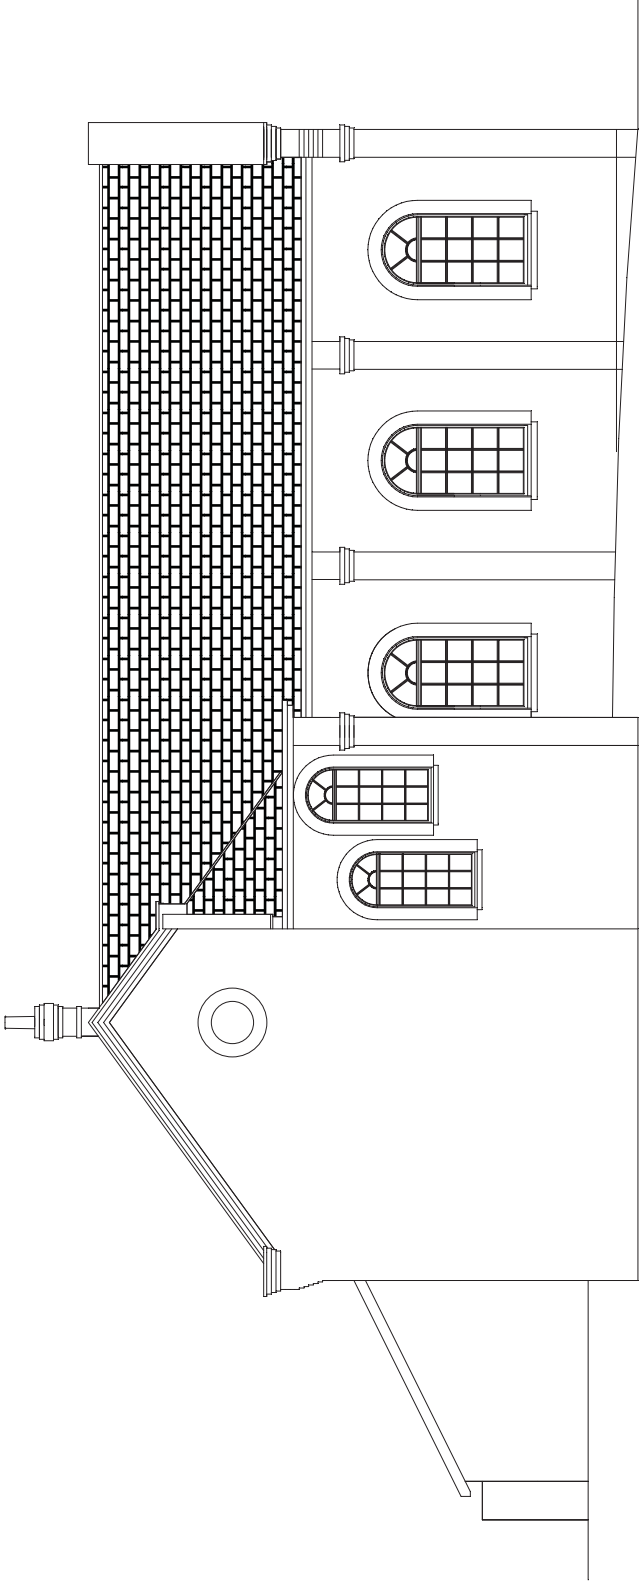
Figure 12. North-west facing elevation.

The north-west facing wall of the worship area has three yellow brick buttresses, including one on the corner (Pl. 6). There are also three large windows with yellow brick surrounds and semi-circular heads. The surround of the northernmost window was partially obscured when the staircase extension was built in 1920. This extension was built to match the original building. It therefore has yellow brick buttresses, and the windows have yellow brick surrounds with semi-circular heads (Pl. 6). The SW facing elevation of the extension has two large windows on the first floor level and a smaller one on the ground floor. The extension includes a small porch with side alcoves, which obscures the original external wall of the building. The existing wooden doors of the building are positioned within this original wall. The NW facing elevation of the extension has two windows with yellow brick surrounds and semi-circular heads, which provide light to the internal staircase. The rest of the extension is hidden behind the neighbouring buildings which abut the church. These also obscure the rest of the NW facing elevation of the original building apart from the top of the gable end, which contains an ocular window at first floor level.

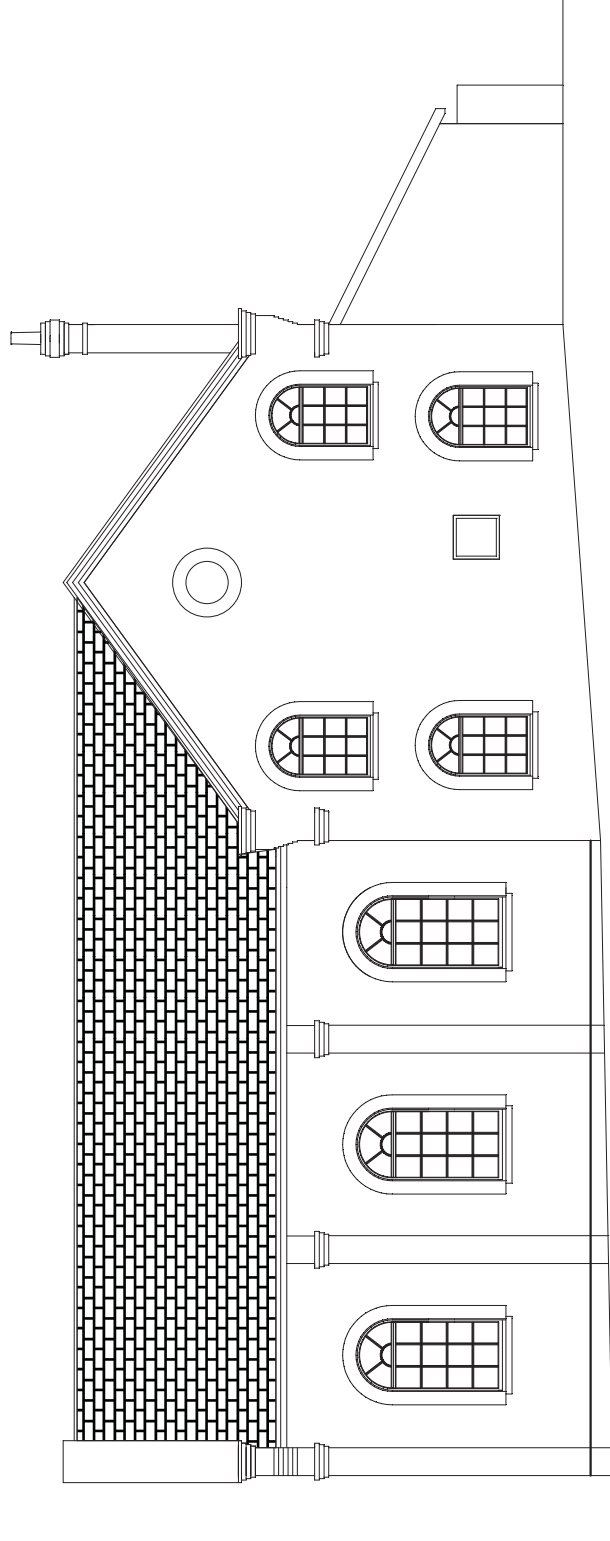
Figure 13. South-east facing elevation.

The south-east facing side of the building incorporates the worship area, the former vestry / classroom, and the eastern wall of the 1920's WC extension. There are six yellow brick buttresses, including those on the corners of the worship area and former vestry / classroom. The worship area has three large windows with semi-circular heads, all in yellow brick, which match those on the north-west side of the building. The south-east wall of the former vestry / classroom has two windows on the ground floor with yellow brick surrounds and semi-circular heads. There are two similar windows on the first floor, along with a small ocular window. There is a south-west facing ground floor door into the former vestry / classroom, which latterly acted as one of the fire exits for the building. The door is positioned within two of the buttresses, and has a small fanlight window directly above it with a semi-circular head, constructed from a mixture of red and grey bricks. There is a first floor window above the door, which has a grey brick semi-circular head.

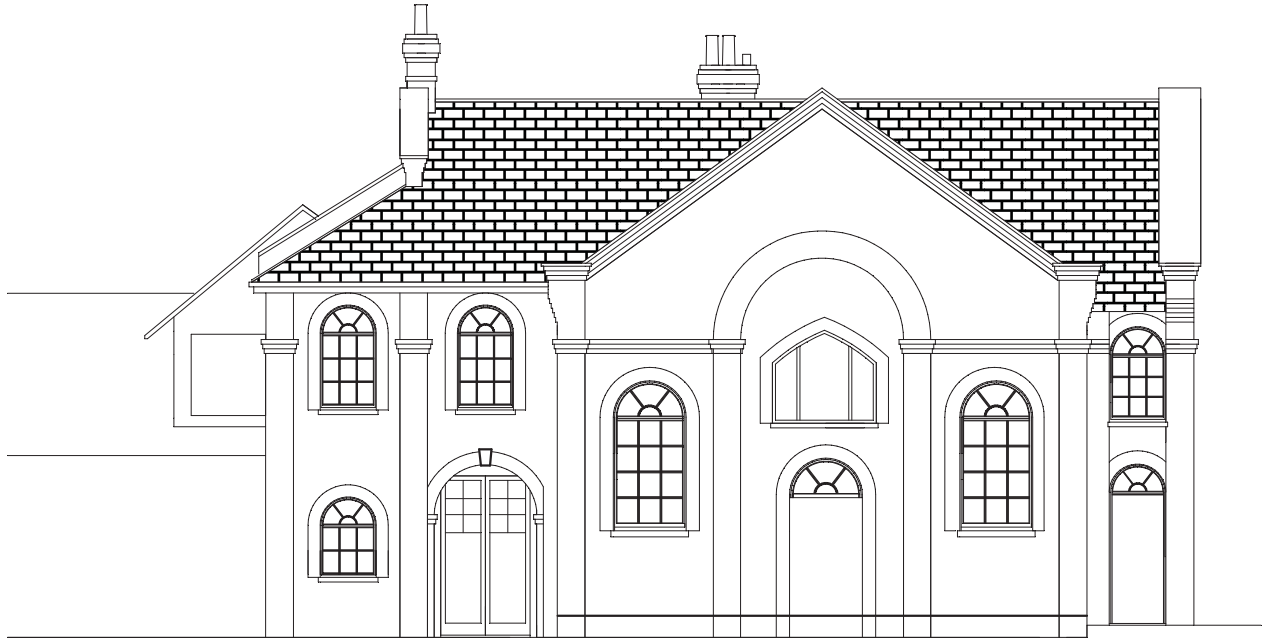
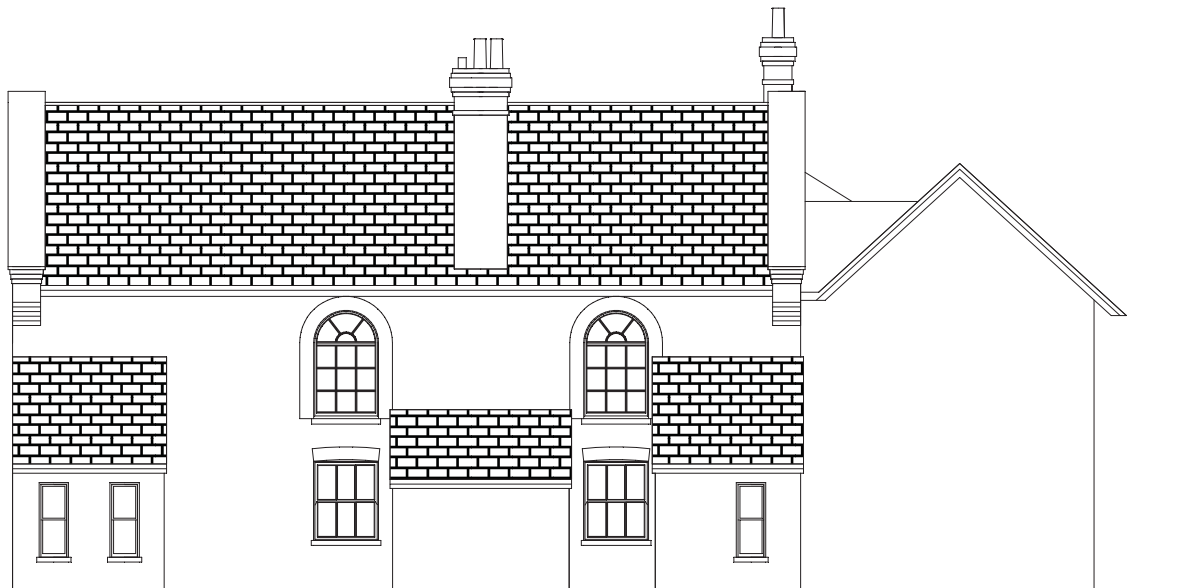
Figure 14. South-west and North-east facing elevations.

The front (SW facing) of the original church has yellow brick corner buttresses, along with two central buttresses which support a large decorative blind arch. The central buttresses and blind arch enclose the original front door, a large window and the name plaque which reads "Wesleyan Chapel 1874". The original front door has a yellow brick surround, with a semi-circular head. The door was blocked up in 1959 with red bricks in Flemish bond to match the rest of the building (Pl. 5). It is not clear whether the fanlight window above the door is an original feature, or whether it was inserted when the door was blocked. The large window above the door has a yellow brick surround with a pointed head. A photograph dating from 1966 (Pl. 26) indicates that this window has been altered since that time. There is a decorative yellow brick string course between the corner and

The north-east facing elevation of the building is quite difficult to see in its entirety due to the boundary wall (Pls 7 and 8). It was this side of the building which had three small extensions added in 1920. The original part of the building has two windows at the first floor level, which are similar to those seen on the other elevations. However, they are smaller, and the semi-circular heads are in grey brick, with the rest being in yellow brick. There are two original rectangular windows on the ground floor, with yellow brick surrounds. These windows are less ornate than the ones with semi-circular heads, possibly due to the fact that they would not have been clearly visible from a distance.

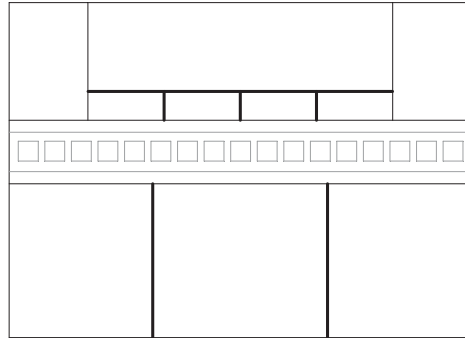
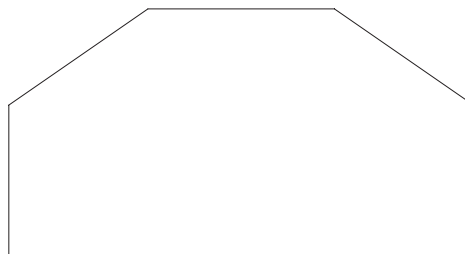
Figure 15. Sections.

**Section A - Worship Area looking North-east, showing gallery**

**Section B - Church Hall looking North-west**

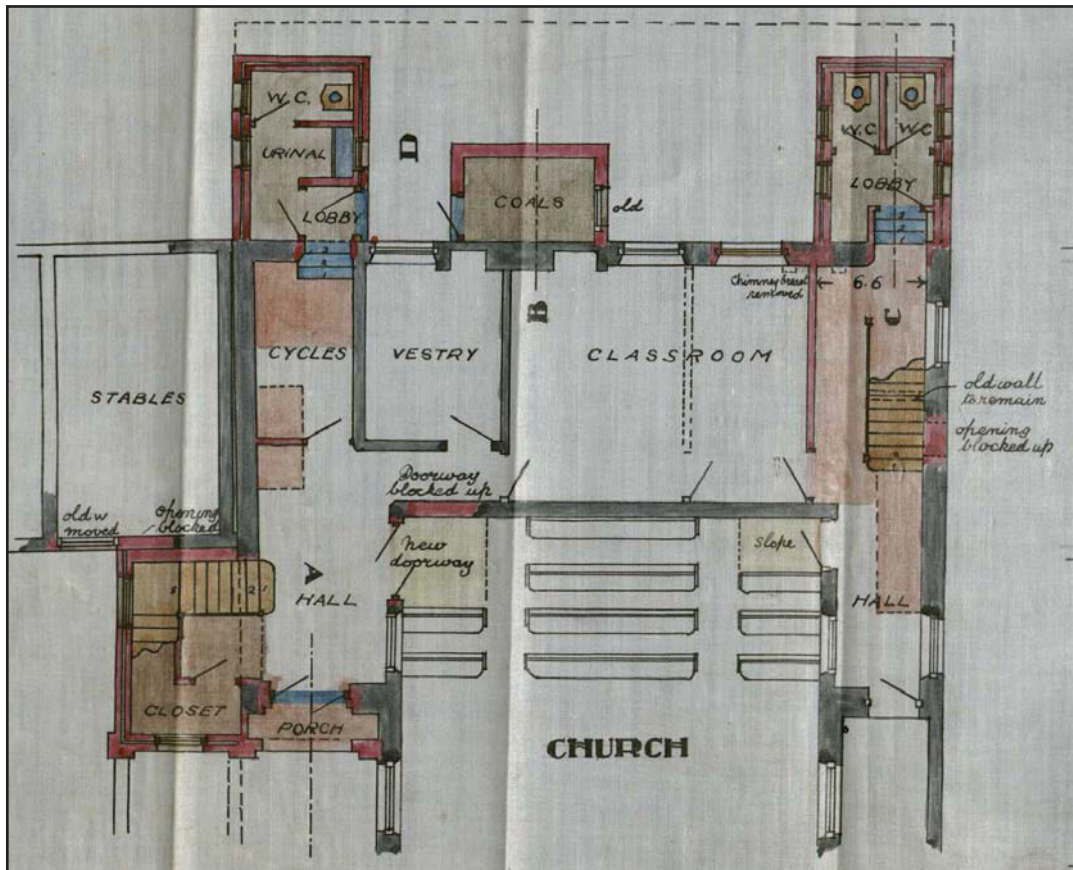
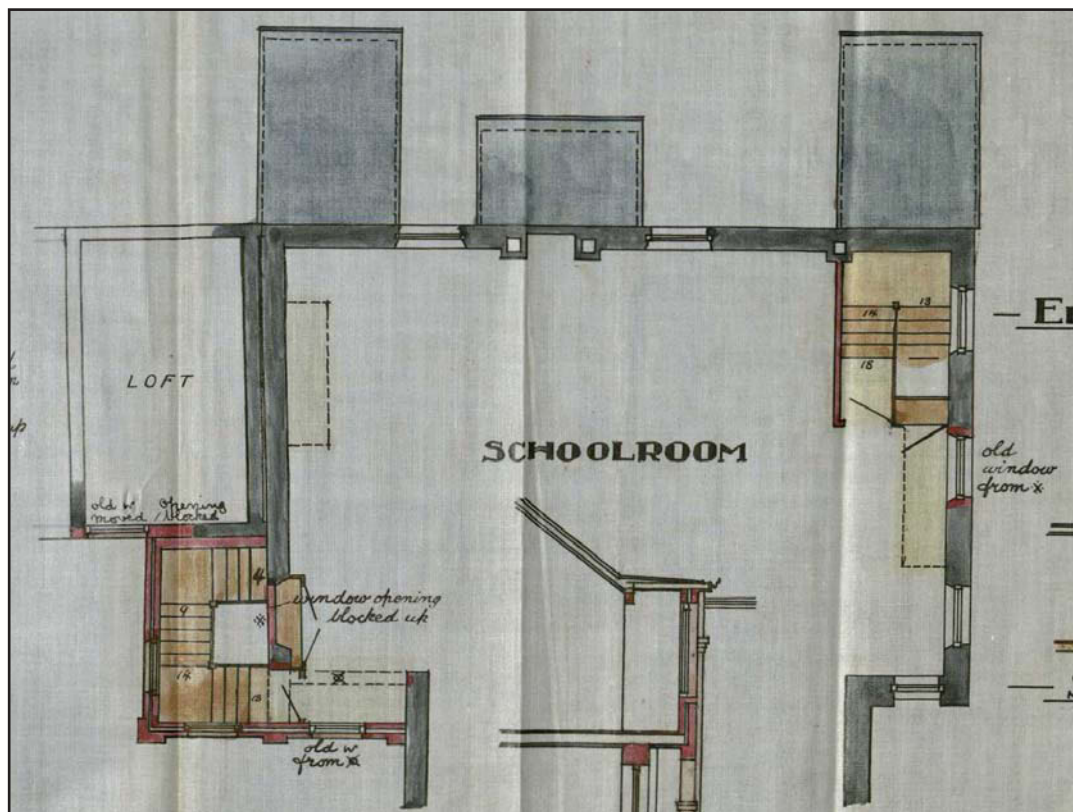
There have been numerous changes to the internal layout of the building since 1874, most notably to the rear of the ground floor. The 1920 plans show that this area was split between the vestry, a classroom and a cycle storage area. Various partition walls have been built in this part of the building, most recently to house a disabled toilet, although most had been removed prior to the survey taking take. Elsewhere in the building it was sometimes difficult to identify original and later features as so much had been removed by the Methodist Society before the church was sold.

Figure 16. Plans from 1920 showing proposed alterations and additions for ground floor (top) and first floor (bottom).

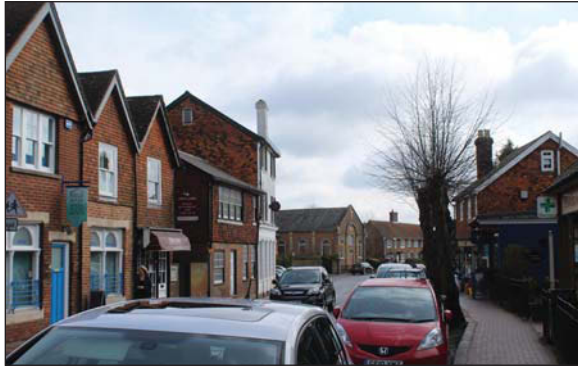
The church is set back slightly from the main road, and has a low brick boundary wall surmounted with iron railings (Pls 1 and 2). There are three ornamental iron gates along this wall. The north-western one leads to the current main entrance via a brick pathway which runs between the wall of the church and a raised flower bed. The central gate is positioned in front of the original door to the church (now blocked: Pl. 3), which was served by a stone slab path. The south-eastern gate leads to another doorway, which is the present fire exit, via a brick path.

Plate 1. General view looking South-East down Wadhurst High Street.

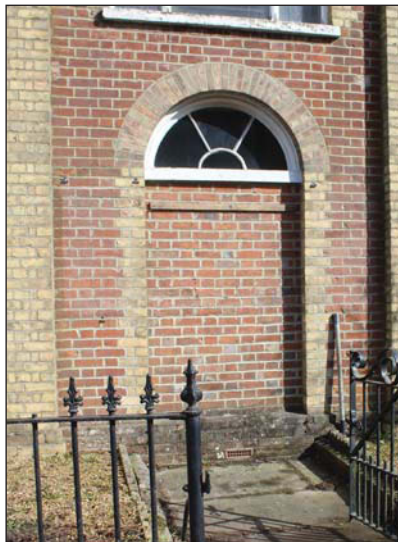
Plate 5. Original front door (now blocked), looking East North-east.

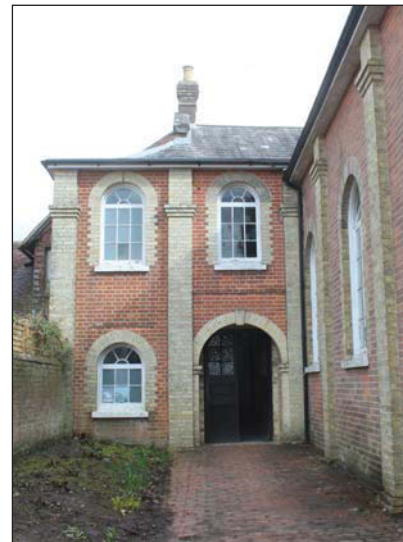
Plate 6. Present main entrance, looking North-east.

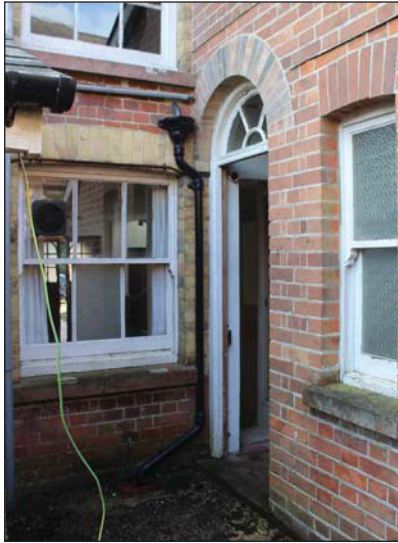
Plate 7. Rear door of church, looking South South-west.

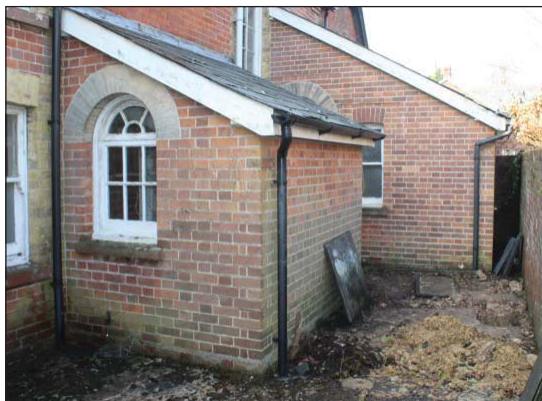
The three small extensions built in 1920 have simple gabled single pitch roofs, and were constructed in red brick to match the rest of the building (Pl. 9). The western extension was originally built to provide a gentleman's WC, and to enable access to the rear of the church. The plans from 1920 show two windows in the western wall but, unless they were subsequently blocked up, these do not appear to have been included in the final design. Instead there was a simple rectangular window in the north wall (not shown on the 1920 plan), and a window and door in the east wall. The east window is rectangular with a red brick slightly arched lintel. The door has fanlight window above it, with a semi-circular head, constructed from red and grey bricks. The central extension was originally built as a coal store, and was later turned into a boiler room. It has a lower pitched roof than the two extensions on either side. There is a door in the west wall with a slightly arched yellow brick lintel

Plate 9. Rear of church, looking West North-west.

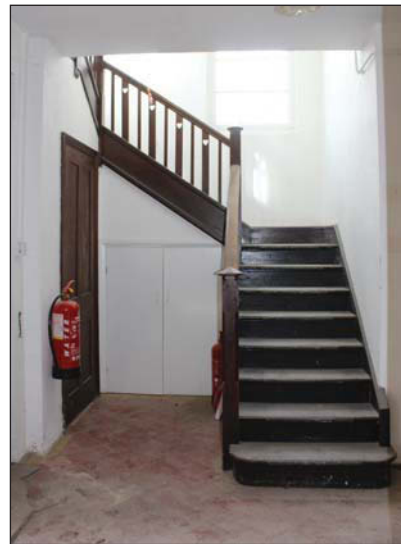
Plate 10. Staircase H, looking North-west from entrance lobby A.

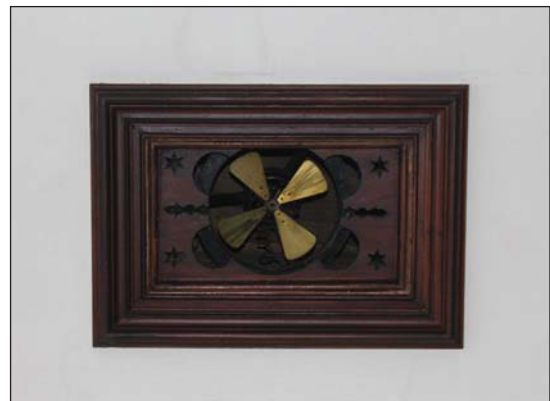
Plate 14. Decorative air vent in ceiling of worship area D.

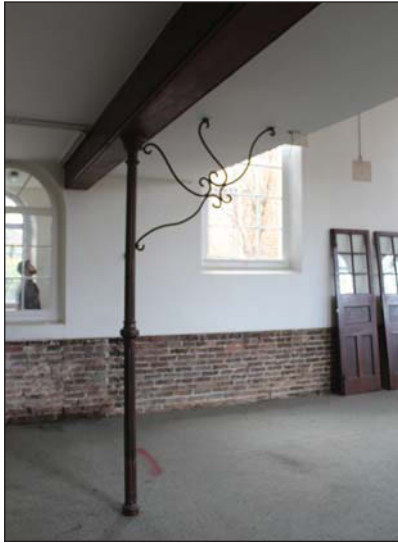
Plate 15. Iron post in worship area D, looking South-east.

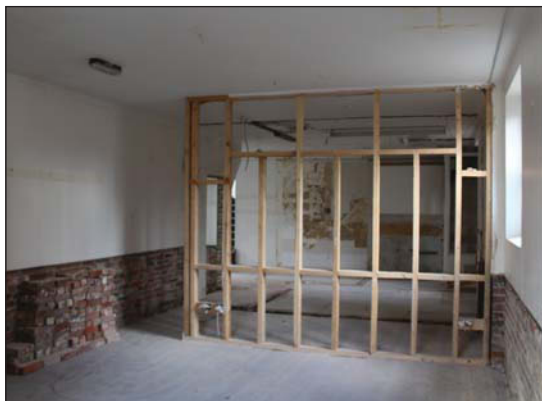
the survey was carried out, along with the kitchen and toilet fittings. However, the timber frame of one of the partition walls was still standing (Pl. 17), and the scars of those which had been removed were clearly visible on the floor and walls. The western part of the room had a tiled floor, whilst the rest was covered with exposed wooden floorboards. The lower section of the walls in the eastern part of the room had previously been timber panelled, but these had been removed by the Methodist Society. Very few items of historical interest remained in the room, but these include the old fireplace in the northern wall (Pl. 18), and a series of brass tracks on the floor which may have been associated with some fitted cupboards which have subsequently been removed. The 1920 plan indicates that the room was to be split between a cycle store, vestry and classroom, but it is not clear if all the partition walls shown on the plan were built as planned. Certainly, the proposed staircase and partition wall at the eastern end of the room do not appear to have been constructed. Instead, the proposed staircase (J) (Pl. 16) appears to have been built slightly further south, in the area occupied by corridor E. An L-shaped partition wall was built to separate room C from corridor E (Pl. 20), and there were originally two doorways connecting the two. One of these, opposite the entrance to room F, had been blocked up in the past.

Plate 17. Room C, looking West North-west.

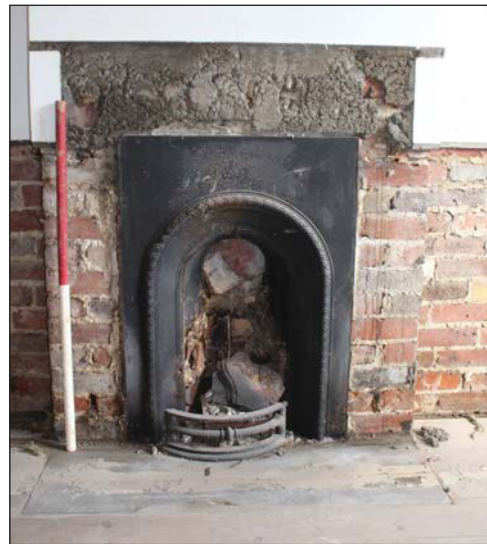
Plate 18. Fireplace in room C, looking North-east.  
Scale: 1m.

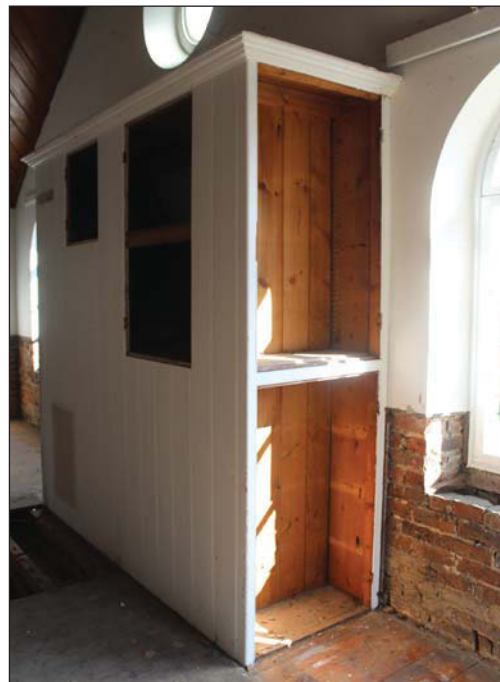
Plate 25. Wooden surround of staircase J, looking East.
