**Farthings, River Lane, Alfriston,
East Sussex**

Building Recording

Site Code: FAS18/18

Report 18/18

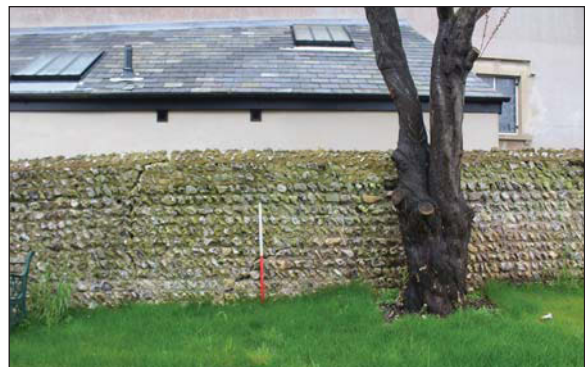
Plate 6. East side of wall, looking West.
Scale: 1m.

The earliest section of the recorded wall is at its southern end, measuring approximately 12.40m. This part of wall is constructed from flints laid in a herringbone pattern, although there are a few random bricks present. The flints are relatively uniform in size (c. 80mm x 150mm), and set within a grey lime mortar with shingle inclusions. A number of cracks are visible in this section of the wall, including two major ones at the southern end. Up to fifteen courses of flint were visible, although it is likely that further courses have been obscured by a build up of soil against the wall.

The upper section of the southern part of the wall appears to have been repaired or re-pointed with a greyish sandy mortar which contained occasional shingle inclusions. The flintwork still appeared to follow the herringbone pattern seen in the original wall. A further repair was visible along the top of the entire wall, consisting of concrete or cement with frequent shingle inclusions. The flints in this later repair were laid in a random manner.

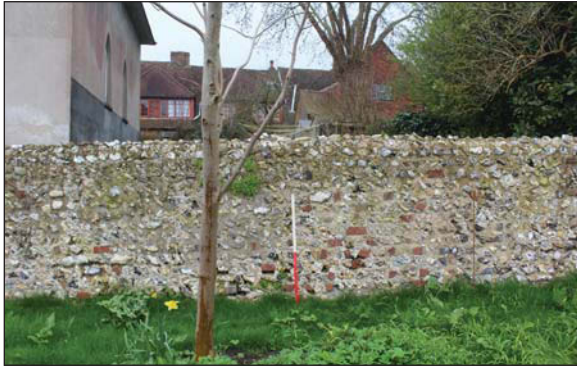
Plate 7. East side of wall showing later 'bungaroosh' construction, looking West. Scale: 1m.

The northern part of the recorded wall is clearly a later rebuild as the coursing is more random in nature, and there are more bricks present. This style of 'bungaroosh' construction is common in East Sussex, especially in the Brighton area. In contrast to the earlier section of wall to the south, no clear coursing is visible in this part of the wall's construction. Numerous patches of grey sandy mortar were visible along the eastern elevation, obscuring the original wall, and these are obviously later repairs.
