**Land at Westford Park Farm,  
Chard Junction, Dorset**

**Archaeological Evaluation**

**Site Code: WCJ 18/65**

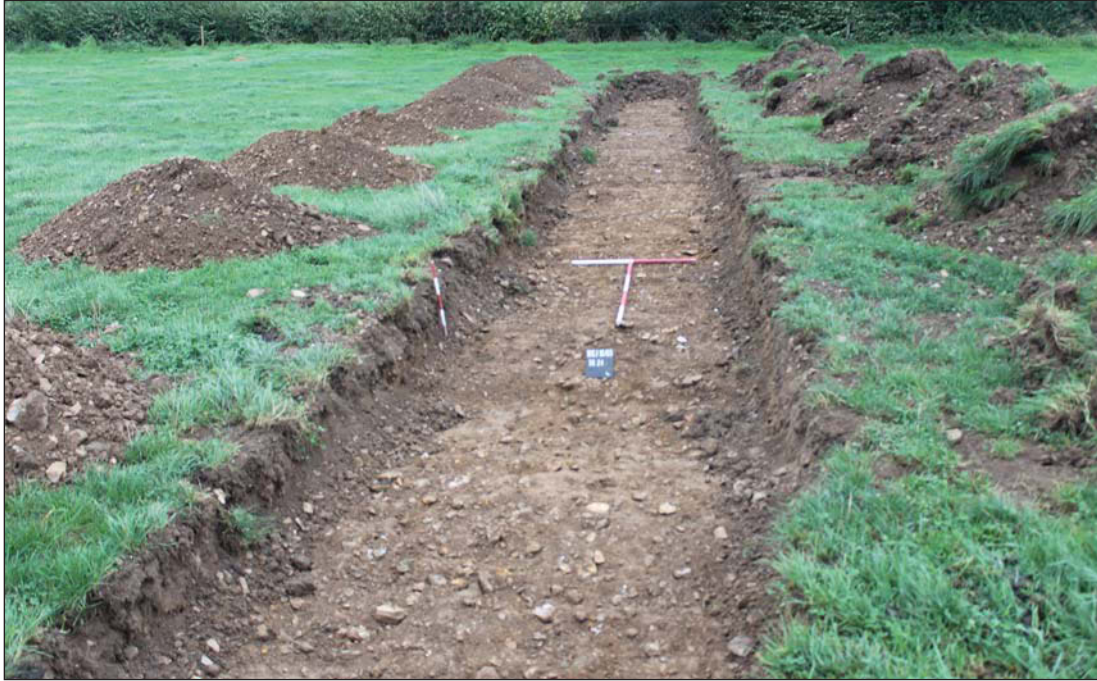
Plate 1. Trench 24 Looking North East Scales: 2m, 1m and 0.5m

Trench 24 was aligned roughly South-West – North-East and was 25.50m long and 0.49m deep. The stratigraphy consisted of 0.35m of topsoil, above 0.06m of subsoil above brown yellow silty clay with large stones and gravel natural geology. Cut into the geology was Ditch 7 which was aligned NE to SE, and was 1.09m wide and 0.30m deep. It was filled with a light grey yellow silty sand with occasional gravel (58) but no artefacts. Ditch 9 was also aligned NE to SE and was 2.54m wide and 0.50m deep. It was filled with a light grey yellow silty sand with lens of red brown silty sand and 10% gravel (60). It contained a single broken and burnt flint flake probably of Neolithic or Bronze Age date. This ditch corresponded closely with a semi-circular geophysical anomaly.

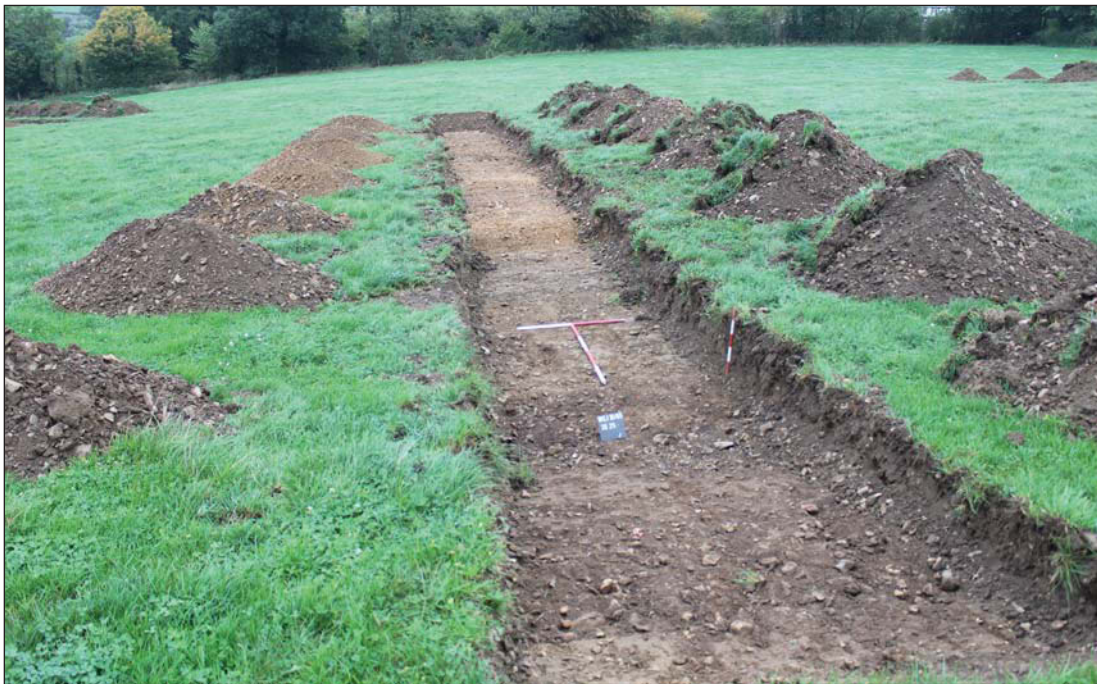
Plate 2. Trench 25. Looking North West. Scales: 2m, 1m and 0.5m

Trench 25 was aligned roughly South-East – North-West and was 26.00m long and 0.46m deep. The stratigraphy consisted of 0.37m of topsoil above 0.06m of subsoil above brown yellow silty clay with large stones and gravel natural geology. However, the south-east end of the trench for a distance of 10.8m was within a palaeochannel (17) corresponding to the location of the dry coombe cutting across the field. A test pit was machine-excavated through the channel at the south-east end of the trench. The test pit was 4.50m long at its top and 2.30m at the base and dug to 1.10 deep. The stratigraphy within the test pit comprised topsoil 0.26m thick, beneath which was subsoil up to 0.30m thick. Beneath the subsoil was a deposit (72) of light brown silty sand with 30% stone and

gravel. Beneath deposit 72 was a dark red brown silty sand and gravel (73) which was also noted in palaeochannel 19.

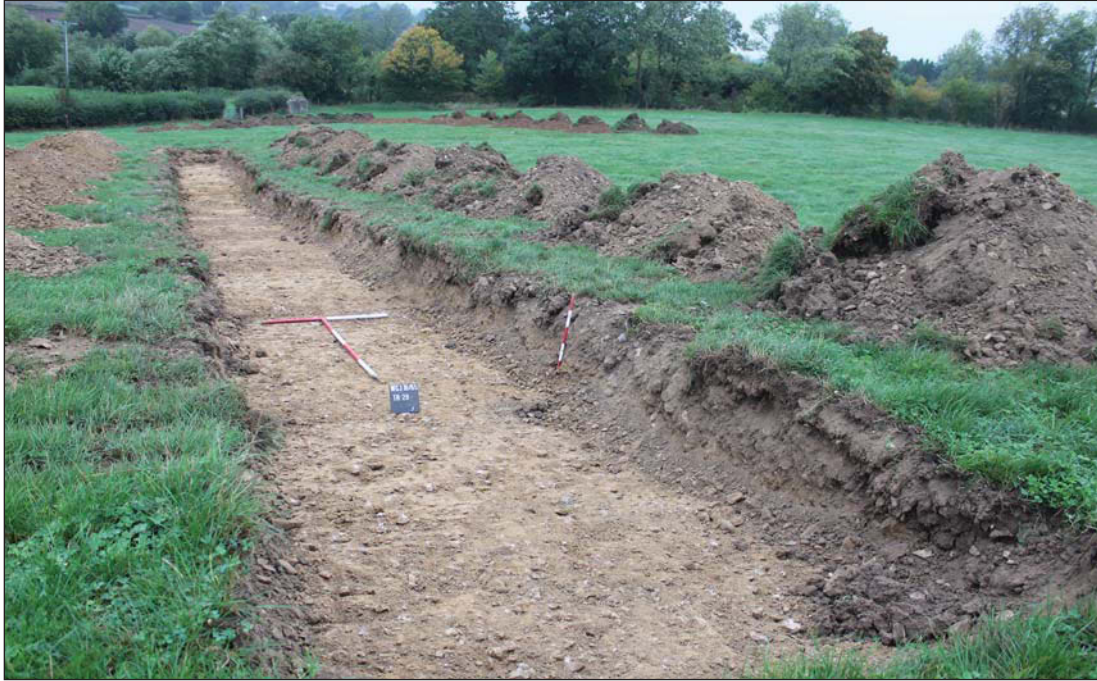
Plate 3. Trench 28. Looking North West. Scales: 2m, 1m and 0.5m

Trench 28 was aligned South-East– North-West and was 31.0m long and 0.5m deep. The whole of the trench appeared to coincide with the alluvial deposits of the palaeochannel 17 forming the dry coombe. A test pit was machine-excavated through the palaeochannel at the south-east end of the trench. The test pit was 4.30m long at its top, 2m at the base and a maximum of 1.51m deep. The stratigraphy within the test pit comprised topsoil up to 0.22m thick, above subsoil up to 0.07m thick. Beneath the subsoil was deposit (67), a light to mid brown grey silty clay with gravel up to 0.06m thick followed by deposit (68) a light grey yellow silty sand with gravel up to 0.24m thick. This in turn overlaid deposit 69, a light brown grey sand with gravel up to 0.07m deep. Beneath deposit 69 was a light grey yellow sandy clay with large stones and gravel (70) up to 0.18m thick which covered the base of the channel. No archaeological finds were recovered from any of these deposits.

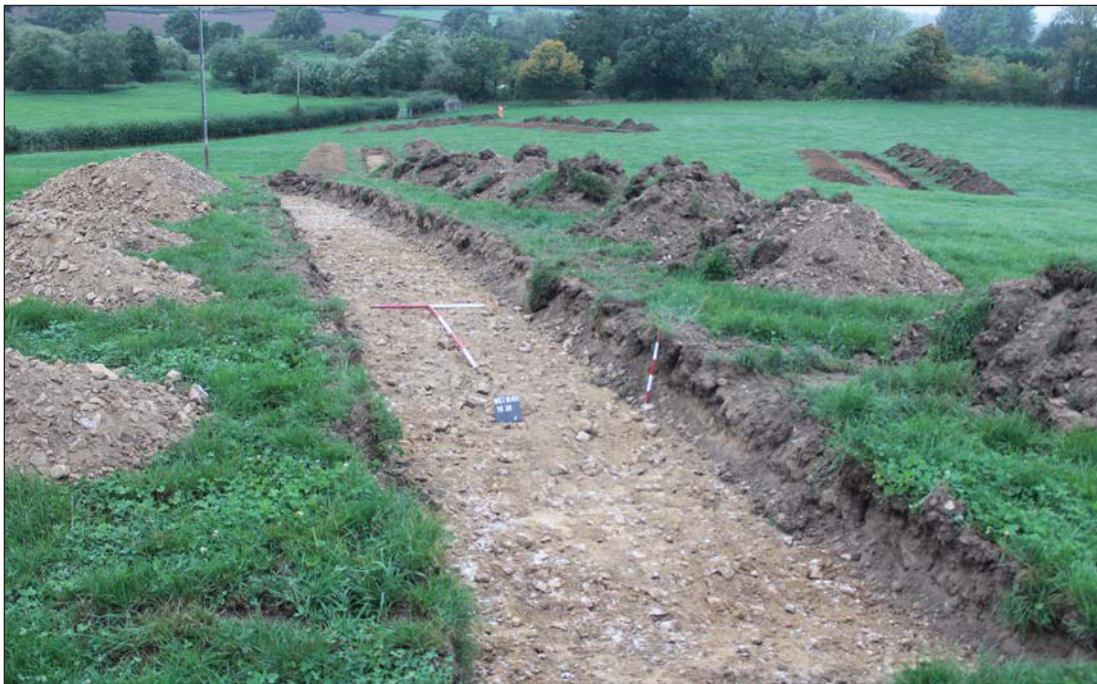
Plate 4. Trench 30. Looking North West. Scales:2m, 1m and 0.5m

Trench 30 was aligned South-East – North-West and was 27.40m long and 0.42m deep. The stratigraphy consisted of 0.30m of topsoil above 0.09m of subsoil which in turn overlaid natural geology. Cut into the geology was Ditch 8 which was aligned SW to NE. It was 1.27m wide and 0.39m deep and filled with a dark brown grey sandy silt with approximately 80% gravel and stones (59), but contained no artefacts.

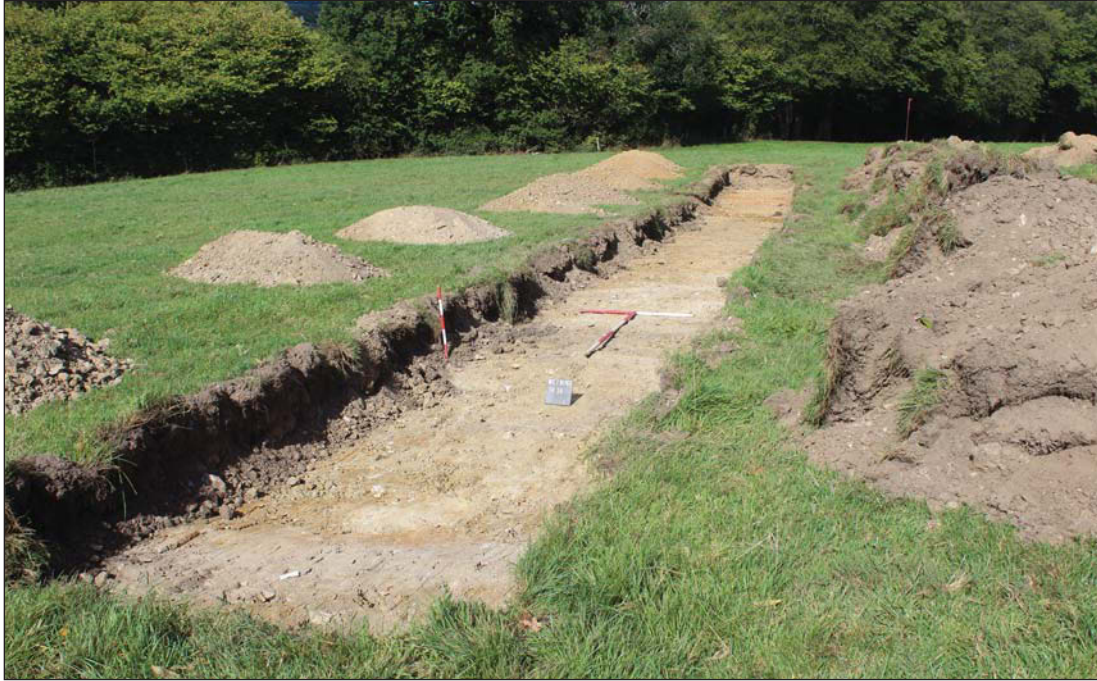
Plate 5. Trench 38. Looking North West. Scales: 2m, 1m and 0.5m

Trench 38 was aligned North-West – South-East and was 26.80m long and 0.40m deep. The stratigraphy consisted of 0.34m of topsoil above 0.04m of subsoil which overlaid natural geology. Cut into the geology was Ditch 14 which was aligned roughly south to north. It was 0.52m wide and 0.16m deep and filled with mid red

brown silty clay (55) that contained no artefacts. Ditch 14 did not appear on the geophysical survey as an anomaly.

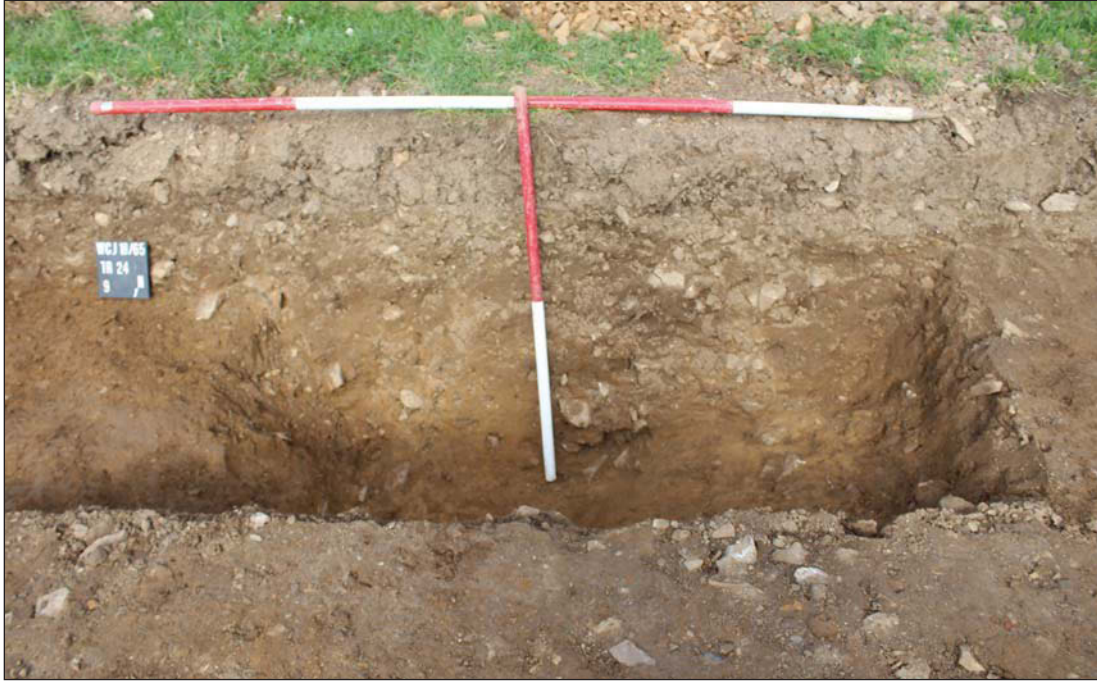
Plate 7. Trench 24 Ditch 9. Looking South West. Scales: 2m and 1m

However, two semi-circular geophysical anomalies do appear to be of archaeological origin and coincide well with ditches 10/ 11 (trench 25) and ditch 9 (trench 24). The latter also contained a prehistoric struck flint.

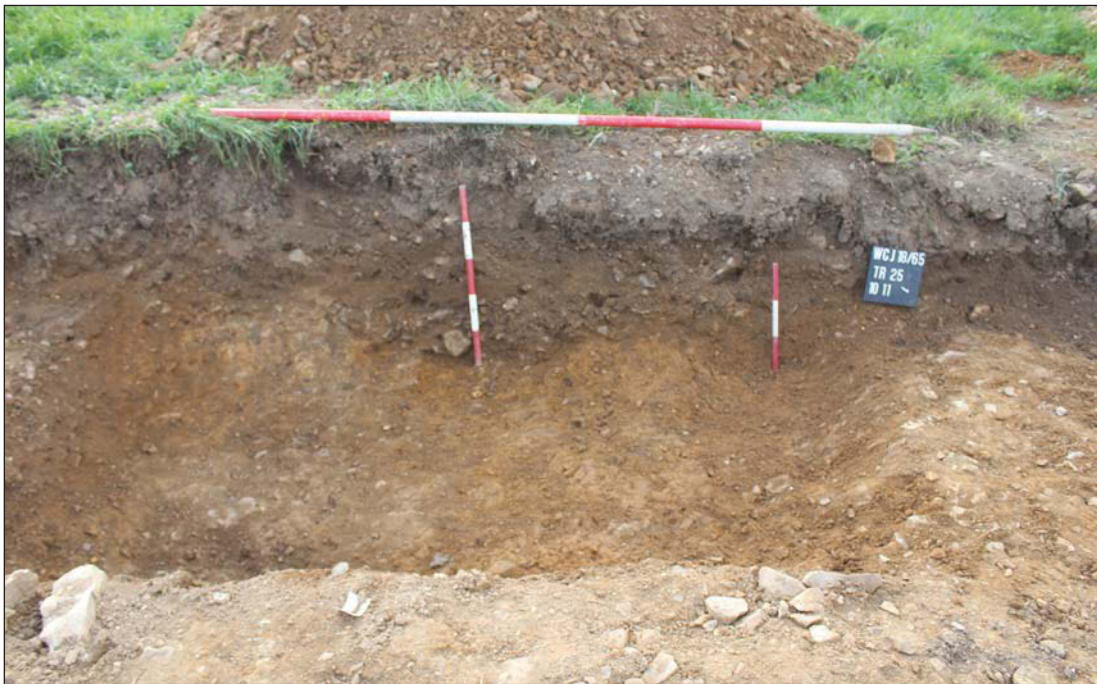
Plate 8. Trench 25 Ditches 10 and 11. Looking South West. Scales: 2m, 0.5m and 0.3m

Ditch 10 was aligned SW to NE and was 1.64m wide and 0.33m deep. It was filled with a mid red brown silty sand with 50% gravel (61). Ditch 10 cut parallel ditch 11 which was 0.82m wide and 0.28m deep. Ditch 11 was filled by a mid red brown silty sand with less than 10% gravel (62). Neither feature contained artefacts. Ditch 10 may be a recut of ditch 11 and they appear to be in a similar location and orientation to another semi-circular anomaly found during the geophysical survey.

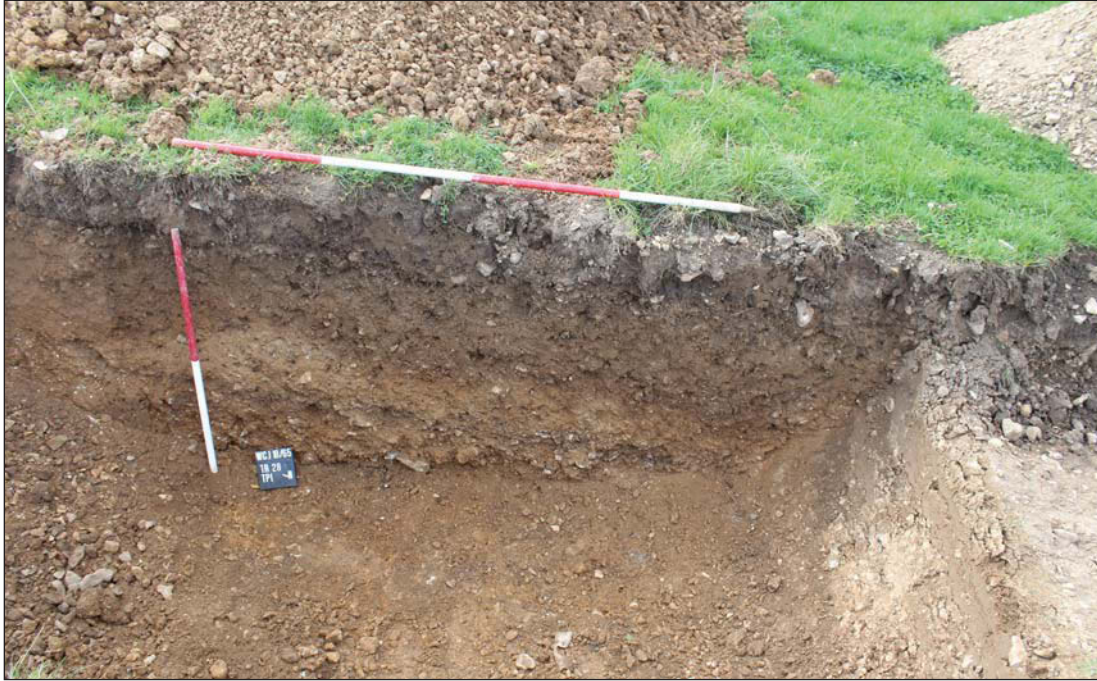
Plate 9. Trench 28, Test Pit 1 Ditch 18. Looking South West. Scales: 2m and 1m

Ditch 18 was coincident with the test pit and was aligned south-west to north-east. It was 0.86m wide and 0.30m deep. It was filled with a mid grey/brown silty clay with gravel and stone (67). It contained no artefacts.

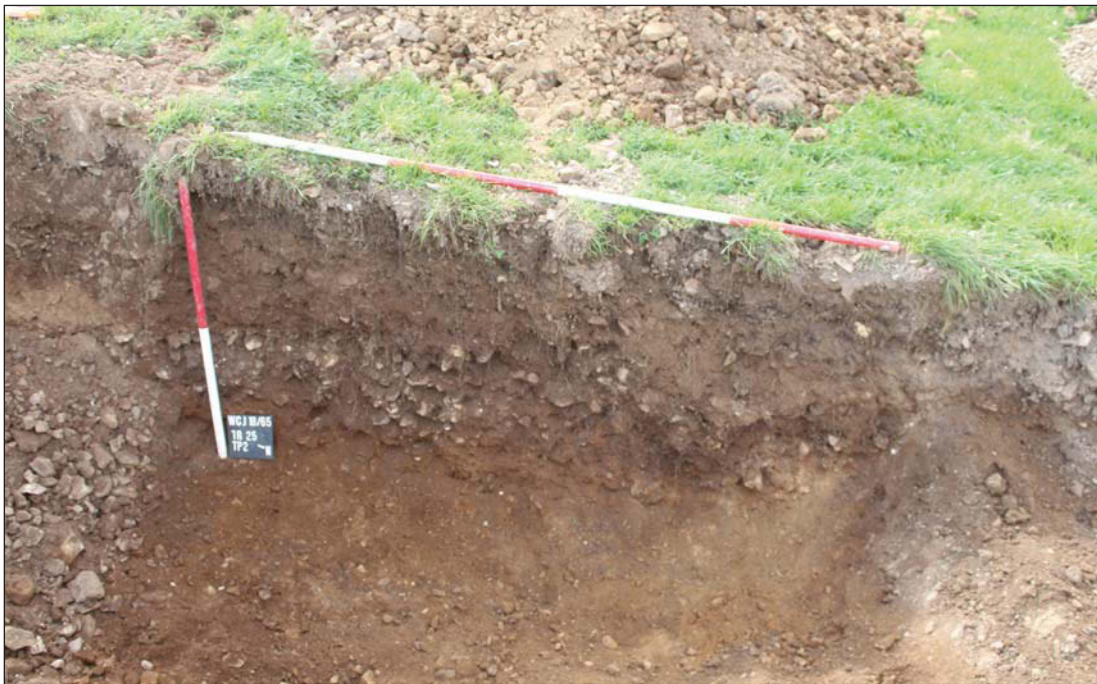
Plate 10. Trench 25, Test Pit 2. Looking South West. Scales: 2m and 1m
