**Former Cooper BMW, Kings Meadow Road,
Reading, Berkshire**

Archaeological Evaluation

Site Code: KMR 14/191

**An Archaeological Evaluation
for Lochailort Reading Ltd**

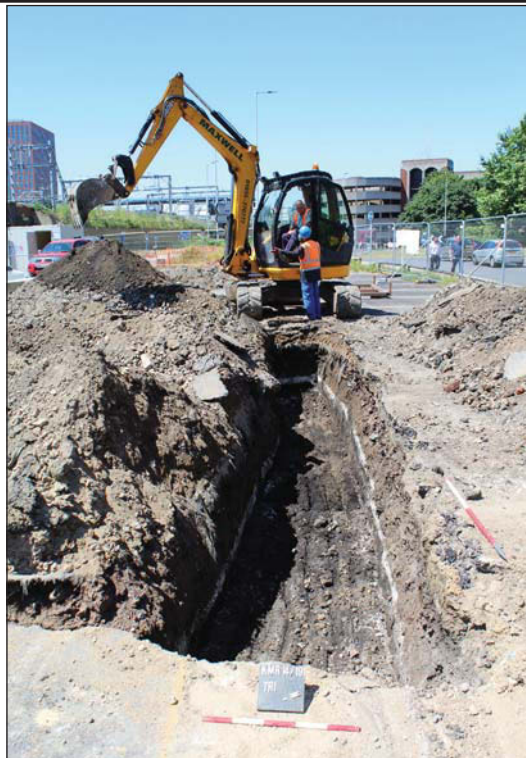
Plate 1. Trench 1, looking east, Scales: 1m and 0.5m.

This trench was aligned E–W (slightly bending at the west end towards the south) and measured 10m long and 1.30m deep. The stratigraphy consisted of 0.10m of Tarmac overlying a preparatory layer made of light brown sand with common coarse gravels, 0.10-0.15m thick. Below this was another made ground composed of poorly sorted sub-angular stones in a sandy clay matrix, 0.70-0.75m thick. Underneath this lay a 0.12m thick layer of chalk fragments. The deepest layer encountered over most of the trench was a mid to dark brown sandy clay, with a thickness of at least 0.20m, and presenting traces of recent activity (coal). To the west a possibly less disturbed mid grey clay was reached but the trench layout offered only a limited view of it and could as well possibly be another deliberate deposit. (Contaminated) water ingress prevented any further excavation.

No finds or features of archaeological interest were observed at this level.

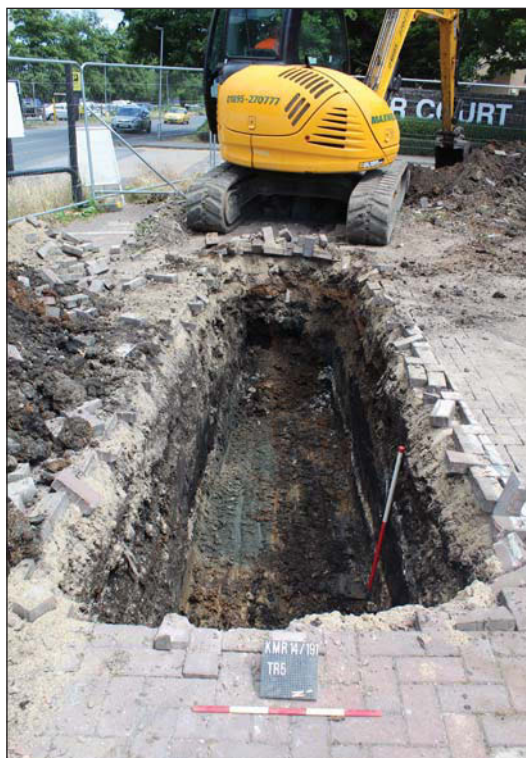
Plate 2. Trench 5, looking east, Scales: horizontal 0.5m, vertical 1m.

Here again the positioning of the trench had to be reconsidered. It was dug towards the north-east corner of the site and was 5m long. Its orientation was approximately W-E. The width varied between 1m and 1.30m. A depth of 1.50m was attained. Safety reasons and proximity of the access path dictated a stop at that level. The deepest layer seen was 0.20m thick and consisted of a clay or silty clay deposit with varied colours: mid greenish grey/grey at north, rather mid brown at south and west. It was unclear if this change could be due to human intervention, contamination or just natural alteration. Above it lay a crushed chalk deposit, also seen in Trench 1. It was 0.12m thick. The upper layers were a firm mixed made ground, mostly dark brown sandy clay or silty clay but with part incorporating more coarse gravels. It was topped with a yellowish sandy gravel (0.15m thick), bedding for the brick block paving (0.05m thick).
