**24 North Road, Preston, Brighton,
East Sussex**

Building Recording

**Building Recording
For Stone Chris Properties Ltd**

January 2019

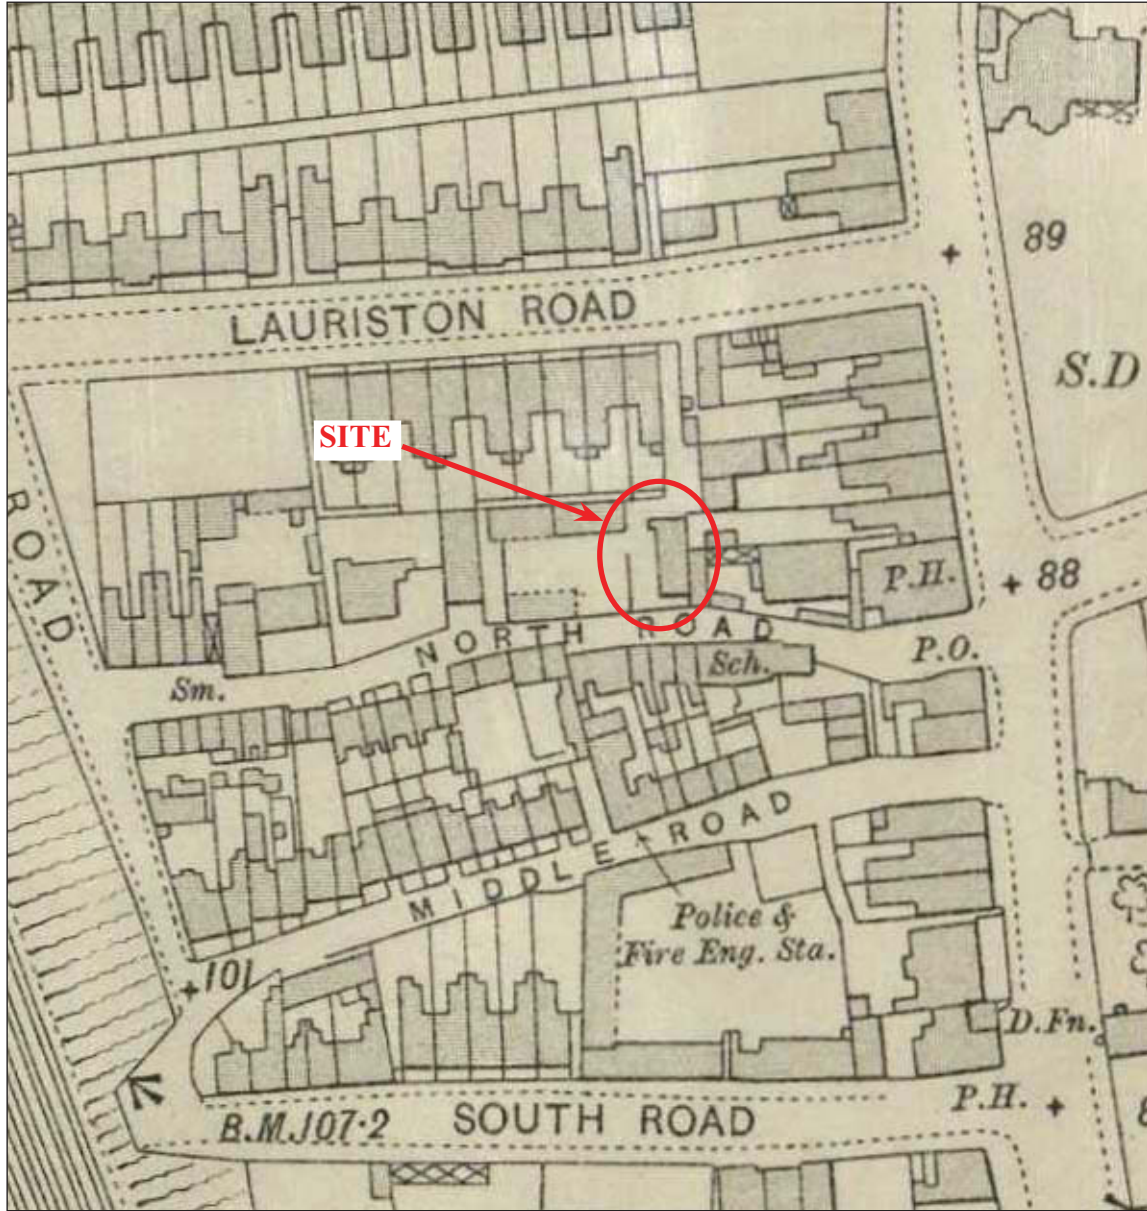
Figure 9. Third Edition Ordnance Survey, 1911.

The 1911 Ordnance Survey (Fig. 9) shows further changes, with numerous new buildings appearing to the west and north of the present site. All the buildings shown on the site on the 1898 map seem to have been demolished between 1898 and 1911, and the building which is the subject of this report appears for the first time. The northern end of the small yard shown on the earlier maps appears to have been opened up, and a new access road created to the north, from Lauriston Road. The only change to the site evident on the 1931 Ordnance Survey (Fig. 10) is the construction of a short length of wall to the south-west of the present building. A further length of wall appears to the north-west of the present building on the 1950 Ordnance Survey (Fig. 11).

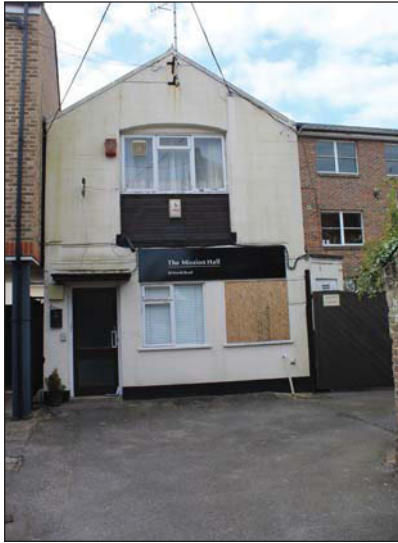
Plate 1. General view of north side of building, looking South.

The northern elevation of the building is similar to the southern one in that it is rendered and painted with an ashlar stone design impressed into the plaster (Pl. 1). The front door to the property is on the left of the ground floor, where there are also two wooden framed windows. The first floor window has a wooden frame and a slightly curved lintel. The bottom part of the window opening is timber panelled, suggesting that an original loading bay may have been converted into a window at some point. There is a large black sign showing the address of the property, and calling it the 'Mission Hall'. This sign was put up by the printing firm who occupied the first floor until 2011.

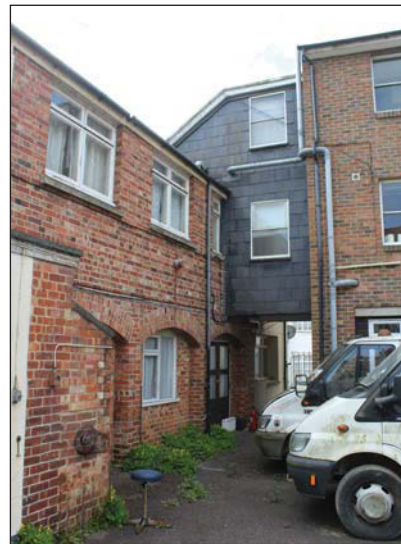
Plate 4. General view of west side of building, looking South-south-east.

The western elevation is partially obscured at first floor level by the adjacent property, which actually extends over part of the roof (Pls 4 and 7). The southern end of the wall is rendered and painted to match the southern elevation of the building, with the rest being exposed red bricks. Much of the exposed brickwork shows the same English Bond style as seen on the east side, but a number of later alterations are visible (Pl. 3). There is a small extension on the north-west corner of this elevation which could not be accessed during the survey. The

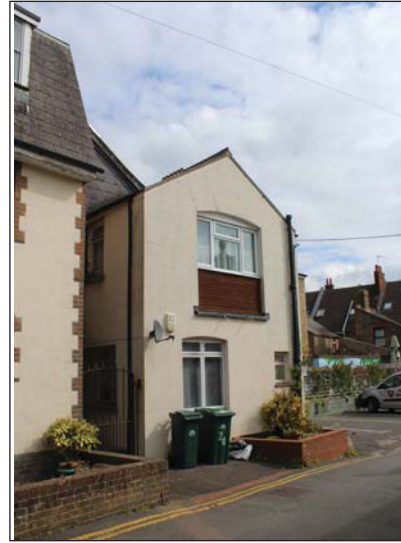
Plate 6. General view of west and south sides of building, looking North-east.

The building is set back slightly from North Road (Fig. 2), and can be accessed via an iron gate (locked at time of survey). There is a small brick built flower bed in front of the building. The southern elevation (Pl. 6) is rendered and painted, with an ashlar stone design impressed into the plaster. It is likely that the render obscures the original brickwork. There are two windows with wooden frames at ground floor level, with the larger one having a slightly curved lintel. There is one large window on the first floor which is of modern PVC construction, with timber panelling in the lower section. This window also has a curved lintel, and the feature may originally have been a loading bay.

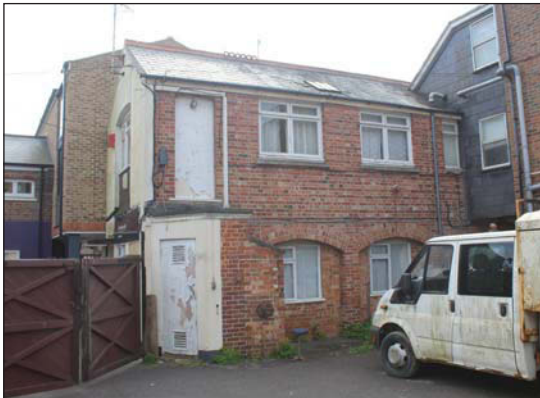
Plate 7. General view of north and west sides of building, looking South-east.

historic maps suggest that this extension was altered between 1950 and 1977, and a blocked doorway above it indicates that the original extension had two stories. It is possible that this earlier extension may have provided the original entrance to the first floor, via a spiral staircase (Pl. 7). To the south of the extension there may have been three large 'openings' with curved lintels constructed from red brick. Differences in the colour and style of the brickwork suggest that these 'openings' have been bricked up and two wooden framed windows and a door inserted (Pl. 3). There is another blocked door at the southern end of this wall, at ground floor level, along with a wooden framed window (Pls 2, 5). On the first floor level there are four windows with wooden frames, in addition to the blocked door mentioned above.

The building has a simple gabled pitched roof covered in slates, with red clay ridge tiles, some of which are crested with decorative holes (Pl. 7). There are three small skylights inserted into the roof.

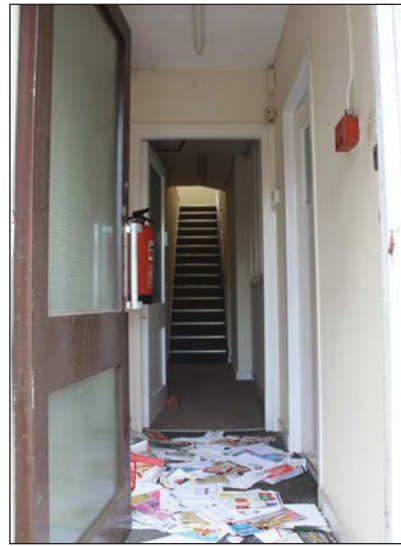
Plate 10. View through front door towards corridor G1, looking South.

The ground floor flat is accessed from corridor G1 (Pl. 10) via the kitchen (G2). The rooms in the flat consisted of, from north to south, the kitchen (G2: Pl. 11), dining area (G3), living room (G4: Pl. 12) and bedroom (G5). There was a small cupboard (G5) under the stairs, which was accessed from the living room. At the southern end of the building there was small room (G7), accessed via the bedroom, which contained a shower and WC.

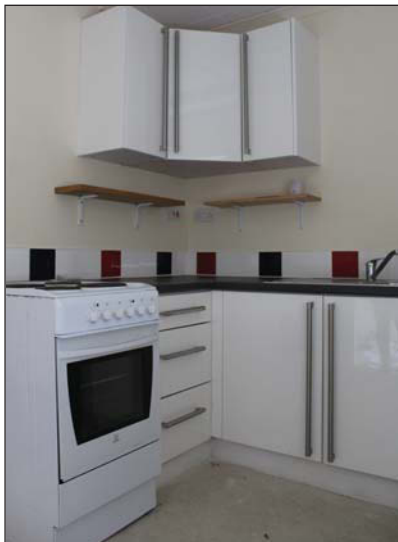
Plate 11. General view of room G2, looking South-west.

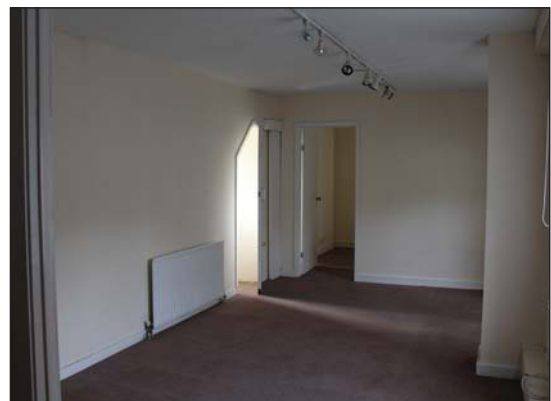
Plate 12. General view of room G4, looking South-south-east.

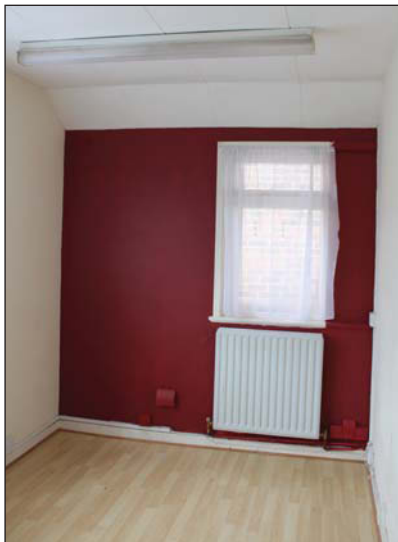
Plate 15. General view of room F2,
looking West.

The first floor is accessed via a staircase leading from corridor G1. The flat had its own front door at the top of the staircase, which opened onto a corridor (F1) (Pl. 14). There was a bedroom (F2) at the southern end of the building (Pl. 15). Corridor F3 was unusual as it led westwards from corridor F1 and its western end was actually within the extension which had been built at some point between number 24 and the neighbouring property (Media House). There was a shower at the western end of corridor F3, and a storage area beneath the staircase of the Media House extension. A small room (F4) containing the WC was accessed to the north of corridor F3. The northern end of corridor F1 provided access to the kitchen (F5) (Pl. 16) and living room (F6) (Pl. 13). The blocked doorway in the north-west corner of the building, visible on the western external wall, could be seen internally in room F6.
