**Land at York Road, Maidenhead,
Berkshire**

**Archaeological Evaluation
Part 1**

Site Code: YRM18/185

January 2019

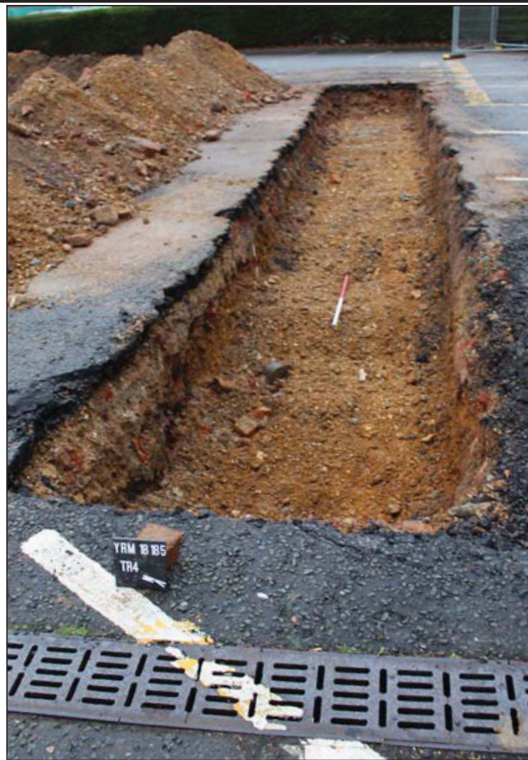
Trench 4 was aligned WSW–ENE and measured 13.2m in length and 0.6m in depth: it had to be shortened because of existing drainage. The stratigraphy consisted of 0.25m of made ground and Tarmac sitting on top of 0.3m of modern demolition deposits, above 0.13m of grey silty clay made ground, overlying gravel natural geology. No archaeological finds or features were observed in this trench.

Plate 1. Trench 4, looking east north east, Scales: 1m and 0.3m.

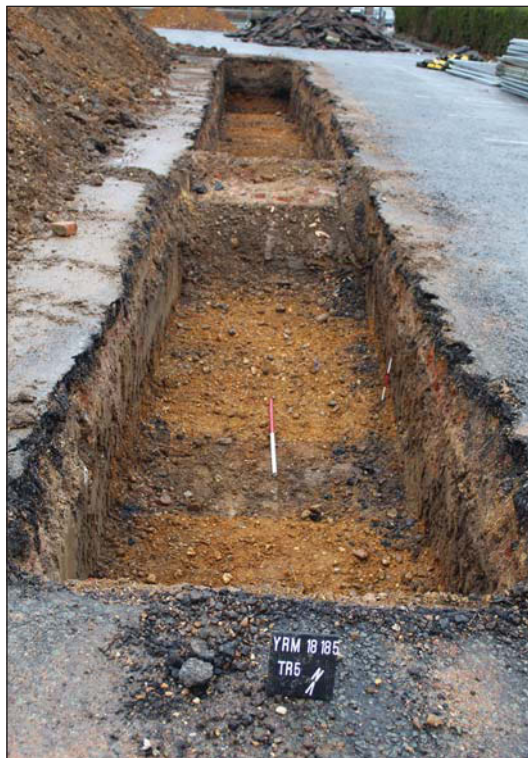
Trench 5 was aligned N-S and measured 20.3m in length with a depth of 1.1m. The stratigraphy consisted of 0.3m of modern made ground and Tarmac overlying 0.2m of modern demolition debris, above 0.5m of redeposited alluvium and made ground mix, over the natural gravel geology. The increased depth of this trench was due to the levelling of the naturally sloped ground for the construction of the existing car park. Modern linear features were observed aligned E-W at both ends of the trench. A central section of the trench was left unexcavated due to the presence of a electrical cable. No archaeological features or finds were recorded.

Plate 2. Trench 5, looking north, Scales: 1m and 0.3m.

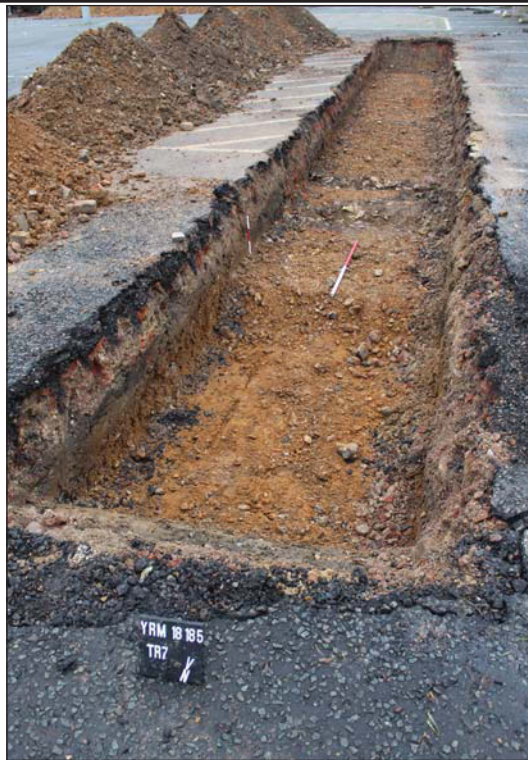
Trench 7 was aligned NNW-SSE and measured 17m in length with a depth of 0.65m. The stratigraphy consisted of 0.25m of modern made ground and Tarmac above 0.35m of demolition rubble which overlay the natural gravel geology. No archaeological finds or features were observed.

Plate 3. Trench 7, looking south south east, Scales: 1m and 0.3m.

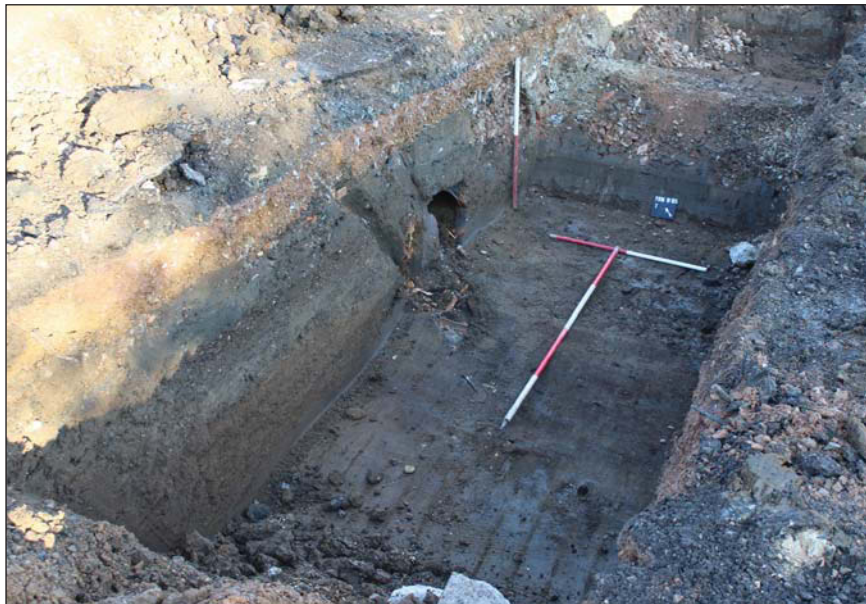
Trench 9 was aligned NE-SW and was 14.5m long. The depth of the trench was stopped at 1.3m along its length for health and safety reasons, but a test pit (stepped out to 3.6m wide) was excavated at the NE end down to 2.5m. The stratigraphy consisted of 0.1m of Tarmac onto 0.3m of compact yellow gravel and concrete made ground. This overlay a further 1m of made ground consisting of loose stone and chunks of concrete crush. Below this was 1m of mid greenish brown silty clay (redeposited alluvium) with brick inclusions. Underlying this at 2.4m+ was further alluvium which was not further excavated. The thick layers of made ground recorded in this trench relate to the multi-storey office building which had occupied this site before its temporary use as a car park. No archaeological finds or features were recorded or observed.

Plate 4. Trench 9, looking north,
Scales: horizontal 2m and 1m, vertical 1m.
