**Former Public House, Sunnyside Holiday Park,
Quintrell Downs, Newquay, Cornwall**

Building Recording

Site Code: SQD18/173

Summary of results: The building recording was carried out on the former public house prior to demolition. The building was found to be in a dilapidated state, with the core unstable, and was recorded to the fullest extent possible given its condition. The building dates to the early Victorian period (c.1840-1860) and has cob walls and a simple layout, with two phases of remodelling represented by an early outshut at the north-east, and a further outshut at the north-west and internal remodelling carried out for its conversion from a cottage to a public house, forming part of the holiday park complex.

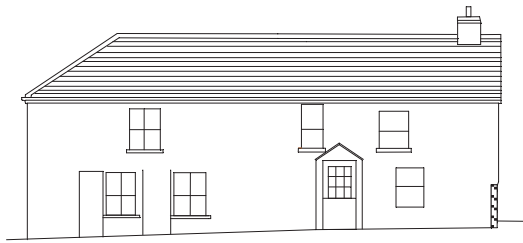
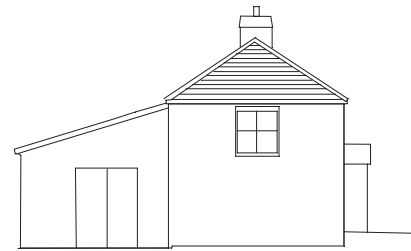
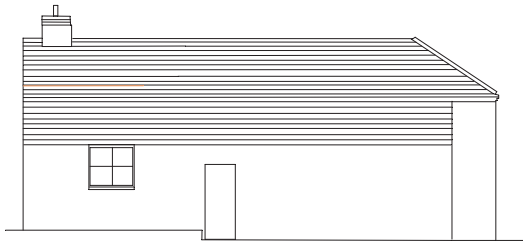
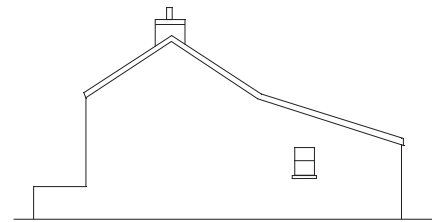
Figure 5. Elevations

Front elevation

West facing elevation

Rear Elevation

East Facing Elevation

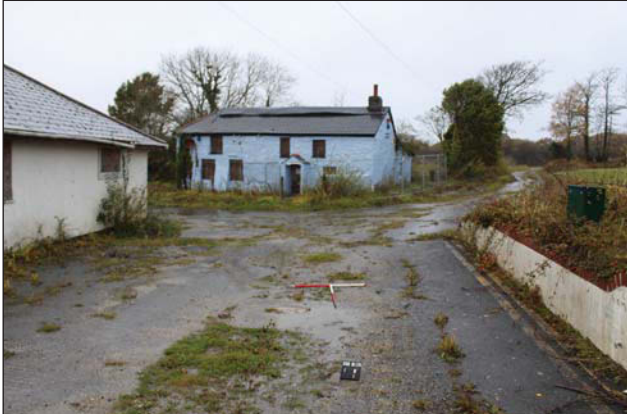
Plate 1. Exterior, general, looking NNW, Scales: 2 x 1m.

The building is set within a field, and is approached by a Tarmac access road via a car park (Pl. 1), with a modern single-storey building to the west (part of the range of buildings forming the holiday park complex). The land around the building is relatively flat, beyond which is a gentle slope up to the south and to the north.

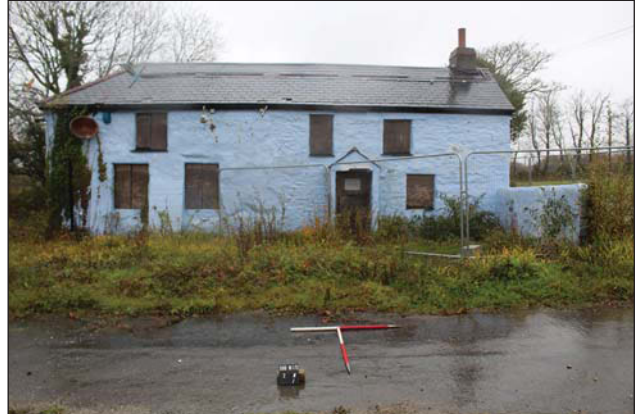
Plate 2. Exterior, front elevation, looking NW, Scales: 2 x 1m

The front elevation (Pl. 2) is asymmetric, with the front door and porch to the right hand side. The porch appears to be cob-built, with walls thinner and slightly neater than the building overall. Damage to the render shows that there is a timber lintel above the doorway. The three first-floor windows are irregularly spaced, and of differing dimensions. These were boarded but it was possible to establish that they each comprise two (probably side-hung) panes in simple black-painted wooden frames. The cob wall appears to be in good condition in the front elevation,. An area to the left of the porch is of a slightly smoother finish and suggests a blocked window adjacent to the pair of windows at the left. There is also tentative evidence for this on the corresponding area of the interior wall.

At the left of the elevation, the wall has two slightly projecting buttresses which are steeply sloping and die into the wall at first floor level. There is nothing to suggest they are a later addition. The ground-floor windows are of similar two-light types, are of the same dimensions and black painted wood and simple form without moulding and do not match the dimensions of the windows above. At the eaves, there is modern guttering, a satellite dish, and two electric lights. At the right of the ground floor, a low garden wall built of cob extends to the south, in line with the eastern extent of the building.

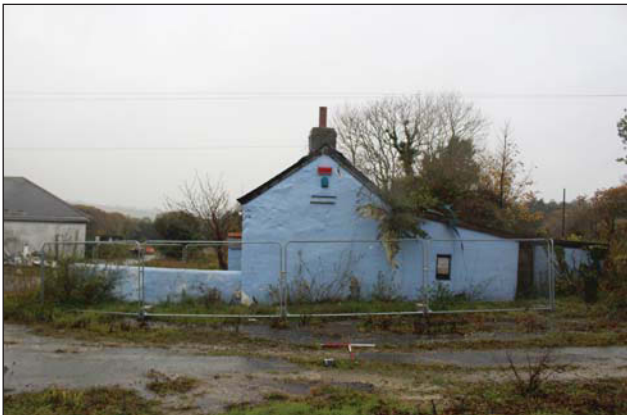
Plate 3. Exterior, NE facing side elevation, looking SW,
Scales: 2 x 1m

The east facing elevation (Pl. 3) comprises a gable end with no window, plain modern bargeboards at the eaves and modern alarm fittings. At the right is the side of the outshut, with a small modern window of one fixed pane, and beyond this, the breeze-block extension.

The upper part of the gable on its north side, and the north side of the main roof apex, are in very poor condition and a large part of the cob wall has crumbled into the building interior. The remaining cob walls in this part of the building are in a precarious state. Plastic protective sheeting has been put in place by the current owners to prevent further deterioration but it was judged to be in a very unstable condition at the time of the building recording, and at risk of imminent further collapse.

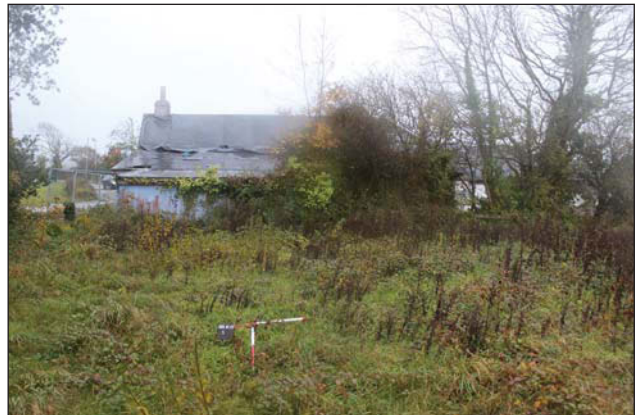
Plate 4. Exterior, rear elevation, looking SE, Scales: 2 x 1m.

The rear elevation (Pl. 4) shows the flat roofed extension, though trees, shrubs and undergrowth obscure the rear wall, including the door and window. The west side elevation (Pl. 5) has a hipped roof tiled in grey slate, with red ceramic ridge tiles. A single window at the centre of the first floor comprises two panes with black-painted wooden frames.

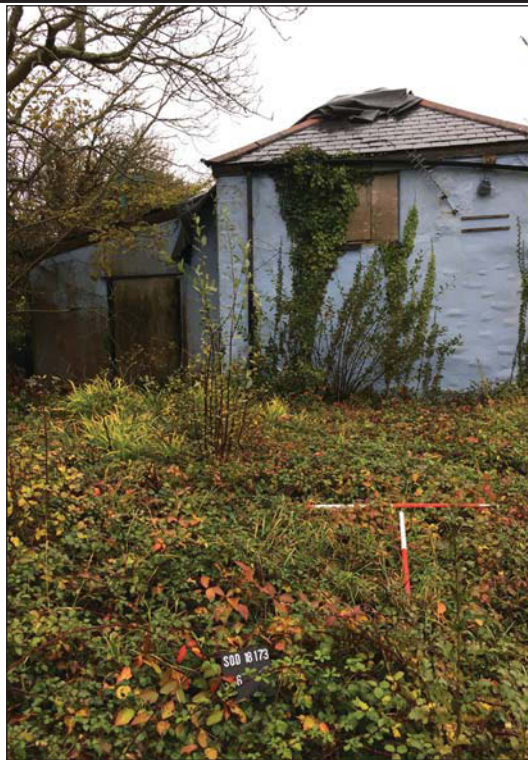
Plate 5. SW facing side elevation, looking NE, Scales: 2 x 1m.

At the left of the elevation is the cob-built single storey extension with a catslide roof, and a door which is of similar short height to the front door.

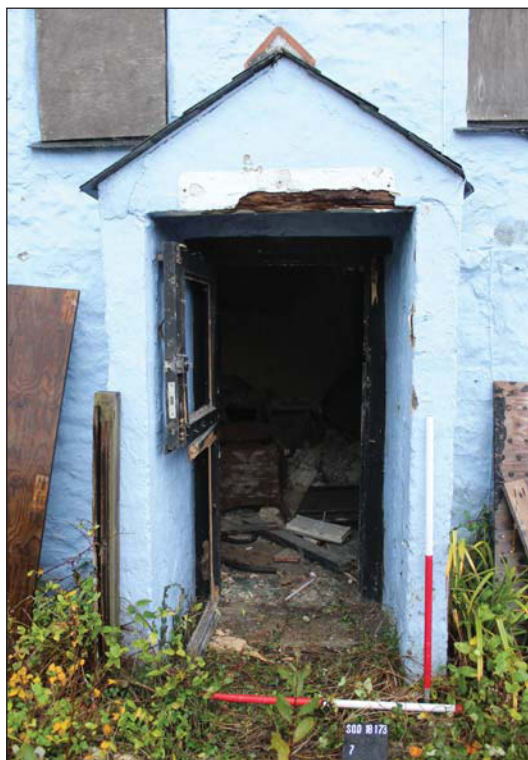
Plate 6. Exterior, Porch, looking NW. Scales: 2 x 1m.

The front door gives access to the main room [1] (Pl. 6), which occupies the width of the building. It served as the main bar area and the room is plastered internally, which has removed any evidence for the location of a partition wall which would have separated the space into two rooms in its original form of a cottage.

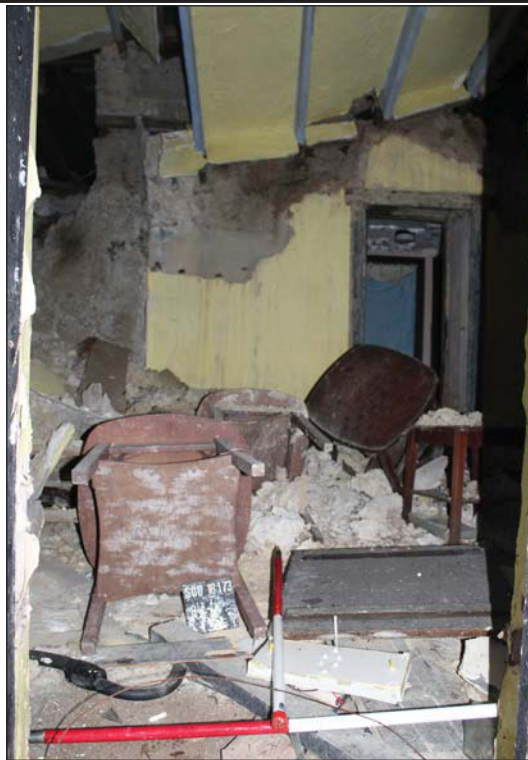
Plate 7. Interior, Room 1, looking NW, Scales: 2 x 1m.

The ceiling joists are exposed and are fairly widely-spaced, and appear to be machine-cut timbers. At the north-east corner, the damage to the roof and the gable end wall has resulted in the partial collapse of the ceiling (Pl. 7). The precarious state of this wall and the ceiling prevented full access to the rear rooms at the east (Pl. 8). These occupy the single-storey outshut at the east and represent the male and female toilets of the public house (Room 3). The upper part of the rear (north) wall has also collapsed into the room, with a substantial quantity of fragmented cob material and other debris filling the space (Pl. 9). A void is exposed which represents the chimney of a former fireplace which faced into the west of the main room. This has been removed (probably in the 1995 conversion to a public house). The windows are deeply-set and splayed, illustrating the thickness of the walls, and have wooden sills and lintels (Pls 10 and 12).

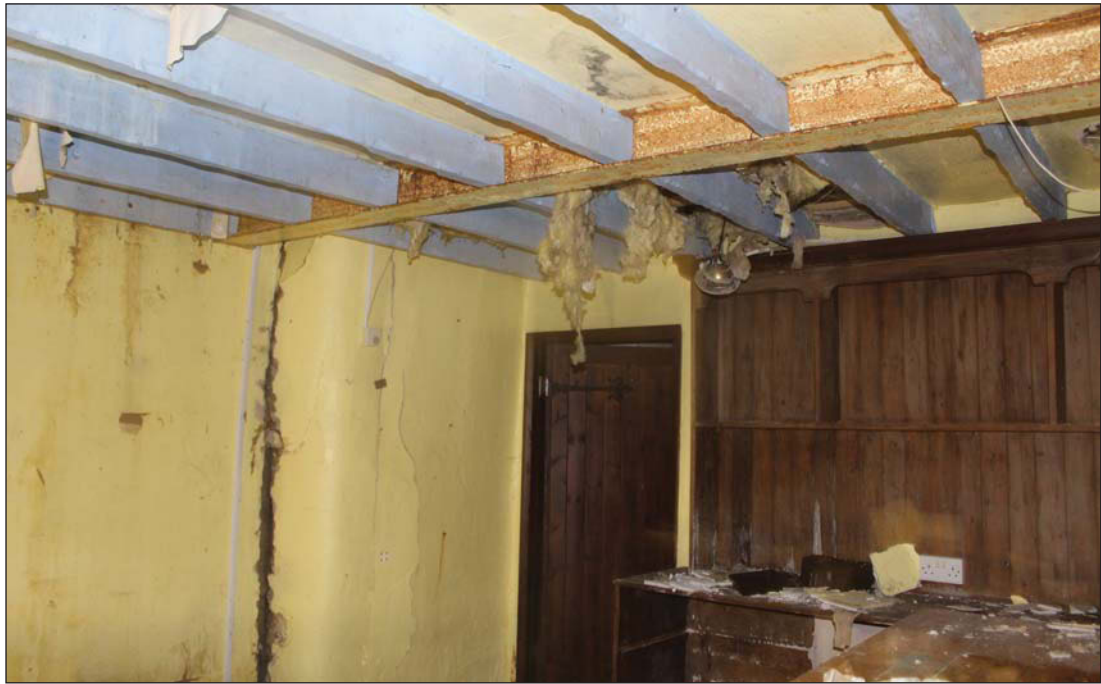
Plate 11. Interior, Room 2, Looking N

At the west of the room, the bar area continues in an L-shape to occupy the rear outshut (Pl. 11). This is a one-storey high space, with machine-cut joists set at right angles to those in the main room. These are supported on a rigid steel joist at the centre of the room and this part of the building has an internal (modern, wooden) door leading to the east into the store room [4] which occupies the original rear projection of the building, though this could not be accessed due to the risk of collapse.
