**Barton Junior School, Barton Road,  
Dover, Kent**

**Building Recording**

**Site Code: BJS181/74**

**January 2019**

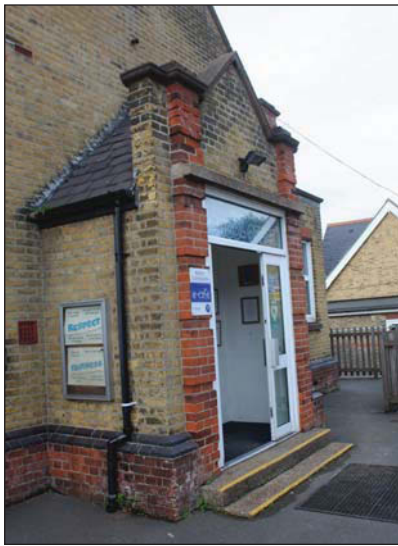
Plate 1. General view of main entrance to Building A, looking West.

The north facing elevation of Building A has always contained the main entrances into this part of the school, and is far more decorative in appearance than the other elevations. The wall is largely constructed from yellow bricks, although it sits on a decorative red brick plinth topped with shaped blue bricks. There are three gable ends visible in the elevation. The east and west gable ends have large circular vents into the roof space, with decorative surrounds constructed from red brick with stone keystones. The central gable end has a date plaque stating "DTC, Barton Road Girls School, 1912", with the DTC standing for Dover Town Council. The two lengths of wall between the gable ends are flanked with false red brick pillars, and have a decorative red brick string course running below the eaves. There are six decorative red bricks features below this string course, which appear to represent false flying buttresses. Although there is a further false red brick pillar at the western end of the elevation, it is possible that the area to the west of this may have been altered in the past as the windows in this part of the building appear different in style. The present main entrance into this building is located at the western end, and is via a small porch extension which is relatively elaborate in design, with two false red bricks pillars flanking the doorway. Apart from the window to the west of this entrance, which has a simple red brick lintel, the fourteen large windows along this elevation have red brick lintels with central keystones. The window immediately west of the central gable end appears to have been converted into a doorway at some time in the past. There is another window above one of the original entrances, in the central part of the elevation, and this is topped with a decorative fan design in red brick and stone. The window at the far eastern end of the elevation has been partially obscured by the later vestibule structure (A19). Although the window openings all appear to be original, the actual windows and doors are clearly modern replacements as all the frames are of UPVC construction.

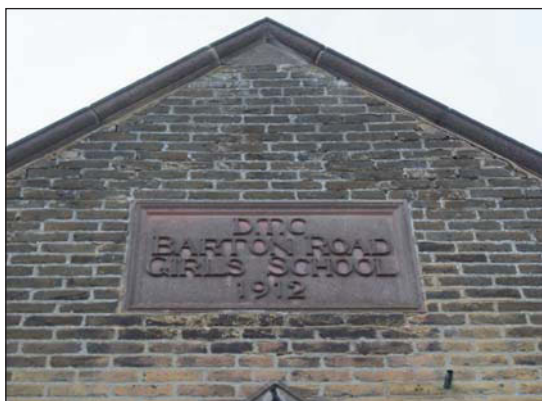
Plate 3. Date plaque on wall of Building A, looking South South-west.

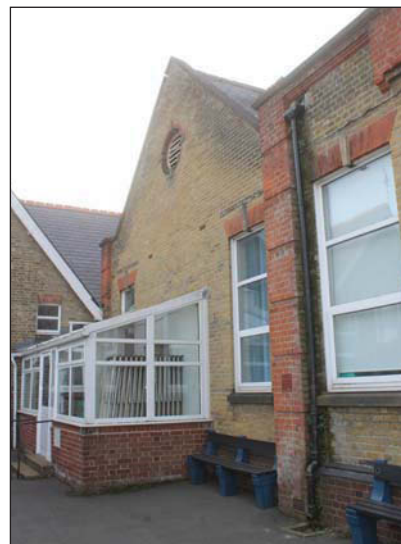
Plate 4. Vestibule A19, linking Buildings A and B, looking South South-east.

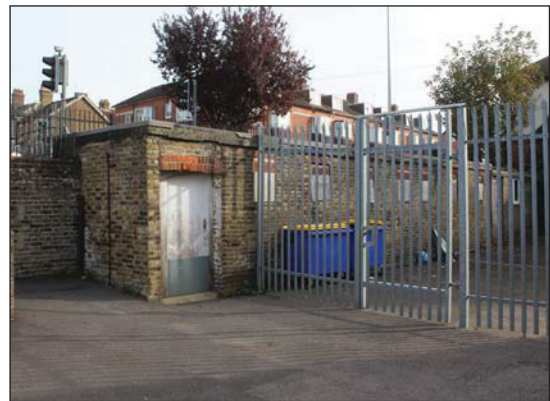
Plate 8. General view of Building C,  
looking North-east.

The historic maps indicate that the structures in the north-east corner of the site were rebuilt several times during the 20th century. The present structure appears to be an amalgamation of two possible buildings, due to differences in the windows and roofs. The western section is constructed from yellow bricks, and has red bricks

lintels above the door and windows. The eastern section has no red brick lintels, and its roof has a slight pitch, in contrast to the flat roof of the western section. The building was originally used as a toilet block. It was not possible to enter the building for health and safety reasons, as it is in quite a dilapidated state.

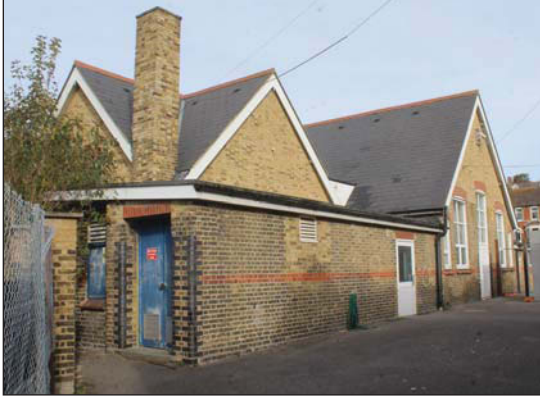
Plate 21. General view of Building D,  
looking North.

This building was originally built in around 1901 to house the infants school. It was built in a similar style to the boy's school (Building B), being of yellow brick with a decorative red brick string course, and red brick lintels on the doorways and windows. Scars on the brickwork on the north facing elevation indicate that this part of the building was modified in the past, and this is supported by the historic maps. The southern part of the building is still used as a hall by the school, whilst the northern part is occupied by a TV production company.

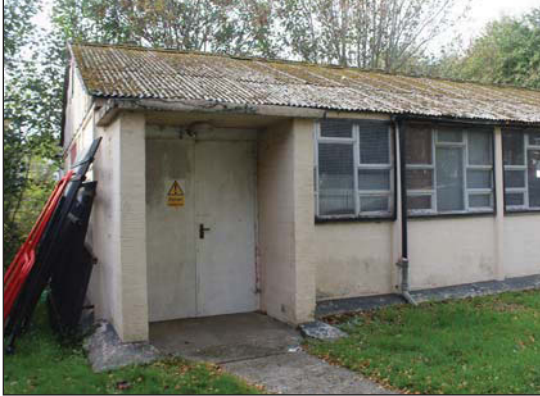
Plate 25. General view of Building E,  
looking South-west.

This building dates from the second half of the 20th century, and is of breeze block and brick construction. It is currently used as a store for the TV production company based nearby in Building D.

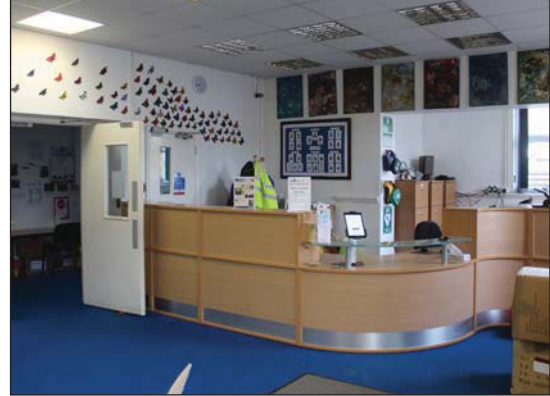
Plate 26. General view of Reception Area A1,  
looking West.

The main entrance to the school leads to a large reception area (A1), from which two offices (A2 and A3) can be accessed. There is a doorway leading to the main corridor (A4) which runs along most of the length of the building. At the western end of this corridor there is a treatment room (A5) and medical supply store (A6), along

Although it is likely that the main corridor (A4) and some of the larger rooms (A7, A8, A9, A14, A16, A17 and A18) may have remained relatively unchanged since the building was built in 1912. In contrast, the northern side of the building has probably seen numerous changes over the years, including the installation of the toilets at some point, as previously there was a separate toilet block to the north of the building. This is also reflected in some of the partition walls in the area around rooms A1, A2 and A3, which seem quite modern additions.

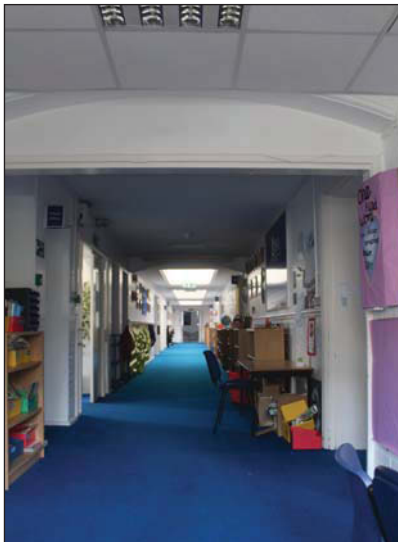
Plate 27. General view of Corridor A4,  
looking South-east.

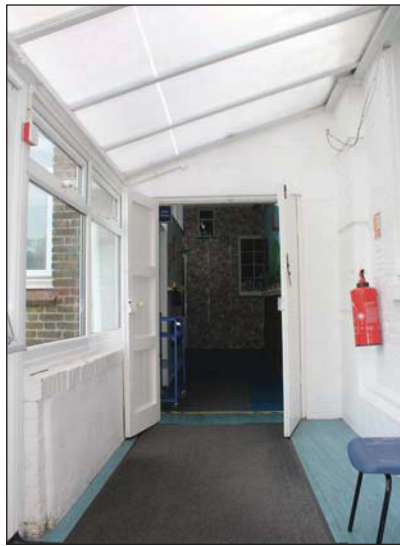
Plate 37. General view of Vestibule A19, looking South-east.

with the Principal's office (A7). Doors along the southern side of the corridor provide access to three classrooms (A8, A9 and A16) and the staffroom (A14). A short corridor leads north from the main corridor towards the fire exit, and also provides access to an office (A10) and the girl's toilets (A11). The staff toilets (A12 and A13) and boy's toilets (A15) are accessed to the north of the main corridor A4, along with a further classroom (A17). At the far eastern end of the corridor is a large room which is used as an assembly hall and gym (A18). A southern door in room A18 provides access to the rear garden and playground areas, whilst a northern door leads into Building B, via vestibule A19.

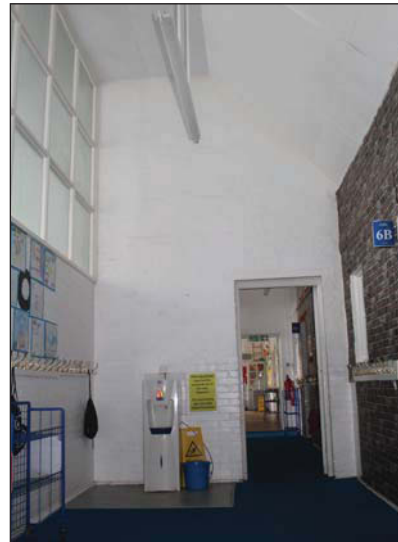
Plate 40. General view of Lobby / Corridor B1, looking North North-east.

At present, the main entrance into this building is via vestibule A19, which leads into a main corridor and lobby area (B1). It seems possible that the original main entrance may have been on the north-west corner of the building, as historic maps show a separate structure here, and there is evidence externally of doors and windows being blocked up in this area. Although the internal layout of the southern part of the building may not have changed that much since it was built, it is clear that the dining hall (B10) and kitchens (B13, B14 and B15) at the northern end of the building are not original features. It is also probable that the girl's (B3) and boys (B11) toilets are relatively modern, as they would have replaced the external toilet block. The main corridor / lobby area (B1) provides access to classrooms B2, B4, B7 and B8, along with Intervention Room (B9). A storeroom (B6) in the south-east corner of the building can be accessed via a corridor (B5) from classroom B4. This corridor also leads to the fire exit. In the north-east corner of the building there is a caretaker's office (B16) and staff toilet (B17).

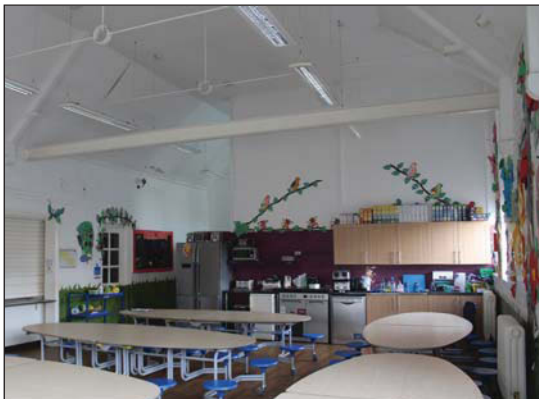
Plate 47. General view of Dining Hall B10, looking South.

The north facing elevation of the building currently has two entrances and two windows, all with red brick lintels above them. The historic maps indicate that this part of the building has been altered in the past, and various changes are clearly visible. A former entrance was blocked up with yellow brick, and there is the surviving brick lintel of a blocked window above it. Another surviving lintel indicates that a further window was blocked up in the north-east corner of the building, above the current doorway into the dining hall (B10).
