**New gas pipeline, St Thomas' Churchyard and
Lybbes Almshouses, Goring-on-Thames, Oxfordshire**

Archaeological Watching Brief

Site Code: TGO 19/09

Report 19/09

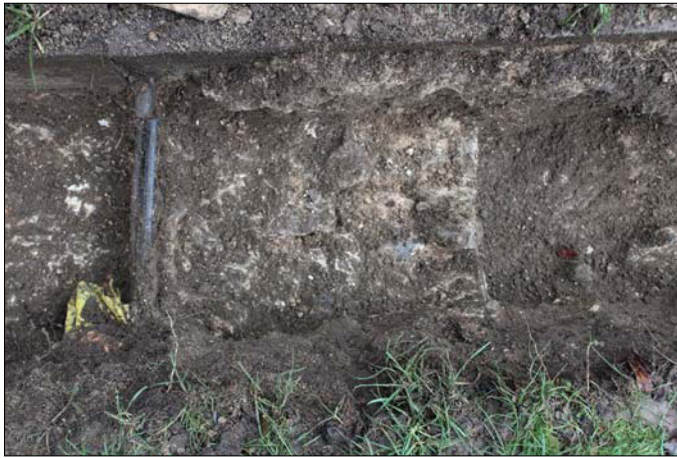
A wall foundation (2) was observed at 6.9m from the southern end of the trench. The remaining wall foundations (53) consisted of mortar with flint inclusions and appears to have been truncated by the churchyard pathway at the northern end of the pipe trench (Pl. 1).

Plate 1. Wall 2 (northern exterior wall), looking east.

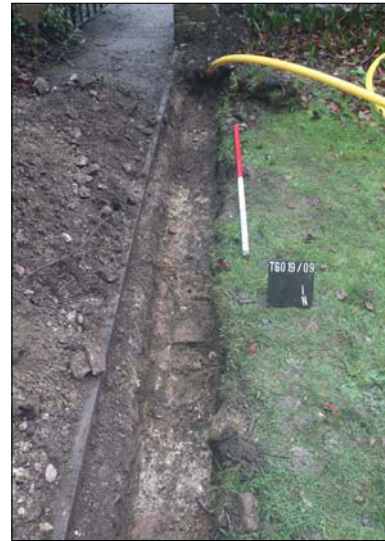
At 1.7m from the southern end of the trench a medieval tiled and mortared surface (52) was observed 2m in length, probably set within an east-west cut (1) (Pl. 2). The tiles recovered from the topsoil probably derived from this surface but this was not conclusively demonstrable. The trench was not excavated deep enough to disturb this surface, which was left *in situ*.

Plate 2. Surface 50, looking south,
Scales: 1m.

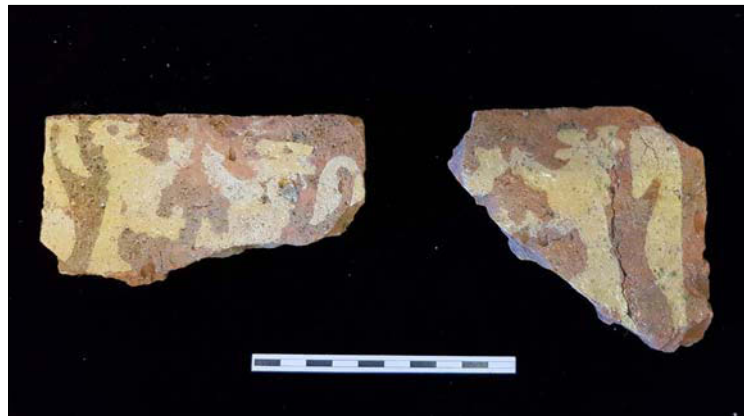
Two partial bi-chrome inlaid tiles were recovered (Pl.3). Both pieces bear the same motif, a pair of lions rampant (Pl. 3). The similarity in pattern is close enough for them to have been produced by the same stamp. The depth of the design (1mm) suggests they are likely to have been produced by the same stamp. The motif is not represented in any of the catalogues consulted, though parallels may exist in assemblages recorded elsewhere and these pieces could potentially be the subject of further research.

Although two-colour inlaid tiles were produced from the 13th century, the method of manufacture and the motif are broadly suggestive of a 14th or 15th century date (van Lemmen 2000). Inlaid tiles of this type were produced in great quantities in the periods in Penn, Buckinghamshire but other production sites are recorded elsewhere.

Plate 3. Glazed floor tiles, from topsoil, Scale: 100mm.
