**Land at The Old Castle Club, Castle Street,
Ludgershall, Wiltshire**

Archaeological Watching Brief

**Site Code: CSL17/99
(SU 2639 5098)**

**An Archaeological Watching Brief
For Wilmont Building Services Ltd**

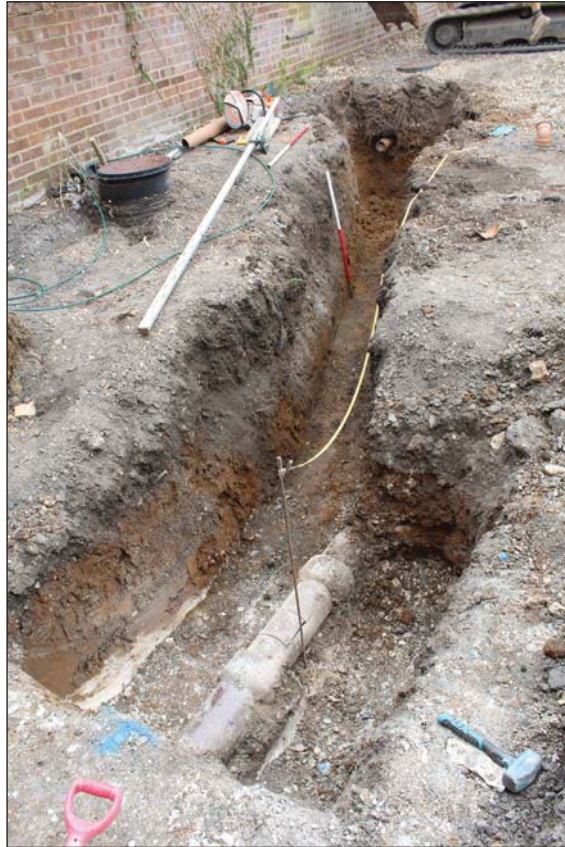
From there, the pipe trench was excavated to the next manhole (MH1: Fig. 3; Pl.1). The pipe trench was 0.45m wide and dug to a depth of 1.1m. Two layers of soil were observed in section, the top layer under 0.25m of site overburden, was a reddish-brown silty clay (52) to a depth of 0.8m. The lower fill was a pale, yellow brown silty clay with occasional chalk inclusions (56). After the excavation of MH1, these layers ended against a steep slope to the base of the overburden with the section showing chalk natural directly under the overburden (Fig. 4). It is thought this represents the edge of a large cut feature (2), probably a quarry pit. No finds were recovered from its fills (fills 52, 56). Two sherds of residual Medieval pottery were recovered from the spoilheap near this location. These however, can only have been derived from the overburden and must be redeposited from elsewhere: no other areas produced this type of pottery from across the site. This feature was at least 3.3m wide and at least 8.5m long across its NW-SE axis and more if it extended beyond to the site to the north-east and east. It is more than 1m deep.

Plate 1. Existing sewer pipe and new diversion to next manhole chamber, with fill in section of large feature (cut 2) cutting chalk, looking south east, Scales: 2x1m.

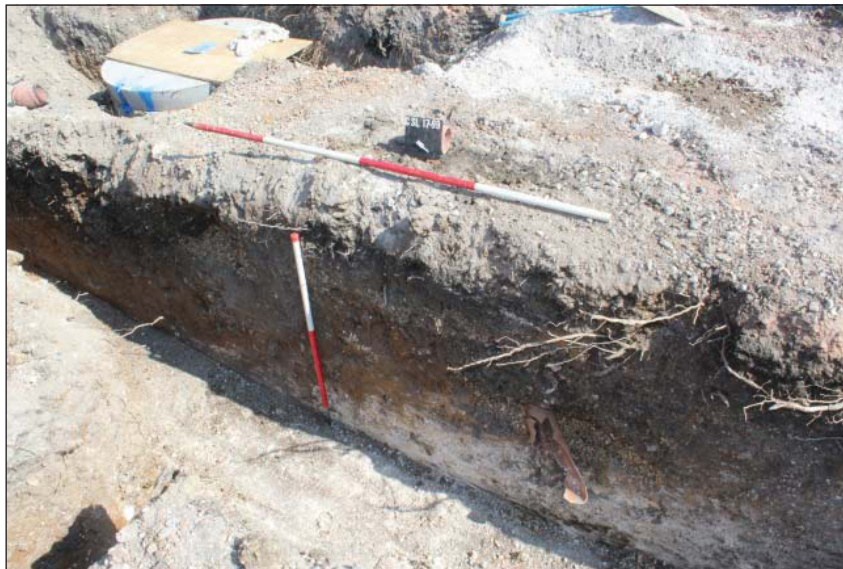
Plate 2. Plot 1 east section, lower fill of feature (cut 2) under overburden, looking north east, Scales: 2m and 1m.

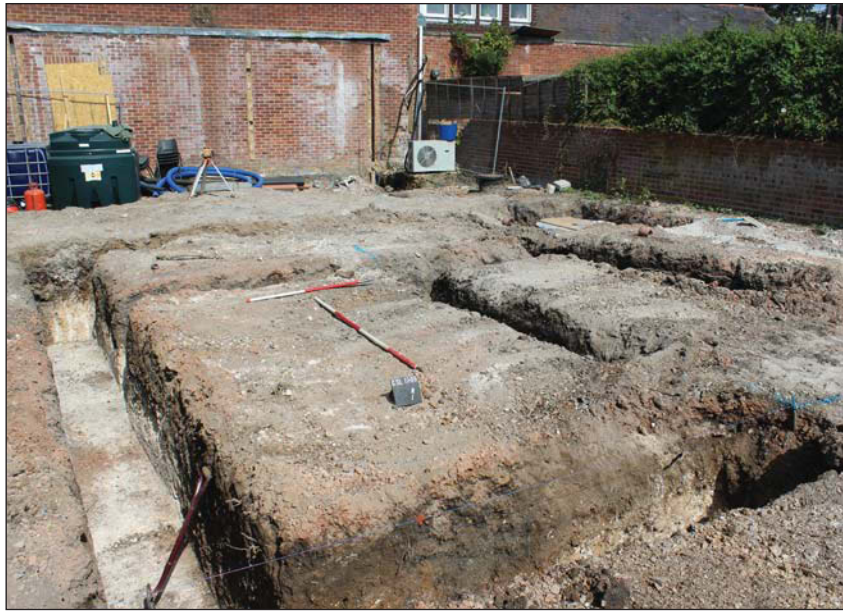
This plot, in the north, was *c.* 8m x 6m in extent, with footing trenches 0.6m wide and generally between 0.9m and 1m deep (Pl. 3). During the excavation, the former sewer pipe was encountered and had disturbed the eastern sections of the footings. Similar fill to that previously seen in the east associated with Cut 2 was recorded in the north-east corner of the plot (fill 52; Pl. 2). No pottery was encountered during excavation here, and only the upper fill of this cut was exposed from the pit’s eastern section under the site overburden. It was 0.88m deep. The final depth of the footing was 0.95m, with generally no disturbance of the natural on the north-west side. All sections showed a remnant of homogenous soil dumped from recently disturbed parts of the site. This was 0.25m deep and in turn overlay the overburden (51). The total depth combined was 0.49m. Under the western section, chalk natural was exposed to the depth of excavation.

Plate 3. Plot 1, looking north north east, Scales: 2m and 1m.

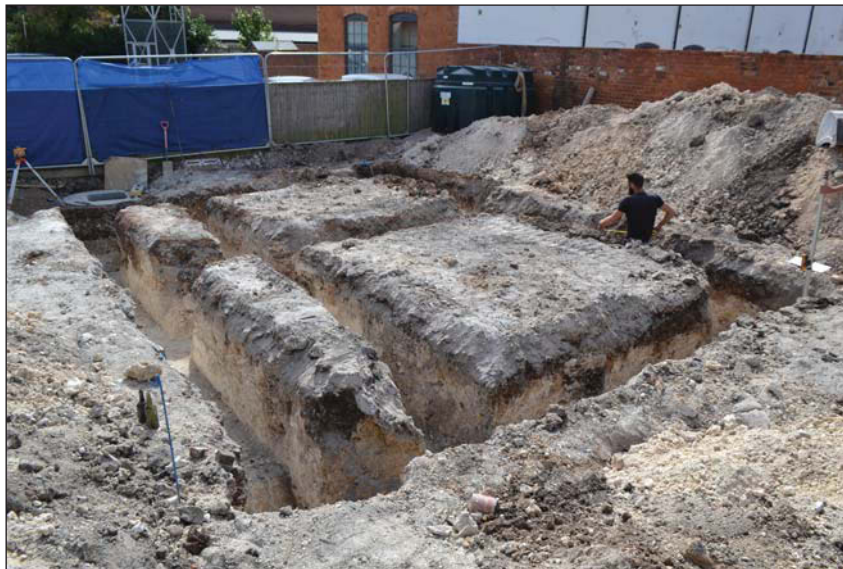
This plot was to the south, and was similar in dimensions to Plot 1 (Pl. 4). The depth of excavation was also similar to Plot 1, with the deepest part of the excavation in the south-west, and against the western section (1.15m deep). Due to this the whole area from the western section of the plot to the western side of the site was reduced by 0.35m (Fig. 3). No chalk natural nor finds of interest were encountered during this. Once the footing trench reached the north-east corner of Plot 2, the course of the pre-existing pipe trench was encountered and dug through. In the centre of the plot the old pipe trench cut through a shallow pit in its eastern side. It was however, not of archaeological interest as it contained bits of modern plastic, pottery and CBM.

Plate 4. Plot 2, looking south south west.

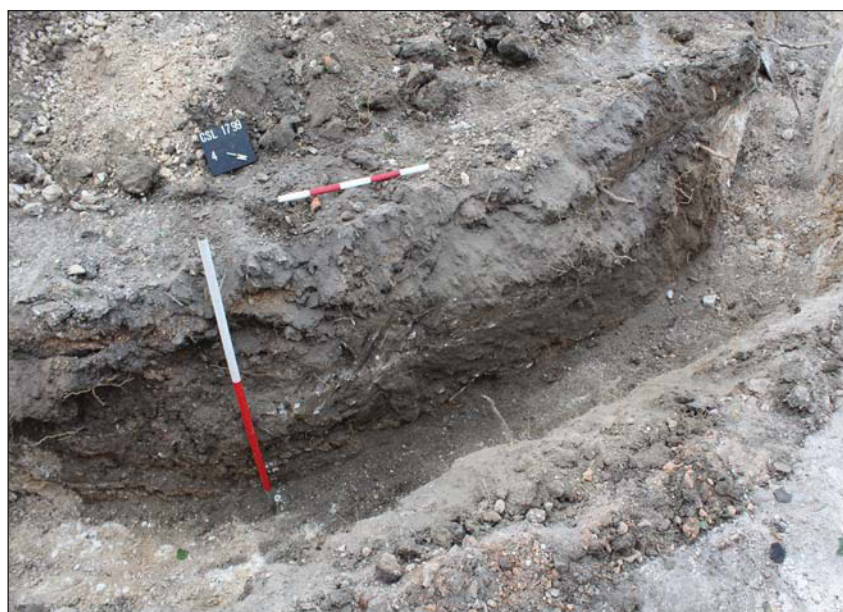
Behind No. 9 Castle Street, in the east of the site, a pit (4) (Fig. 4; Pl.5) was recorded in the NE facing section. This was a 3m wide pit with the base of excavation recorded at 0.7m deep. It had a flattened base and the sides were near vertical. It contained an homogenous fill (57) of chalk and dark grey sandy silt with dark brown lumps of clayey silt with CBM. Post-Medieval pottery was recovered from the fill. The trench roughly passed through its centre.

Plate 5. Service trench, pit 4, looking west, Scales: 1m and 0.5m.

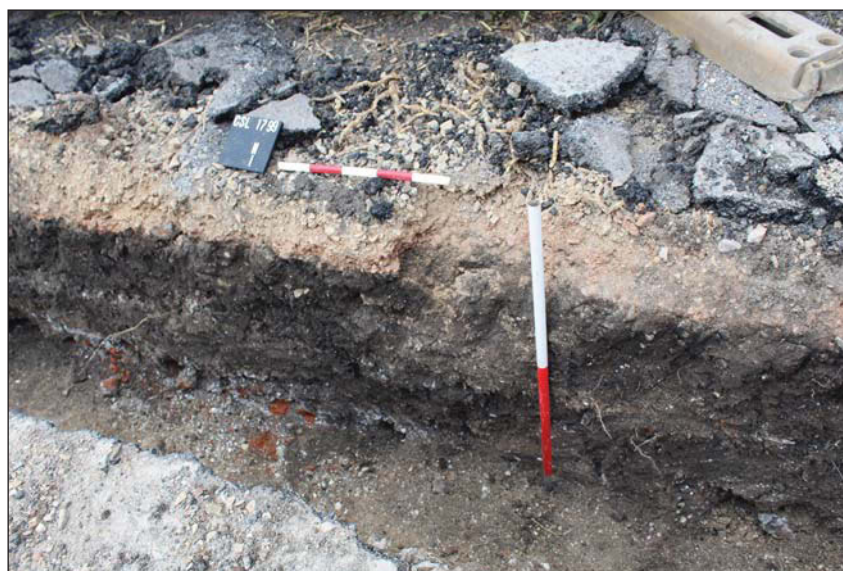
disturbed by the new trench. This cut from the base of the upper fill (59) (Pl. 6; Fig. 4). The lower layer (58) covered the base of excavation beyond the full depth excavated of 0.87m deep. The upper layer (59) was a yellowish grey brown clayey silt, and contained pottery. The lowest exposed layer was a chalk-flecked, grey brown silt with occasional CBM and charcoal inclusions (58). Due to the projected size of this feature (Fig. 3), it would have extended under the site boundary to the north and under the extant location of the rear of No. 7, and was also likely to extend further to the south. Pottery recovered from these fills was Post-Medieval in date.

Plate 6. Service trench overburden cutting deposits of pit 5 and exposed layer 58, looking north north west: Scales, 1m and 0.5m.
