**56 High Street, Southampton,
Hampshire**

Building Recording

Site Code: HSS19/29

April 2019

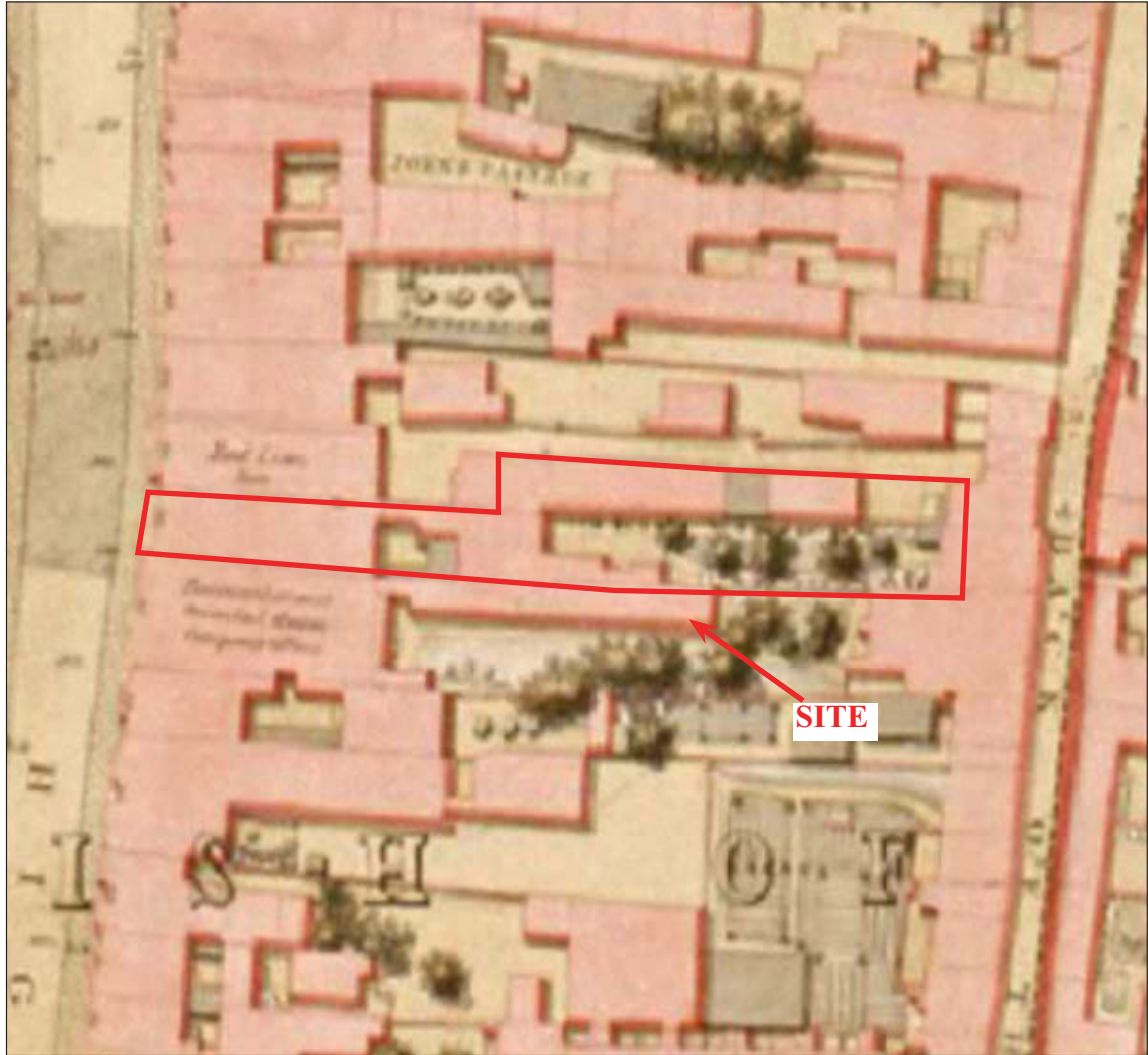
The first available map showing building detail is the 1846 map of Southampton (Fig. 2), which shows 56 High Street as clearly identifiable between the labelled Red Lion and Post Office. The exact detail is less clear and the boundaries have changed, with the current building plot extending into the outbuildings to the rear of the Red Lion and into the garden area of the buildings to the rear of Back of the Walls. The building fronting the High Street consists of an approximately rectangular building, approximately the same length as the adjacent

Red Lion. An internal courtyard is then present to the east before the building continues with a staggered rear, possibly indicating several small buildings.

**56 High Street, Southampton,
Hampshire, 2019
Building Recording**
Figure 2. Map of Southampton, 1846.

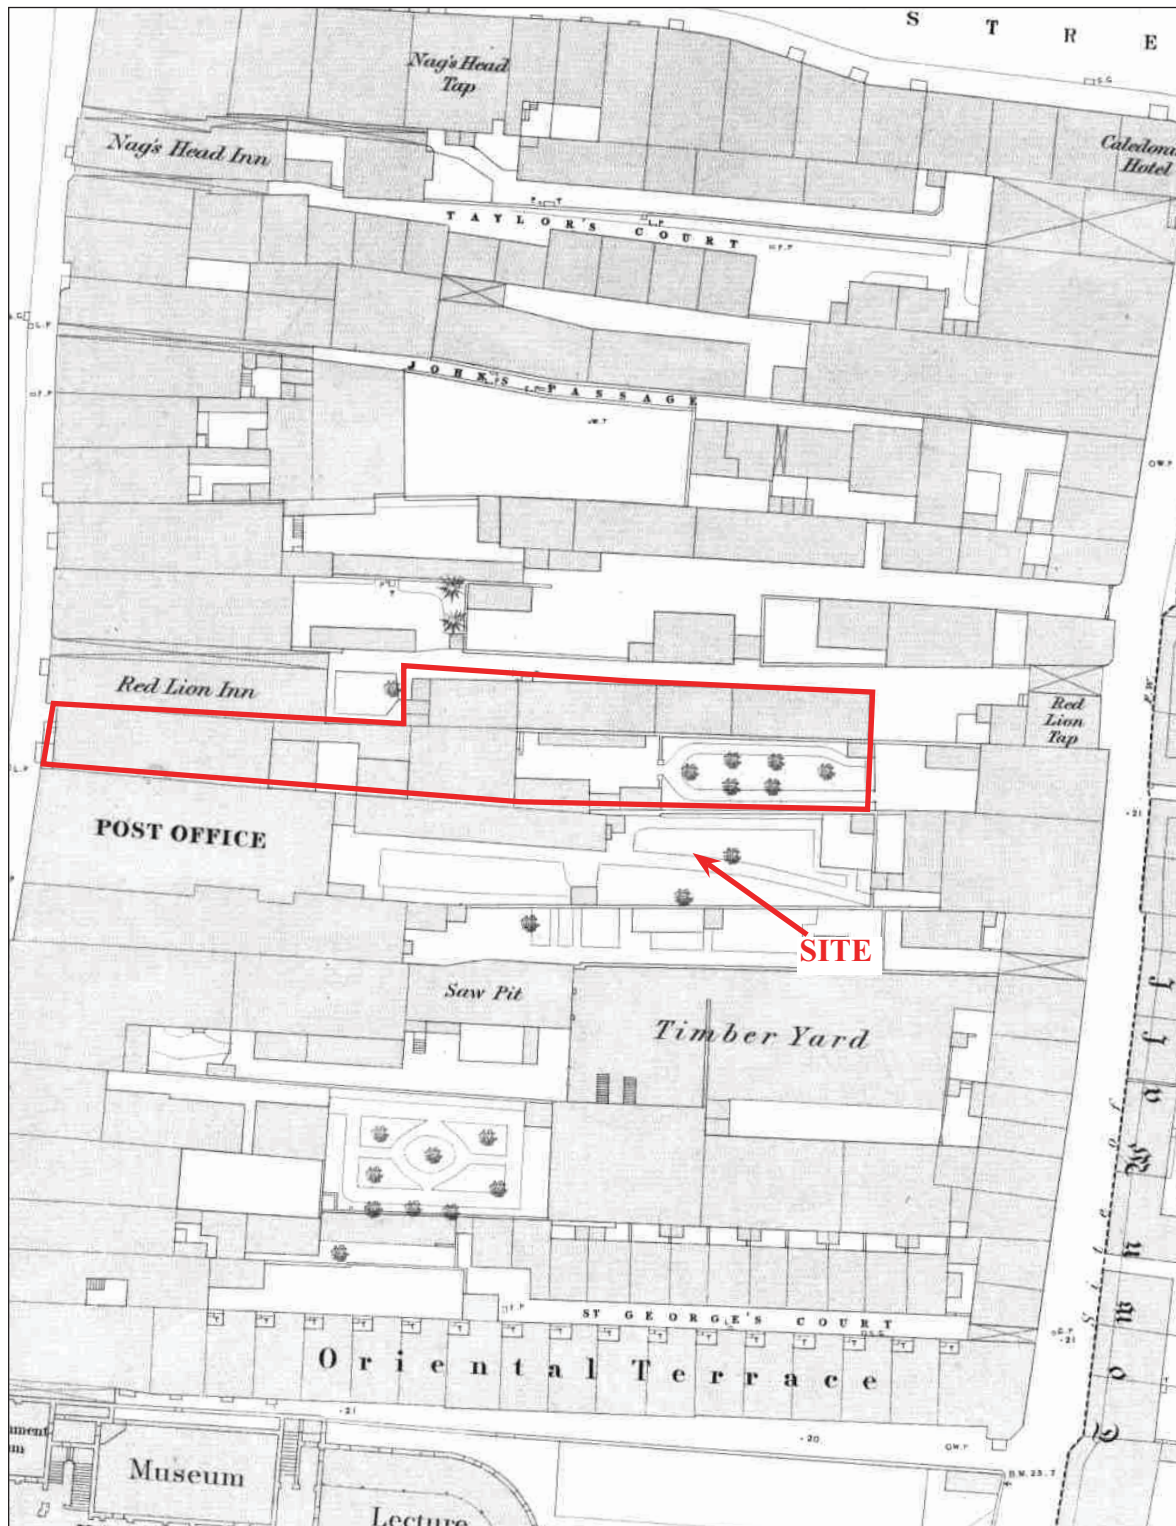
The next available map is the 1870 Royal Engineers Map of Southampton (Fig. 3) which shows more detail. It can be seen that the building frontage is set back from the street elevation, with perhaps a canopy or porch shown as well as a probable cellar access at the south end of the building frontage. The modern property boundary can clearly be shown to contain a number of different buildings spread across several plots consisting of; the main building fronting the High Street, three buildings around an internal courtyard, an approximately square building the width of the historic plot, three buildings on the south side of the boundary and two on the north side of the boundary of the Back of the Walls plot around a garden area and seven outbuildings of varying sizes within the Red Lion plot.

56 High Street, Southampton,
 Hampshire, 2019
 Building Recording
 Figure 3. Map of Southampton, 1870.

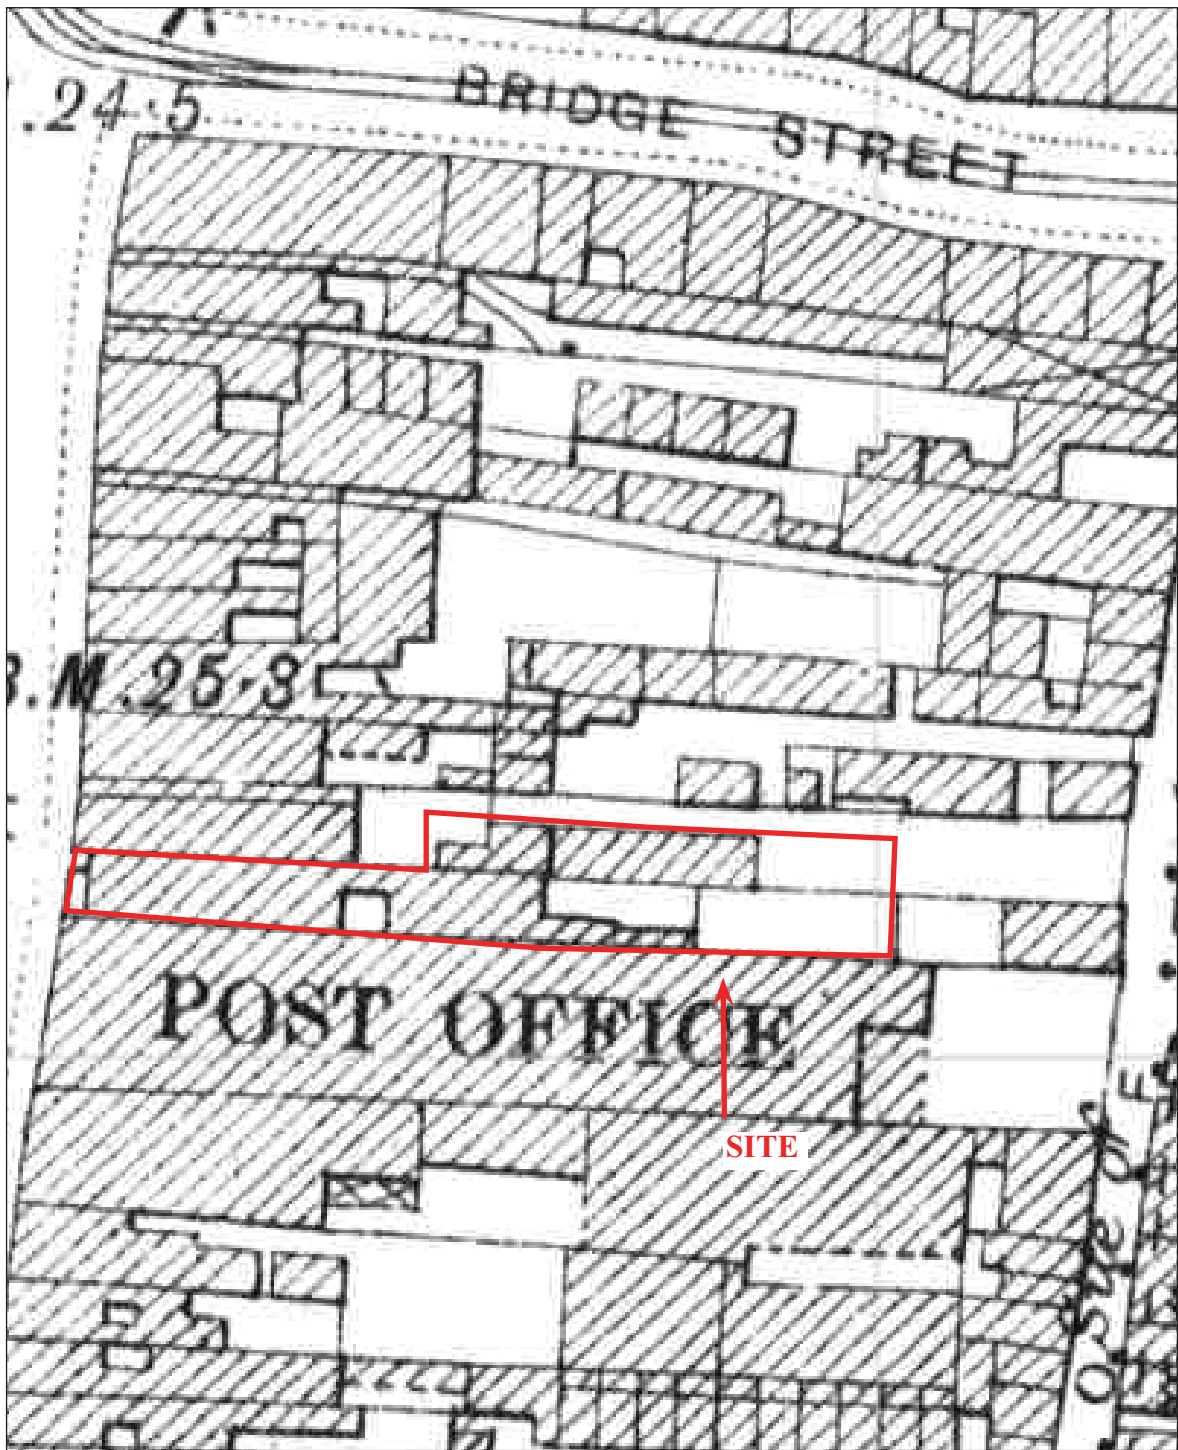
The next available map of 1897 (Fig. 4) shows less detail of the buildings though they are broadly the same as in 1870, except that the northern range is shorter. Some kind of boundary is now present in the same position as the modern-day boundary at the west end of the site to the rear of 56 High Street.

56 High Street, Southampton,
Hampshire, 2019
Building Recording
Figure 4. Ordnance Survey, 1897.

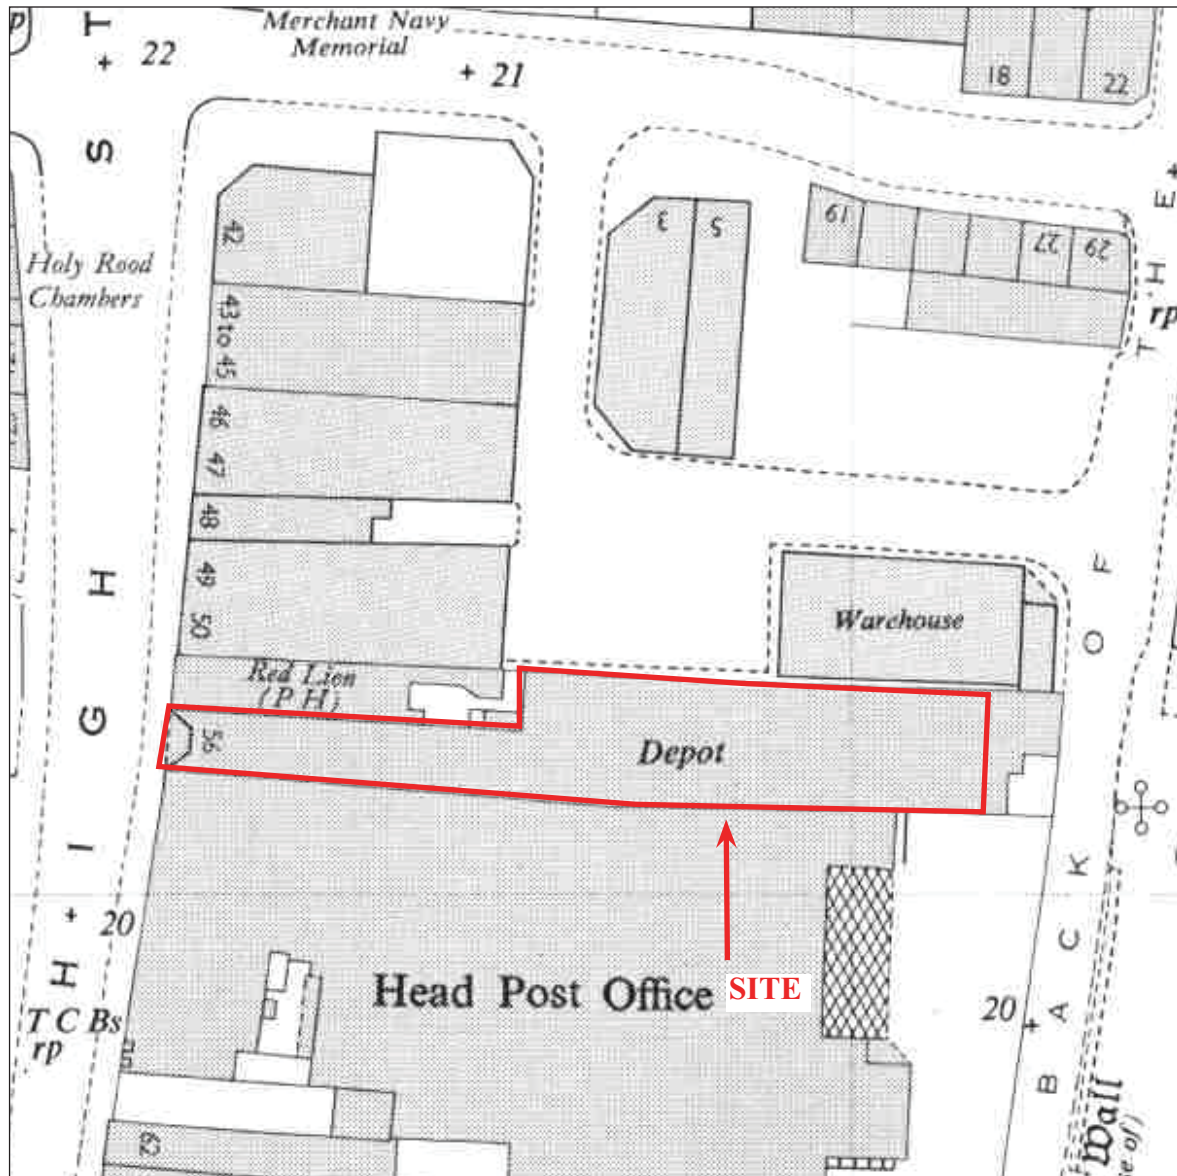
High Street bomb to have destroyed the shop frontage on the ground floor and taken out the windows on the upper floors. Little has changed within the maps by 1952 (Fig. 8); the building to the rear is labelled as a *depot* whilst another from the same year labels it as a *Wholesale Fruit and Vegetable Market* and has the plot boundary dashed where it lies within the building. The shop frontage is indicated as having a recessed porch.

56 High Street, Southampton,
 Hampshire, 2019
 Building Recording
 Figure 8. Ordnance Survey, 1952.

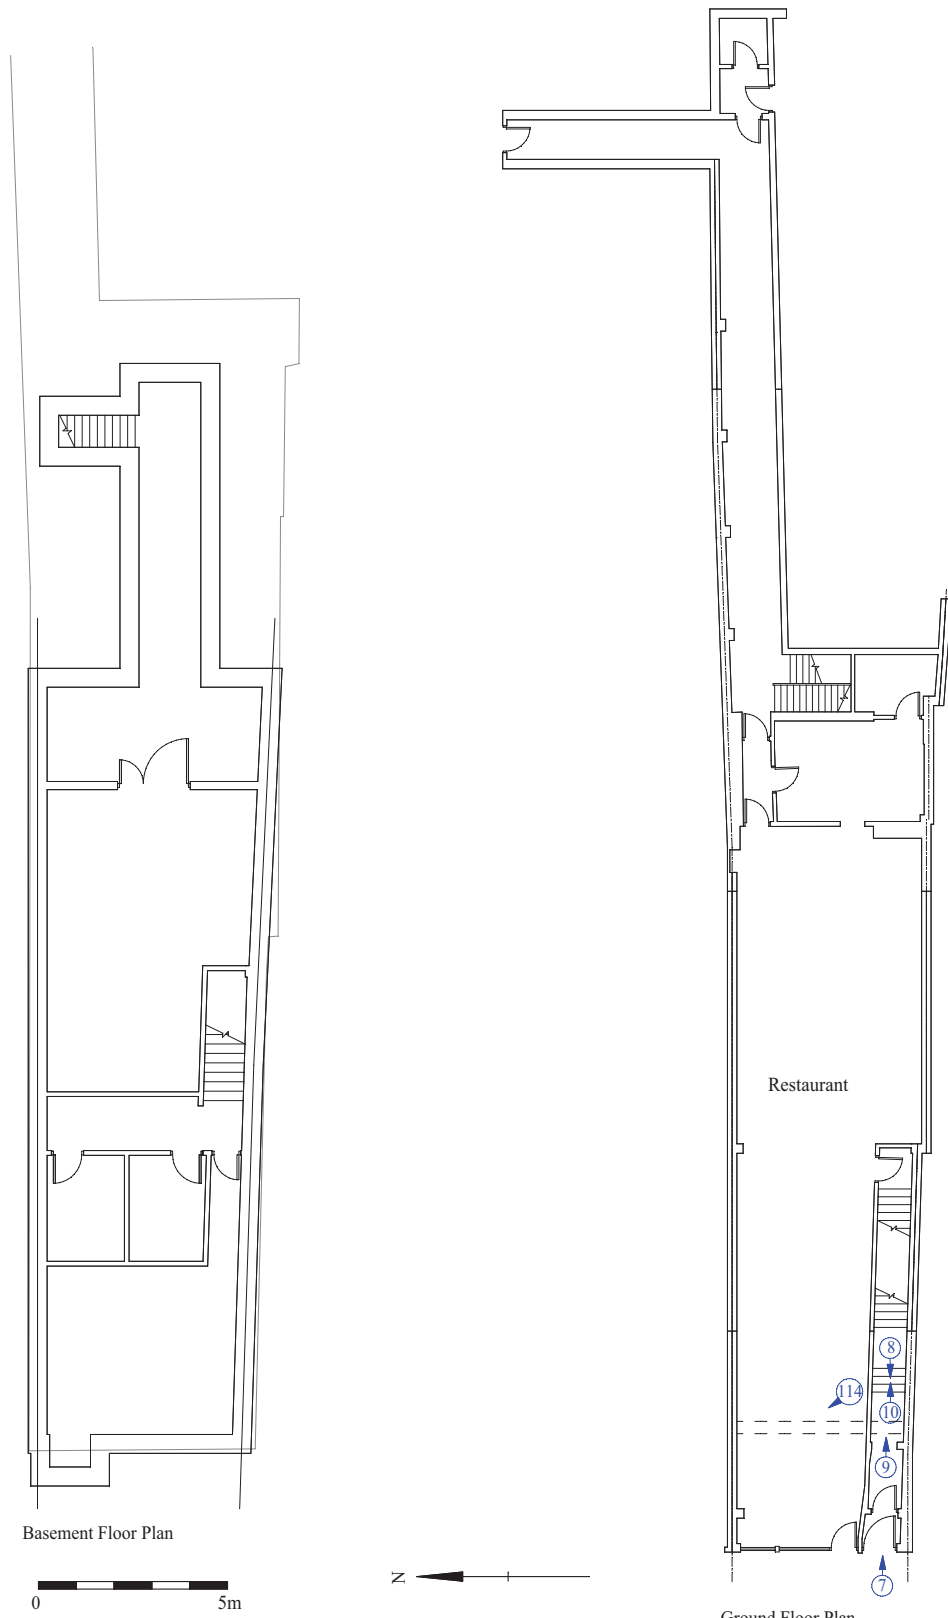
Figure 11. Basement and Ground floor plan (not to scale) showing locations and directions of view of photographs.

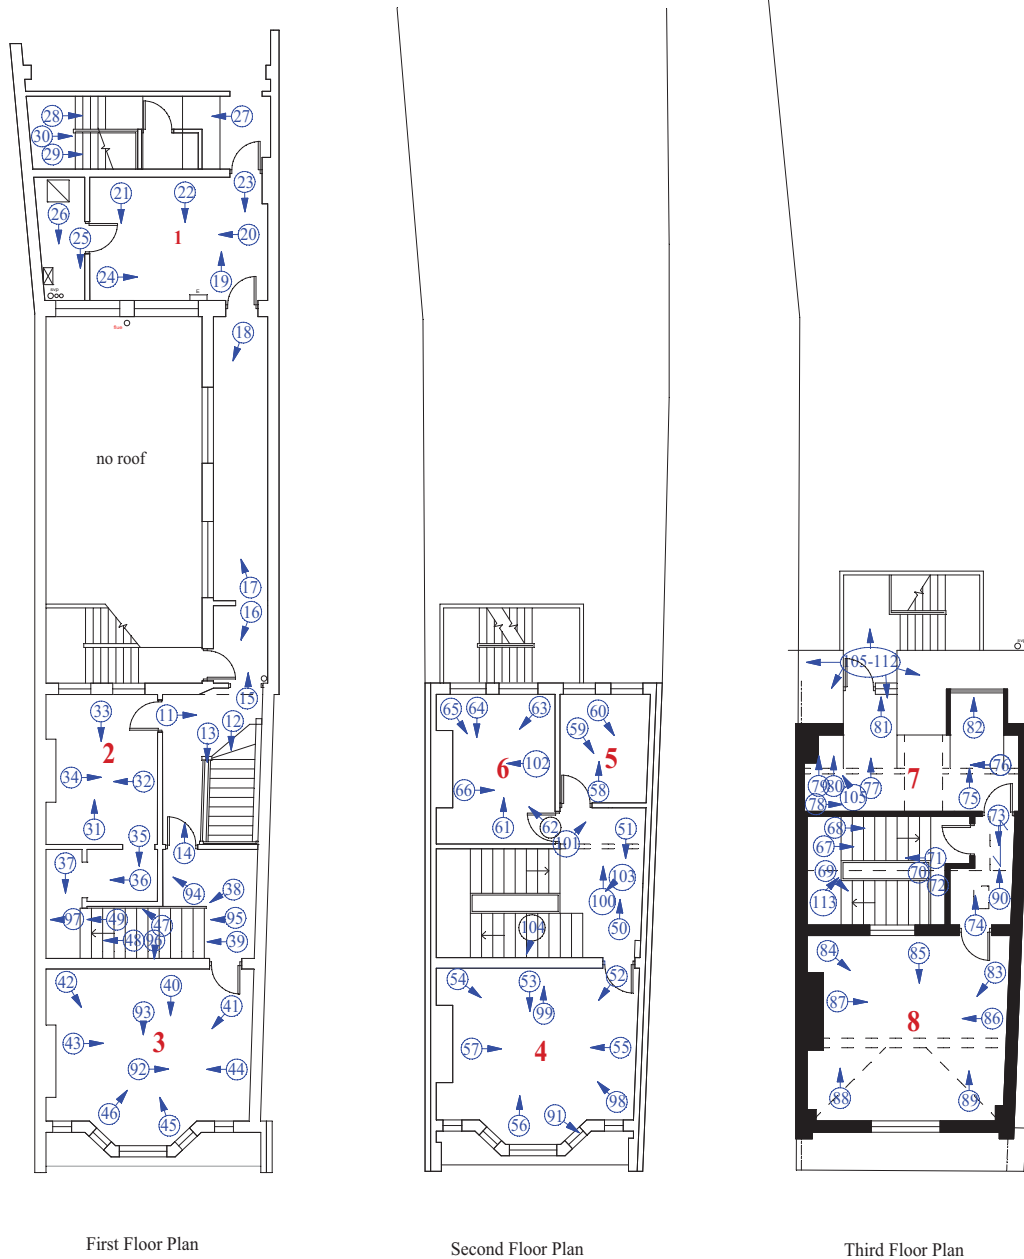
Figure 12. First, second and third floor plans showing locations and directions of view of photographs.

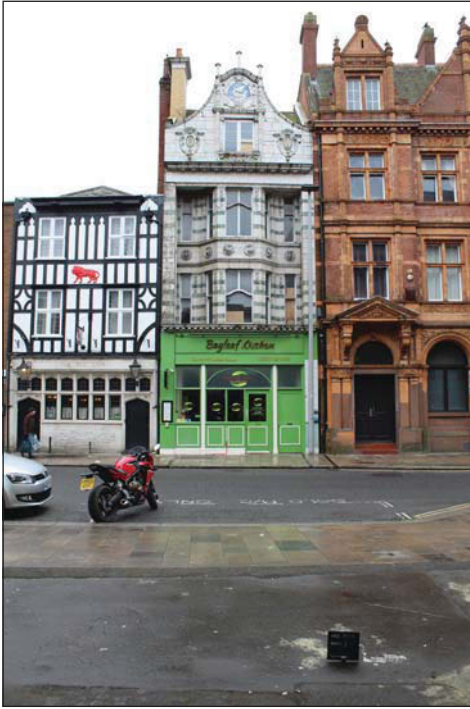
The front (west) elevation, fronting onto the High Street is the most ornate of the three visible elevations (Pl. 1, Fig. 10). It consists of the ground floor with an additional three stories above and a cellar below, access to which is present in the pavement at the north end of the elevation via a pair of metal covers. The ground floor (Pl. 2) is now the entrance to the Bayleaf Kitchen Indian Restaurant with separate access to the upper floors via a door at the south end of the elevation. The ground floor section is divided into three unequal sections, mirroring that above, divided by slim pilasters. The south section consists of the door to the upper floors with a window above,

the central section consists of the door to the restaurant and two windows with a large window above and the north section consists of a further window with a window above. A frieze is present above the whole with the restaurant signage. The ground and first floor are separated by a moulded cornice.

Plate 1. General shot of High Street elevation, looking East, Scales: 1m and 1m.

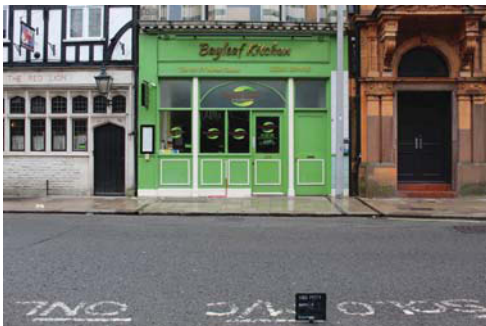
The upper floors of the building (Pl. 3) are clad in Doulton Carraraware tiles in white and grey, a popular style in the early 20th century. The first and second floors are of the same style of build, set within a rectangular frame consisting of the moulded cornice at the bottom, a plain pillar of tile on either side, and an architrave above. The windows within the first and second floors consist of a central, canted bay window with a tall, narrow window on either side. They are sash windows with horns and horizontal glazing bars, with the exception of the large central windows which have a curved glazing bar (Pl. 4). The second-floor window has an additional vertical glazing bar that is missing on the first floor. These windows are all of post-WWII date; the originals having been blown out by the nearby bomb blast. Between the first and second floor is a decorative frieze with a moulded string course above and below. Set within the frieze are six moulded roundels (Pl. 5) with images of fruit on a blue background, set beneath each of the window lights. From the north they consist of; a pineapple, a bunch of bananas, a bunch of grapes, a bunch of bananas, a bunch of grapes and a pineapple (Pls 6-10). The windows are enhanced with alternating courses of grey and white tiles and the top lights of the windows are further enhanced with dangling bunches of floristry and fruits (Pl. 4). Between the second and third floor is a moulded cornice.

Plate 3. 1st and 2nd floor, High Street elevation, looking east

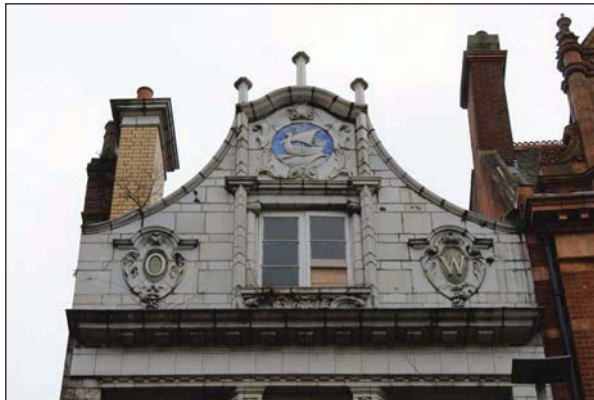
The third floor (Pl. 11) is set within a Flemish style gable with a single, central window. The window itself consists of two lights in the casement style. On either side of the window is the letters *O* (Pl. 12) and *W* (Pl. 13) (for Oakley and Watling) framed within leaves and set beneath a moulded hood. Above the window is a roundel containing a depiction of a Southampton hulk on a blue background (Pl. 14). Above the roundel and parapet are three short 'flag poles'. The roof itself is not visible behind the parapet.

Plate 11. Third floor detail of High Street elevation, looking east

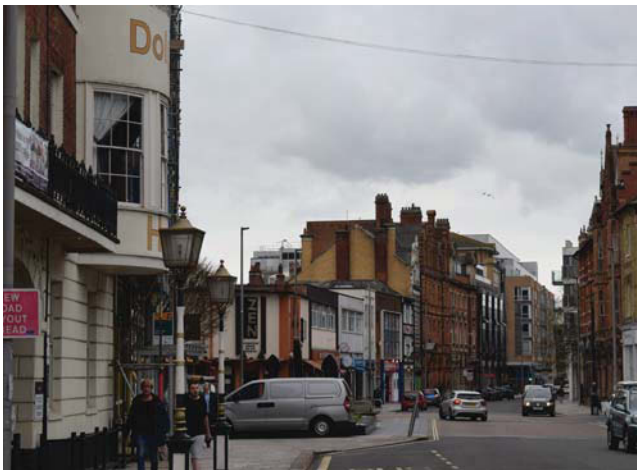
Of the north elevation (Pl. 15), only the third-floor area is visible above the roofline of the Red Lion Pub. The wall itself is built in buff coloured brick, possibly the London stock brick of that colour, laid in Flemish bond. A pair of chimneys are present either side of the ridge line. The front edge of the roof, and the top of the front chimney, are capped in Carreraware tiles. The rear chimney has a stone cap.

Plate 15. North gable wall, facing S.

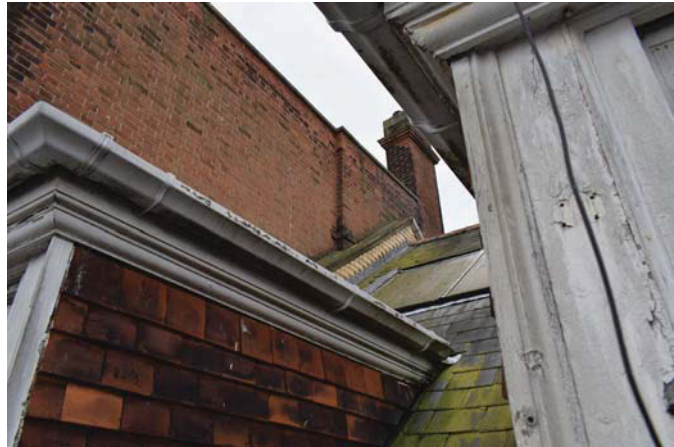
Only the north face of the south elevation is visible above the height of the roofline and can be seen to be the same as that of the north elevation; of yellow brick capped in stone at the rear and Carraraware tiles at the front (Pl. 18).

Plate 18. South gable detail. SW facing

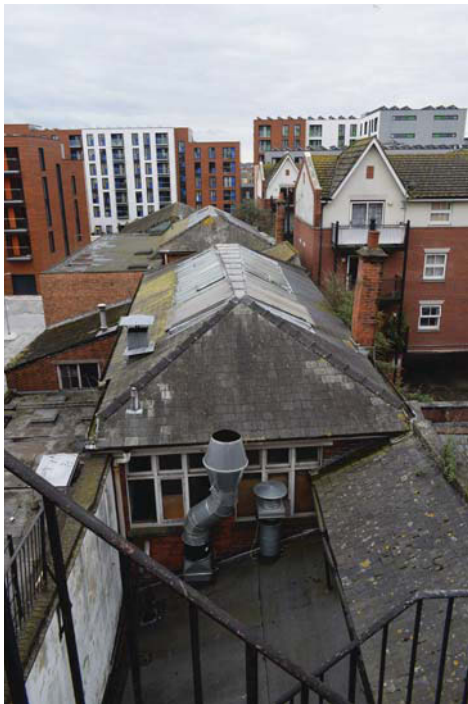
The link walkway (Pl. 19) between 56 High Street proper and the warehouse was located up against the southern plot boundary. It was two storeys high beneath a single pitched roof, covered in slate tiles. The only external elevation (north) was not visible on the day of the survey.

The warehouse building (Pl. 19) which occupies the rear of the plot is rectangular in plan form, two storeys high with a hipped roof covered in slate tiles. Along the ridgeline are a series of skylights. Only the first floor of the west elevation is visible, showing two tri-partite windows set within a Flemish bond red brick wall.

Plate 19. Warehouse roof detail .
E facing

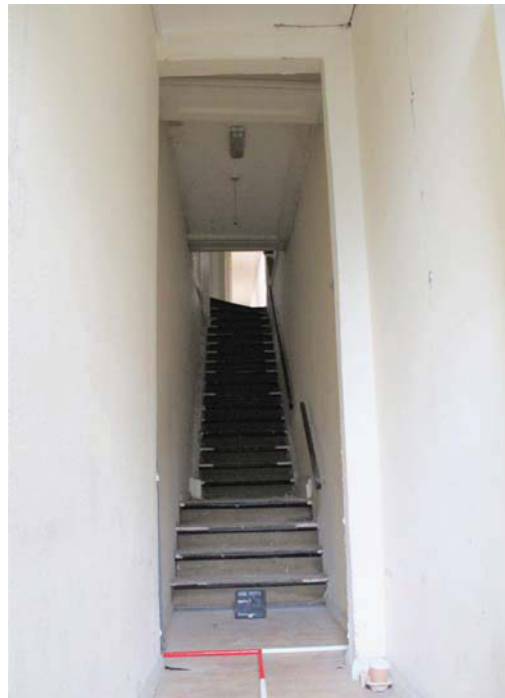
The ground floor access consisted of a small entrance lobby with an internal door that gave access to the corridor leading to the stairs (Pl. 20). The internal door was modern with two large panes of glass to provide natural light. The walls were plastered white and the floor was covered in linoleum. The stairs were located beyond a structural beam and pillar and consisted of a straight flight up to the first floor. The flight was broken by a small landing, four steps up, indicating the change between the original staircase and the lower section inserted in 1973 to create a separate access to the upper floors. This alteration can be seen in both the change in skirting board and in the coving round the ceiling and boxed in beam which continues through the wall into the restaurant area (Pl. 21). The stairs give access to a small landing area.

Plate 20. Ground floor corridor. Stair detail.
E facing.

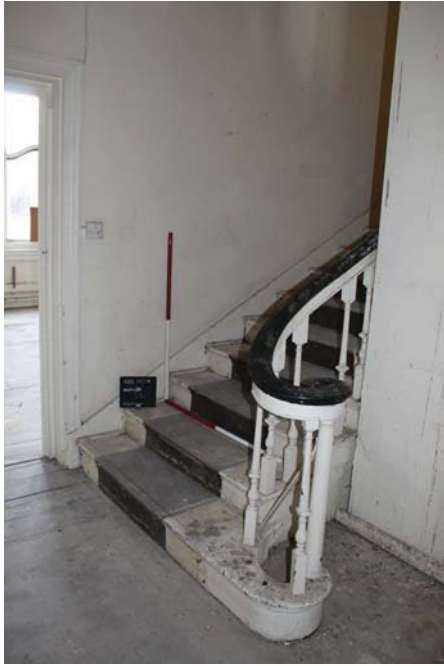
Stairs to the second floor are located through the fire door beneath the arch (Pl. 31). The staircase is dog-legged with a half-landing between each floor. The stairs have an open tread, the detail of which has been obscured by the insertion of a later wall beneath the return flight. The bannister rail consists of dark wood finished in a spiral, typical of the Regency period and supported by turned balusters painted white.

Plate 31. First floor corridor, stair detail, looking north-west.

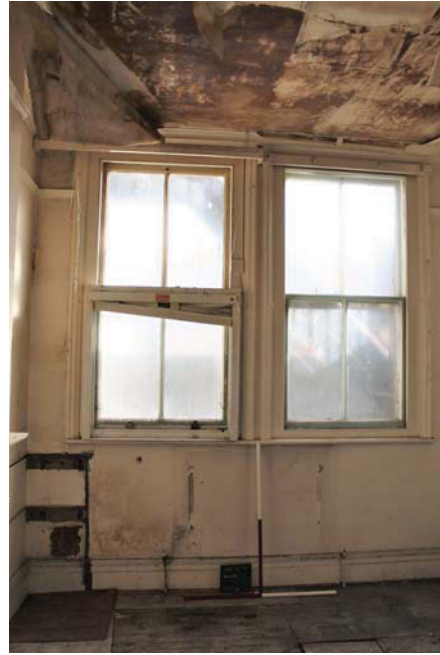
Room 2 is located at the rear of the building with two windows in the east wall (Pl. 32). The room itself has bare floorboards, white painted plaster walls and a lath and plaster ceiling. Around the walls is a moulded skirting board, a picture rail and moulded coving at ceiling height. The door frames within the south and west walls have ovolo moulding. Centrally, within the north wall is a chimney breast containing a cast iron fireplace typical of the Edwardian period (Pl. 33). The door in the west wall leads to a small box room that has been built beneath the main staircase at a later point and consists of plain plaster walls with a sloped ceiling and modern skirting board (Pl. 34). It leads to the original understairs cupboard, located beneath the half-landing. The doors to this cupboard have been removed but a wooden panel remains on the east side (Pl. 35). The ceiling within this cupboard is of painted boards.

Plate 32. Room 2, view to window, looking east.

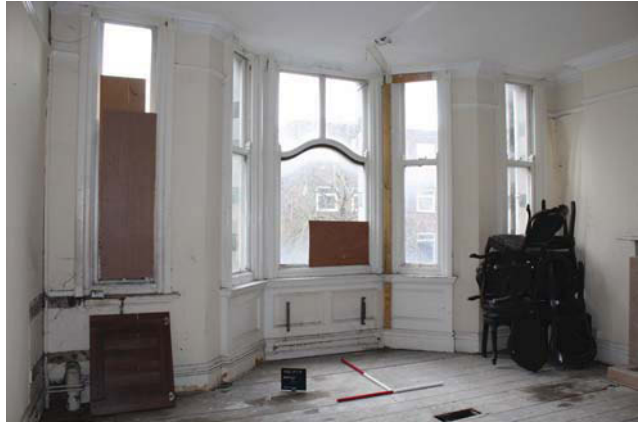
Room 3 is located at the front of the building and is the principal room on the first floor. It is accessed via a door adjacent to the stairs to the second floor. The original door has been replaced. In general the room has plaster walls, a lath and plaster ceiling and floorboards. Around the walls is a moulded skirting board, a picture rail and moulded coving. Entrance to the room is in the south-east corner, and neither the south or east walls contain any other features. The west wall contains the windows overlooking the High Street with a canted bay

Plate 36. Windows, room 3, looking north-west.

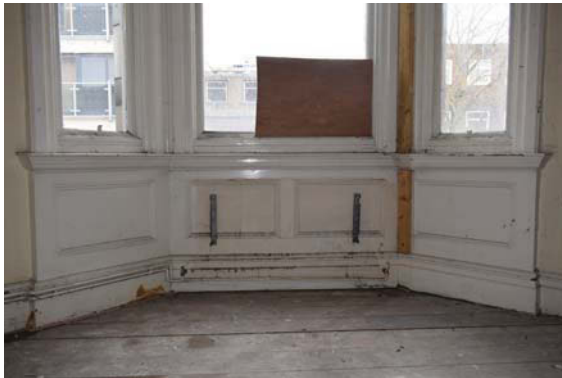
(Pl. 36). Beneath the windows in the bay are three moulded wooden panels, painted white (Pl. 37). Located slightly off centre, within the north wall, is a large chimney breast containing a small, tiled fireplace (Pl. 38). The fireplace form is typical of the Art Deco period. It is possible to see within the wooden floorboards that this has replaced an earlier, larger fireplace.

Plate 37. Detail of window panel, room 3,
looking west.

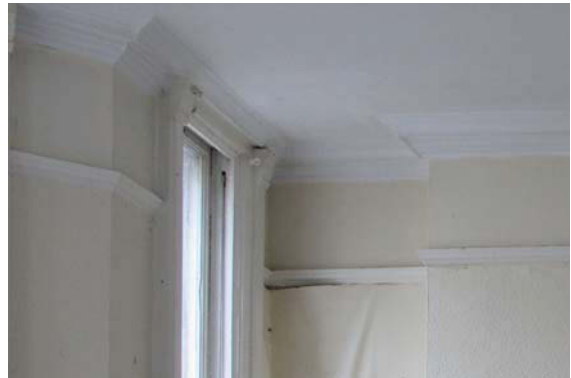
Plate 38. Room 3, fireplace detail, looking north.

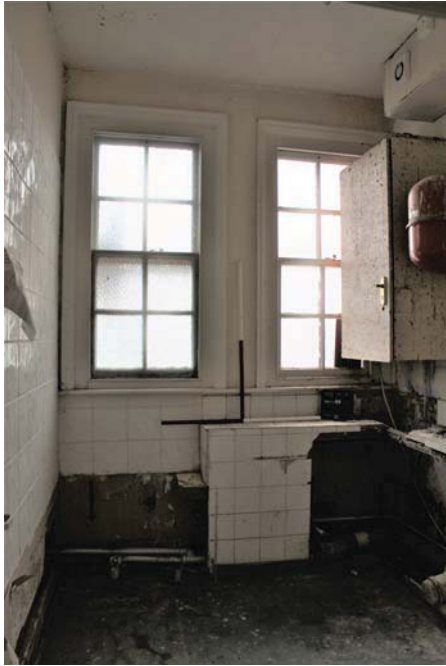
Room 5 is located in the south-east corner of the building. Within the east wall is a pair of windows overlooking the rear of the building (Pl. 43). The room itself is fairly small and has been stripped of any former coving and picture rails etc on the north, east and south walls and replaced with tiles. The picture rail and skirting board are still present on the west wall containing the door. Above the door is a blocked internal window which can be partially seen from the hallway (Pl. 44).

Plate 43. Room 5, looking east to windows.

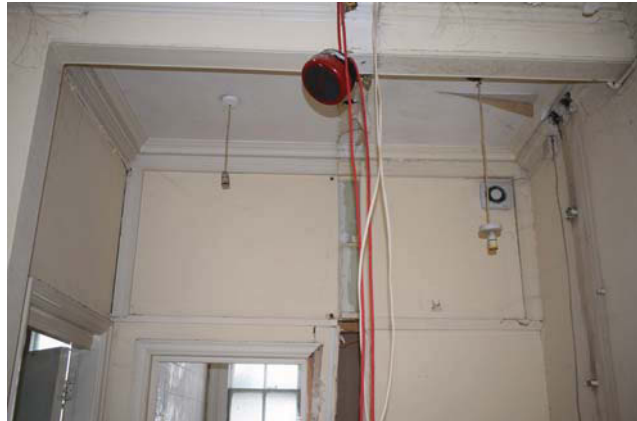
Plate 44. Second floor corridor, looking east to blocked window.

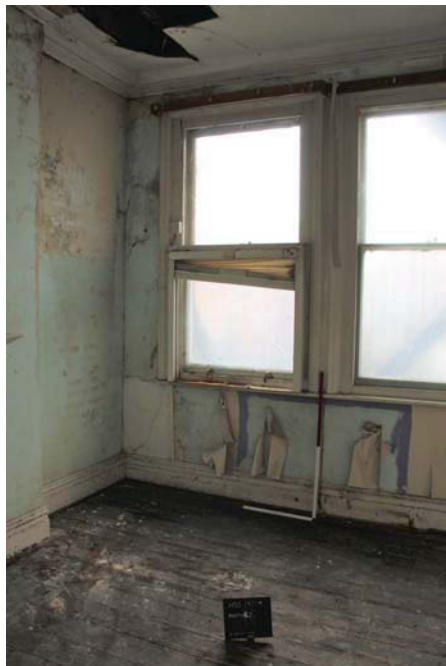
Room 6 is located in the north-east corner of the building, above room 2. Within the east wall two windows overlook the rear of the building (Pl. 45). The picture rail has been removed, but the coving and skirting board are still present. Within the north wall is a central chimney breast containing a cast iron fireplace identical to the ones in rooms 2 and 4. The hearth consists of small green tiles identical to those within the surround (Pl. 46).

Plate 45. Room 6 looking north-east to windows.

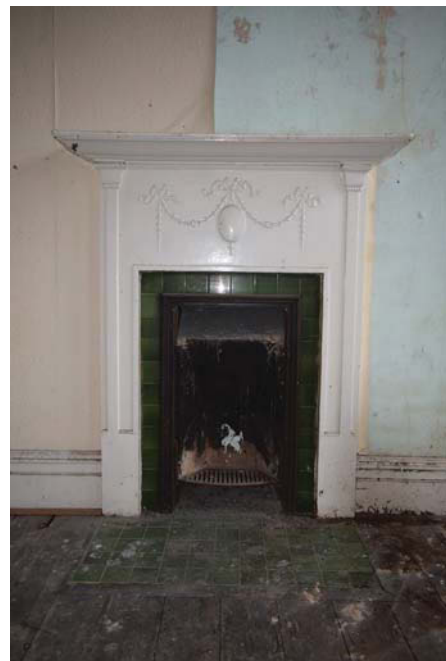
Plate 46. Room 6, looking north to fireplace.
