**Bloom Buildings, West End,
Cholsey, Oxfordshire**

Archaeological Watching Brief

Site Code: BWC16/207

(SU 5808 8592)

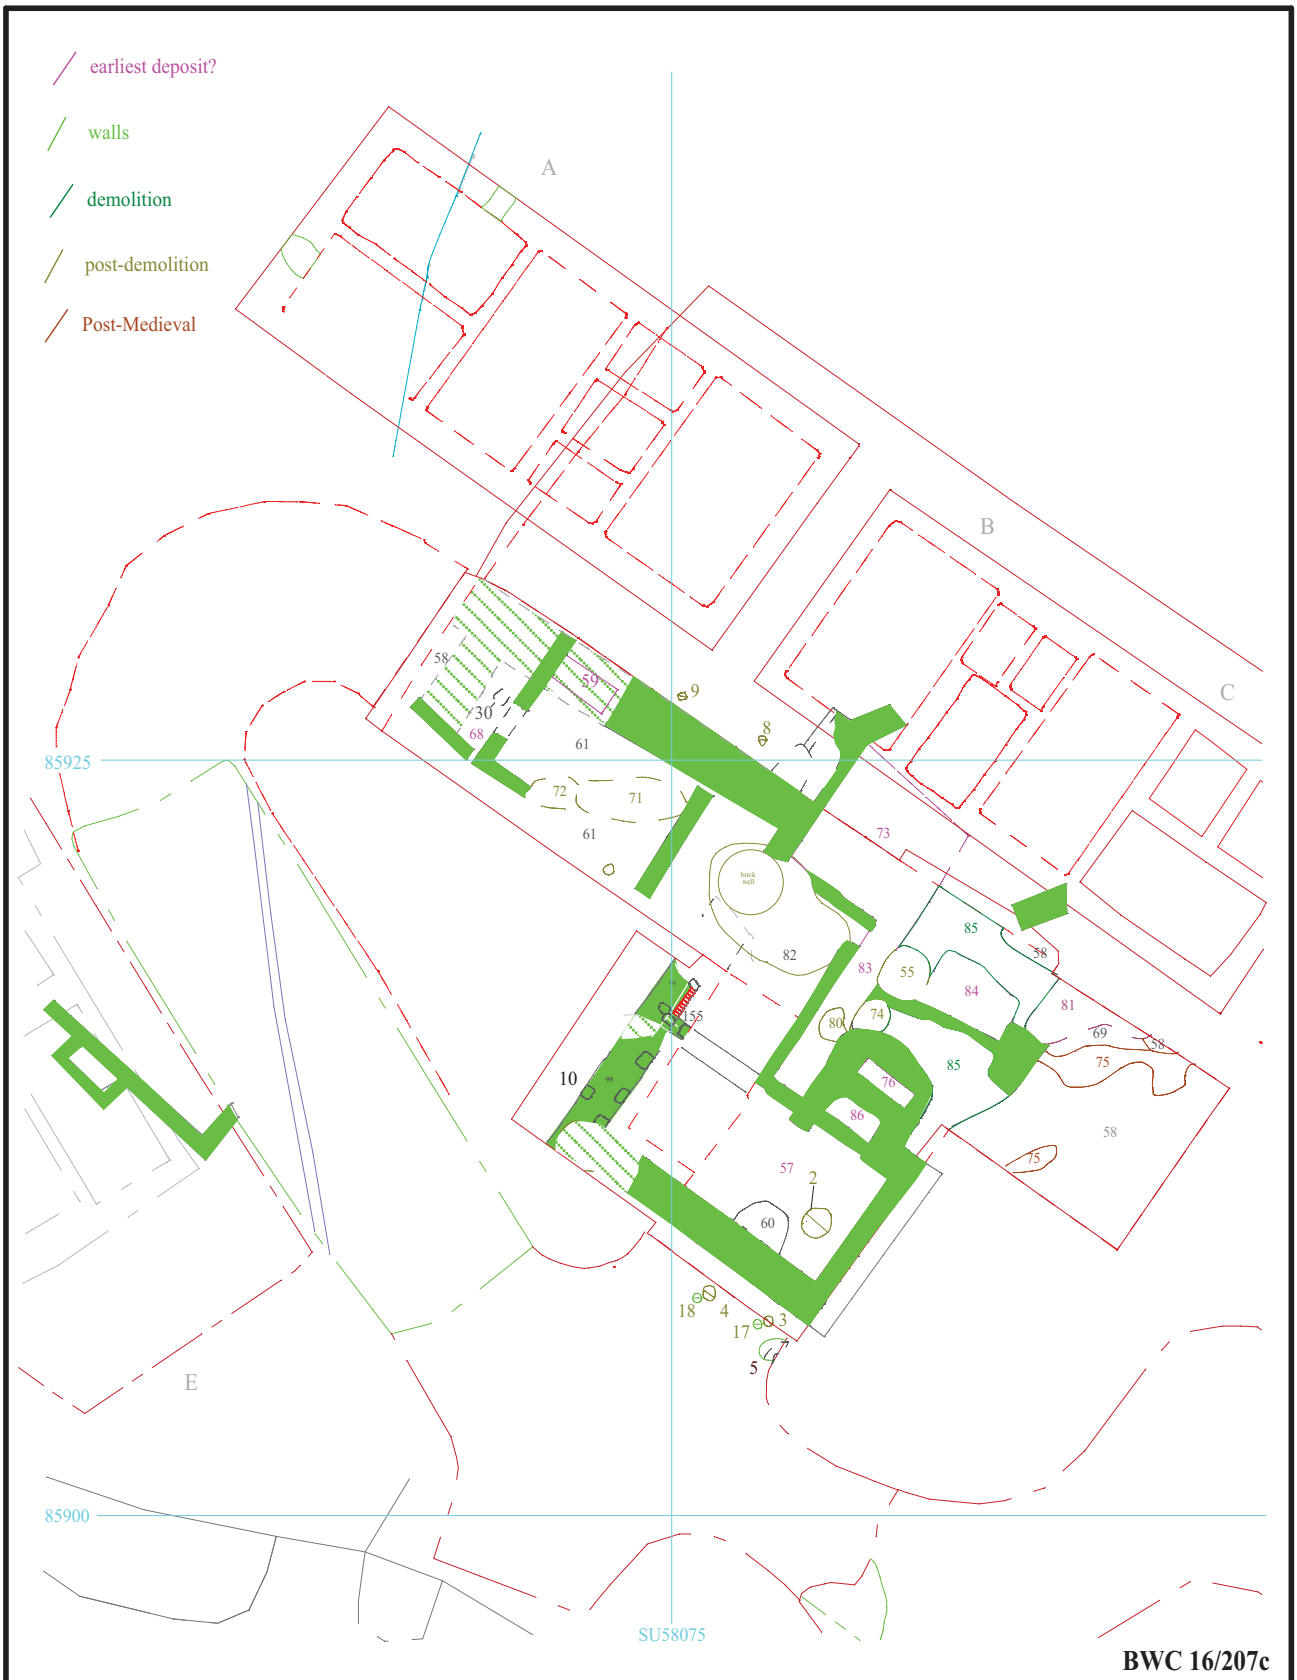
Figure 4. Deposit details.

A partial rectangular building can be defined by footings 93, 97, 99 and 157 (Fig. 4; Pl. 4), which were all 1.25-1.30m in width. The materials used were limestone blocks of various sizes, with a rough finish, with a yellowish to light brown mortar matrix. Wall 157 was orientated NNE- SSW for 5.5m before it was truncated by a well. It continued as 99 further SSW for 7.25m. This wall then turned 90° to ESE for 7.5m as 92, and reverted back to the NNE direction as 93, partially under the baulk, for 5.25m.

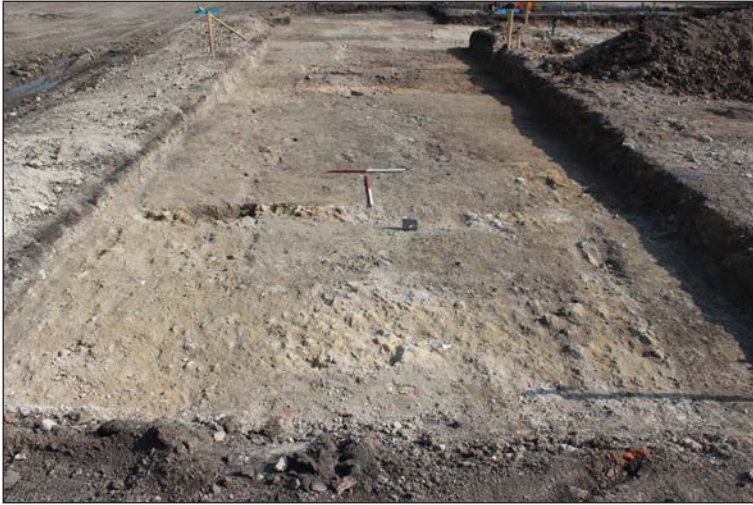
Plate 1. General view with wall foundations 151-152, looking South East, Scales: 2x1m

There was a more certain perpendicular shift towards the SSW with wall 151 (Pl. 1), 3m long and 1.60m wide. It was stopped by a 3m long NW-SE wall, 158. As it was not seen the other side of 158, it probably terminated here with a possible entrance at its SW. Wall 158 was only 0.45-0.50m wide. As its orientation differed from the usual alignments it can be almost assured that it belonged to a later phase or addition to the building. It was also not exactly aligned with the L-shaped wall 150, nor connecting with it, though their fabric and breadth were similar. Wall 150 was 5.30m long from NE to SW and then going SE for 2.05m.

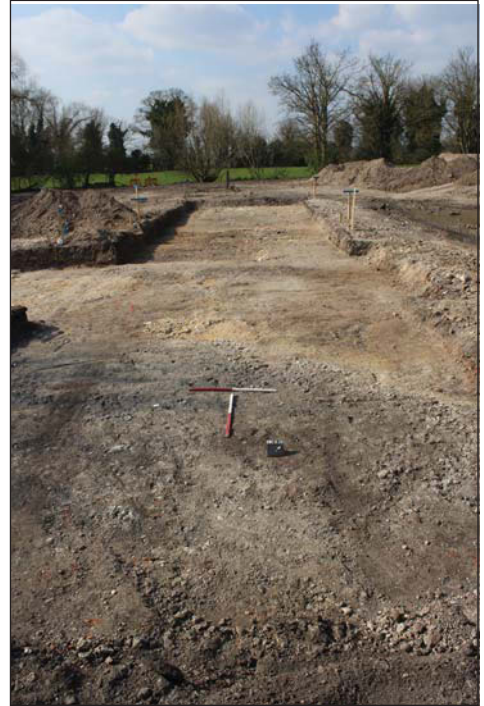
Plate 2. Working shot - deposit (58) in foreground, looking North West, Scales: 2x1m

Further east the stripping level was slightly higher and thus only later deposits could be observed. They comprised, a compact mid brownish grey silty clay or clayey silt (58) (Pl. 2) with occasional fragments of bricks, stones or pebbles as well as some charcoal and chalk flecks and a sherd of medieval pottery; and two irregular lenses of gravels or pebbles (69 and 75). Of these, lens 69 had a mid yellowish grey sand matrix while 75 was greyer with larger pebbles. These deposits seemed outside any conjectured building.

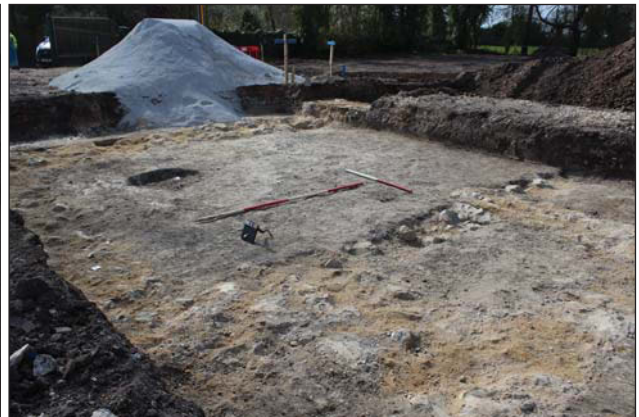
Plate 4. Area with wall foundations 96-98 (foreground), 92 (background) and pit 2; looking South West, Scales: 1m and 2m

Wall 98 (Pl. 4) was an ESE-WNW wall of smaller breadth, 0.48-0.50m, visible for 3.70m. It was not known if it was part of the initial layout, truncated by 97 or if it was a shear-wall, condemning the apse and taking advantage of the existing portion of 97 to define a new room. It had basically the same fabric as the other walls, except it had less frequent limestone blocks and more gravels/pebbles. It stopped just before a perpendicular wall, 94, but was seen past an unexcavated area and butting against 99 (recorded here as 155). North of that junction, the south-east edge of 99 seemed to have been reworked to insert a brick-made doorstep, 1m wide.

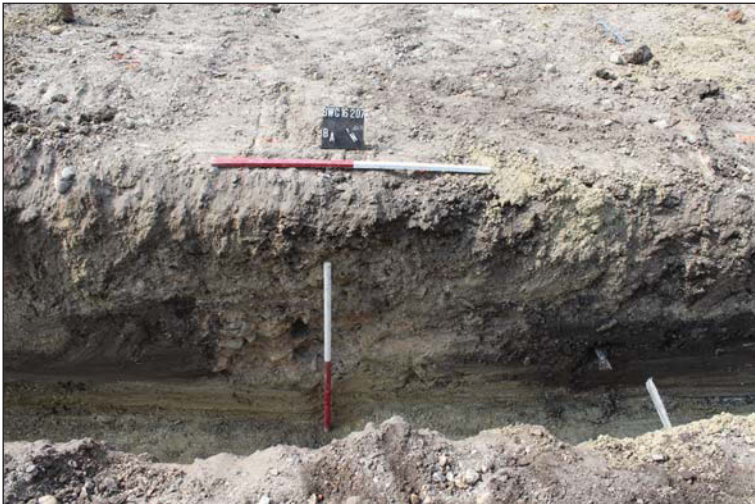
Plate 5. Section in Barn B foundation trench with cut 157, looking South West, Scales: 2x1m

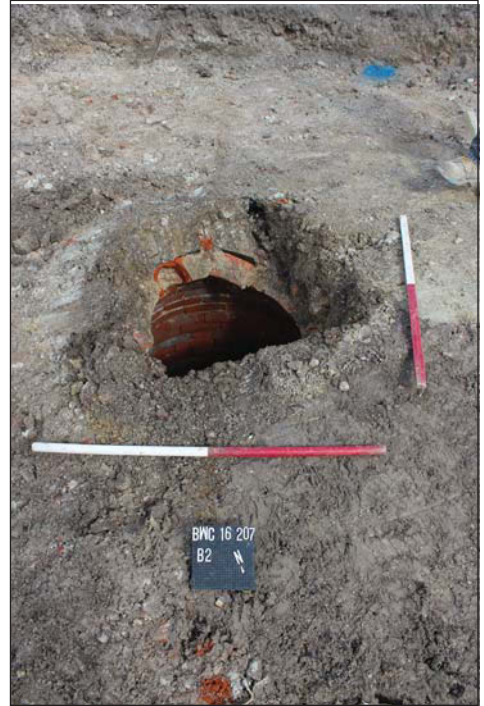
Plate 6. Brick well or cistern in driveway in front of barn B, looking North, Scales: 2x1m

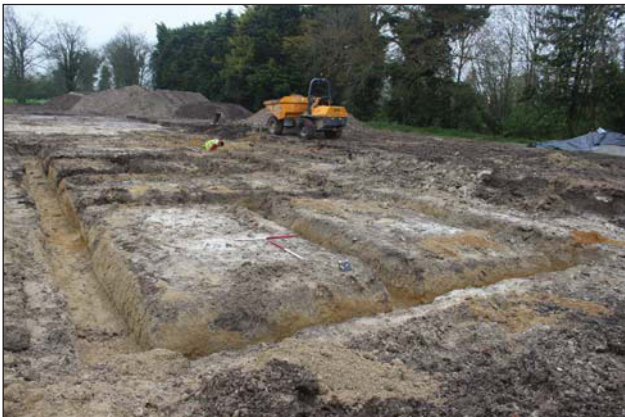
Plate 7. Working shot of Barn D foundation trenches, looking North West, Scales: 2x1m

At the location of barns A-D (Pl. 7) only disturbed ground could be seen, which is not surprising as it was where the previous buildings stood.

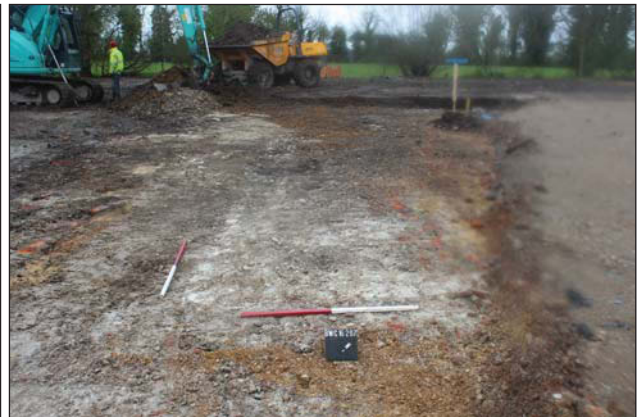
Plate 8. Ground reduction for Barn E; looking North West, Scales: 1m and 2m

The archaeology observed was concentrated in two areas. Where house E was planned, some unclear possible wall foundations were observed (Fig.3; Pl. 8) but had definitely been disturbed by later construction. A brick wall (162) was postulated but observation was severely limited.
