**Newbury Racecourse, Newbury,
West Berkshire**

Building Recording

Site Code NRW 15/179

September 2015

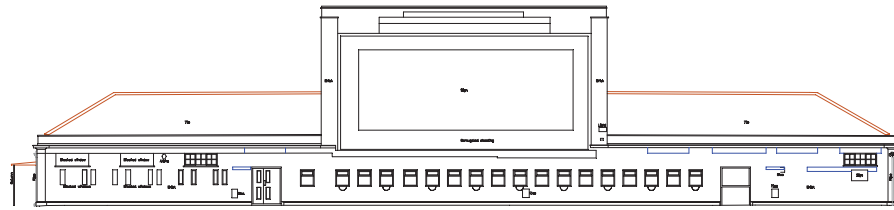
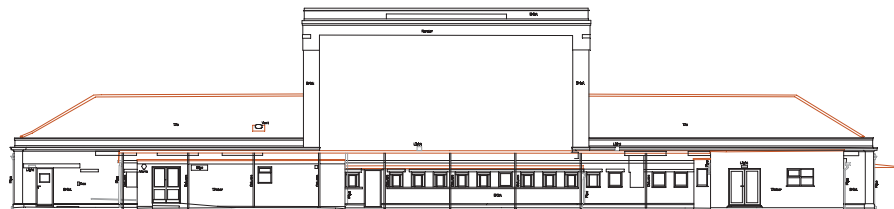
Figure 6. Copper King Building Elevations.

Front, east facing elevation

North facing elevation

South facing elevation

Rear, west facing elevation

The Copper King Building (Pls 1-4) consisted of an approximately north-south aligned rectangular building with two extensions on the east side. It had a central two-storey part with a single storey at either end. It was of steel

RSJ construction, infilled with bricks laid in English Bond, bonded in cement mortar. The bricks measured 221mm x 108mm x 62mm (8 ¾" x 4 ¼" x 2 ½"). Lintels above the windows were of concrete. The upper part of the first storey was decorated with a frieze (Pl. 5), possibly of stone, or imitation stone with reeded decoration, extending around three sides of the building with a separate section on the west face. Above the frieze was a brick parapet concealing the flat roof. A small brick parapet was also present around the single-storey sections.

Roof construction was a combination of a slate covered, hipped roof at either end and a central flat roof above the two storey section. The flat roof was constructed of steel panels overlaid with concrete beams. Drainpipes, where seen, were original cast iron.

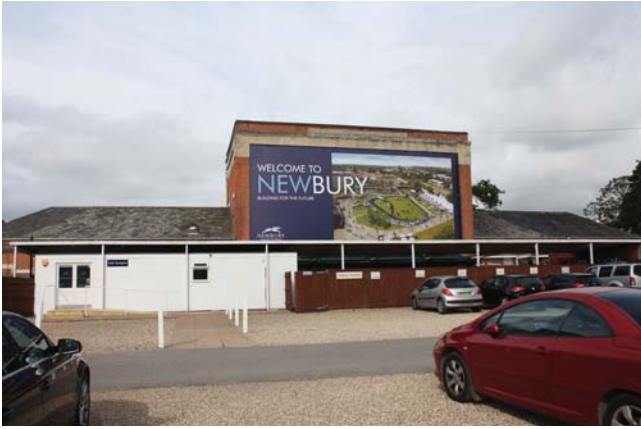
Plate 1. Overview of building, looking west Scales: 2m and 1m.

Externally it was possible to see a number of alterations, namely the two portacabin type extensions on the east side (Pl. 1) situated beneath a covered canopy (also a later addition) supported on steel girders and running the length of the building and covered in corrugated steel sheets. In order to accommodate the two extensions a number of windows were blocked as evidenced by the concrete lintels. Alterations were clearer on the other elevations with three blocked windows present on the south elevation (Pl. 2), infilled with bricks laid in Flemish bond, and a number of horizontal blocked windows beneath the roof line on the west side of the building along with a doorway that had been converted into a window and a likely door at the south end. All were infilled with bricks laid in Flemish bond.

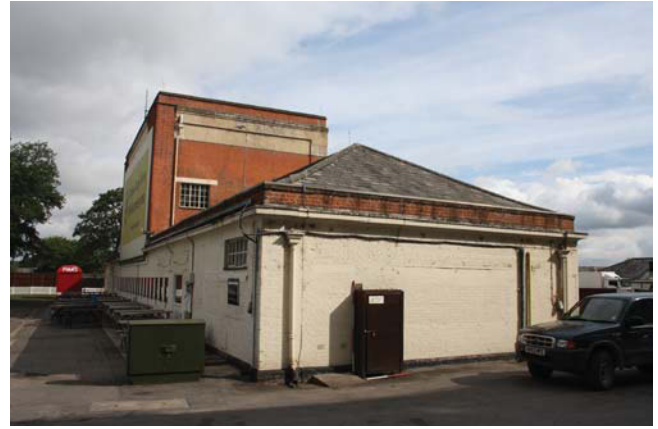
Plate 2. Oblique view of south wall, looking north-east, Scales: 2m and 1m.

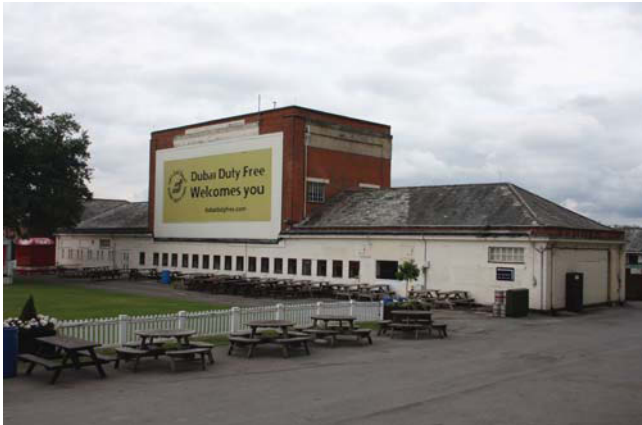
Plate 3. Oblique view of building, looking north-east, Scales: 2m and 1m.

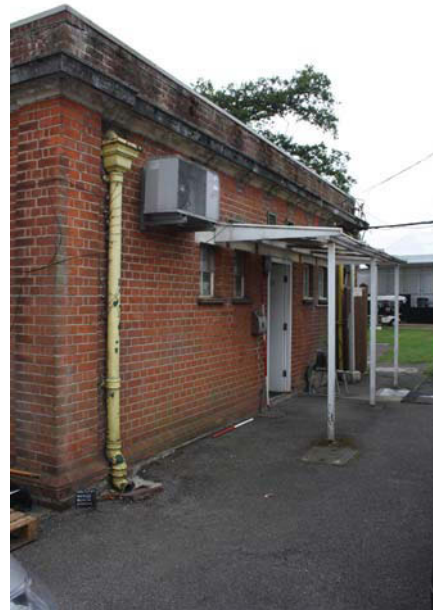
Plate 4. Oblique view, north end of building, looking south-west, Scales: 2m and 1m.

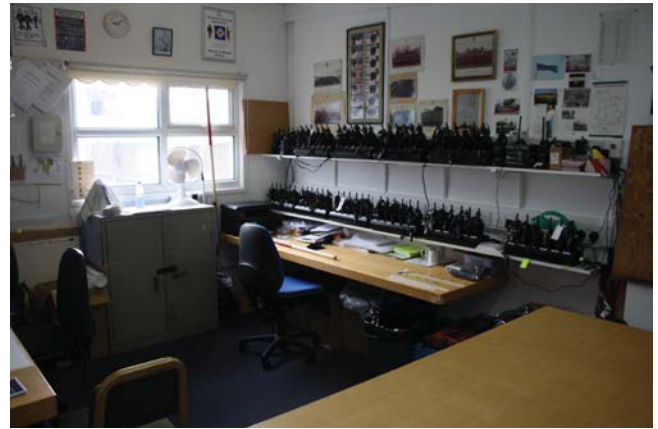
Plate 14. Room 14: general view, oblique, looking south-east, Scales: 2m and 1m.

Section 5 was located within the northernmost portacabin extension and contained rooms 12-14. The portacabin was of the same modern style as section 1. Access was off corridor 15 within the original building or via two external doors within room 12. Room 12 was an office space, room 13 a small kitchen and room 14 a control room (Pl. 14).

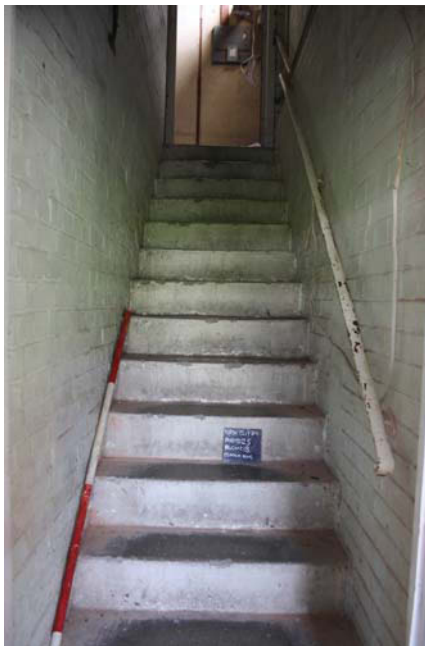
Plate 15. Room 18: stairs, looking east, Scale: 2m.

The first floor (room 18) was accessed from room 5 (section 3). The stairs were fully enclosed and of concrete construction with a simple metal hand rail (Pl. 15). The first floor primarily consisted of one large room (Pl. 16) with narrow corridors panelled off along the east and west sides. In the north and south walls were two large, multi-paned windows. It was utilitarian in style with exposed steelwork and panelling. The floor was covered in vinyl floor tiles and at the north end was a small internal store room of later construction. Giving access to the narrow corridors along either side was a, probably, original four panel sliding door (Pl. 17). Within the centre of the room was a cast iron spiral staircase giving access to the flat roof. The stairs themselves (Pl. 18) were slightly ornate with concave and convex shapes beneath the open tread. The balusters had a square cross-section with a fleur-de-lis surmounted by a knob supporting a plain bannister rail. The entire staircase structure was painted grey.

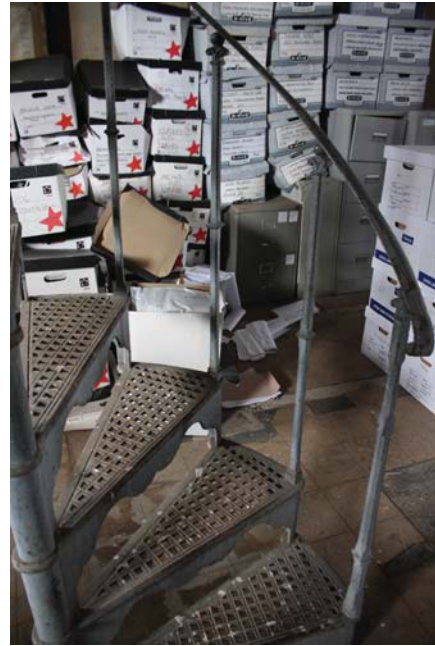
Plate 18. Room 18: detail of spiral staircase, looking west.

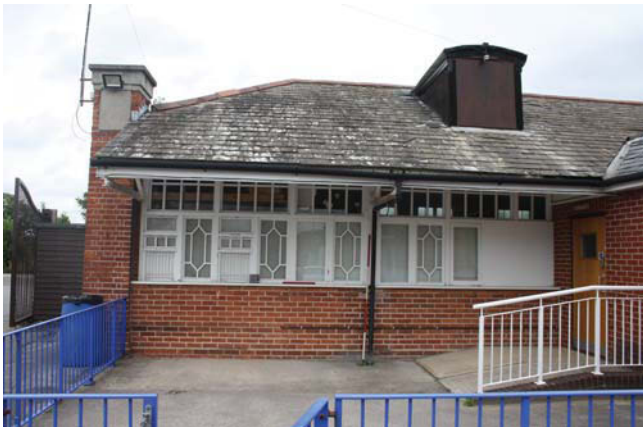
Plate 19. Nursery: south elevation (E – W building),
looking east, Scales: 2m and 1m.

The windows had for the most part been blocked up or replaced, but a section of the original fenestration was present on the south side of the east-west building (Pl. 19). This consisted of a set of multi-paned windows, sub-divided into sections of eight panes (four over four), immediately below the roof line. Below each eight pane section was a pair of casement windows; one sub-divided into three sections (a horizontal sash, above three small panes, above a barred area), the other containing a lozenge shape sub-dividing the glass. On the north face and two of the gable ends were original two over two pane windows, arranged in pairs on the north face. Dormer windows were present on either side of the roof, and consisted of a pair of casement windows sub-divided into six panes, where they had not been blocked up.

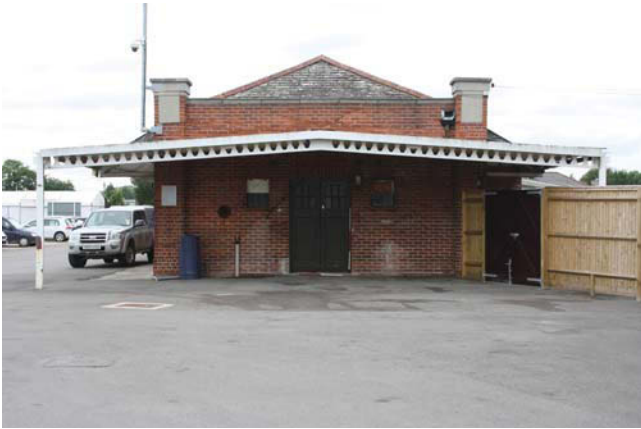
Plate 25. Nursery: south elevation (N – S building), looking north, Scales: 2m and 1m.

Original doors were present only on the south gable end (Pl. 25). These consisted of a pair of two panel wooden doors containing six small glass panes in the upper section, arranged three-over-three, above a larger plain panel. A modern canopy had been erected at this end of the building, of steel and corrugated steel construction.

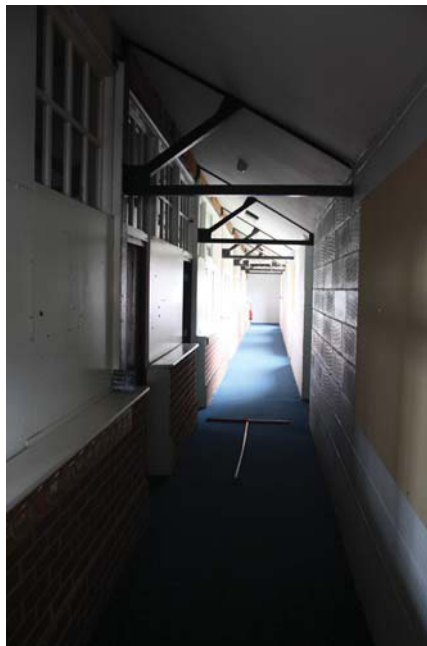
Plate 27. Nursery Room 1: view along corridor, looking east, Scales: 2m and 1m.

Access to the building was through a door in the south-west corner, at its junction with the modern infill. This gave access to corridor 1, the former external covered area (Pl. 27). The floor throughout the building was carpeted and the infilled, concrete block walls painted white. Two doors were present in the southern wall giving external access. The former external elevation consisted of brick walling, beneath a white sill and windows, this was the same as that seen externally, where original windows were present. The majority of the lower windows had been blocked up, but the upper ones were still in their original state. Accessed from the corridor were rooms 2-6 (from west to east), these were all classrooms or used for naps. Rooms at the far west end of the building were not accessible. The rooms themselves consisted of original painted brickwork and more recent stud walling dividing the space (Pl. 28). Doors had presumably been inserted in place of windows through the former external elevation; these were all modern. Within room 6, at the east end of the building an inserted door into the north face had been subsequently blocked up again and the east end of the building altered. The two end windows had been bricked up and the door opening widened and the door replaced (Pl. 29).

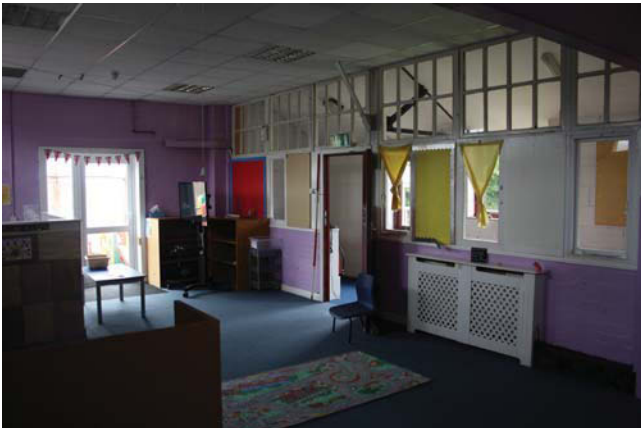
Plate 29. Nursery Room 6: general view to internal windows, looking south-east, Scales: 2m and 1m.

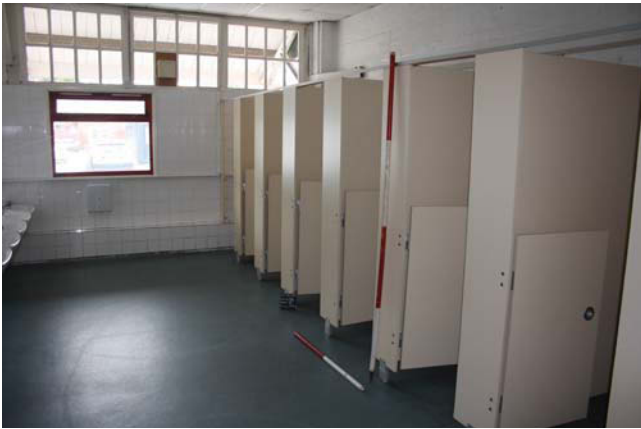
Plate 33. Nursery Room 10: toilet view old wall, looking north-west, Scales: 2m and 1m.

Within the children's toilets (room 10) (Pl. 33) located at the north end of the building it was possible to see the blocked windows and door of the original end of the building, though it was predominantly obscured by toilet stalls. Rooms 10-12 were for storage and were located one behind the other. Rooms 15, 17 and 18 were classrooms (Pl. 34), each with one or two storage cupboards at the south end and rooms 15 and 18 were extended to the west to include additional toilet facilities. Room 19 was the kitchen (Pl. 35), located at the far south end of the building. It had its own access through the southern end of the building (Pl. 36) and a storeroom and toilet (room 20). Room 21 was the staff toilet, also located at the southern end of the building.
