**The Former Big Cheese Public House, West End Road,  
Southampton, Hampshire**

**Building Recording**

**Site Code: BCS 20/44**

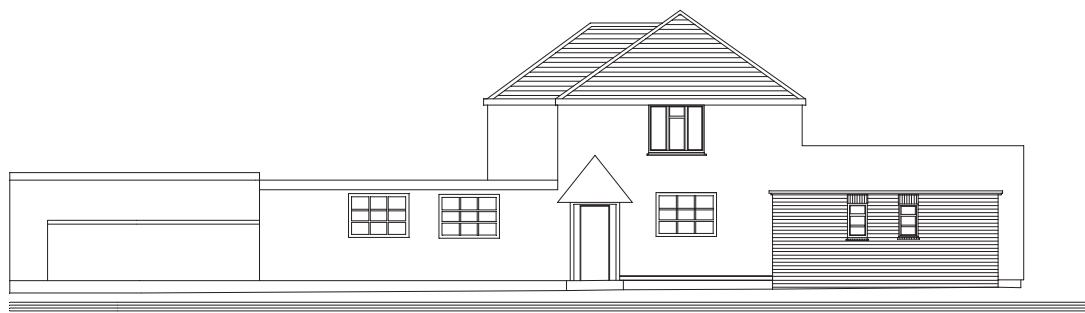
Figure 8. Side (northeast) elevation

The side (north-east facing) elevation consists of the later single-storey extension and the main building, set further back. The extension contains two single windows set within the cream painted brickwork. The single-storey front wing extends above the level of the roof (Pl. 4). To the south-east is the two-storey section of building containing a window and door on the ground floor, and a central window on the first floor. The door is

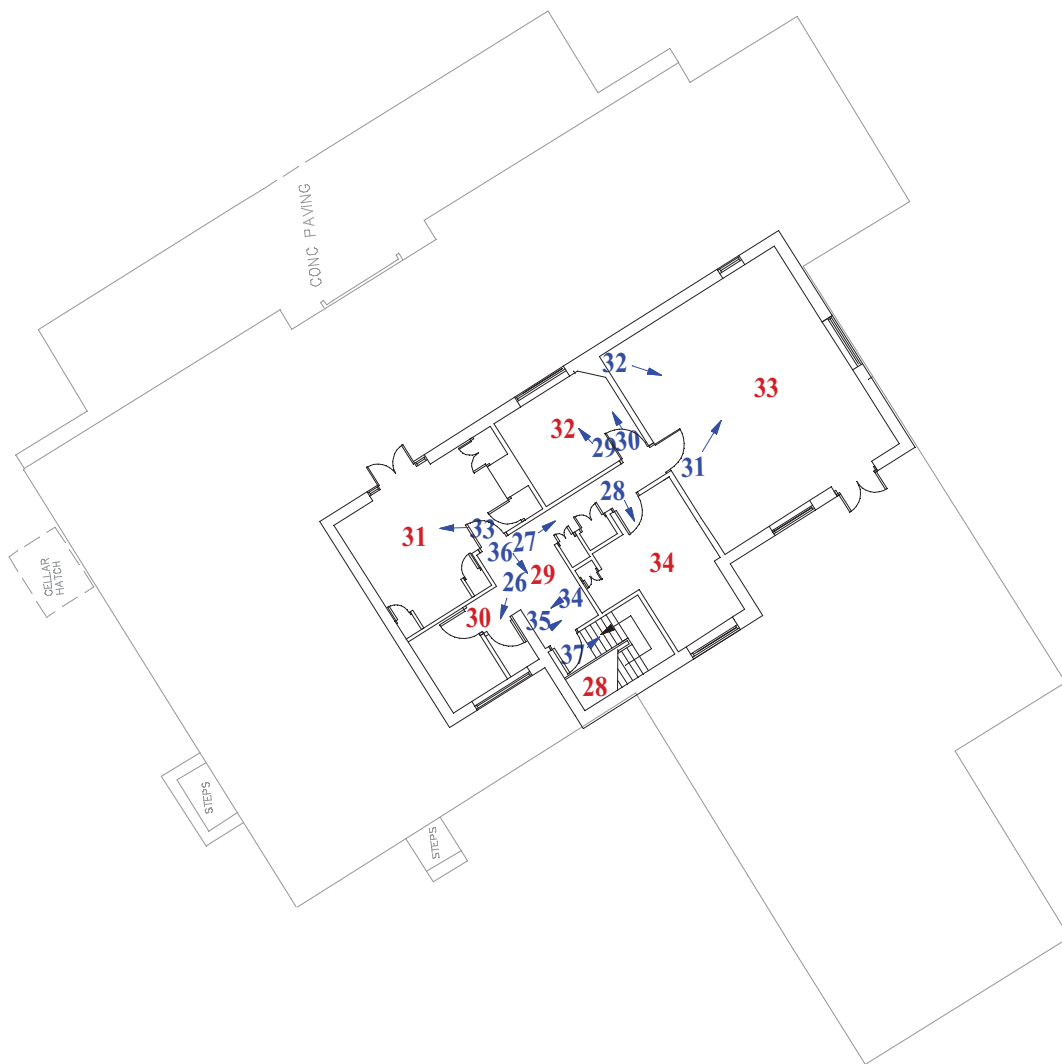
Figure 13. First Floor Plan

In general the first floor was decoratively similar to the ground floor with plastered walls and ceiling and plain skirting boards. All the flooring had been removed leaving chipboard on the floors beneath all the debris. Not all rooms were fully accessible due to the quantity of debris, but all could be observed from the doorways. The windows were of casement type white upvc, as were the external doors giving access to the flat roof.

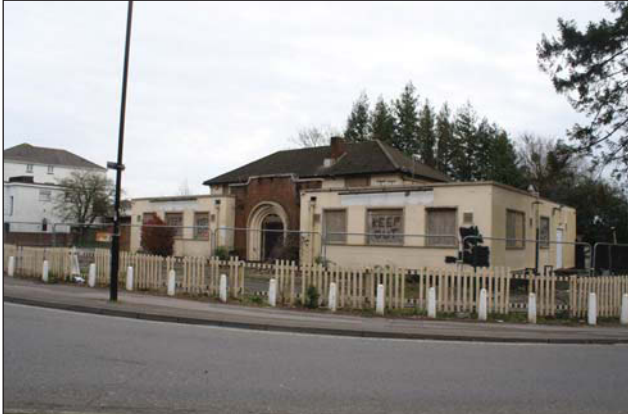
The front (north-west facing) elevation consists of the main building (two wings set either side of the main entrance) and a slightly set-back brick extension at the north-east end (Pl. 1). The main focus of the frontage is the central brick entrance, set back from the two wings and beneath a simple raised and shaped pediment (Pl. 2). The entrance itself is beneath a stone arch outlining a further three stepped arches in brickwork and painted cream to match. The entrance had been boarded up externally but internally these could be seen to be the same shape as the arch, with a lower square wooden panel, and shaped glass filling the upper part of the door (Pl. 3). The rest of the wall was constructed of stretcher bond brickwork in cement mortar. The bricks are particularly narrow measuring 201mm x 100mm x 48mm (7 <sup>7</sup>/<sub>8</sub>" x 4" x 1 <sup>7</sup>/<sub>8</sub>") and were presumably selected for decorative purposes. The two wings on either side were identical and contained three windows, the central window slightly larger than the other two. On both are a pair of vents, a down pipe and space for the pub sign above the windows (since removed). The small extension on the north-east end of the building is set at a lower height with the roof exposed. A single window is set within the stretcher bond brickwork. The first floor is set further back and contains three windows (two triple windows and a single window). A chimney is also present within the roof.

Plate 1. Oblique of frontage , looking southeast

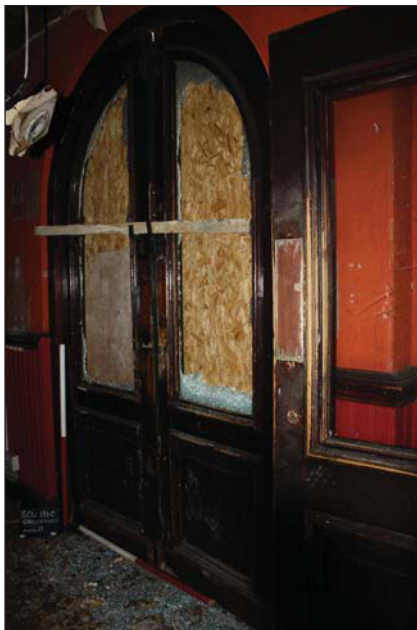
The main access was on the north-west side, through a pair of double doors into a small lobby (room 6) (Pl. 3). Walls within this room and in the bar areas had a dado rail with tongue-and-groove panelling beneath. A pair of doors on either side led to the family bar (room 7) to the north-east and the public bar (room 19) to the south-west. The family bar extended the length of the building along the north-east side, and comprised room 7 at the north-west end and room 11 at the south-east end (Pl. 15). The division between the two rooms represents the original room 7 and the extension, room 11. Room 7 has three windows in the north-west elevation and a further window in the north-east elevation (Pl. 16). The bar is located on the south-west side of the room and consists of dark wooden tongue-and-groove panelling set upon a one-brick-high plinth (Pl. 17). The rear of the bar contained further dark wood shelving. On the north-east side within a small extension were the male and female toilets (rooms 8 and 9) set either side of a feature wall appearing to once have housed a modern fire and likely a television screen above (Pl. 18). A half wall divided the area in two creating smaller seating areas (Pl. 15). The division between rooms 7 and 11 was marked by a small lobby area to the side entrance (room 10) (Pl. 16). Within the wall on the north-west side appeared to be a former display cabinet. Within room 11 (Pl. 19) were two windows in the north-east wall, a pair of doors in the south-east wall and access to the kitchen via a pair of swing doors in the south-west wall. The room itself contained two seating booths along the north-east wall.

Plate 3. Main doors, looking west, Scales: 2 x 1m.

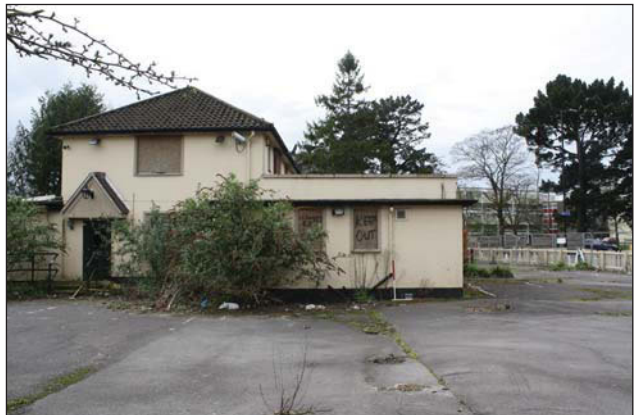
Plate 4. Northeast facing elevation, looking southwest,  
Scales: 2 x 1m.

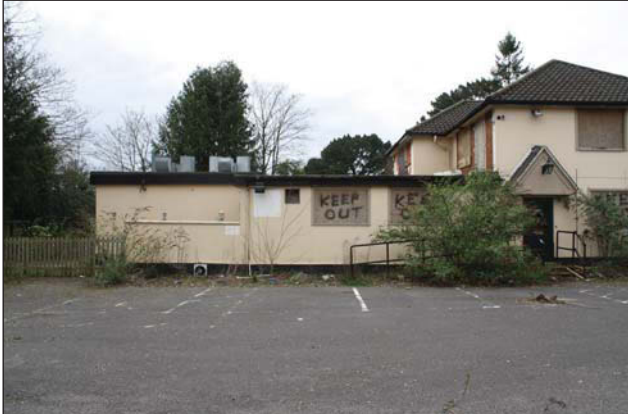
located up two concrete steps that is also ramp accessible. The door itself has the appearance of a front door to a house with a square of glass divided into nine unequal sections above a central brass-coloured letter box and two rectangular panels. It is set beneath a gable end porch with an infilled gable of wooden planks (Pl. 4). To the south-east is the single-storey extension, containing a pair of windows and a vent (Pl. 5). Beyond this is a low wall. Set back from the plane is a further single-storey extension with no features within the wall and extractors and vents on the roof (Pl. 5).

Plate 5. Northeast facing elevation, looking southwest,  
Scales: 2 x 1m.

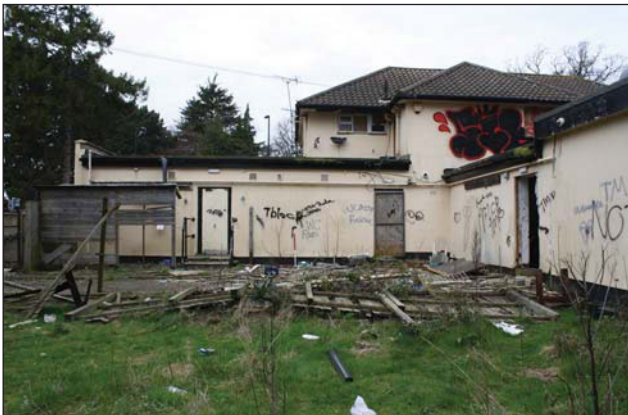
The rear (south-east elevation) is complex, with a number of different sections. At the north-east end is the rear of the small extension at the front of the building containing three windows. The rear of the pub proper consisted of a pair of doors within the north-easternmost section, no features within the section which extended to the south-west the most (Pl. 6), and two doors within the south-westernmost section (Pl. 7). The first floor contained three windows and a set of doors onto the flat roof.

Plate 7. Rear of building, looking northwest,  
Scales: 2 x 1m.

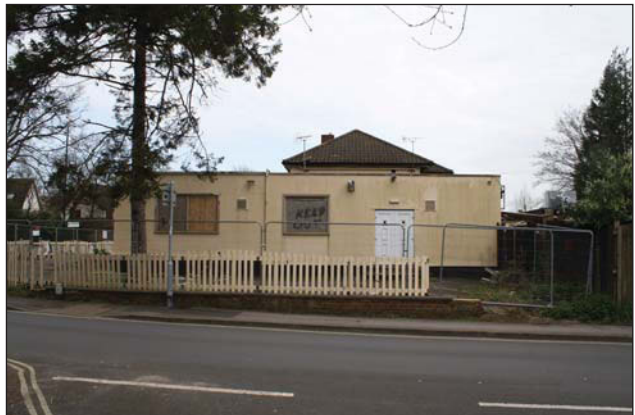
The side (south-west elevation) contains two windows and a pair of white, modern doors accessed up two steps. At the north-west end is the cellar access hatch set within the ground (Pl. 8). The rear extension contains a single, approximately central door beneath a flat roof. The building has been extended to the south-east clearly seen where the roof is at a higher level (Pl. 9). The first floor contains no features.

Plate 8. Southwest facing elevation, looking northeast.

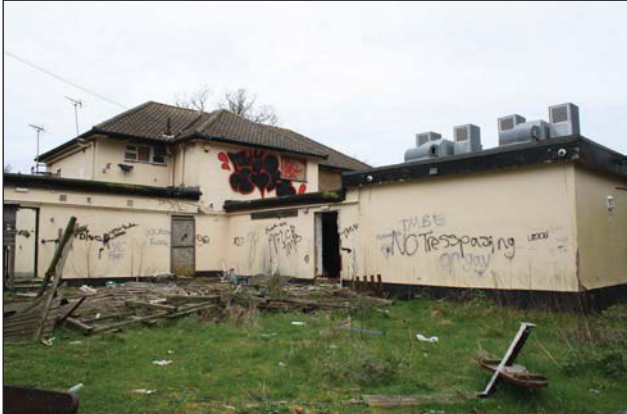
Plate 9. Oblique of rear of building, looking northeast,  
Scales: 2 x 1m.

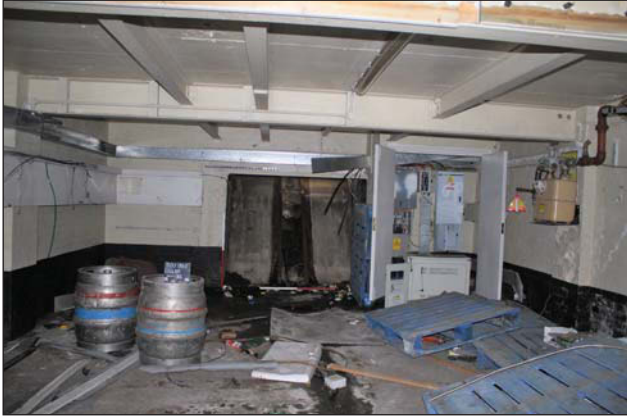
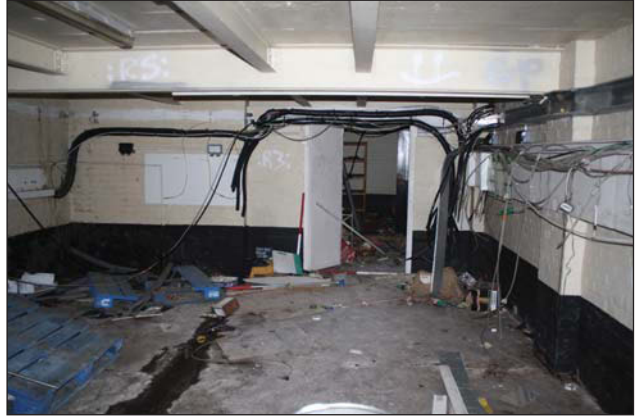
The cellar is accessed via a set of steps located in the centre of the building. The cellar consisted of four rooms around a central lobby. The walls are built of brick and painted white. The bonding varies, with English bond around the stairwell area and Flemish bond elsewhere. The bricks measure 225mm x 106mm x 65mm (8 <sup>7</sup>/<sub>8</sub>" x 4 <sup>1</sup>/<sub>4</sub>" x 2 <sup>1</sup>/<sub>2</sub>"). The floors were of concrete and the ceilings consisted of steel I-beams supporting concrete beams. The stairs consisted of a straight flight of concrete steps giving access to a small lobby area (room 1) (Pl. 10). Directly ahead was a small alcove containing shelving. To the south-east was a small room (2), within the south-west wall, opposite the internal door was a blocked doorway (Pl. 11). To the north-west was access to the remaining rooms. Room 3 extended to the north-east (Pl. 12) and gave access to room 4 to the south-east, a small room behind the lobby. The main room 5 was located to the south-west of room 3 and contained the barrel slide at the south-west end of the room (Pls. 13 and 14). Within the centre of the floor was a drain.

Plate 13. Room 5, view to barrel slide, looking southwest, Scales: 2 x 1m.

Plate 14. Room 5, looking northeast, Scales: 2 x 1m.

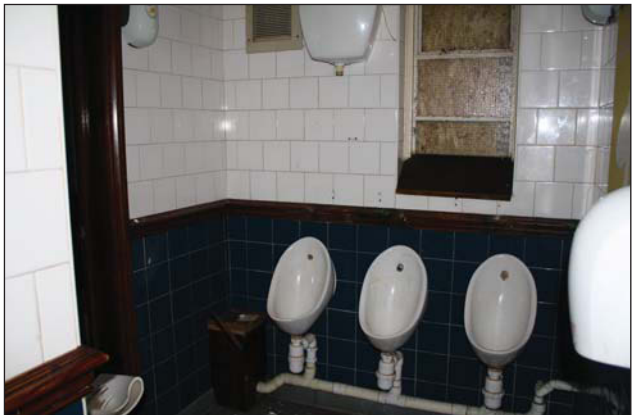
Room 8 (Pl. 20) was the male toilets and consisted of a small entrance lobby with window, which gave access to the toilet proper: urinals were located on the north-east wall beneath a window with a cubicle on the north-west wall also containing a window. Decoratively the toilet was fully tiled with dark green tiles beneath a dark wood dado rail and white tiles above. Room 9, the ladies' toilet was similarly decorated and accessed off a small lobby. The two cubicles were located on the south-east wall and each contained a window. A further window was located within the lobby area and the circulation space.

Plate 20. Room 8, gents toilets, looking northeast.

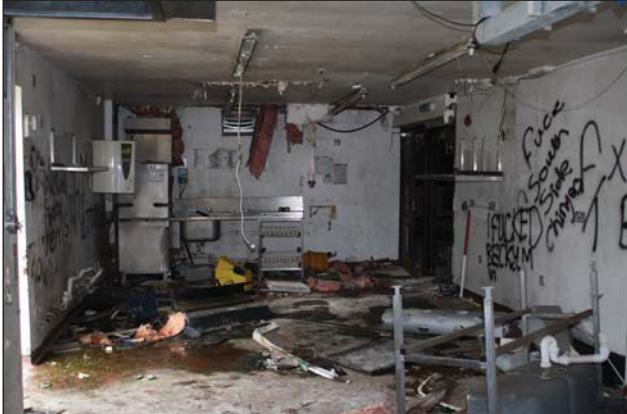
The kitchen (room 12) was part of two later extensions to the rear of the building forming an L-shape around the rear of room 11 (Pl. 21). Much of the kitchen had been removed but the walk-in fridge and freezer were located within the L-shape at the north-east end of the room and the cooking ranges would have been located along the south-west wall at the south-east end. The doors to the bar area were located at the north end of

Plate 21. Room 12, kitchen, looking north,  
Scales: 2 x 1m.

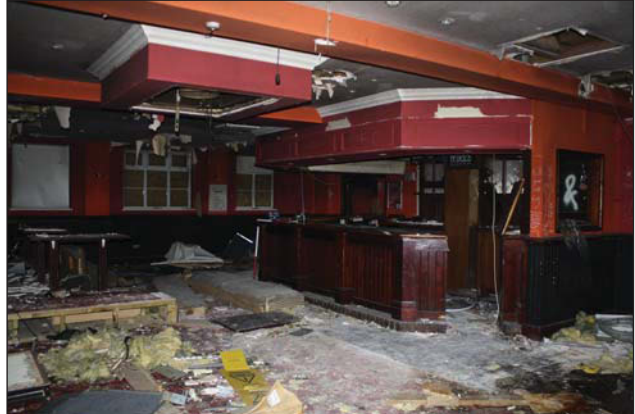
On the south-west side of the main lobby (room 6) was the public bar (room 19) running almost the entire length of the south-west side of the building (Pl. 22). Within the north-west wall were three windows with a further two windows and a pair of doors in the south-west wall. The bar was located on the north-east side of the room and was a continuation of the bar from room 7. In the west corner of the room is a raised 'stage' of timber construction. To the rear of the room a central door gave access to a small lobby (20) which in turn accessed the rear garden and a small store room on either side of it. Room 21 to the north-east is a simple roughly square room with no distinguishing features whilst room 22 (Pl. 23) to the south-west contains the back of a chimney stack located centrally within the north-west wall. There is no trace of a fireplace in the wall of room 19.

Plate 22. Room 19, public bar, looking northeast,  
Scales: 2 x 1m.

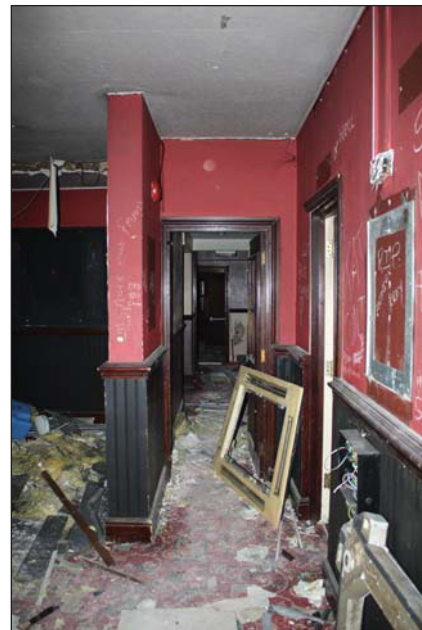
In the south-east corner of the room is access to corridor 13 (Pl. 24) which runs NE to SW and links the family and public bars (rooms 7 and 19). Along the corridor is access to the cellar, toilets, the first floor and cupboards/store rooms. To the north-west is located the straight flight of steps down to the cellar set within a small recessed area (Pl. 25), along with access to the ladies' toilet (Pl. 26). The men's toilet was located adjacent to the ladies', also off of a small lobby. Between the two were two small rooms in use as a cupboard and washroom. On the south-east side of the corridor is a disabled toilet (Pl. 27) at the north-east end and access to a short section of corridor which has an external door on the south-east wall into the garden, a storeroom to the south-west (room 16) and stairs to the first floor to the north-east (room 15) (Pl. 28).

Plate 24. Room 13, view along corridor,  
looking northeast, Scales: 2 x 1m.

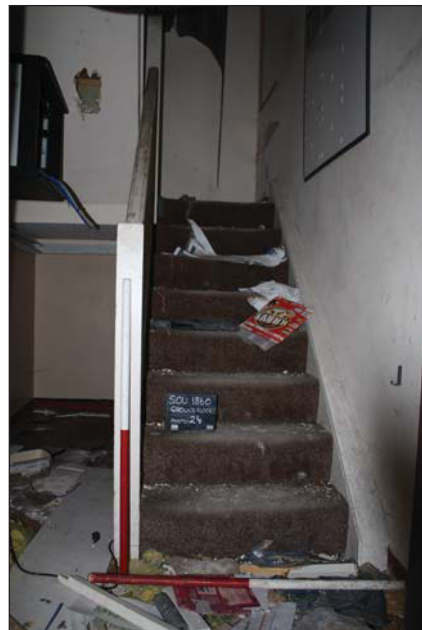
Plate 28. Room 15, stairs to first floor,  
looking northeast, Scales: 2 x 1m.
