**Porters' Lodge, St John's College,
Oxford**

Building Recording

Site Code: JCO18/33

May 2020

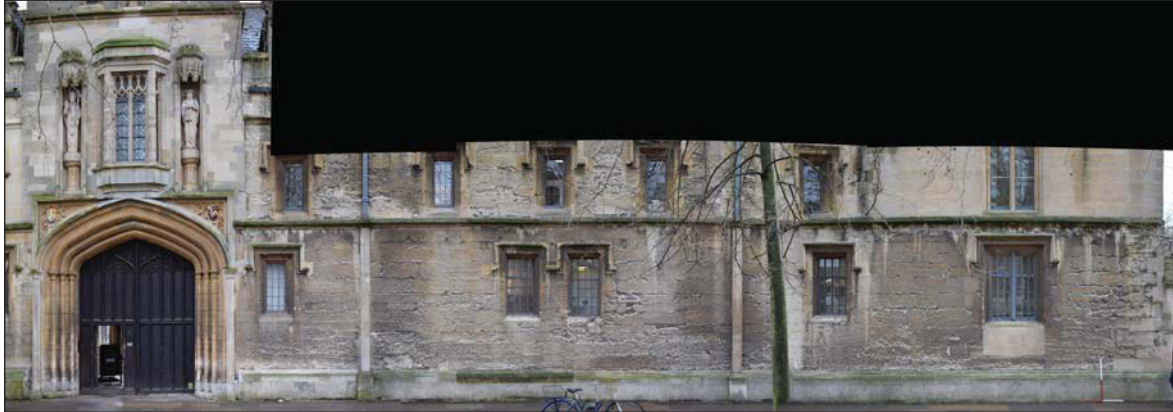
The front façade (west elevation) (Pl. 1) consists of the entrance way beneath the tower; a pedestrian door set within the much larger double doors, giving access to the internal quad and the college itself. To the south are four single windows arranged as a three-by-six leaded window, a pair of four-by-six leaded windows, a single four-by-six leaded window and a double width window that has been shortened at the base by two courses of stone blocks in this vicinity. Above the windows is a moulded hood. Beneath the windows is a moulded plinth course and between the single and pair of windows is a covered drain pipe on either side; it is exposed at first floor level. Dividing the ground and first floors is a moulded string course. The blockwork making up the wall is narrower at the base and wider towards the top. The coursing is consistent across the façade up to section of wall in which the double window is located at the southern end of the building, in the location of room 4. Here the wider blocks begin at the third course rather than the seventh course above the plinth.

Plate 1. Ground floor front elevation, looking northeast,
Scales: 2x1m.

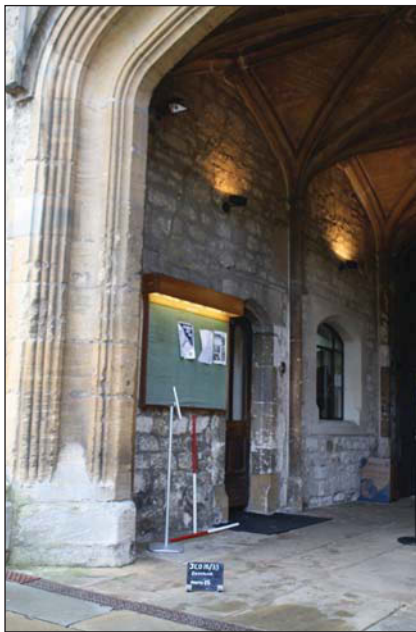
The north façade (within the archway) (Pl. 2) consists of two four-centred arches supported on three engaged columns which extend into the roof to form the ribs of the vaulted roof (Pl. 3). The columns themselves are fairly simple with a five-sided pedestal and corresponding base, a slim, rounded shaft, and five-sided capital out of which five ribs extend. Bosses are present at all intersections of ribs. At the top of each of the arches these appeared to consist of arrangements of foliage with the three central ones consisting of a person holding a shield, an animal with horns in a fetal position to fit the circular boss and perhaps a serpent (Pls. 4 & 5). The westernmost arch contains a modern window, inserted in the 1990's (Pl. 6). The easternmost arch contains a narrow doorway at the western end (Pl. 7). The doorway (Pl. 8) is set beneath a four-centred arch with a chamfer around the edge and a straight-cut stop. The door itself is wooden with a pair of small rectangular panels at the base beneath a pair of four-centred arched windows and an infill small window between them. On the western side are a pair of ornate cast iron hinges and an ornate cast iron base plate to the modern door handle. The walling is made up of small, coursed rough blocks. The opposite wall (Pl. 9), within the archway, facing south, consists of two solid stone walls within the two arches. Each wall contains a noticeboard. The stones are roughly

Plate 2. Gatehouse, oblique, looking South,
Scales: 2x1m.

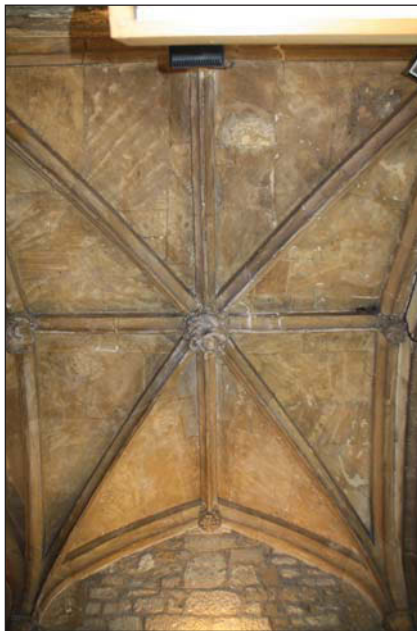
coursed though the blocks are generally larger than those present in the north wall of the archway. The tops of the arches contain arrangements of foliage (Pls. 10 & 11).

Plate 10. Vault roof detail, looking Northwest.

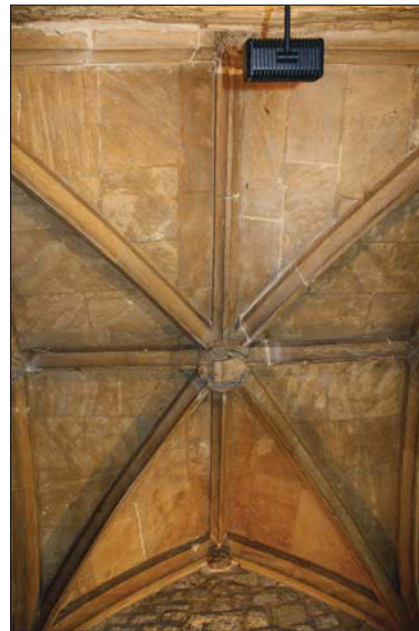
Plate 11. Vault roof detail, looking Northwest.

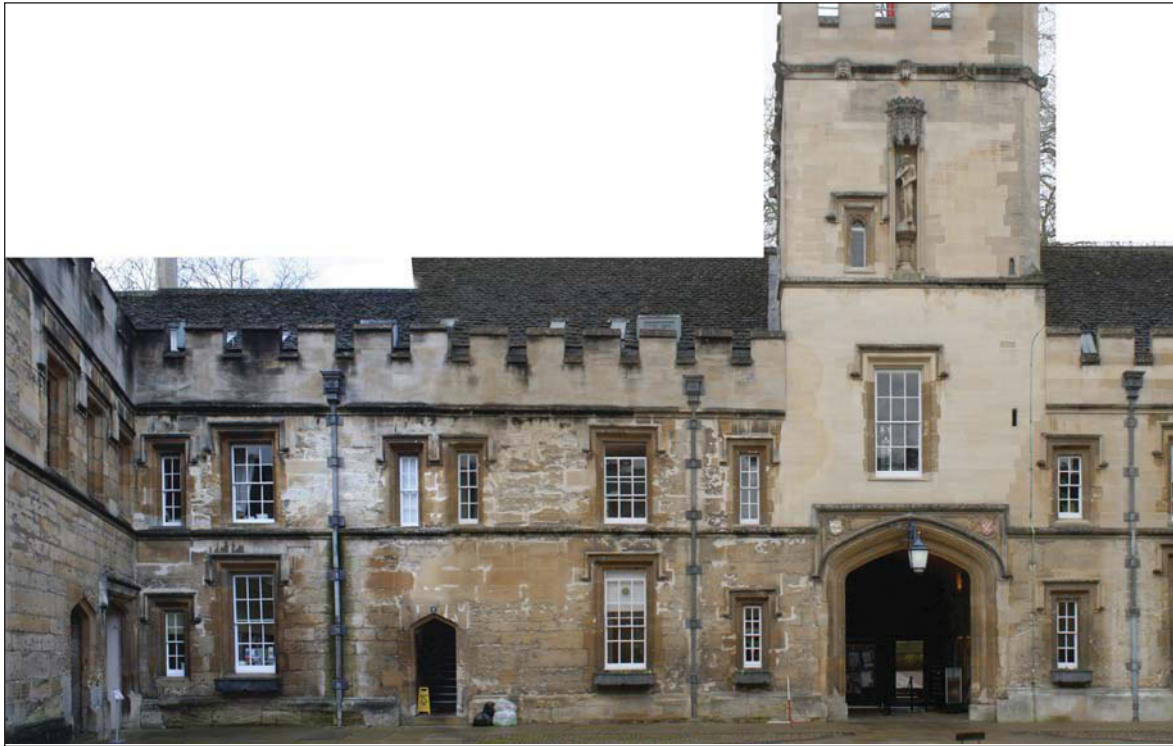
The eastern façade (facing onto the quad) consists of the entranceway beneath the tower, and four windows set either side of a doorway (Pl. 12). A further window and doorway are located beneath the passageway accessing the locker room (Pl. 13). The windows within the Porter's Lodge area are all sash windows consisting of (from north to south) a narrow four-over-four window, a six-over-six window, the doorway, a six-over-six window, and a narrow four-over-four window creating a symmetrical façade. Above each of the windows is a moulded hood. The doorway consists of a four-centred arch with a chamfer and straight cut stop. Beneath the windows is a moulded plinth and above them is a moulded string course. The wall itself is constructed of coursed blocks, the size and coursing of which varies. The wall within the passageway forming the locker room has been rendered over and contains no additional detailing such as the plinth. The window is a four-over-four sash window with no hood whilst the doorway has a flat lintel.

Plate 12. Rear elevation, looking southwest,
Scales: 2x1m.

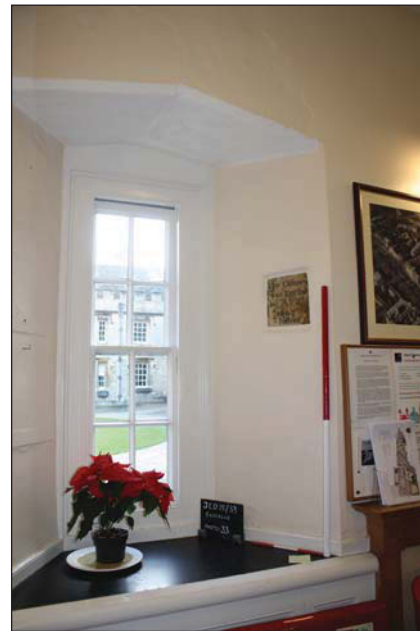
has a curved head (Pl. 19). On the northern side of the north window is a small locked door with wooden surround and on the southern side is a plaque dating the chimney (Pl. 18);

This chimney was erected by A:2. 1694 Porter

Plate 18. Room 1, window and plaque detail,
looking East, Scales: 1m and 0.3m.

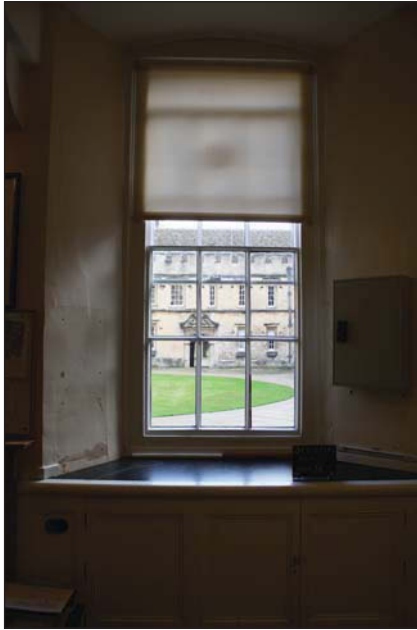
Internally the layout is largely modern with only the walls forming the central stairs and the kitchen/cupboard immediately to the south of any age, being of timber frame construction rather than modern partitions. The area north of the stairs (room 1) had been divided into three; a public waiting area, reception area and the fellow's pigeon holes. Entrance was via the narrow door beneath the archway in the north wall and up a step to the ground floor level (Pl. 15). In general the walls are plastered along with the ceiling and on the floor is herringbone parquet, the reception area is carpeted. At the base of the walls within the waiting area is rectangular moulded panelling painted white (Pl. 16). On the north wall to the east of the doorway is potentially an older section of panelling onto which the moulded panelling has been attached. The older panelling is taller and consists of a plain board with moulded edges (Pl. 15). Above the panelling sits a small postbox with wooden door and white moulded surround. Within the wall of the entrance, on the west side are two angled niches (Pl. 17). The eastern wall contains two windows of different sizes but each with a splayed opening. The smaller, northern window has a shallow, pointed head (Pl. 18), whilst the southern window extended to the ceiling and

Plate 19. Room 1, window detail, looking Northeast,
Scales: 1m and 0.3m.

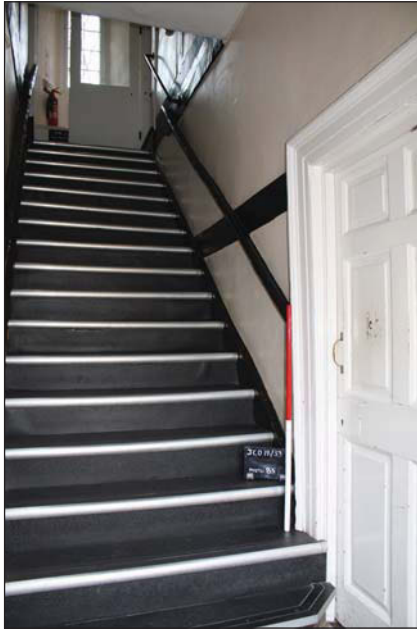
The area of the stairs (room 2) consists of two separate parts forming a central divide between rooms 1 and 3. The access to the stairs and the stairs themselves form room 2 whilst the area to the rear of the stairs has been numbered room 2b. Room 2 has an external entrance from the quad into a small hallway (Pl. 22). To the northwest is access to room 1, straight ahead are the stairs to the first floor (Pls. 23 & 24) whilst to the southeast the corridor continues with a small store cupboard to the southwest and access to room 3 to the southeast. The area of the stairs is carpeted whilst to the southeast is herringbone parquet flooring. The walls are plastered and along with the ceiling. The exception to this is the section of ceiling next to the cupboard which consists of three wide boards aligned northwest-southeast and supported by a small beam, where there appears to be access to a ceiling cavity (Pl. 25). A number of the walls show timber-framing with horizontal timbers present within the walls on either side of the stairs (Pls. 23 & 24) and a further horizontal timber present on the southeastern side of the cupboard. The timber within the cupboard has a chamfer along the edge finishing with a straight-cut stop (Pl. 26).

Plate 23. Room 2, oblique of stairs showing timber framing, looking West, Scales: 1m.

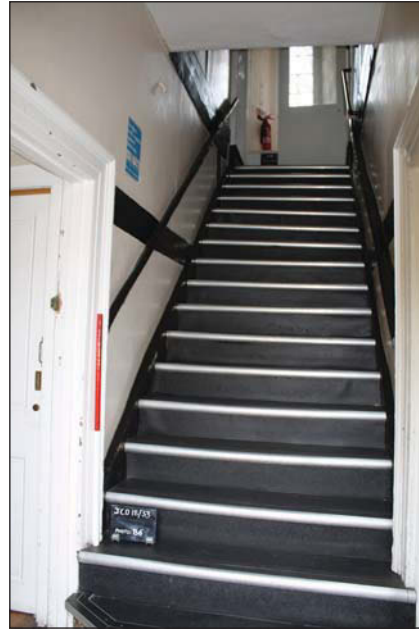
Plate 24. Room 2, oblique of stairs showing timber framing, looking South, Scales: 1m.

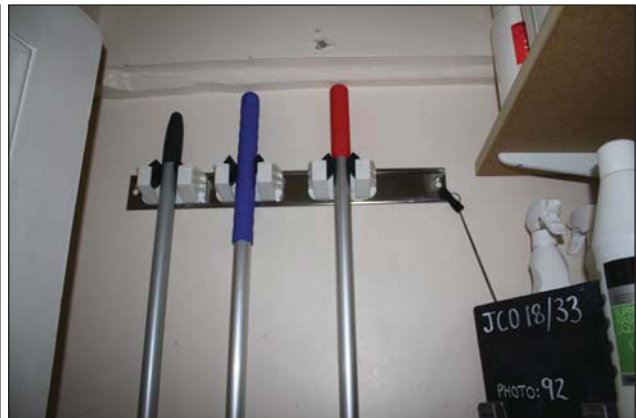
Plate 26. Room 2, store cupboard showing timber framing, looking Southwest.

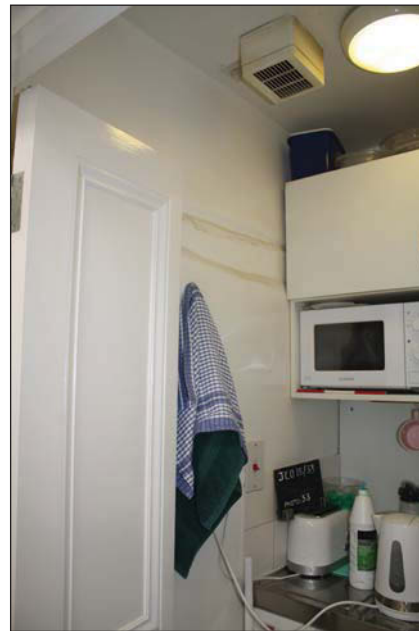
The area to the rear of the stairs (room 2b) consists of a corridor linking rooms 1 and 3, a cupboard beneath the stairs to which there was no access, a toilet and a small kitchen area to the rear of the cupboard (Pl. 27). A pair of windows are present in the southwest wall; one lighting the corridor (Pl. 28), the second within the toilet (Pl. 29). Both windows have a pointed head. The area of the kitchen continues the horizontal wooden timber seen within the adjoining stair wall (Pl. 30). No timber can be seen on the southeast wall though the upper part of the wall has been boxed in approximately at the height at which the timber within the store cupboard of room 2 is present (Pl. 31).

Plate 30. Room 2b, Kitchen showing timber framing, looking North, Scales: 1m and 0.3m.

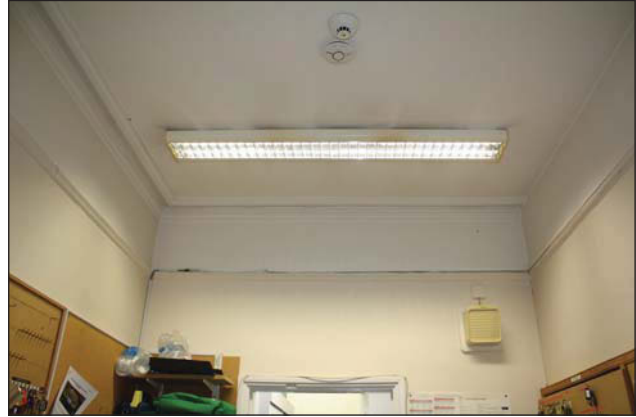
Walls were plastered with a picture rail present and around the ceiling was moulded coving (Pl. 32). Floors were carpeted in the franking room and box store and herringbone parquet in the student pigeon hole room. A third beam is present running across the ceiling. Doors are present in both the north and south walls of the student room and there are two windows in the east wall. The windows varied from those in the northern room with the larger window having a flat head and the splay infilled with panelling along the top and sides (Pl. 33). A shelf formed the window sill with space beneath it. The smaller window had the same pointed head as the other windows of a similar size (Pl. 34). A door is present within the south wall of the franking room and subsequent access is possible to both the box room and student pigeon holes through the modern partitions. The only window within the two rooms is partially obscured by shelving in the box room but has a flat head (Pl. 35).

Plate 32. Room 3, coving detail, looking Northwest.

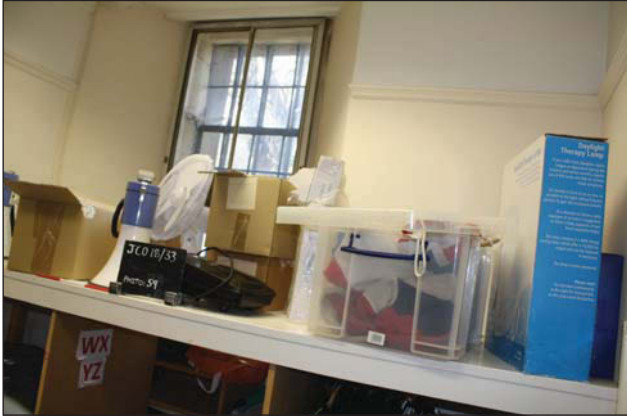
Plate 35. Room 3, window detail,
looking Southwest, Scales: 0.3m.

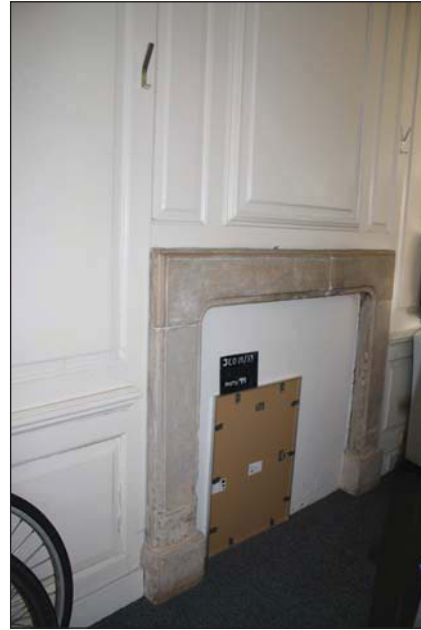
At the far southern end of the building (room 4), the area has been divided into 3 with each room arranged to have a window. Access was via the student pigeon holes (part of room 3) into the deputy manager's office which in turn gave access to the manager's office. The locker room has a separate external access as well as an internal door between it and the manager's office. The walls are floor to ceiling panelled and painted white. The panelling consists of a lower rectangular panel, laid horizontally and an upper, larger vertical, rectangular panel divided by a dado rail (Pl. 36). A cornice hides the wall and ceiling junction (Pl. 37). The ceiling is otherwise of plain plaster and the floor is carpeted throughout. The window within the northeastern elevation was largely obscured but consists of a simple rectangular opening, whilst that in the southwestern elevation has the splayed opening which extends up to the ceiling (Pl. 38). The two windows in the southeastern elevation have shallow splayed openings and extend up to the ceiling (Pl. 39). Running across deputy manager's office and the locker room, on the northeastern side of the room is a beam within the ceiling. The northeastern external wall is also substantially thinner than the other three walls and would likely be a later addition. Within the locker room, between the two windows on the southeastern wall is a blocked fireplace. The fireplace is of stone and the panelling has been built around it. It is relatively plain with a plinth block and a rounded edge on both the internal and external edges (Pls. 40-42).

The panelling is similar to an example dated to 1694 in Yorkshire and 1693 in Oxfordshire with a similar fireplace (Hall, 2005, 141-142). The Oxfordshire example shows a Bolection fireplace with over-mantle with pilasters on either side of a central rectangular panel. It is not clear what material the fireplace surround is made of. With the exception of the panelling immediately above the fireplace the panelling in room 4 is generally of a fairly simple design with an ovolo mould around the frame suggesting a date in the late 17th to 18th

centuries. The cornice with its central square projection would also suggest a date of the late 17th to 18th century. The fireplace is typical of the plainer Bolection moulded fireplaces, a similar example of which is dated to 1734 at Kew (Surrey) (Hall, 2005, 182).

Plate 40. Room 4, fireplace and panelling detail,
looking South.

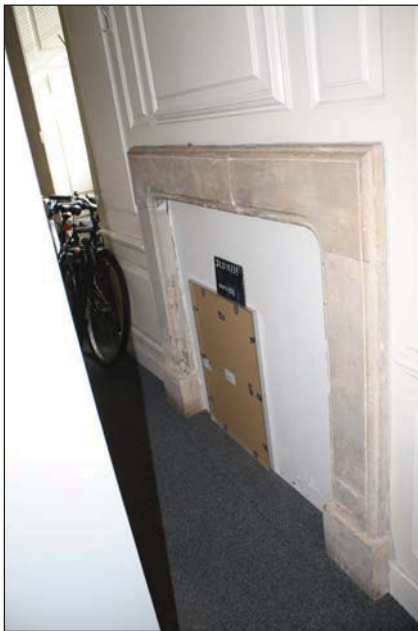
Plate 41. Room 4, fireplace detail, looking Southeast.

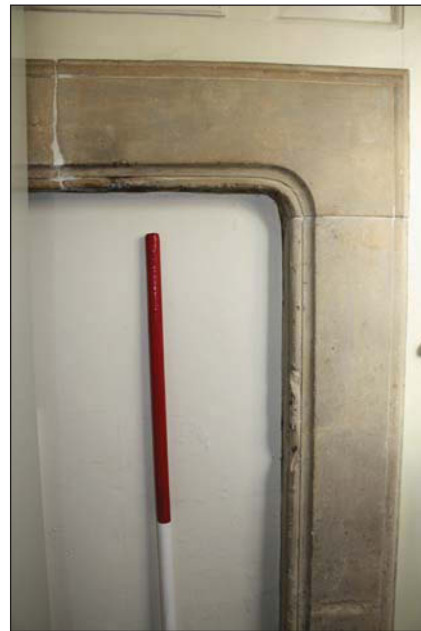
Plate 42. Room 4, fireplace detail, looking Southeast,
Scales 1m.
