**Land east of Church View,  
Sutton Benger, Wiltshire**

**Archaeological Evaluation**

**Site Code: SBW20/146**

**October 2020**

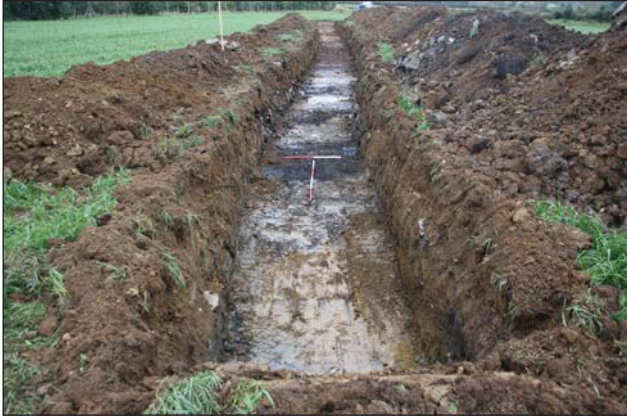
Trenches 4 and 14 were the only two out of the three planned 50m length trenches to be fully excavated. Trench 4 was aligned SE – NW and was 50.5m long and between 1.5m deep at the SE end and 0.9m deep at the SW end. The stratigraphy consisted of 0.15m of topsoil (50) followed by between 0.1m of subsoil overlying mottled dark brown/black/grey sandy silt which contained large amounts of modern waste (52) that continued below excavated depth.

Plate 1. Trench 4, looking NW, Scales: 2m and 1m.

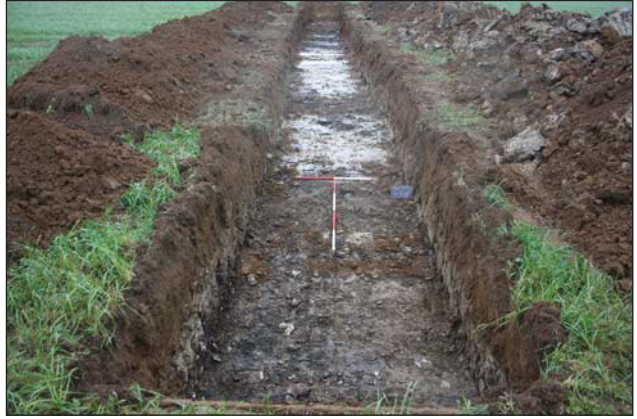
Trenches 5, 7, 10, 11, 12 and 13 were all opened as planned, ranging in length from 30m to 31.4m and in depth from 0.95m to 1.3m. Trench 3 had to be moved some 10m south in order avoid a paddock fence. Trench 17 was only partially opened to 17.3m long due to potentially harmful material being discovered during its excavation and its depth was 0.9m. The stratigraphy of all these trenches consisted of between 0.1 and 0.24m of topsoil (50), followed by between 0.38m and 0.9m of subsoil (51). This sat above a layer of mottled grey/orange clay backfill material (54, 56, 58, 60, 63, 65, 67, 69) followed by a black ash deposit containing various amounts and types of modern rubbish (53, 55, 57, 59, 61, 64, 66, 69, 70) that continued past the depth of excavation.

Plate 2. Trench 11, looking E, Scales: 2m and 1m.

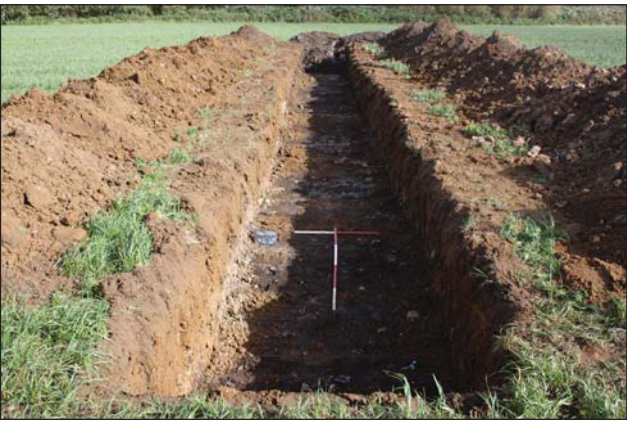
13	30	2	1.08	0-0.24m topsoil (50); 0.24-0.33m subsoil (51); 0.33-0.93m mottled grey/orange clay made ground (67); 0.93m+ black ash and modern waste (68). No natural geology. <b>[Pl. 3]</b>
14	50.15	2	0.98	0-0.18m topsoil (50); 0.18-0.46m subsoil (51); 0.46-0.83m mottled grey/orange clay made ground (60); 0.83m+ black ash and modern waste (61). No natural geology. <b>[Pl. 5]</b>
15	c.2	2	c. 1.2	c. 0-0.6m topsoil (50) and subsoil (51); c. 0.6-1.2m black waste material backfill continuing beyond depth of excavation.
16	c.2	2	c. 1	c. 0-0.6m topsoil (50) and subsoil (51); c. 0.6-1m black waste material backfill continuing beyond depth of excavation. <b>[Pl. 7]</b>
17	17.3	2	0.9	0-0.1m topsoil (50); 0.1-0.35m subsoil (51); 0.35-0.5m mottled grey/orange clay made ground (69); 0.5m+ black ash and modern waste (70). No natural geology.
18	-	-	-	No excavated due to potentially hazardous material within first fills

Plate 3. Trench 13, looking E, Scales: 2m and 1m.

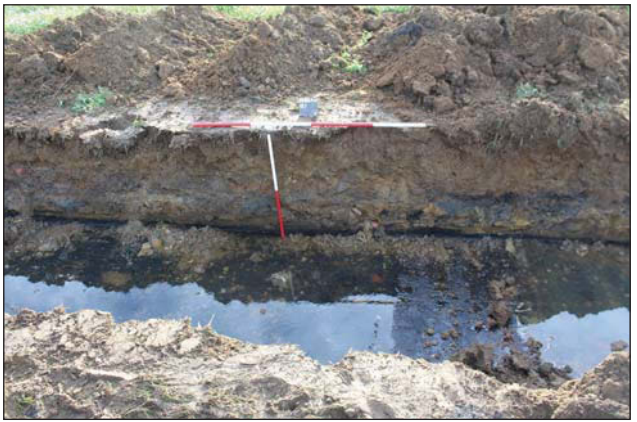
7	31.2	2	0.98	0-0.1m topsoil (50); 0.1-0.40m subsoil (51), 0.4-0.85m mottled grey/orange clay made ground (54); 0.85m+ black ash and modern waste (55). No natural geology. <b>[Pl. 4]</b>
8	c.2	2	c. 0.9	c. 0-0.4m topsoil (50) and subsoil (51); c. 0.4-0.9m grey backfill material coming onto black waste backfill.
9	c.2	2	c. 1	c. 0-0.6m topsoil (50) and subsoil (51); c. 0.6-1m black waste material backfill continuing beyond depth of excavation.
10	30	2	0.95	0-0.1m topsoil (50); 0.1-0.25m subsoil (51); 0.25-0.83m mottled grey/orange clay made ground (56); 0.83m+ black ash and modern waste (57). No natural geology.
11	30.3	2	1	0-0.1m topsoil (50); 0.1-0.48m subsoil (51); 0.48-0. mottled grey/orange clay made ground (58); 0.83m+ black ash and modern waste (59). No natural geology. <b>[Pl. 2]</b>
12	30.6	2	1.3	0-0.23m topsoil (50); 0.23-0.46m subsoil (51); 0.46-0.85m dark grey clay with modern waste; 0.85-1.1m mottled grey/orange clay made ground (63); 1.1m+ black ash and modern waste (64). No natural geology.

Plate 4. Trench 7 section, looking SE, Scales: 2m and 1m.

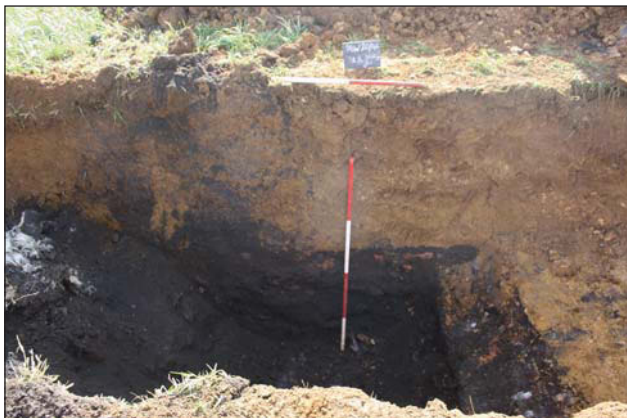
Trench 14 was 50.15m long, aligned W - E and 0.98m deep, with stratigraphy of 0.18m topsoil, 0.9m subsoil, above 0.6m of mottled grey/orange clay backfill (67) followed by a black ash and modern waste (68). A sondage at the trench's east end found this final fill continued for at least 1.5m with no bottom found.

Plate 5. Trench 14 sondage, looking S, Scales: 2m and 1m.

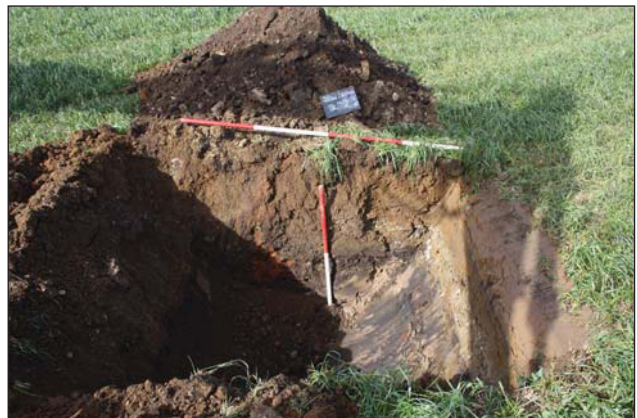
Trench/ Test pit	Length (m)	Breadth (m)	Depth (m)	Comment
1	c.2	2	c. 2	0-0.6m topsoil (50) and subsoil (51), 0.6-2m number of layers of backfill continuing beyond depth of excavation.
2	c.2	2	c. 1	0-0.5m topsoil (50) and subsoil (51); 0.5-7m grey backfill material 0.7-1m black waste material backfill continuing beyond depth of excavation. <b>[Pl. 6]</b>
3	30	2	1.04	0-0.1m topsoil (50), 0.1-0.25m subsoil (51); 0.25-0.83m mottled grey/orange clay (65); 0.83m+ black ash and modern waste (66). No natural geology.
4	50.5	2	0.9 nw - 1.5 se	0-0.15m topsoil (50); 0.15-0.25m subsoil (51); 0.25m+ mottled dark brown/black/grey sandy silt with modern waste (52). No natural geology <b>[Pl. 1]</b>
5	31.4	2	1.05	0-0.1m topsoil (50); 0.1-0.3m subsoil (51); 0.3m+ landfill deposits (53). No natural geology
6	c.2	2	c. 1	c. 0-0.5m topsoil (50) and subsoil (51); c.0.5-1m grey backfill material coming onto black waste backfill.

Plate 6. Trench 2, looking W, Scales: 2m and 1m.

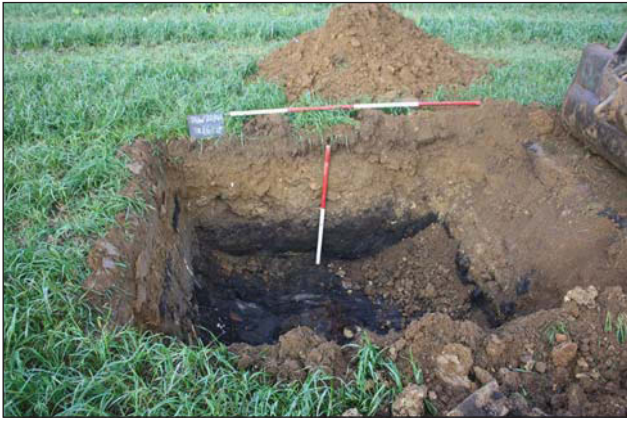
This revised programme of work resulted in 21 test pits being excavated, ranging in depth from 0.98m to 2m each with slightly variable depths of topsoil/subsoil followed by a range of backfill and landfill deposits that continued beyond the excavated depths reached. No natural geology was reached.

Plate 7. Trench 16, looking W, Scales: 2m and 1m.

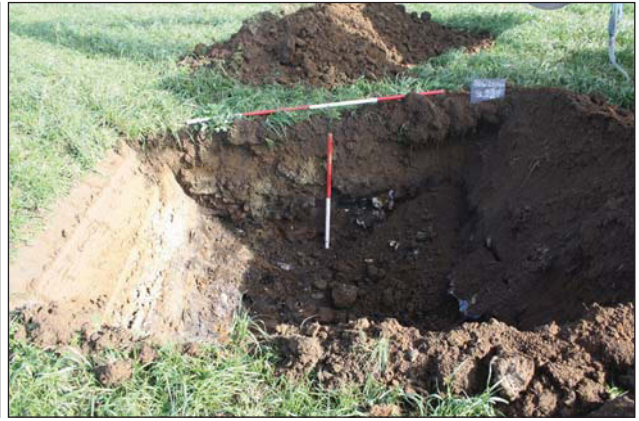
Plate 8. Trench 22, looking N, Scales: 2m and 1m.

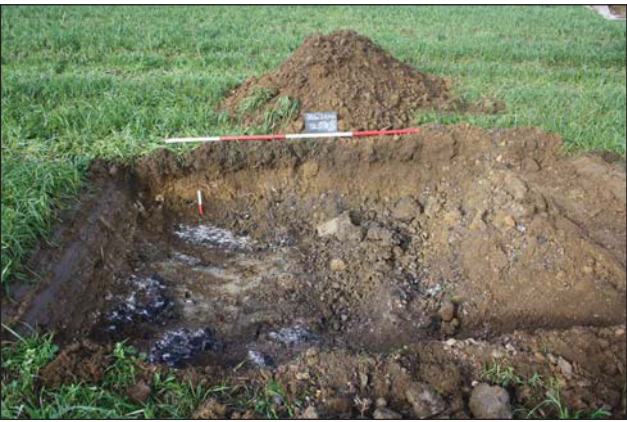
Trenches 21 and 26 were both dug as test pits of *c.* 2m by 2m, however they differed from the other 21 trenches. Trench 21 was 0.5m deep and trench 26, 0.3m deep. The stratigraphy for both consisted of topsoil (50) and subsoil (51) overlying a broken Tarmac deposit that could not be removed in the confined space of the test pit and therefore the full 1m depth could not be reached.

Plate 9. Trench 13, looking W, Scales: 2m and 1m.

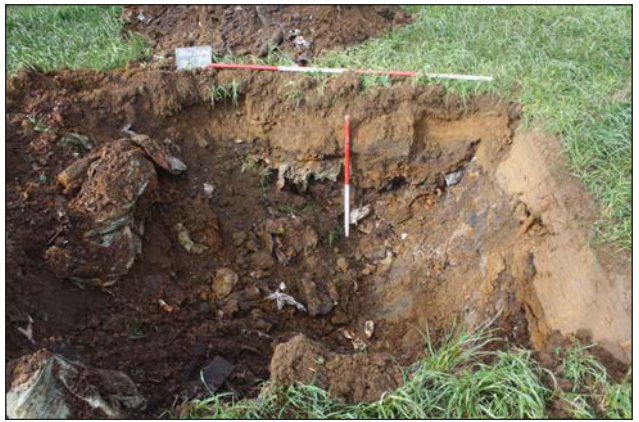
26	c.2	2	c. 0.3	c. 0-0.5m topsoil (50) and subsoil (51); coming onto broken tarmac.
27	c.2	2	c. 1.1	c. 0-0.6m topsoil (50) and subsoil (51); c. 0.6-1m mixed waste material backfill continuing beyond depth of excavation. <b>[Pl. 10]</b>
28	c.2	2	c. 1	c. 0-0.6m topsoil (50) and subsoil (51); c. 0.6-1m black waste material backfill continuing beyond depth of excavation.

Plate 10. Trench 27, looking W, Scales: 2m and 1m.

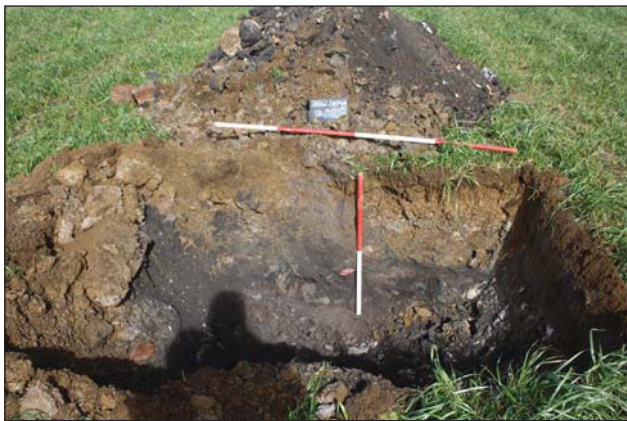
<i>Trench/ Test pit</i>	<i>Length (m)</i>	<i>Breadth (m)</i>	<i>Depth (m)</i>	<i>Comment</i>
29	c.2	2	c. 1.3	c. 0-0.2m topsoil (50); c. 0.2-0.4m redeposited clay; c. 0.4-0.8 grey backfill; c.0.8-1.3 black waste material backfill continuing beyond depth of excavation.
30	c.2	2	c. 1	c. 0-0.5m topsoil (50) and subsoil (51); c. 0.5-1m black waste material backfill continuing beyond depth of excavation. <b>[Pl. 11]</b>
31	c.2	2	c. 1.5	c. 0-0.6m topsoil (50) and subsoil (51); c. 0.6-1m grey backfill material c.1-1.5 black waste material backfill continuing beyond depth of excavation.
32	c.2	2	c. 1.2	c. 0-0.8m topsoil (50) and subsoil (51); c. 0.8-1.2m black waste material backfill continuing beyond depth of excavation.
33	c.2	2	c. 1	c. 0-0.6m topsoil (50) and subsoil (51); c. 0.6-1m black waste material backfill continuing beyond depth of excavation.
34	c.2	2	c. 1	c. 0-0.6m topsoil (50) and subsoil (51); c. 0.6-1m black waste material backfill continuing beyond depth of excavation. <b>[Pl. 12]</b>

Plate 11. Trench 30, looking N, Scales: 2m and 1m.

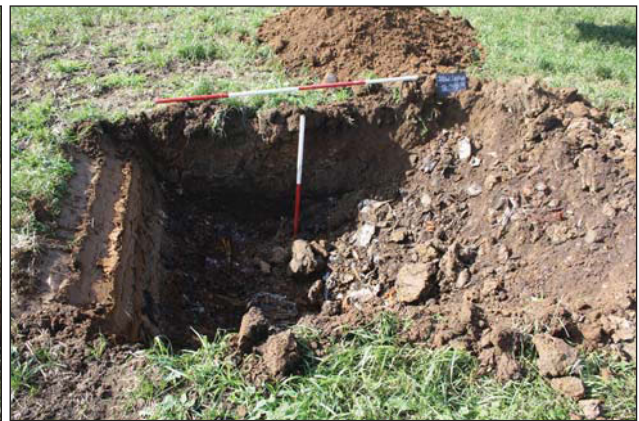
Plate 12. Trench 14, looking N, Scales: 2m and 1m.
