**Demolition of the Second World War Heavy  
Anti-Aircraft Battery at Pirton Fields,  
Churchdown near Gloucester, Gloucestershire**

**Archaeological Watching Brief**

**Site Code: SCI 14/186**

**Report 14/186b**

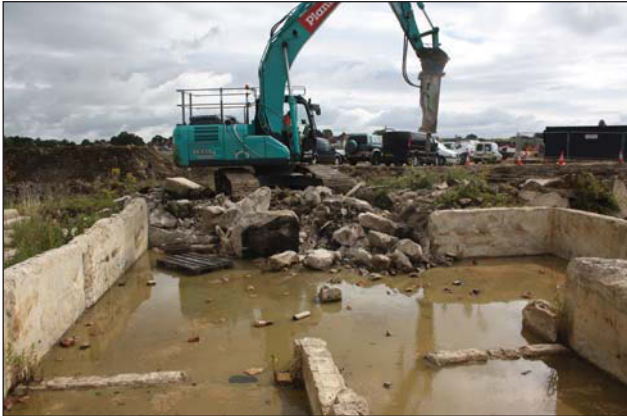
The command post exists as an irregular reinforced concrete structure which is 17.3m by 14m in width and consists of three sunken rooms connected by a ground level concrete surface (175). Observation of its demolition revealed that beneath each of the sunken rooms an initial layer of 0.1m of concrete (857) was placed directly onto the natural geology. The upper surface of this concrete had been smoothed and levelled and a coating of 0.03m of rubberized bitumen damp proof (858) then applied, above which was the floors of the sunken rooms (165, 177, 180). Also noted during demolition of the command bunker was the presence of an internal wall (856) within the east sunken room. This had not been noted in previous archaeological works due to the presence of asbestos preventing excavation of the room. The wall was constructed of single width (0.23m), hollow concrete block laid in a stretcher bond and survived to a length of 1.2m. The wall was located on the east side of the room, some 2.8m along the east edge from south east corner and was orientated north east to south west.

Plate 1. Demolition of command bunker 1000, looking NE.

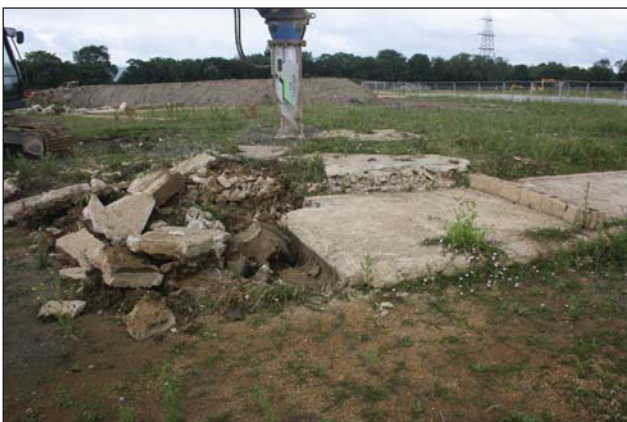
Demolition of the associated concrete building platforms revealed little apart from that the single level of concrete was laid directly onto the natural geology and lacked the rubberized bitumen damp proofing present under floors of the command bunker

Plate 3. Demolition of building platform 1004, looking S.

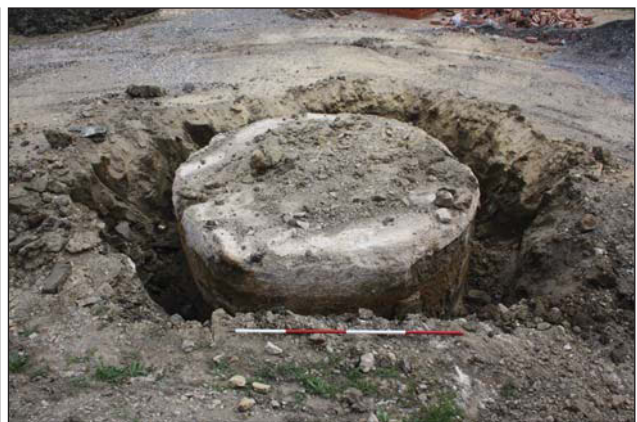
Due to the nature of their construction the demolition of the gun emplacements was carried out by excavating down the side of each gun mount and removing them, allowing a better approach for the hydraulic breaker. It was noted during their demolition that the gun mounts consisted of a 1.2m deep and 4m diameter cylindrical hole (520, 521, 522, 523). The hole was filled with a single block of concrete that domed slightly above ground surface (157, 159, 161, 163). Housed within sat a steel frame box or holdfast (156, 158, 160, 162) with only its top face visible, flush with the concrete. The form of this face in a steel bar square 2.34m in diameter, with a fifth bar running diagonally from the north corner to the south, protruding slightly at either end.

Plate 4. Gun mount 1002, looking W, Scales: 2m.

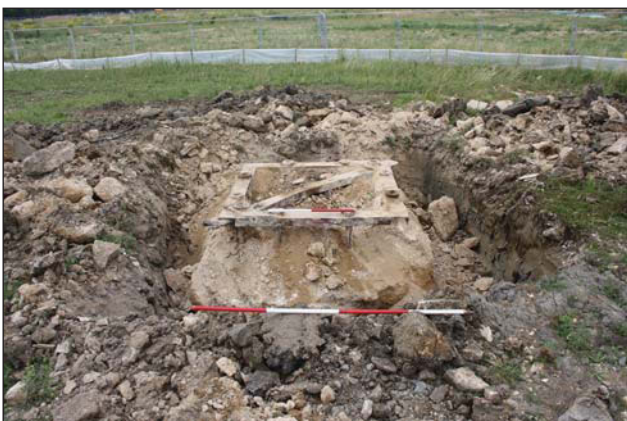
Plate 5. Gun mount 1004, looking W, Scales: 2m and 1m.

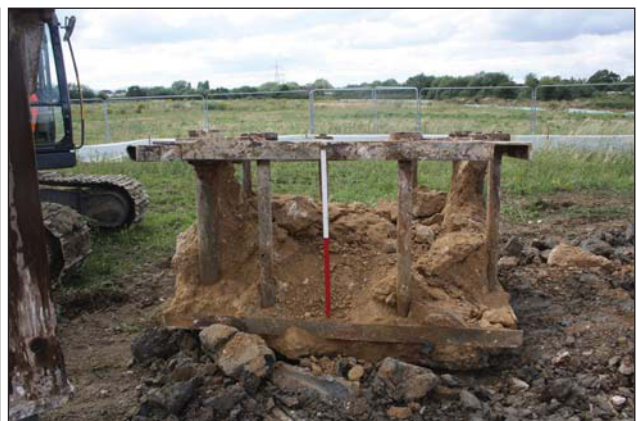
On top of the holdfast's frame sits ten spigots to which the gun would have been attached. Removal of the encasing concrete revealed that from the underside of each spigot protruded a 0.17m diameter hollow steel pipe 1.14m long. These then connected to a second steel frame 2.34m in diameter.

Plate 6. Extracted holdfast 162, Scales: 1m.
