**The Bungalow, Bayhall Road, Royal
Tunbridge Wells, Kent**

Archaeological Watching Brief

Site Code: BRTW20/80

**An Archaeological Watching Brief
For Comber and Son Building Contractors**

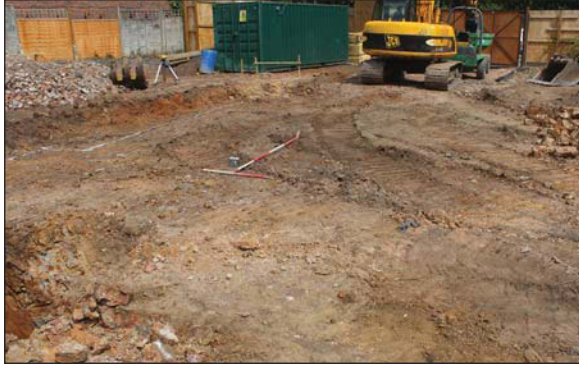
Plate 1. General view of site, looking North.

The site was visited at the end of July 2020, shortly after The Bungalow had been demolished (pPl. 1). It was clear that the entire area had been significantly disturbed by the demolition and subsequent removal of rubble. The footprint of the new dwellings had been marked out (Fig. 3; Pl. 2) and, although there was still some demolition rubble present, patches of the underlying natural sandy clay geology were visible. A small area of footing excavations was monitored, to a depth of 1.5m (Fig. 4), and this confirmed that previous activity on the

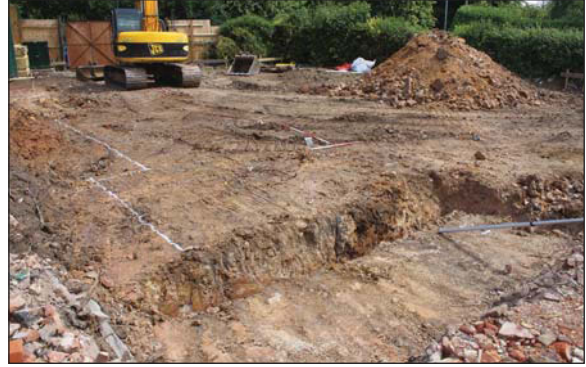
Plate 2. General view of site, looking North-east.

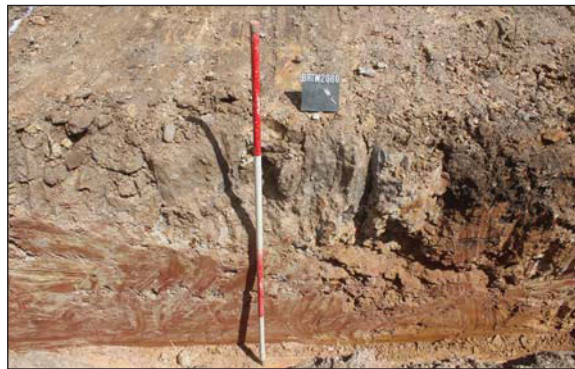
Plate 3. Footing trench showing stratigraphy,
looking North-east.
Scale: 2m.

site had removed any original soil horizons. Ignoring those areas where made ground (demolition debris) was still present, the upper 0.40m of the natural geology consisted of a mid yellow brown sandy clay. Below this depth the natural geology became more clayey and redder in colour (Pl. 3).
