**74 Icknield Way and Icknield House,  
Baldock, Hertfordshire**

**Archaeological Watching Brief**

**Site Code: IWB20/39**

**February 2021**

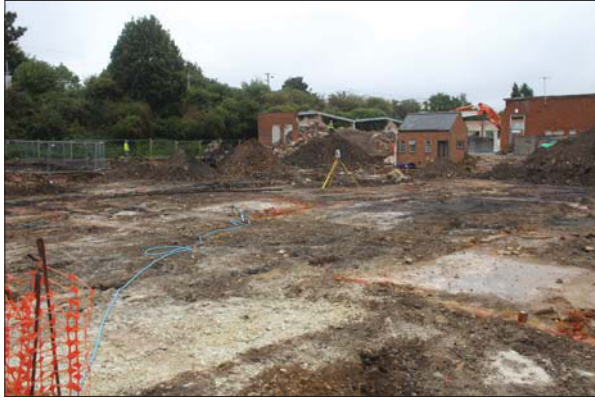
Plate 1. Remediation, excavated level under concrete slab

saw the presence of modern backfill or ground intrusive features. Prior to any re-development, the slabs had to be removed (Pls 1 and 2). They were about 0.20-0.25m thick, overlying bedding layers, usually a light yellowish brown sand or a dark grey to black gravel at west under Tarmacadam. Below this was a mixed made ground (0.22-0.27m thick) with common construction debris but also redeposited chalk also yielding some modern waste. The brick foundations of former (now demolished) buildings and some modern concrete or brick floors were also mechanically removed. Modern backfill or intrusive features reached to between 0.50-1.10m below actual surface.

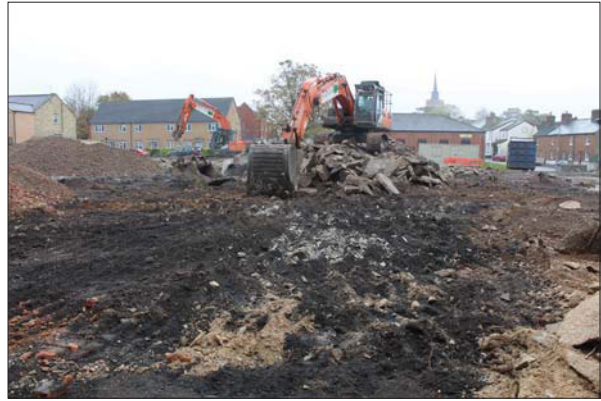
Plate 1. Remediation, working progress.

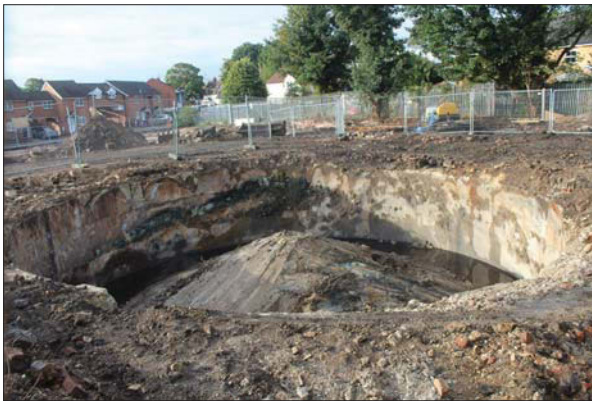
Plate 3. Remediation, interior base of gas holder.

Amidst multiple recent truncations, ranging from a pit 1m in diameter to large scale deposits (30m<sup>2</sup>), a few features could be distinguished. Three large circular features were observed in the north-west, one with diameter of c. 8.80m, and two c. 10.5m. They were built of concrete and bricks (Pl. 3) and easily identified as Victorian underground gas tanks, visible on the 1898 Ordnance Survey (OS) map, one disappearing on the 1922 OS map and only one was left on the 1937 OS map edition. Another observed feature was a tar well (Pl. 4), about 4m in diameter and 2m deep. The ground reduction went deeper in these areas to complete the decontamination.

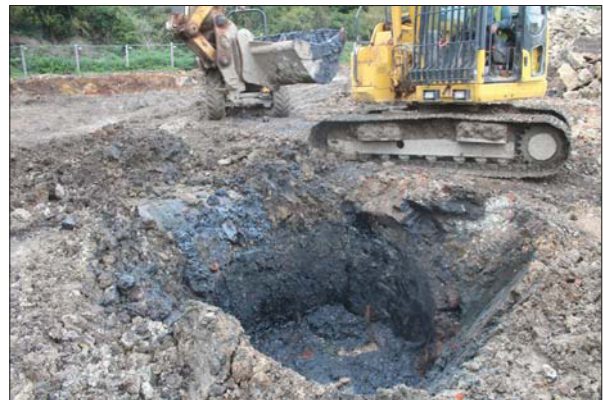
Plate 4. Remediation, tar well.

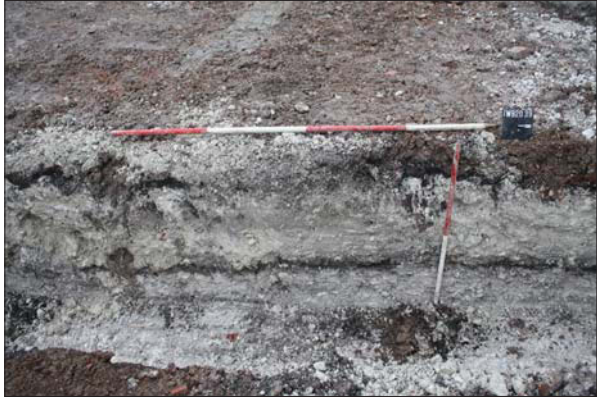
Plate 5. Groundwork, representative section of E building, Scales: horizontal 2m, vertical 1m

The eastern part of the site (Fig. 5) was also heavily truncated by modern deposits but a clearer view of the stratigraphy emerged. Below the slabs was a 0.10-0.15m thick made ground, a dark grey to black clayey silt with frequent modern brick/tile fragments, pipe fragments, plastic, etc. It overlay 0.25-0.55m of chalk, a thick made ground deposit of the redeposited natural, which could be related to the previous development of the site, or from the construction of the bank for the railway immediately to the north. The latter is perhaps suggested as this deposit was more substantial towards the north. In place this covered a 0.10-0.15m dark greyish brown clay silt, which could be interpreted as a buried topsoil or a subsoil (Pl. 5). The geological horizon was then reached

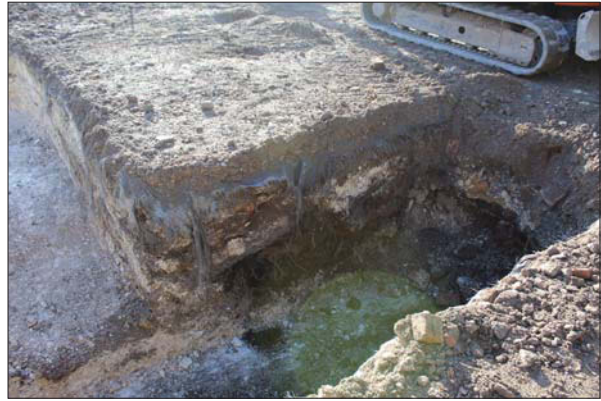
Plate 6. Groundworks, variety of modern fill exposed in section during groundworks.

The footings for the new buildings were excavated with a ditching bucket at a varying depth around 0.80-1.20m and 0.70m wide. No archaeological features or deposits were observed and only modern truncation and services were noted (Pl. 6).

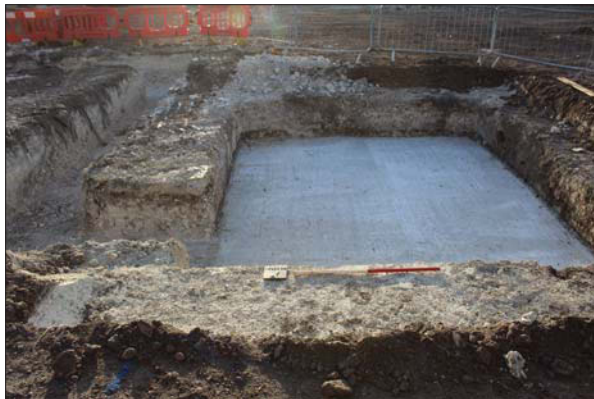
Plate 7. Groundworks, concreted lift base of E building, Scale: 1m.

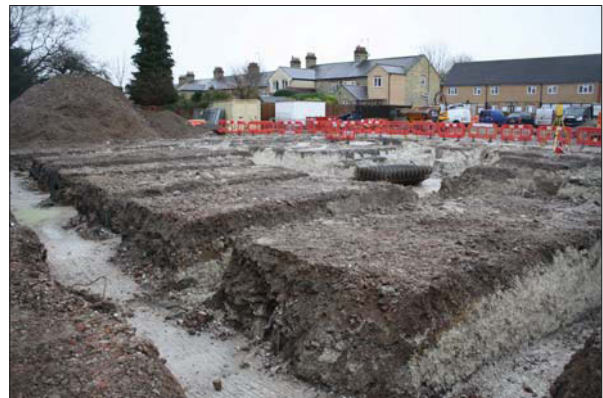
Plate 8. View of new footings, showing the varying depth of made ground overlaying geology.

between 0.70m and 1m below the modern surface. In other parts the overburden directly overlay the natural geology (Pl. 8) or modern truncation.
