104 Peckham High Street, Peckham, London Borough of Southwark

Building Recording

Site Code: PHP20/38

Report 20/38b

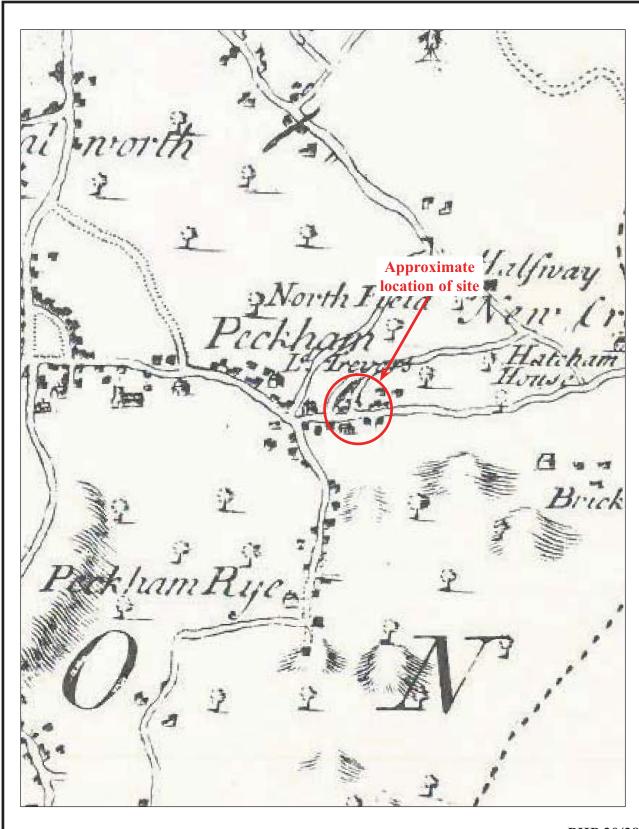
Figure 3. Senex's map of Surrey, 1729.

The first map to give a layout of Peckham is the 1729 map of Surrey by Senex (Fig. 3), although it seems rather stylized or even haphazard. A road leading from Camberwell through the village can be identified as the modern Peckham High Street. Other roads shown on the map, however, are difficult to ascribe to specific modern roads. Houses are shown lining the road corresponding to Peckham High Street and it is conceivable that the site was at least partly developed at this time although it is impossible to identify it with precision. A more detailed layout is shown on Rocque's map of Surrey from 1768 (Fig. 4). In addition to the road corresponding to Peckham High Street, now it is possible to identify Peckham Hill Street and Rye Lane. The area of the site is

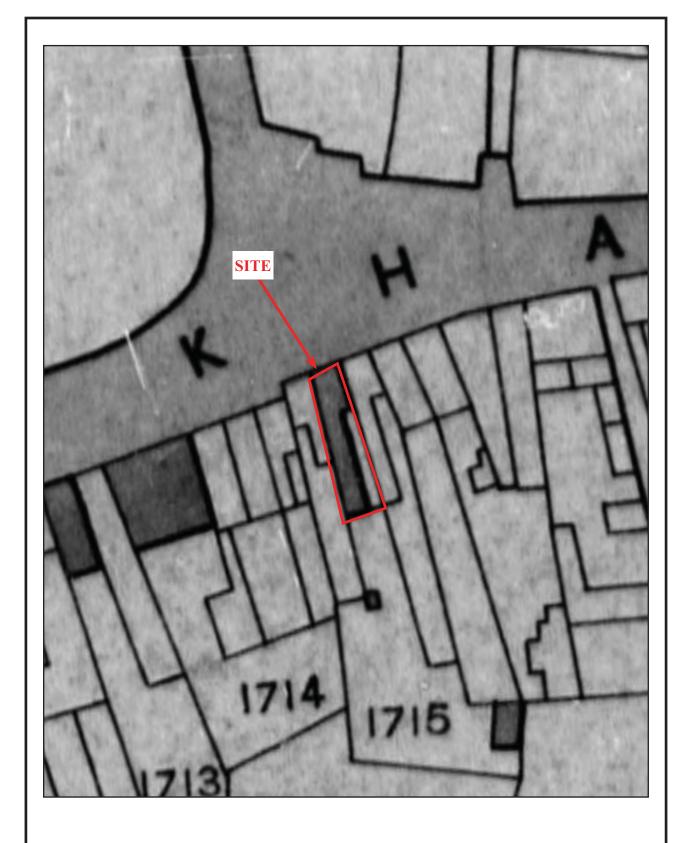
Figure 5. Plan of the Parish of Camberwell in the County of Surrey, 1838.

A Plan of the Parish of Camberwell in the County of Surrey from 1838 (Fig. 5) is the first map to allow for a precise identification of the site. It comprises part of plot 1715. The plot fronts the road and contains a long, reversed L-shaped building. The building occupies the majority of the north of the plot, leaving a narrow strip of undeveloped land in the south-eastern section. The rear part of plot 1715 within the site is undeveloped, although the plot contains two structures, one of which adjoins the site's south-western corner.

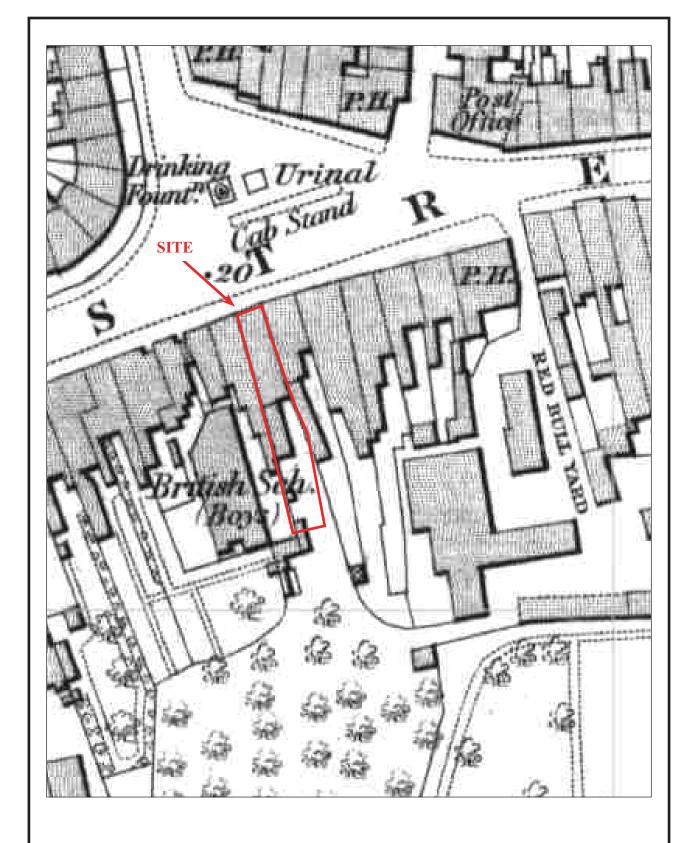
Figure 6. Ordnance Survey map, 1874.

The First Edition Ordnance Survey map from 1874 (Fig. 6) and the 1875 Ordnance Survey Town Plan (not illustrated) depict the site as the northern part of a large plot whose southern part is wooded. The building from the previous map has been enlarged and there is also another small structure to the south, presumably a shed or outhouse, as well as part of another structure in the south-western corner of the site. The 1896 Town Plan (not illustrated) and the Second Edition Ordnance Survey map from the same year (Fig. 7) show the site as a single plot. The main building fronting the road appears unchanged, while the structure to the south appears to have been enlarged. The building in the south-western corner has been removed. By 1916 (Fig. 8), the building fronting the road is smaller and rectangular, although it is impossible to conclude whether the structure from the previous map had been demolished and replaced or greatly altered. It now occupies a little more than two thirds of the site, while the remainder appears undeveloped. The structure to the south has been removed.
