# **Hale Manor Farm, Herringford, Arreton, Isle of Wight**

**An Archaeological Desk-Based Assessment  
and Field Evaluation  
for AE Brown Farms Ltd**

by Simon Cass and Steve Preston  
Thames Valley Archaeological Services Ltd

**Report 08/11**

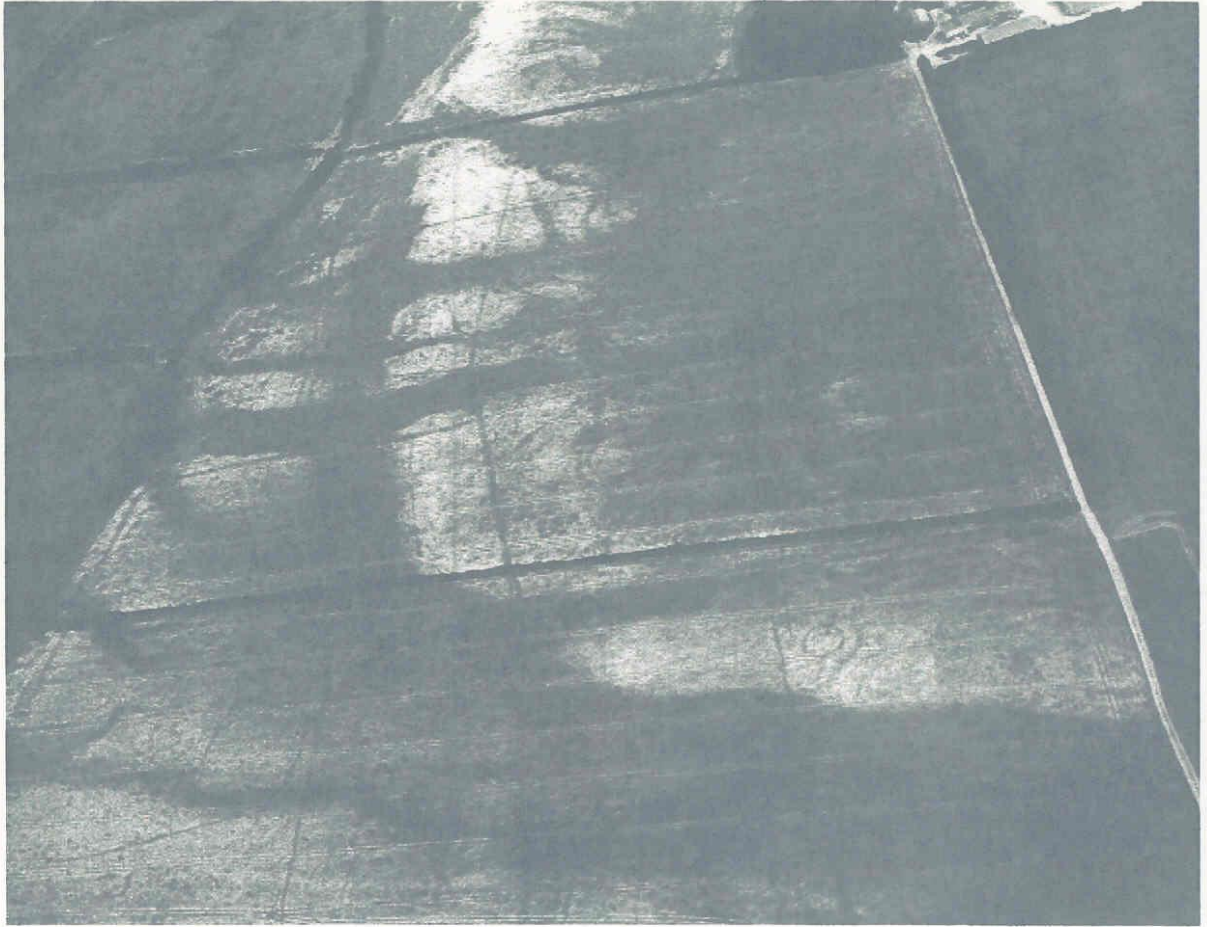
Plate 1. Complex cropmarks east of the site  
Photograph 96A2/09, copyright Isle of Wight, all rights reserved. NMR Reference IOW16987/09

The SMR already notes the presence of cropmarks in the vicinity of the site (numbers 7 and 8 in Appendix 1 and on Fig. 1, see above), but is a little vague as to their actual extent. Examination of the full range of photographs available shows that the large field directly south-west of Hale Manor Farm reveals an extensive array of cropmarks (Plate 1), many of which are clearly geological in origin, but a large number of which suggest prehistoric occupation, including both large and small enclosures, fields, trackways, one clear circular mark that could be a barrow but in this context may be more likely to be a round house, and many maculae that may be natural, or may be pits. There is a very clear dark band of natural origin, broadly corresponding to the 20m contour, which seems to be marking colluvial or alluvial build-up at the edge of a former terrace. This may have buried the archaeologically relevant horizon at this point. In most years the cropmarks are all to the east of this; this need not imply that all subsurface features are also limited to the east of this line, they may simply be deeply buried to the west.

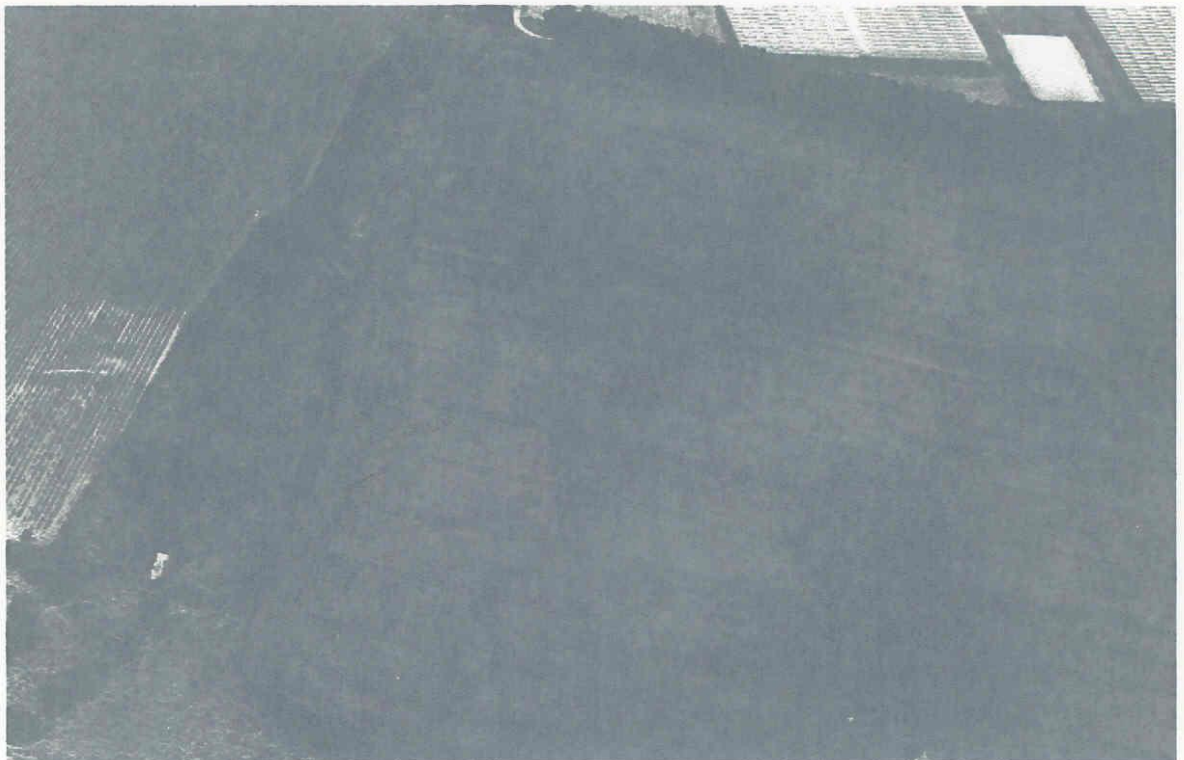
Plate 2. Continuing cropmarks, south of the site.  
Photograph 94B1/22, copyright Isle of Wight, all rights reserved. NMR Reference 19310/22

This series of cropmarks continues in similar vein to the south (the field west of Mackett's Farm: Plate 2), but appears not to extend further east. In most years, the fields of the proposal site proper, west of these cropmarks, have been pasture, and no cropmarks are visible in them (Plate 3). However, several photographs from spring 1968 show cropmarks extending through the small fields by the railway/river line, but not, on this occasion in the fields to the east (Plate 4). Again, most of the marks are clearly of geological origin, and others are modern drains, but one or two might represent continuations of the occupation features from the adjoining fields, in the form of small enclosures.

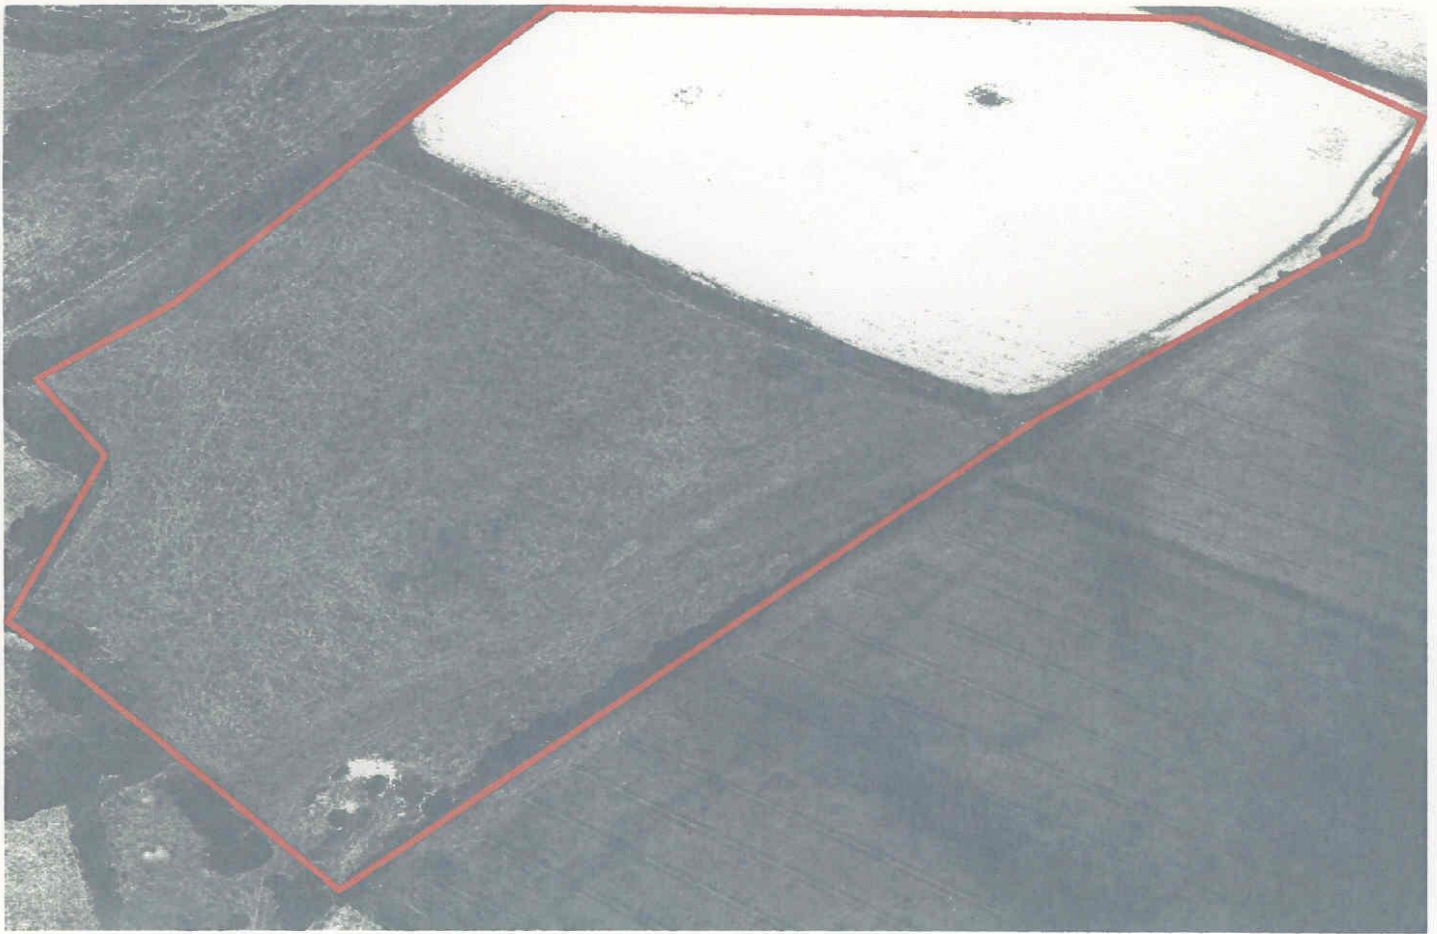
Plate 3. Typical view of south part of site; no cropmarks visible.  
Photograph 87D1/17, copyright Isle of Wight, all rights reserved. NMR Reference IOW3916/17

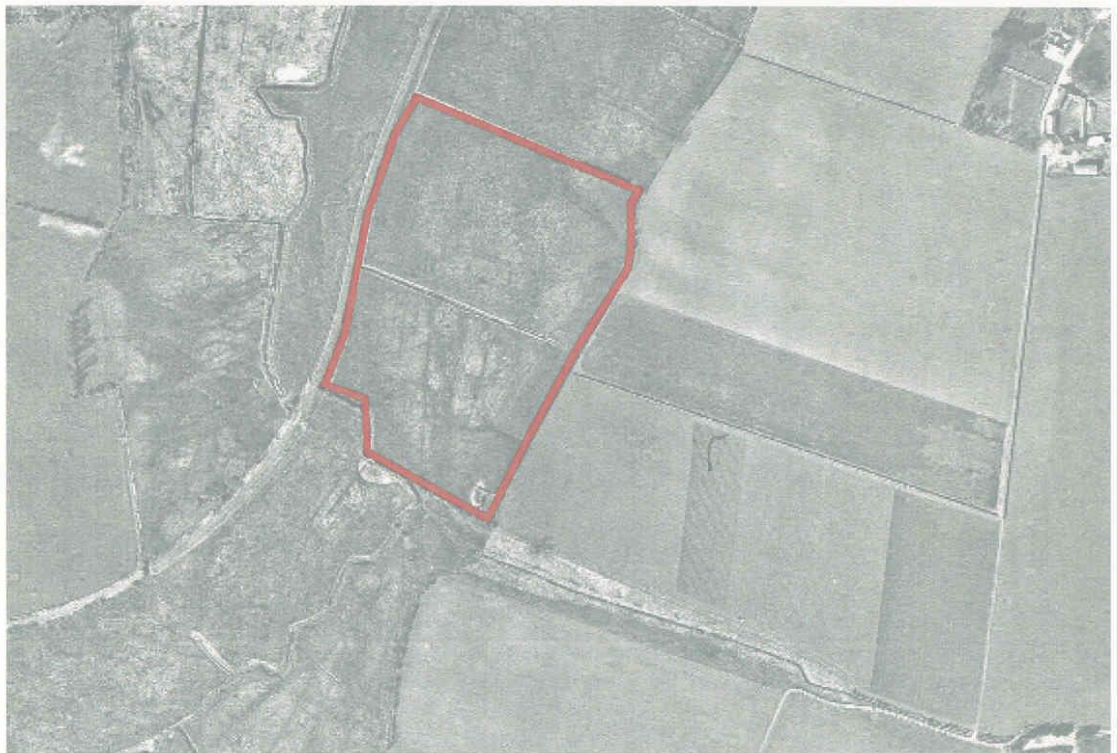
Plate 4. Vertical view, mainly natural marks, some possible features?  
Photograph OS68026/680, Crown copyright reserved.

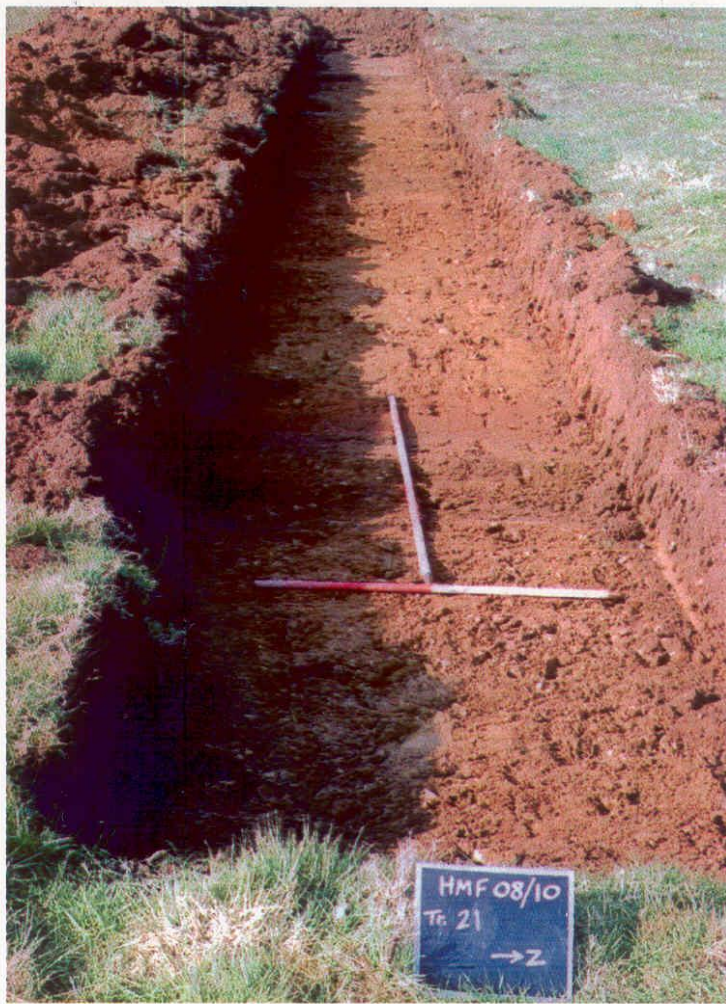
These trenches comprised 0.12m of topsoil above 0.16–0.22m of brown grey sandy silty clay subsoil above natural geology of mottled orange brown clay (with pebbles in Trench 22).

Plate 5. Trench 21 looking west, scales 1m and 2m.

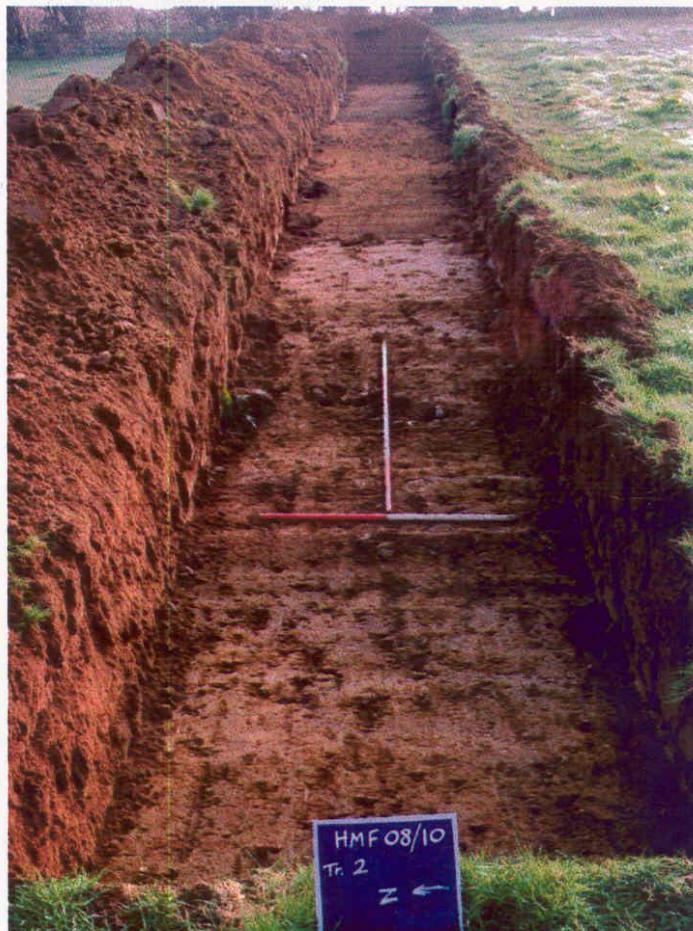
Stratigraphy in this trench consisted of 0.11m of topsoil above 0.43m of grey brown silty clay subsoil above pale brown clay with some gravel inclusions. Two almost identical post holes were excavated (1 and 2) (Figs. 9 and 10). These were both oval, 0.25m by 0.20m and each just 0.07m deep, filled with grey sand and neither produced any finds.

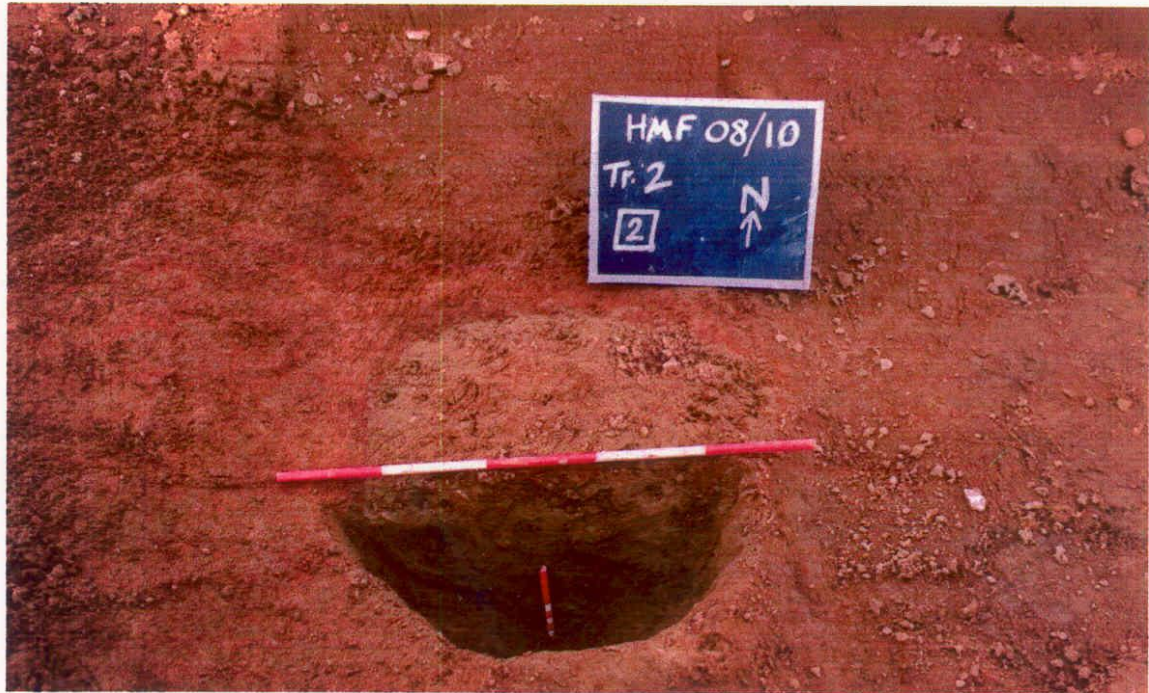
Plate 7 Trench 2, Posthole 2, looking north. Scales 0.5 and 0.1m

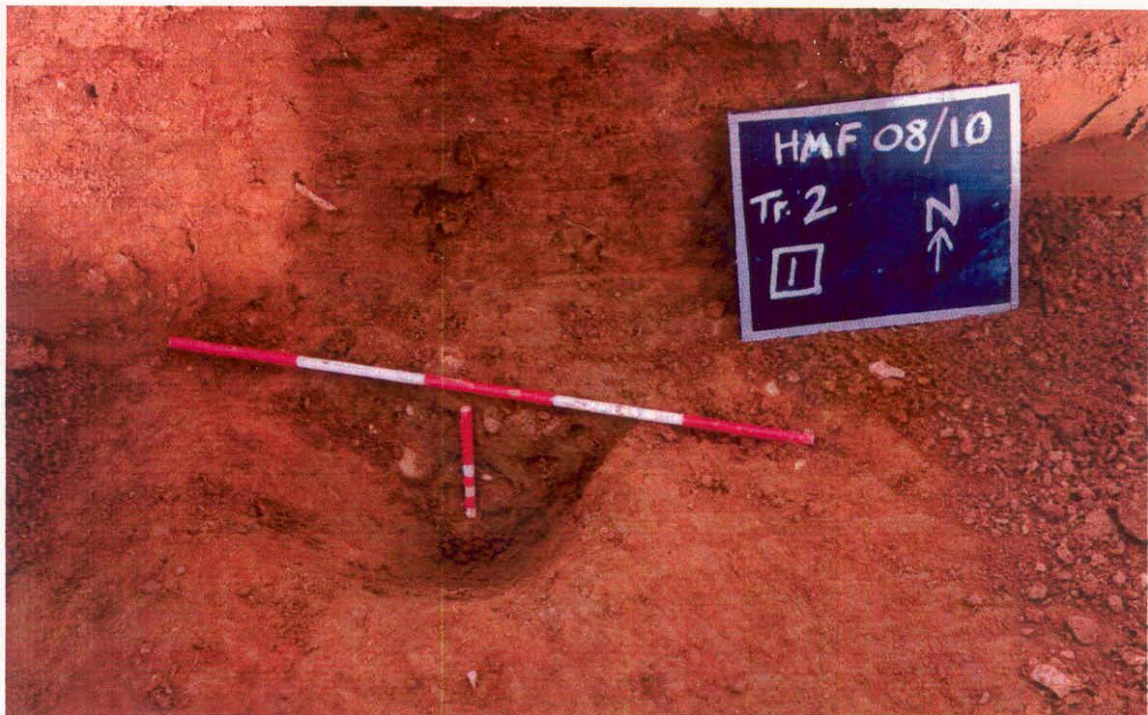
Plate 8. Trench 2, posthole 1, looking north. Scales 0.5 and 0.1m
