**New Sports Hall, St Andrews Catholic School,  
Leatherhead, Surrey**

**An Archaeological Evaluation**

# **New Sports Hall, St Andrews School, Leatherhead, Surrey An Archaeological Evaluation**

**Report 08/88**

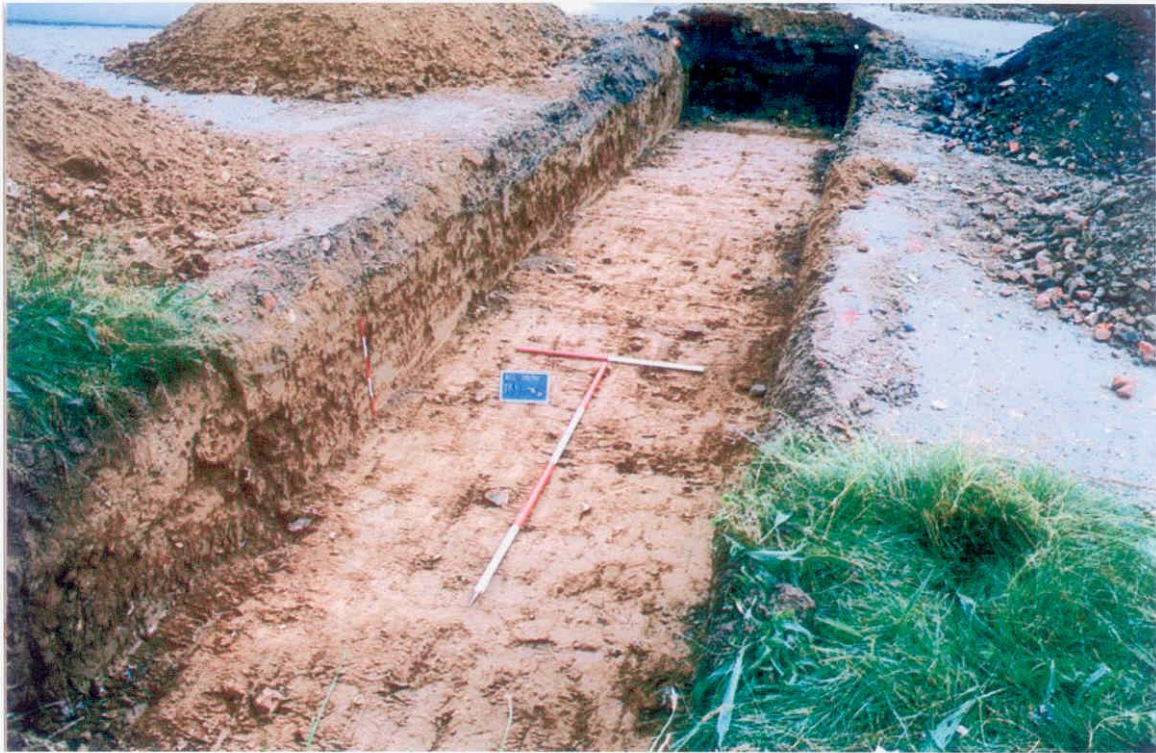
Plate 1. Trench 1 looking north-east, Scales 0.5m, 1m and 2m.

### Trench 1 (Plate 1)

This trench was 10.2m long, 1.6m wide, 0.94m deep and orientated south west – north east. The stratigraphy encountered consisted of 0.2m of made ground (modern demolition crush piling mat) above 0.55m of brown sandy silt subsoil with frequent small stones. This lay above a mottled brown silty sand deposit with occasional small stones, interpreted as a natural formation. There were no archaeological finds or deposits present in this trench.

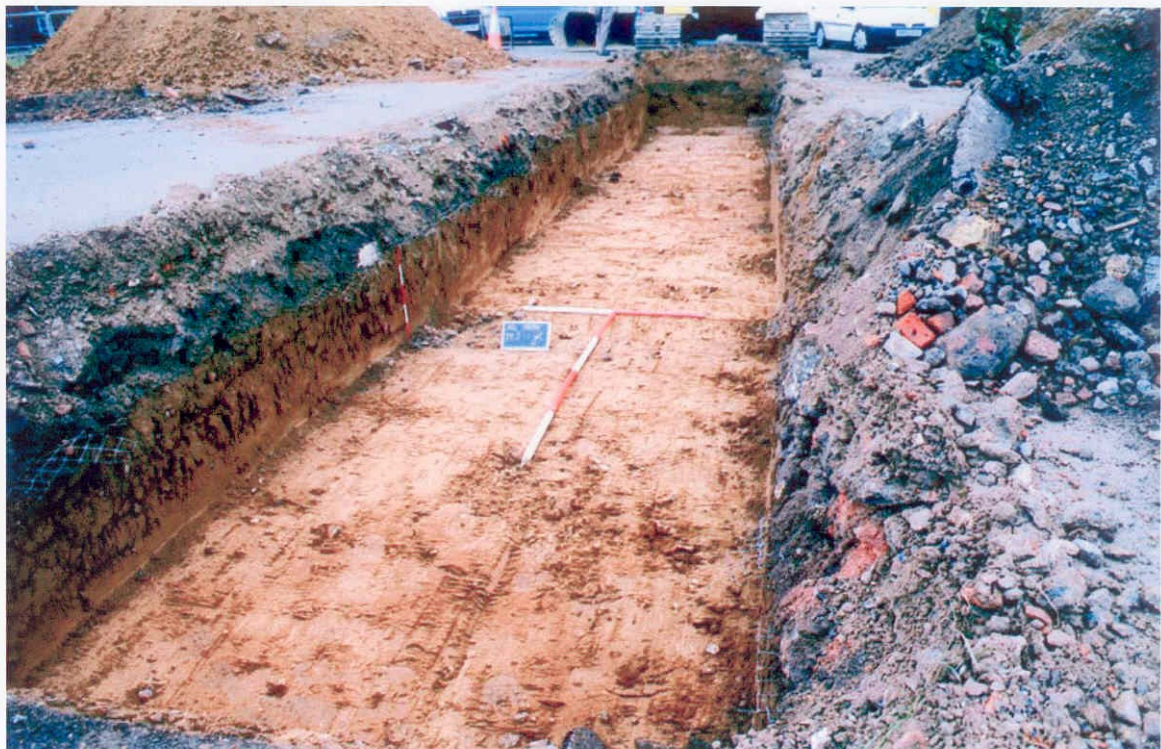
Plate 2. Trench 2 looking south-east, Scales 0.5m, 1m and 2m.

### Trench 2 (Plate 2)

This trench was 15.3m long, 1.6m wide, 0.89m deep and orientated north west - south east. The stratigraphy encountered consisted of 0.4m of made ground (again, modern demolition crush) above 0.4m of subsoil as in Trench 1. This overlay brown silty sand deposit as in Trench 1 with occasional small to medium stones. There were no archaeologically finds or deposits within this trench.

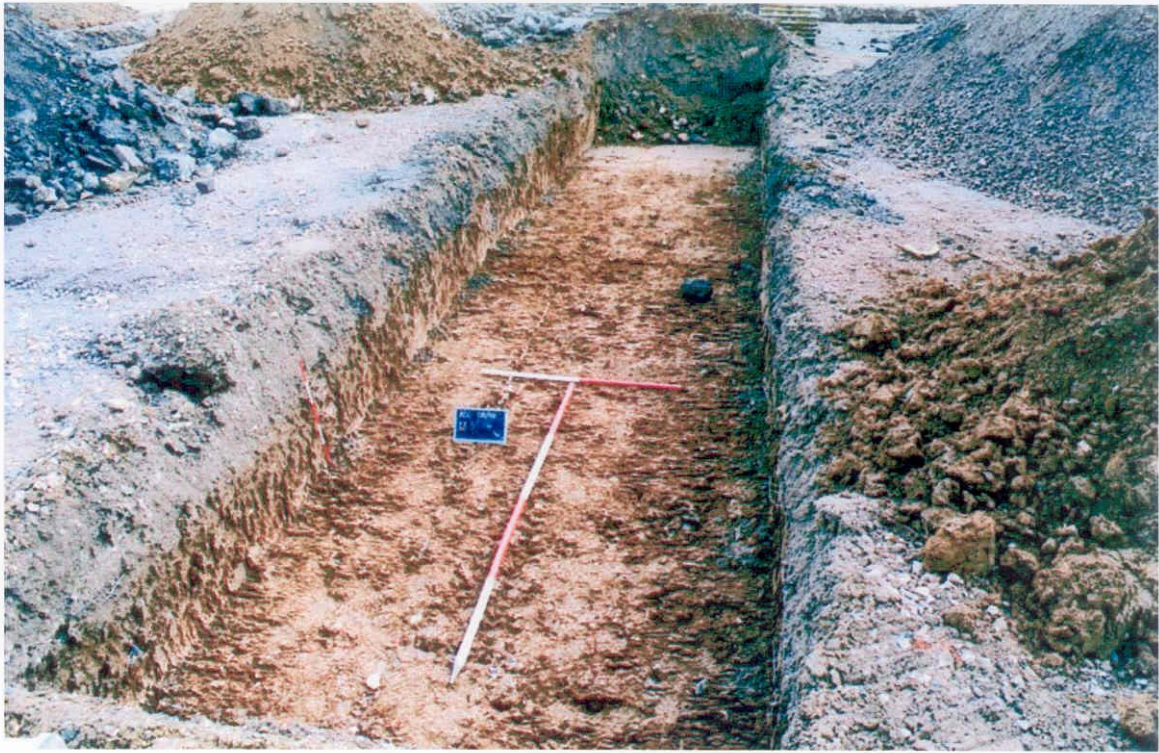
Plate 3. Trench 3 looking south-west, Scales 0.5m, 1m and 2m.

### Trench 3 (Plate 3)

This trench was 10.1m long, 1.6m wide and 0.85 deep, orientated north east - south west. The stratigraphy encountered consisted of 0.3m of modern demolition crush above 0.45m of orange/brown silty clay with

occasional medium stones and small tree roots. This lay above orange/brown clay and stones with occasional degraded chalk present. There were no archaeological finds or deposits present in this trench.

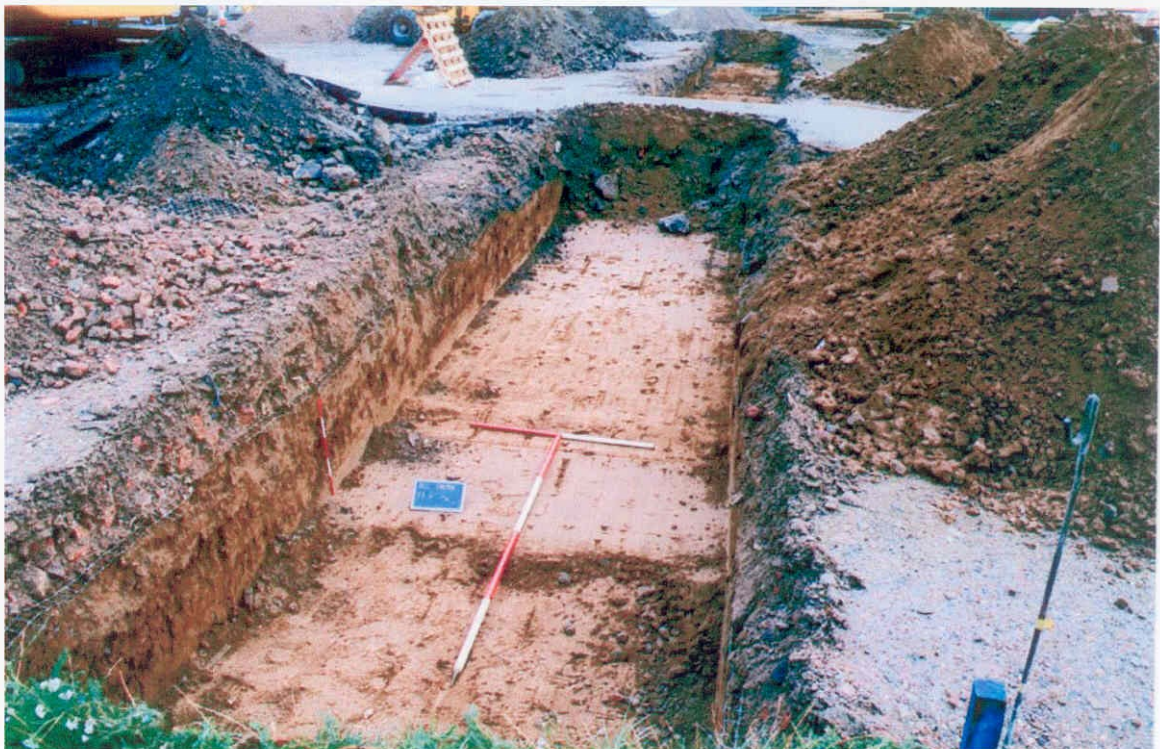
Plate 4. Trench 4 looking south-west, Scales 0.5m, 1m and 2m.

#### Trench 4 (Plate 4)

This trench was 30.3m long, 1.6m wide and up to 0.85m deep, orientated north east - south west. Due to the position of this trench across the main site access it was necessary to excavate it in segments, with one area partially backfilled prior to the excavation of the access road to provide a working platform for the excavator. This did not affect the visibility of any archaeological deposits, and a photographic record was made prior to the partial backfilling. The stratigraphy encountered at the north-eastern end consisted of 0.25m of demolition crush, above 0.55m of brown sandy silt subsoil with moderate small to medium stones. This overlay mottled brown silty sand with occasional small to medium stones. At the south-west end of the trench the stratigraphy consisted of 0.3m of demolition crush, above 0.2m of subsoil which in turn lay above orange/brown clay with moderate stones and occasional chalk outcropping. There were no archaeological finds or deposits present in this trench.
