**19 and 19A High Street, Theale,  
West Berkshire**

**Building Recording**

**Site Code: 19HST21-81**

**July 2021**

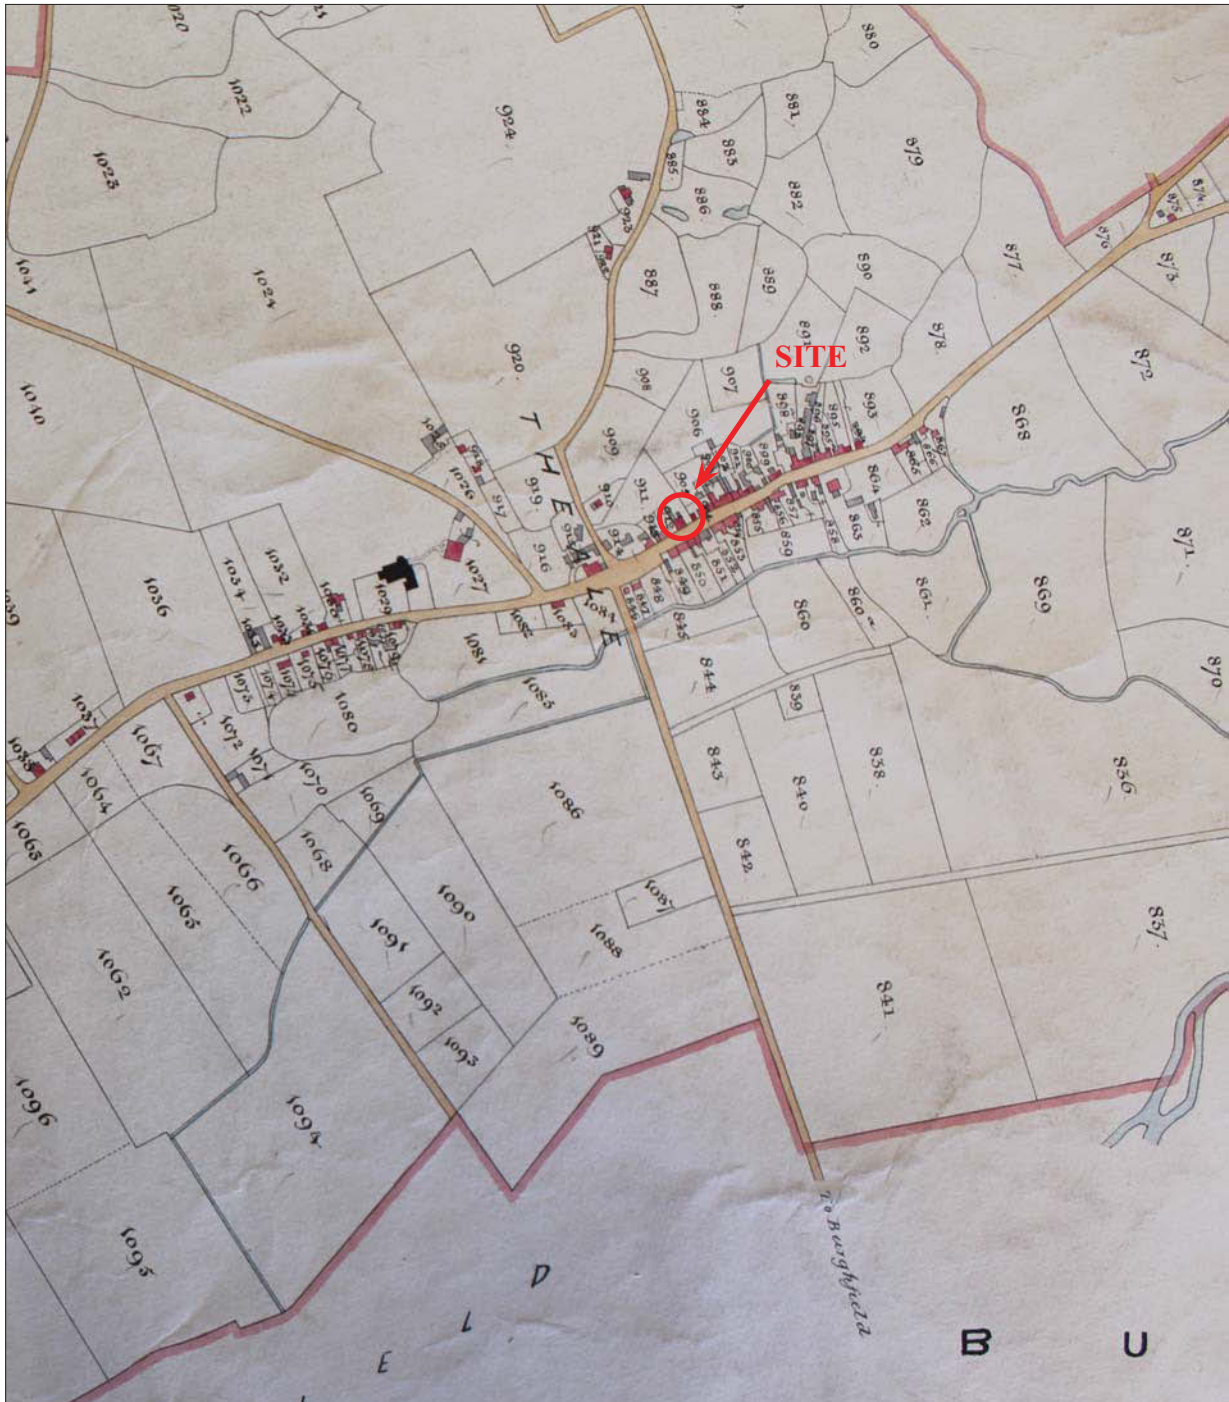
19 and 19A High Street, Theale,  
West Berkshire, 2021  
Building Recording  
Figure 6. Tithe Map of 1844

The Tithe map of 1844 (Fig. 6) shows the site location in detail, with a building on the same axis as that of the 1811 map, but a slightly smaller footprint, fronting the High Street at the south-west corner of the plot, with two outbuildings extending from the rear elevation, towards the north-west. A building is shown on the adjacent plot at number 21, however the 19A plot has yet to be infilled.

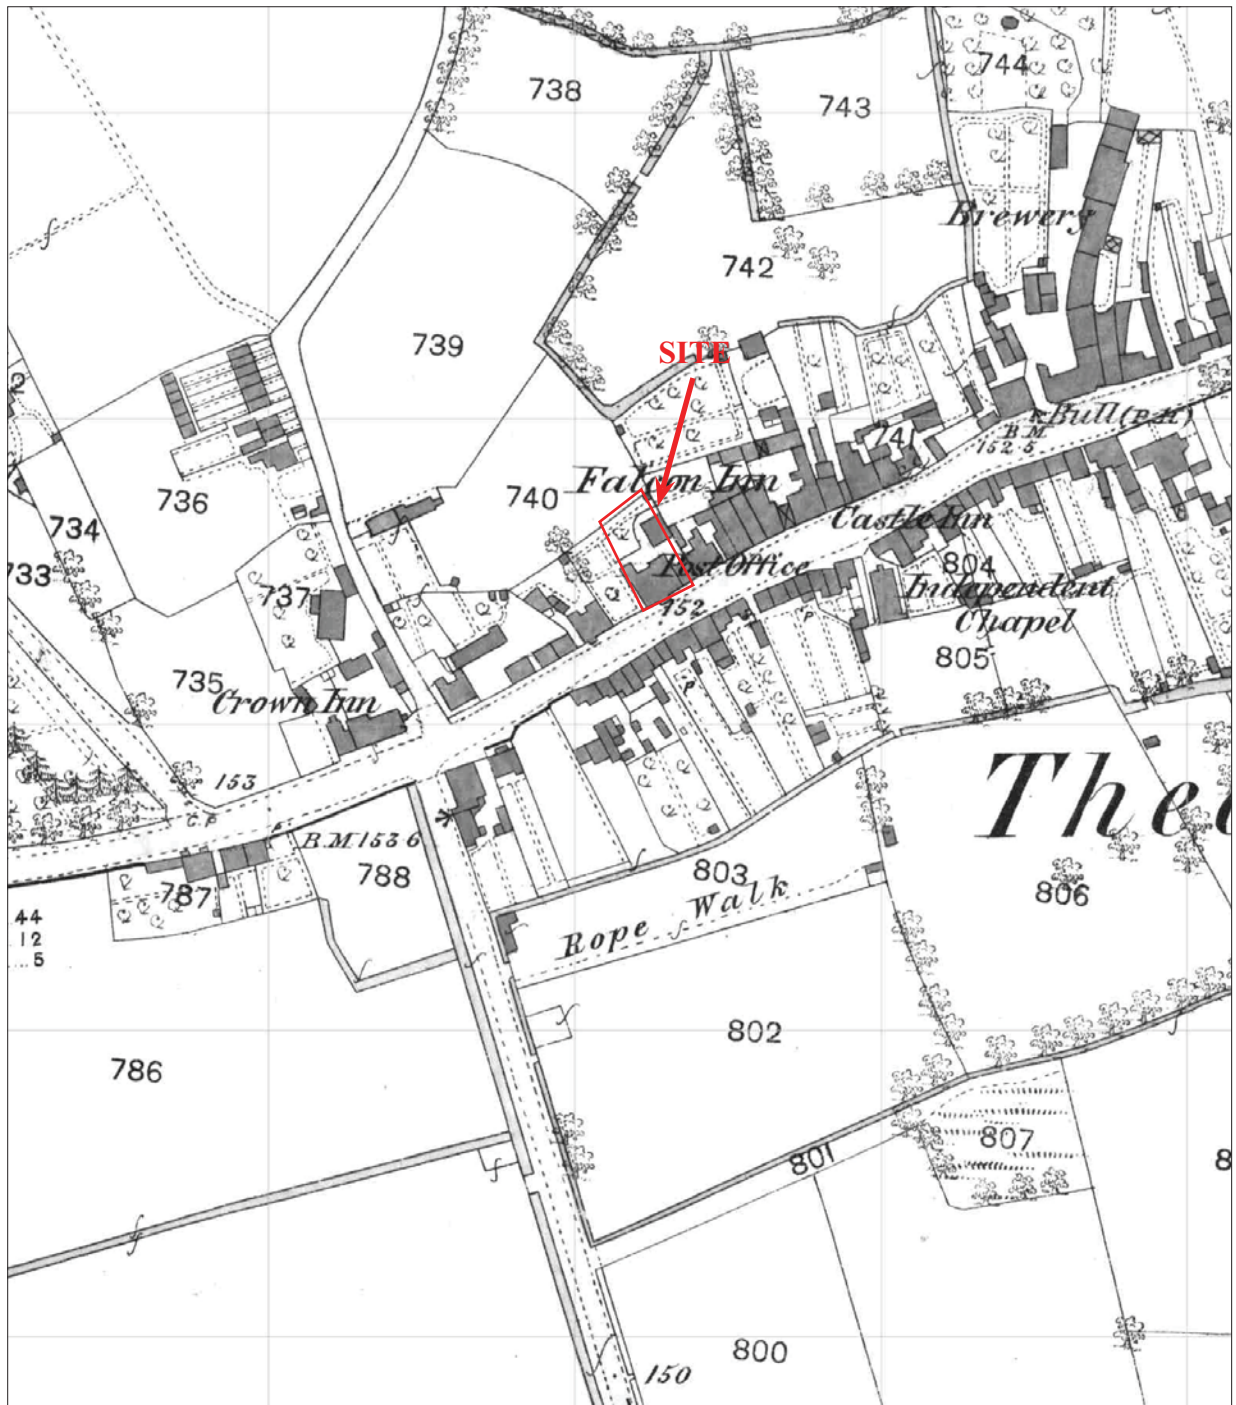
19 and 19A High Street, Theale,  
West Berkshire, 2021  
Building Recording  
Figure 7. First Edition Ordnance Survey 1879

The First Edition Ordnance Survey map of 1879 (Fig. 7) represents the buildings in detail. There is a central porch at the street front, and the footprint is almost square in plan, with a projection (probably an outbuilding) at its north-west corner. At the west is a formal garden, and at the east the 19A plot has been

infilled, possibly a further outbuilding. At the north-east of the plot, a separate rectangular, fairly large building is shown. The outbuildings at the north-west have been remodelled as drawn on the 1899 OS (Fig. 8), though the footprint of 19 is unchanged, and the infilling building in the location of 19A is no longer shown (presumably demolished), though the building at the rear of the plot at the north-east remains.

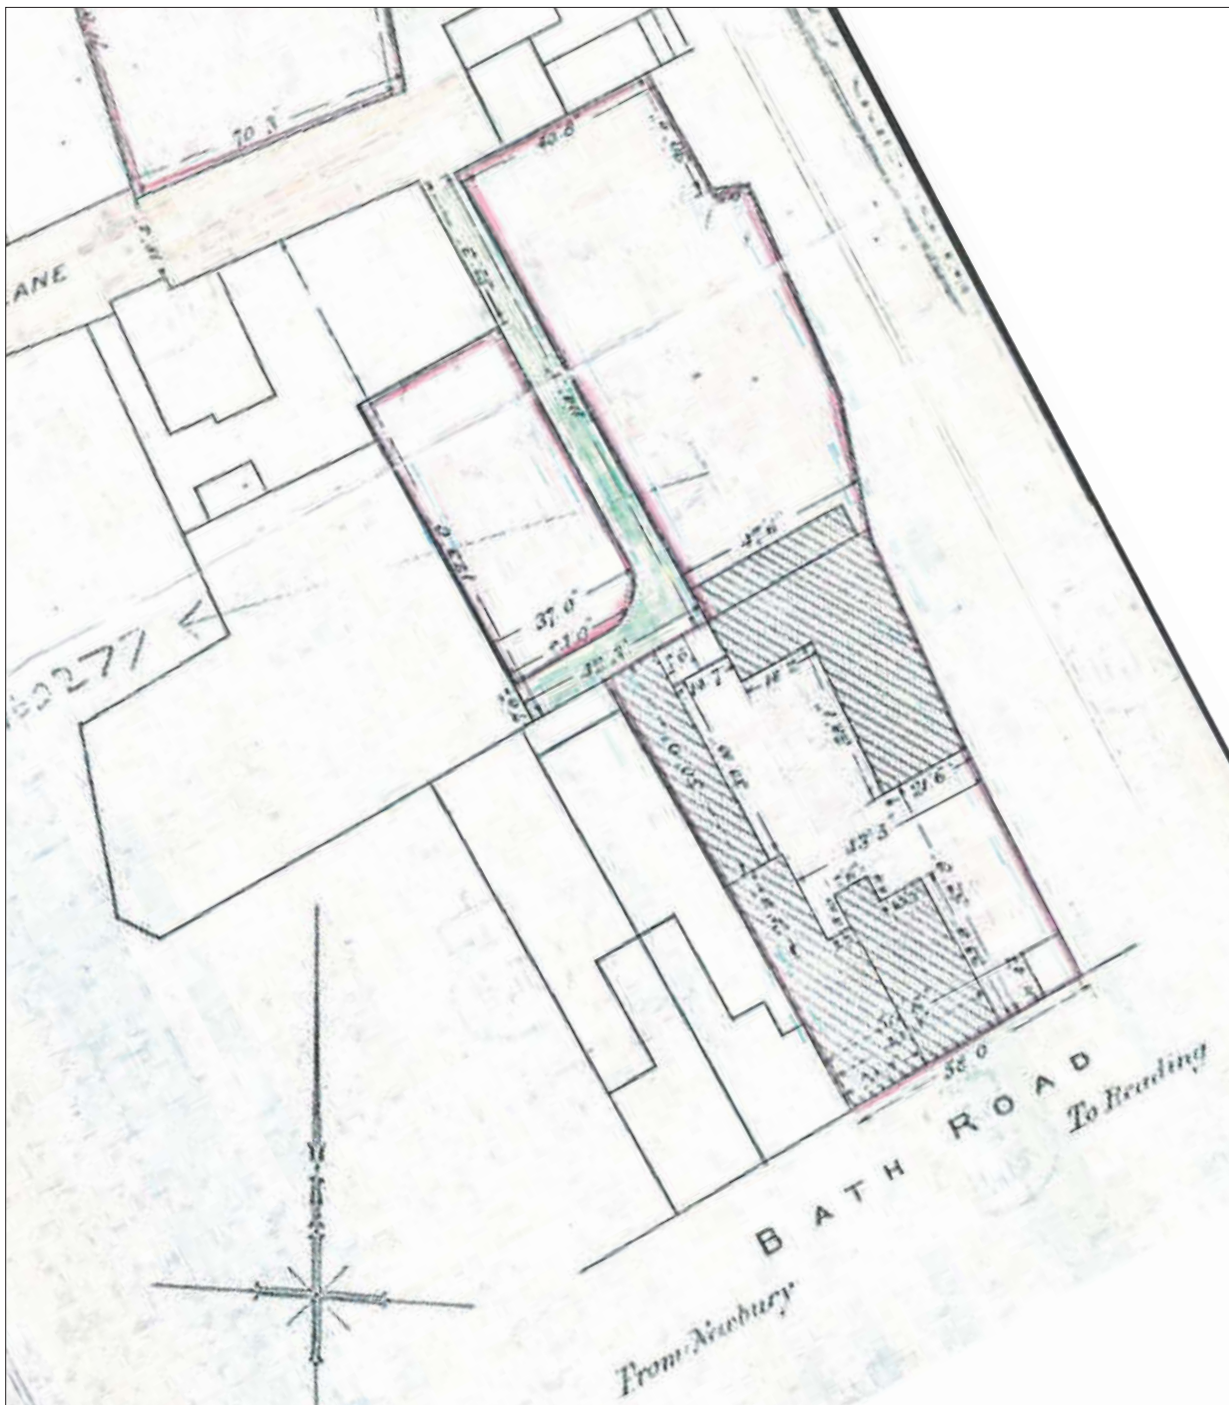
19 and 19A High Street, Theale,  
West Berkshire, 2021  
Building Recording  
Figure 10. Land Registry 1936

A Land Registry map from 1936 (Fig. 10) comprises a measured drawing, showing the house at 19, and on its east side the central number 19 house, and the number 19A plot still empty at the street front. An L-shaped building occupies the north-east corner of the plot, and the west side is occupied by a long rectangular building along the plot boundary. It appears that this map was drawn up before the construction of the building at 19A and after the remodelling of the ground floor central part of the front elevation. Additional outbuildings at the back make the infill of the rear of the plot almost continuous, which by the 1936 OS (Fig. 11) have been joined up to enclose the garden with outbuildings on all three sides. Here, the 19A building is now shown between 19 and 21, and buildings now fill the adjacent plot to the west.

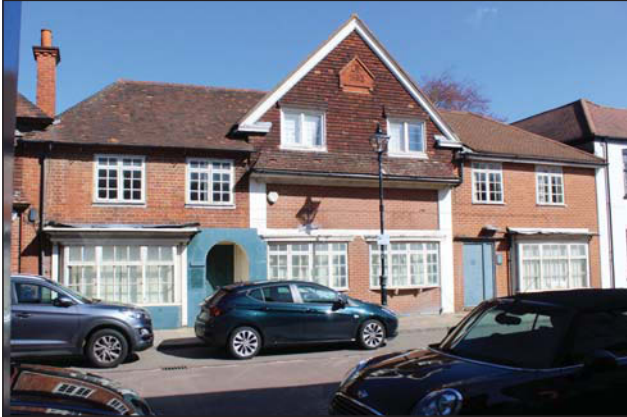
Plate 1. Front elevation, looking NE.

Fronting the street, the south part of the building comprises a broadly symmetrical two-storey building, with a hipped roof of orange/red clay tiles, with a central gable (Pl. 1). The hip end at the east is lower at the eaves than number 17 High Street (the adjoining building to the west), and with a tall rectangular brick-built chimney stack with dentilated brickwork and two chimney pots. The pitch of the roof at the east is slightly less steep and the eaves are slightly higher than the pitch of the west side. The condition of the roof at the west appears to be reasonable (with several slipped tiles), and likely of 19th century date, and the east side in better condition and of later (probably mid-20th century) date. The roof at each side has projecting tile-built soffits under the eaves and fairly recent plastic guttering.

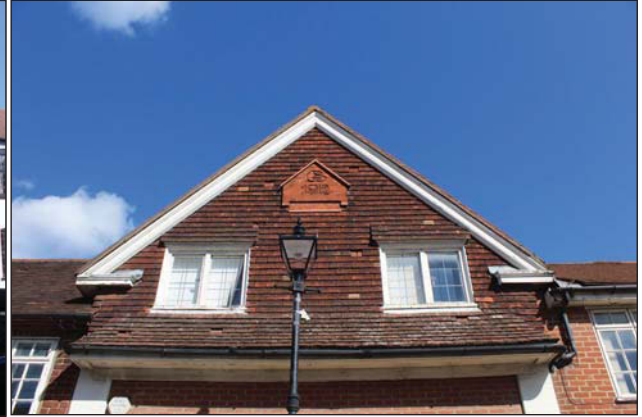
Plate 2. Front elevation, central gable, looking NW.

The central gable is taller than the east and west hip ends and is also roofed with clay tiles. The gable end is covered in dark orange-red lap tiles (several are missing), below white painted timber eaves with an ovolo and step moulding, which continues at each side as a broken pediment. Below this is a decorative terracotta panel in a triangular pediment form edged with tiles, with finely jointed bricks bearing an incised monogram 'CS', above the date 1912 in a typeface of an Art Nouveau style typical of the period (Pl. 2).

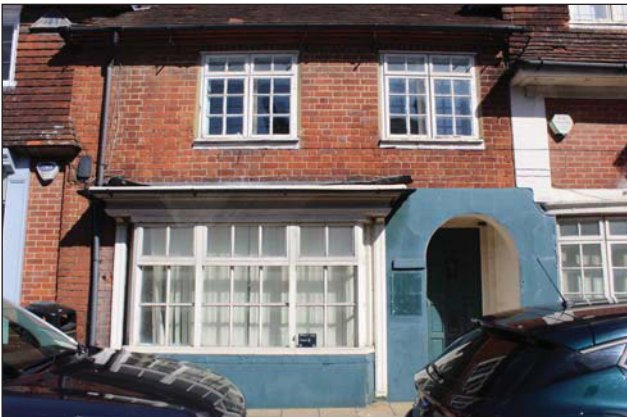
Plate 3. Front elevation, looking NW.

The front elevation brickwork at the west (number 19) is of fairly finely jointed dark red bricks with a slightly soft finish laid to a Flemish bond with closers at the western edge and at each side of the windows (Pl. 3). The windows comprise a pair of side-hung casement windows of six panes each, under a pair of two pane bottom hung casements, with a flat arch of soldier header bricks above. They have timber sills and simple moulded frames. The closer bricks and generally consistent brickwork suggest the first floor windows are early 20th-century replacements for 19th-century original windows of the same size.

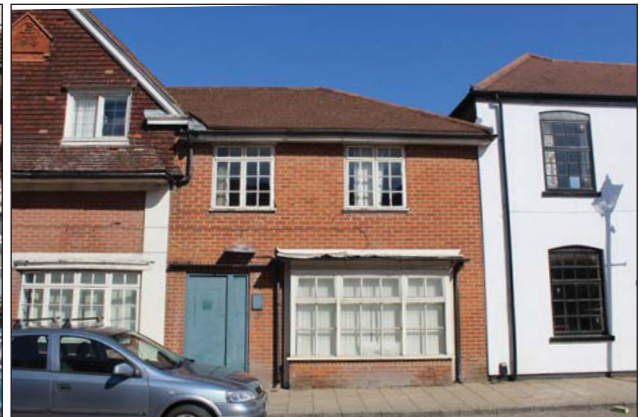
Plate 4. Front elevation, looking NW

The brickwork under the gable at the east (19A) is of a different character (Pl. 4) to that at the west, with bricks of a cooler red colour and sharper finish laid to a stretcher bond. The windows at first-floor level comprise a pair broadly matching those at the west, though the glazing bars are thinner, and there is no soldier arch as the windows are set slightly higher, immediately below the eaves.

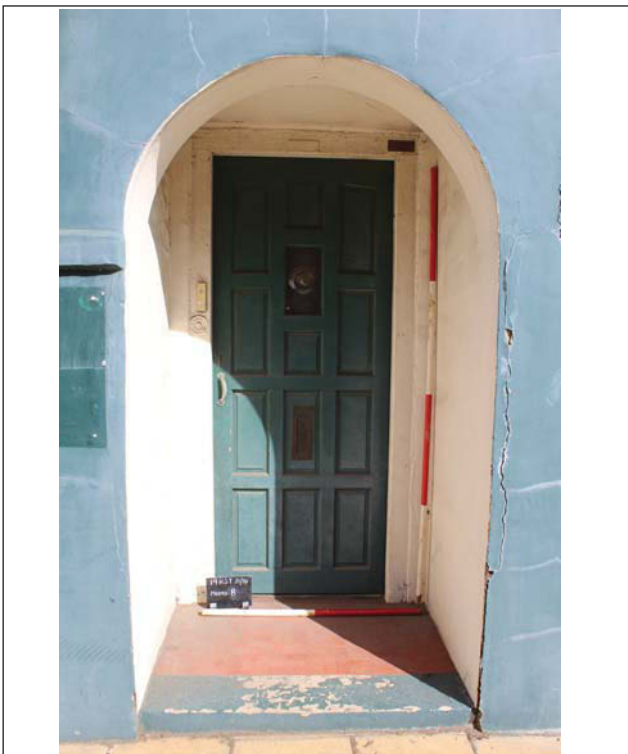
Plate 7. Front elevation, doorway, looking NW, Scales: 1m and 2m.

To the east of this, there is a doorway under a flat arch of soldier header bricks with a plain timber door in a wooden frame with a panel to the east, all painted green (Pl. 7). Above the doorway, a small metal (possibly lead-covered) shelf projects from the wall on a pair of small wrought-iron brackets. The purpose of the shelf is unclear, though it has a small plastic pipe draining water into the gutter of the adjacent bay window, and may represent either a planter or a rainwater container placed to take overspill from the gutter above. The bay window to the east is a shallow square-type, and mirrors that at the west of the elevation, comprising wood-framed narrow windows (one over one) at each side elevation, and at the front, three over three fixed window below a

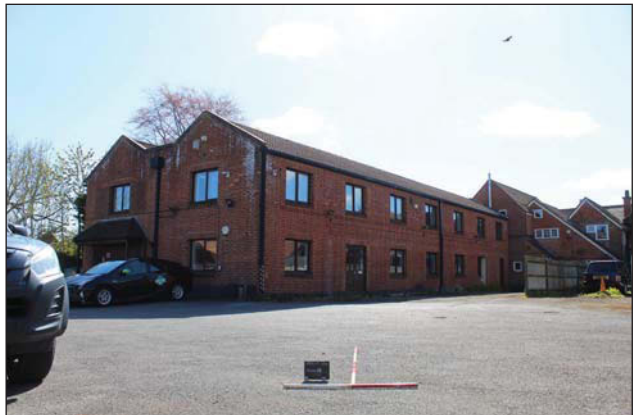
Plate 8. Rear of site showing office block, looking SE  
Scales: 1m and 2m.

The rear elevation at the north comprises the rear of number 19, formed of three gable ends, and the 1980s office building (Pl. 8). At the west of the elevation, the rear of 19 has a fairly steep-pitched roof with a white painted moulded bargeboard at the eaves and bricks in a stretcher bond below, and two fairly recent uPVC windows (top hung single panes, one large and one smaller) under a concrete lintel. The brickwork appears to be of two phases with the upper half of the gable replaced using bricks of a lighter red tone to those below (Pl 9).

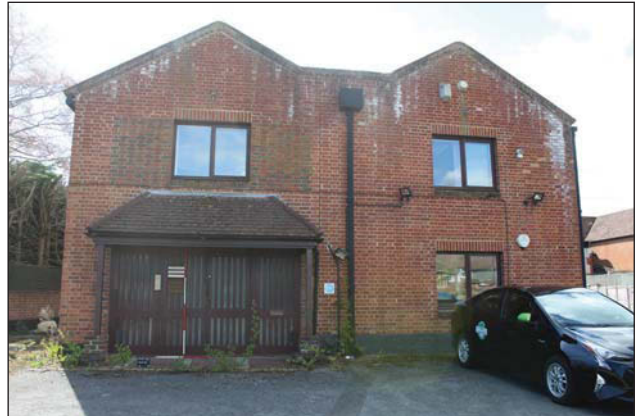
Plate 10. Office block north elevation, looking S, Scales: 1m and 2m

The rear elevation of this block (Pl. 10) takes the form of two gables with fairly shallow pitched roofs with a central flat segment. The elevation comprises brickwork to a Flemish bond, and has a pair of windows at first-floor level, each one fixed pane and one side-hung, under a flat soldier arch. At ground floor level, at the west there is a window of the same form as the first floor, and at the east a wide porch with a pitched roof, supported on timber posts on brick plinths, over a doorway comprising several wooden doors each with long narrow windows of reinforced glass.

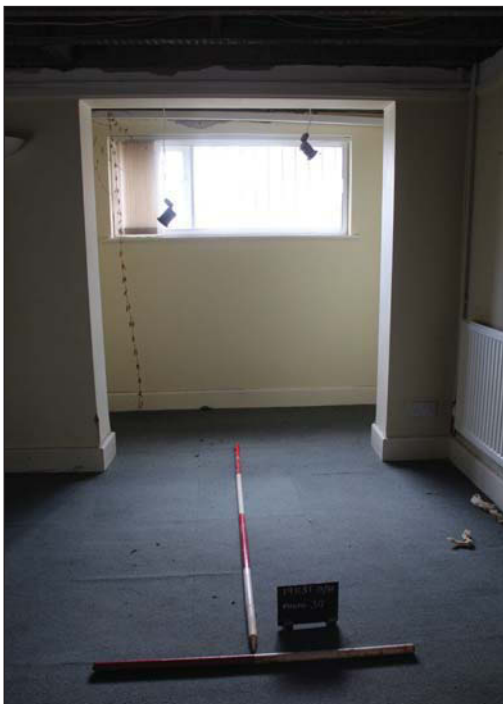
Plate 11. Room 2, looking W, Scales: 1m and 2m

Room 2 (Pl. 11) has a partition on the alignment of the former rear wall of number 19, subdivided to form a storeroom at the west corner. At the east corner of the room, the modern ceiling has been removed to expose the joists, which are machine cut and of likely early 20th-century date. Above these, the brickwork of the former rear wall is visible, showing the brick laid to a Flemish bond, blackened in the location of the chimney on the gable end, and to the west of this, brickwork of likely early 20th-century date infilling the throat of the chimney (Pl. 12). Also visible is the brickwork extending to the north, forming the side of the later 20th-century gable end at the centre of the rear elevation.

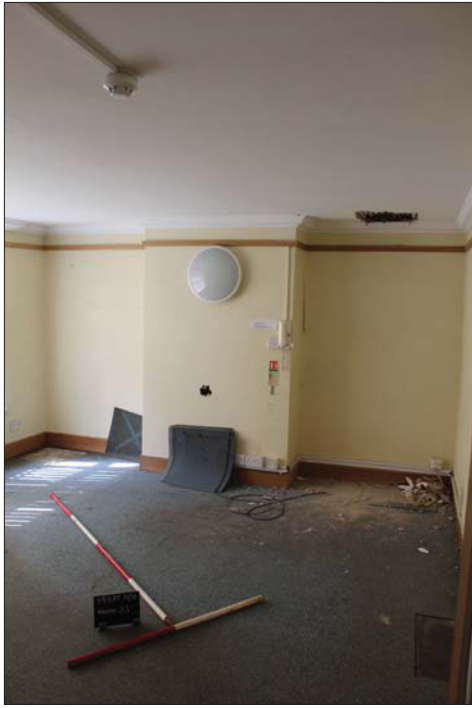
Plate 13. Room 3, looking SW. Scales: 1m and 2m.

Room 3 is located at the front of number 19 (Pl. 13), and represents the front room of the original number 19 dwelling. The fixtures and fittings are of late 20th-century date, including moulded coving, picture rail and skirting, however a small area of the ceiling plaster has been removed, exposing the original wooden laths. The west side of the room has a chimney breast (now blocked) and at the east, there is a modern partition forming an entrance hall for the front door, which appears likely to be in its original location though the doorframe and door are later replacements.

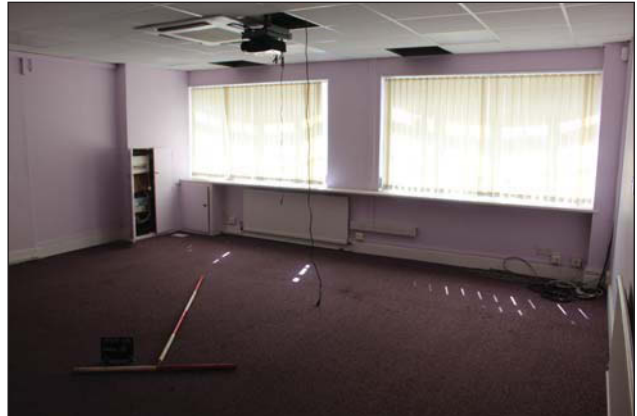
Plate 14. Room 4, looking S. Scales: 1m and 2m.

Room 4 (Pl. 14) comprises the front room of the central building, and has modern fixtures and fittings and a suspended ceiling. Where panels have been removed, the former front elevation is visible, with modern breeze block infill at the top of the wall and above this, rolled up wooden shuttering (Pl. 15). This comprises two shutters which together would have extended the width of the front elevation, presumably with a brick, timber or possibly iron pier between them. They appear to be intact and in good condition, with the metalwork (probably steel) not corroded, and are attached to thick timbers which rest on a brick course, with presumably a steel or timber joist within the wall, spanning the opening. This room appears to have been a workshop or retail space, with access for wagons or carts. Room 5 (Pl. 16) to the rear of this has no suspended ceiling, showing that the original ceilings were relatively high, and again the fittings and fixtures are relatively recent.

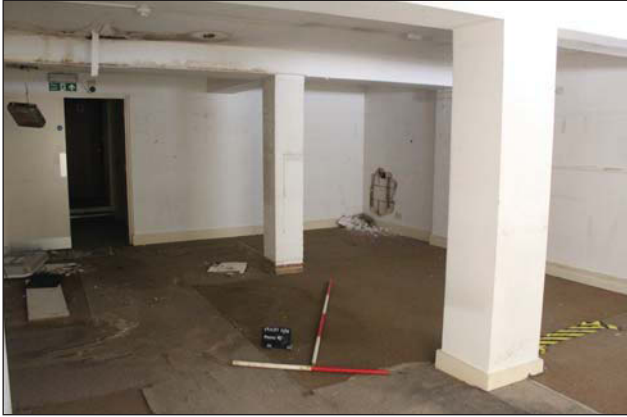
Plate 17. Room 6, looking N, Scales: 1m and 2m.

Room 6 (Pl. 17) occupies the 19A building, and comprises one space, with brick-built pillars, supporting steel joists, with a concrete floor. The front of the room has been partitioned as a separate office (room 7). At the rear of the room, two steps provide access to the corridor with toilets, and beyond these the 1980s block at the north of the building. Here, room 8 comprises one main space at the west with brick pilasters and partitions on the east side dividing the space into several offices. At the north-east corner is a small bathroom (room 9), and a stairwell providing access to the first floor.

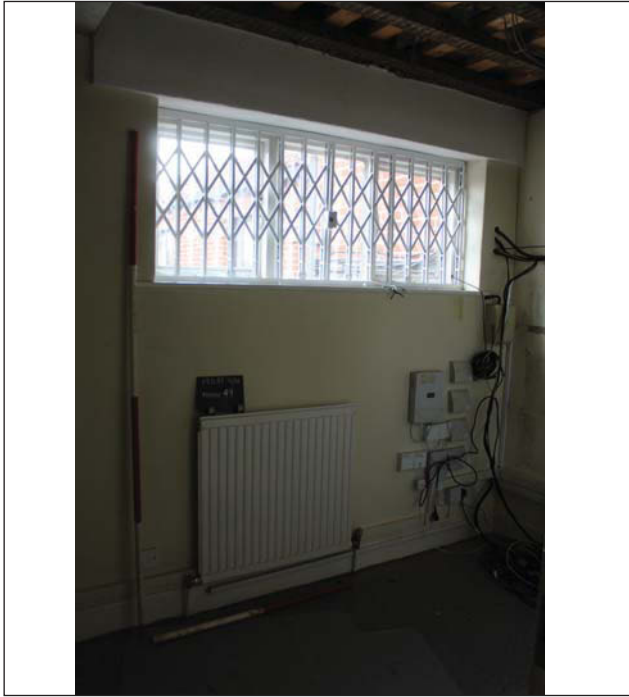
Plate 18. Room 10, looking N, Scales: 1m and 2m.

Within the original number 19 building, the stairs lead to a small landing, with room 10 at the rear of the building (Pl. 18), which has had the ceiling covering removed, exposing the machine-cut joists aligned east-west. Room 11 (Pl. 19) also has the joists and the machine-cut common rafters exposed, which are of likely early 20th-century date. Room 12 is at the front of the first floor (Pl. 20), and has an angled ceiling following the angle of the hipped roof, with a small timber at the south-west corner which is suggestive of the remodelling of the roof from a pitch to a hipped roof (Pl. 21), the change in angle meaning this timber could not be hidden above the ceiling line of the room. At the north-west corner of the room, the ceiling plaster has been removed exposing a small area of wall, which appears likely to represent the wall of the adjoining building number 17 where it abuts the roof of number 19. At the north of the room, a boxed-in beam spans the width of the house and is likely to be the position of the original roof beam and truss. The room has a simple moulded picture rail which may date to the earlier part of the house's development. The windows are of likely 20th-century date, with more recent aluminium-framed windows fitted to the interior. The chimney breast has a cast-iron fireplace with a moulded surround of fluting below a panel and mantel shelf, of a type most often used in bedrooms and lower status houses, and which is compatible with the later Victorian phase of the house's development.

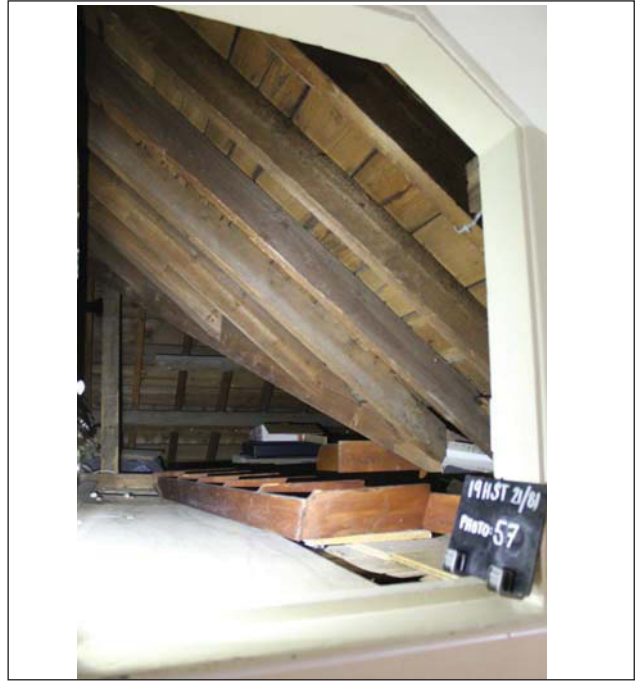
Plate 22. Roof space, looking S, Scales: 1m and 2m.

From the landing, a further short flight of stairs lead upwards to the west into the central number 19 building, and adjacent to the stairs a small opening leads to the roof space over room 12. Here, the structure of the hipped roof, made of machine cut timbers of 20th century date, is visible (Pl. 22).

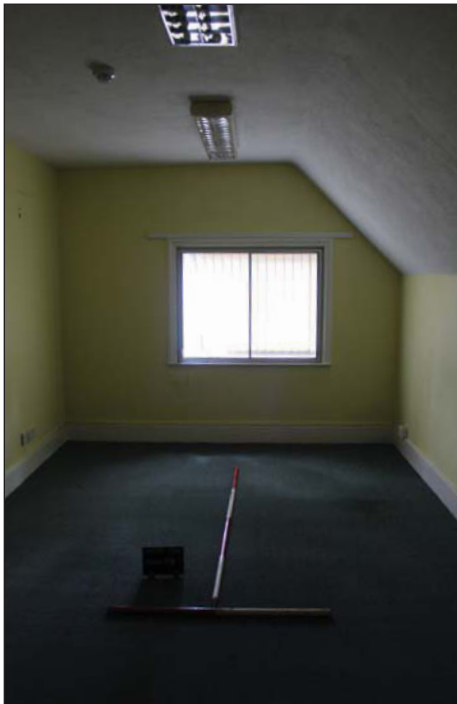
Plate 23. Room 13, looking SE, Scales: 1m and 2m.

Room 13 is located at the front of the central building, and has a sloping ceiling following the angle of the gable (Pl. 23), with the corresponding sloping ceiling in room 14 occupying the east side of the gable (Pl. 24). Here, the ceiling plaster has been removed and again the machine-cut rafters are exposed. This room has a chimney breast and small cast-iron fireplace comprising a combined grate and surround (Pl. 25), of a small Bath grate type, with mouldings and a flower motif, commonly found in late Victorian bedrooms of lower status. The windows have ironwork likely to be contemporary with the 1912 refronting (Pl. 26).

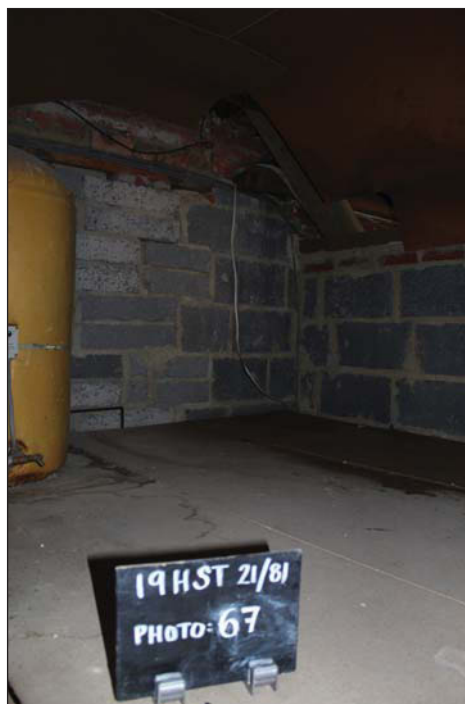
Plate 30. Room 16 cupboard, looking SW,  
Scales: 1m and 2m.

Room 16 occupies the rear of the central number 19 building (Pl. 28). It has a sloping ceiling at the east and is L shaped due to the partition wall creating the landing, and two windows in the north elevation. The ceiling covering has been removed, exposing the joists and rafters which are all of machine-cut timber (Pl. 29). A hatch within the room opens into the space within the roof of the rear gable, which houses the boiler. Here, the breeze-block interior wall is visible, along with brickwork which is likely to represent the former rear wall of number 19 (Pl. 30).

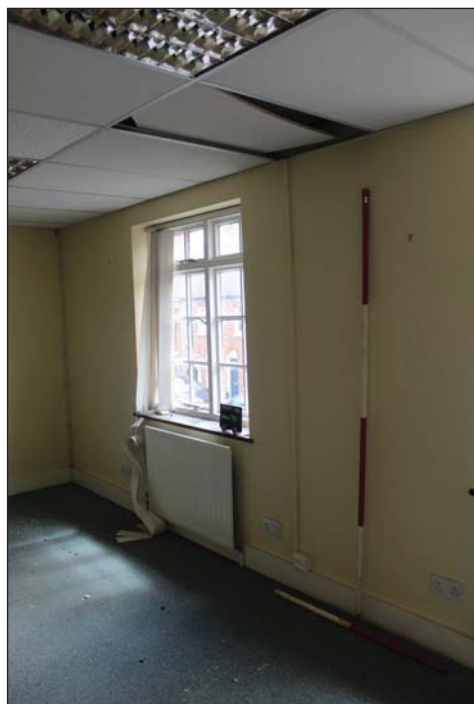
Plate 31. Room 17, looking SE,  
Scales: 1m and 2m.

The first floor of 19A comprises room 17 (Pl. 31), which is L-shaped and consists of the full width of the building at the front, extending to the rear, with a suspended ceiling and fairly recent fixtures and fittings. The window at the rear of the room is of late 20th-century date, and to the west of this, the room occupies the rear extension leading to the north block. The first floor of the block again comprises one large space at the west, with the east partitioned into smaller office (Pl. 32). At the northwest corner of the room, part of the building is occupied by the staircase leading up from the ground floor.
