**Mount Pleasant Hospital, Frederick Road,  
Hastings, East Sussex**

**Archaeological Evaluation**

**Site Code: MPH22/123**

**An Archaeological Evaluation  
for Gemselect Limited**

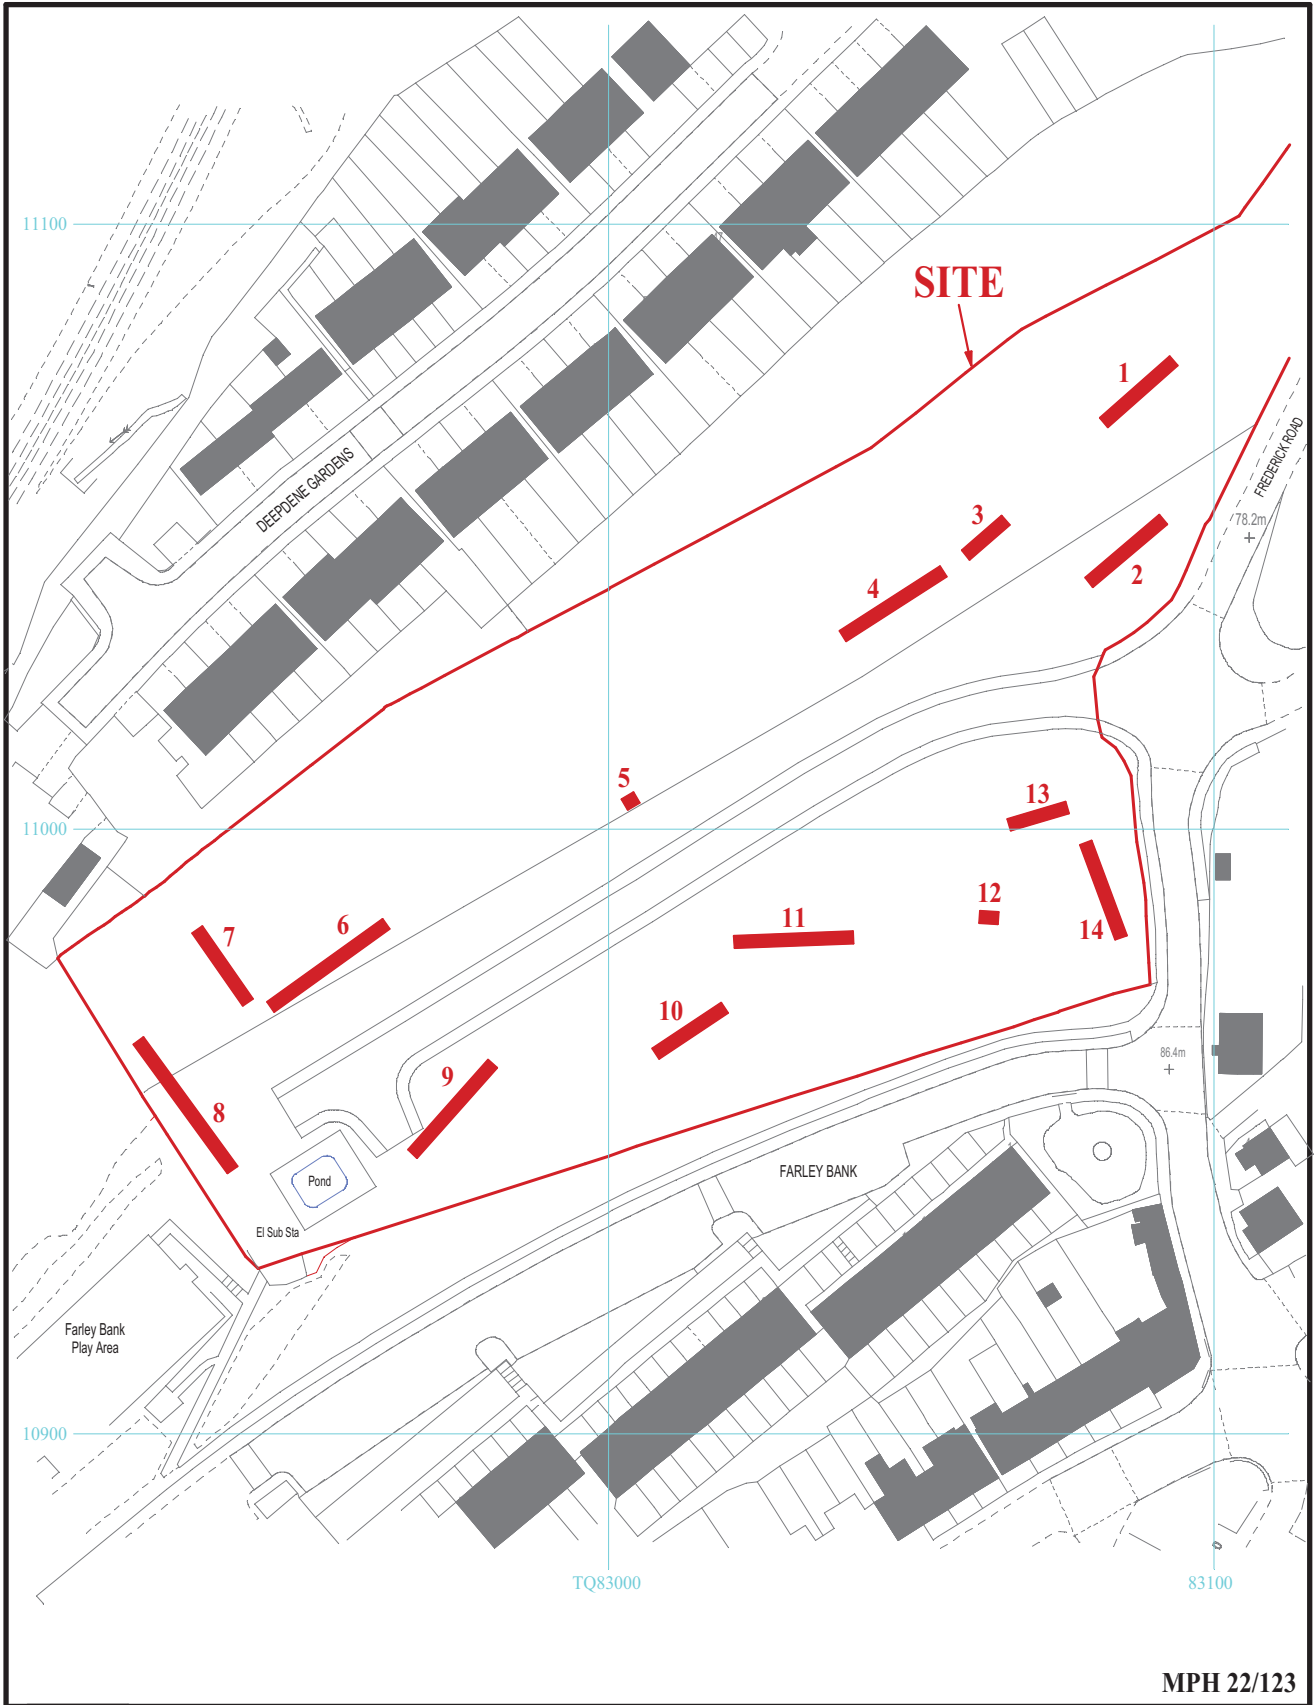
Figure 3. Plan of site showing the evaluation trenches.

The trenches were dug as close to their original planned positions as possible, although most had to be moved and / or shortened to avoid features such as trees and existing spoilheaps (Fig. 3). The excavated trenches were all 2.00m wide, and measured between 2.30m and 25.50m in length, and between 0.15m and 2.30m in depth. The clay or sandy clay geology was observed in most of the trenches. A complete list of the trenches giving lengths, breadths, depths and a description of sections and geology is given in Appendix 1.

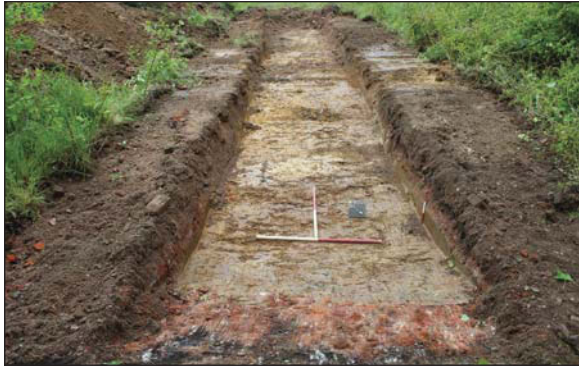
This trench was orientated approximately SW-NE, and was 15.00m long and up to 0.60m deep. It had to be moved some distance from its original intended position as the north-eastern part of the site was heavily overgrown. The natural sandy clay geology was encountered beneath up to 0.45m of made ground, and some areas of modern disturbance were noted along the trench. A small area of Tarmac was noted at the far eastern end of the trench, lying directly above the natural geology. The trench was shorter than planned partly due to a lack of space, but also due to the fact that the western end appeared to show the same modern truncation as that recorded in the eastern end of trench 3. No archaeological features or finds were recorded in the trench.

Plate 1. Trench 1, looking South-west.  
Scales: 2 x 1m and 0.30m.

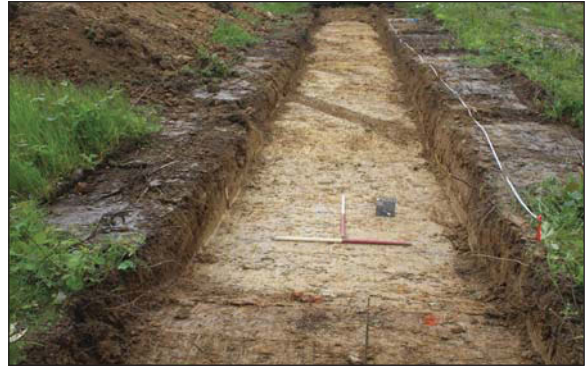
This trench was orientated approximately SW-NE, and was 16.00m long and up to 0.50m deep. It was excavated on a small area of flat ground, and was shortened due to lack of space. The natural sandy clay geology was recorded directly beneath 0.40m of made ground. A probable land drain or service trench was noted in the central part of the trench, but no archaeological finds or features were recorded.

Plate 2. Trench 2, looking South-west.  
Scales: 2 x 1m and 0.30m.

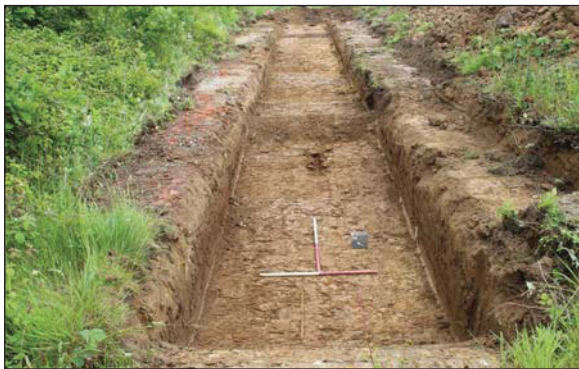
This trench was orientated approximately SW-NE, and was 19.30m long and up to 0.58m deep. The natural sandy clay geology was generally encountered beneath 0.36m of made ground. Some modern truncation was noted at the far eastern end, and two pipes were uncovered along the length of the trench. No archaeological features or finds were recorded in the trench.

Plate 3. Trench 4, looking North-east.  
Scales: 2 x 1m and 0.30m

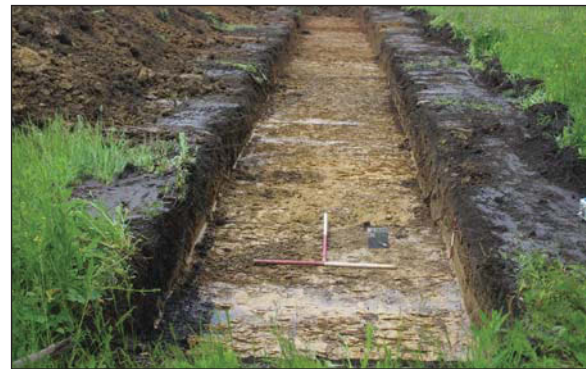
This trench was orientated approximately SW-NE, and was 23.40m long and up to 0.60m deep. The natural sandy clay geology was generally encountered beneath 0.30m of topsoil (50) and 0.12m of subsoil (51). Two land drains were noted within the trench, but no archaeological finds or features were recorded.

Plate 4. Trench 6, looking South-west.  
Scales: 2 x 1m and 0.30m.

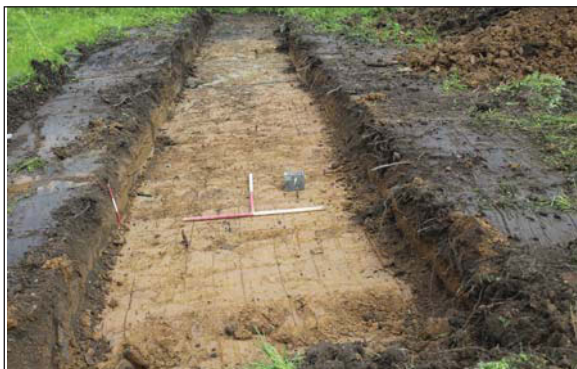
This trench was orientated approximately NW-SE, and was 15.00m long and up to 0.58m deep. The trench was shorter than originally planned due to a lack of space. The natural sandy clay geology was generally encountered beneath 0.35m of topsoil (50) and 0.07m of subsoil (51). A modern truncation was noted at the far northern end of the trench, but no archaeological features or finds were recorded.

Plate 5. Trench 7, looking North-east.  
Scales: 2 x 1m and 0.30m.

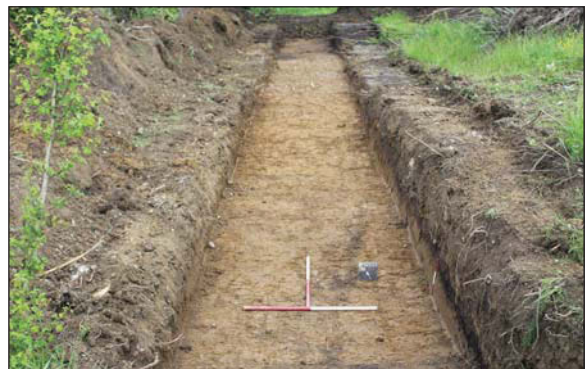
This trench was orientated approximately NW-SE, and was 25.50m long and up to 1.04m deep. There was a marked difference in the stratigraphy recorded in either end of the trench. In the southern part of the trench, the natural sandy clay geology was generally encountered beneath 0.84m of made ground, indicating that the area had been stripped previously and then built up with imported material. The made ground was not present in the northern and central parts of the trench, where the natural geology was recorded below 0.20m of topsoil (50) and 0.10m of subsoil (51). Some modern disturbance was noted in the trench, but no archaeological features or finds were recorded.

Plate 6. Trench 8, looking North.  
Scales: 2 x 1m and 0.30m.

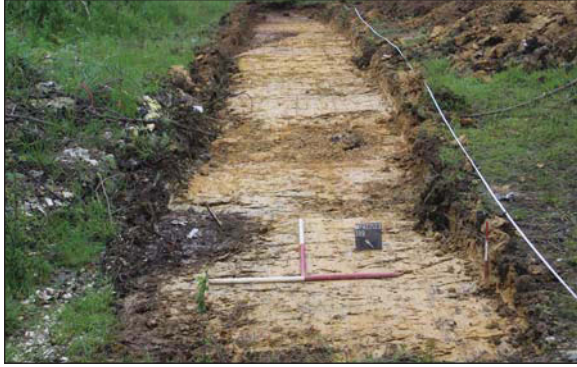
This trench was orientated approximately SW-NE, and was 19.50m long and up to 0.25m deep. The trench was slightly shorter than originally planned due to the presence of trees, spoilheaps, and a fenced off pond. The natural sandy clay geology was generally encountered beneath just 0.05m of topsoil (50). Several areas of modern disturbance were recorded along the length of the trench, but no archaeological features or finds were recorded in the trench.

Plate 7. Trench 9, looking North-east.  
Scales: 2 x 1m and 0.30m.

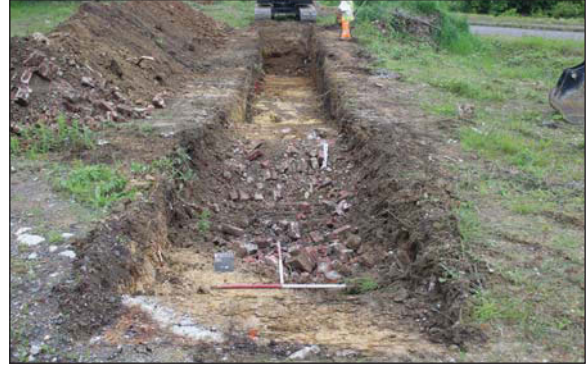
This trench was orientated approximately E-W, and was 19.60m long and up to 1.65m deep. In the south-eastern corner of the trench, the natural sandy clay geology was observed immediately below 0.15m of made ground. However, most of the eastern end of the trench was occupied by a large modern truncation. This contained some fairly large chunks of brick rubble, suggesting that material from the demolished hospital buildings had been pushed into the hole. It is possible that the truncation may actually represent a former basement, which had been backfilled when the hospital was demolished. In the western half of the trench the natural clay geology was recorded between about 1.50m of made ground. No archaeological features or finds were recorded in the trench.

Plate 8. Trench 11, looking West.  
Scales: 2 x 1m and 0.30m.

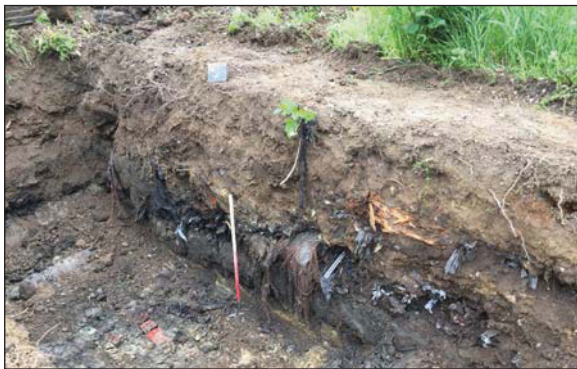
This trench was orientated E-W, and was up to 1.90m deep, but just 3.20m long. The trench was not dug to its intended length due to the fact that it had clearly been positioned on a former spoilheap or dump of modern material. Due to the local topography it was not possible to re-site the trench. The natural geology was not recorded in the trench. The stratigraphy generally consisted of 1.15m of soil made ground, 0.33m of grey clay made ground, 0.07m of yellow clay made ground, and at least 0.35m of made ground with ceramic building material (CBM). A dump of very recent rubbish was recorded in one of the sections, between the soil made ground and grey clay made ground. Unsurprisingly, no archaeological features or finds were recorded in the trench.

Plate 9. Trench 12 (North facing sections), looking South-east. Scale: 1m.

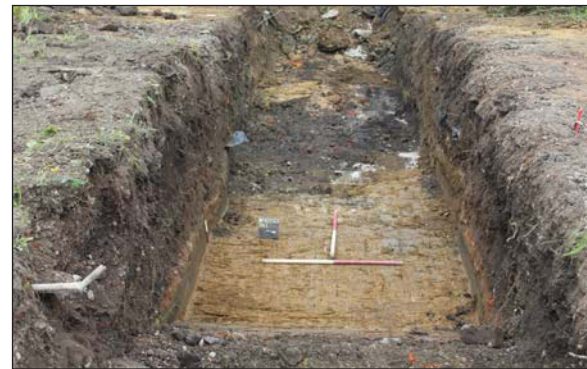
This trench was orientated approximately E-W, and was 8.20m long and up to 1.55m deep. The trench was shorter than originally planned due to trees in the area and the presence of a large modern truncation at the western end. At the eastern end of the trench, the natural sandy clay geology was generally encountered beneath 0.80m of loose made ground, 0.35m of compact made ground, 0.10m of compact clay and CBM. Much of the trench was occupied by a large modern truncation containing concrete and plastic sheeting. As this had clearly truncated the natural geology, no attempt was made to reach the bottom of this feature. No archaeological features or finds were recorded in the trench.

Plate 10. Trench 13, looking West.  
Scales: 2 x 1m and 0.30m.

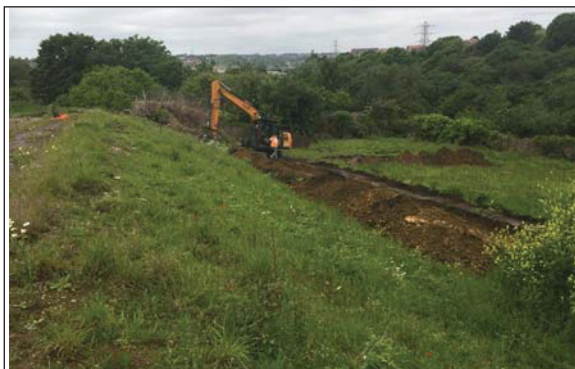
just 62m aOD in the north-west. At the time of the evaluation parts of the site were very overgrown, particularly along the northern boundary (Pls 11 and 12). There were numerous piles of cleared vegetation dotted around the site, along with other spoilheaps. According to the British Geological Survey, the underlying geology consists of Ashdown Sand (BGS 1971). However, due to the fact that the site is on the side of a hill and has been heavily disturbed in the past, the natural geology encountered during the evaluation varied from trench to trench. In general the natural consisted of a mid yellow brown sandy clay, although in some trenches an underlying light yellow brown clay was recorded.

Plate 11. General view of north-west corner of the site, looking west from the access road.

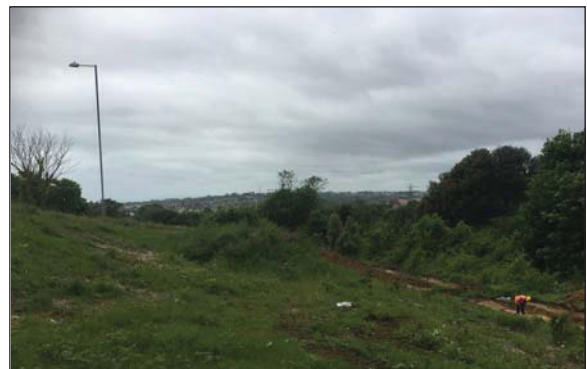
Plate 12. General view of north-east corner of site (trenches 3 and 4 in the distance), looking west from trench 2.
