**Ellerton Manor, Ellerton On Swale, Richmond,  
North Yorkshire**

**Building Recording**

**Site Code: EMR23/01**

**February 2023**

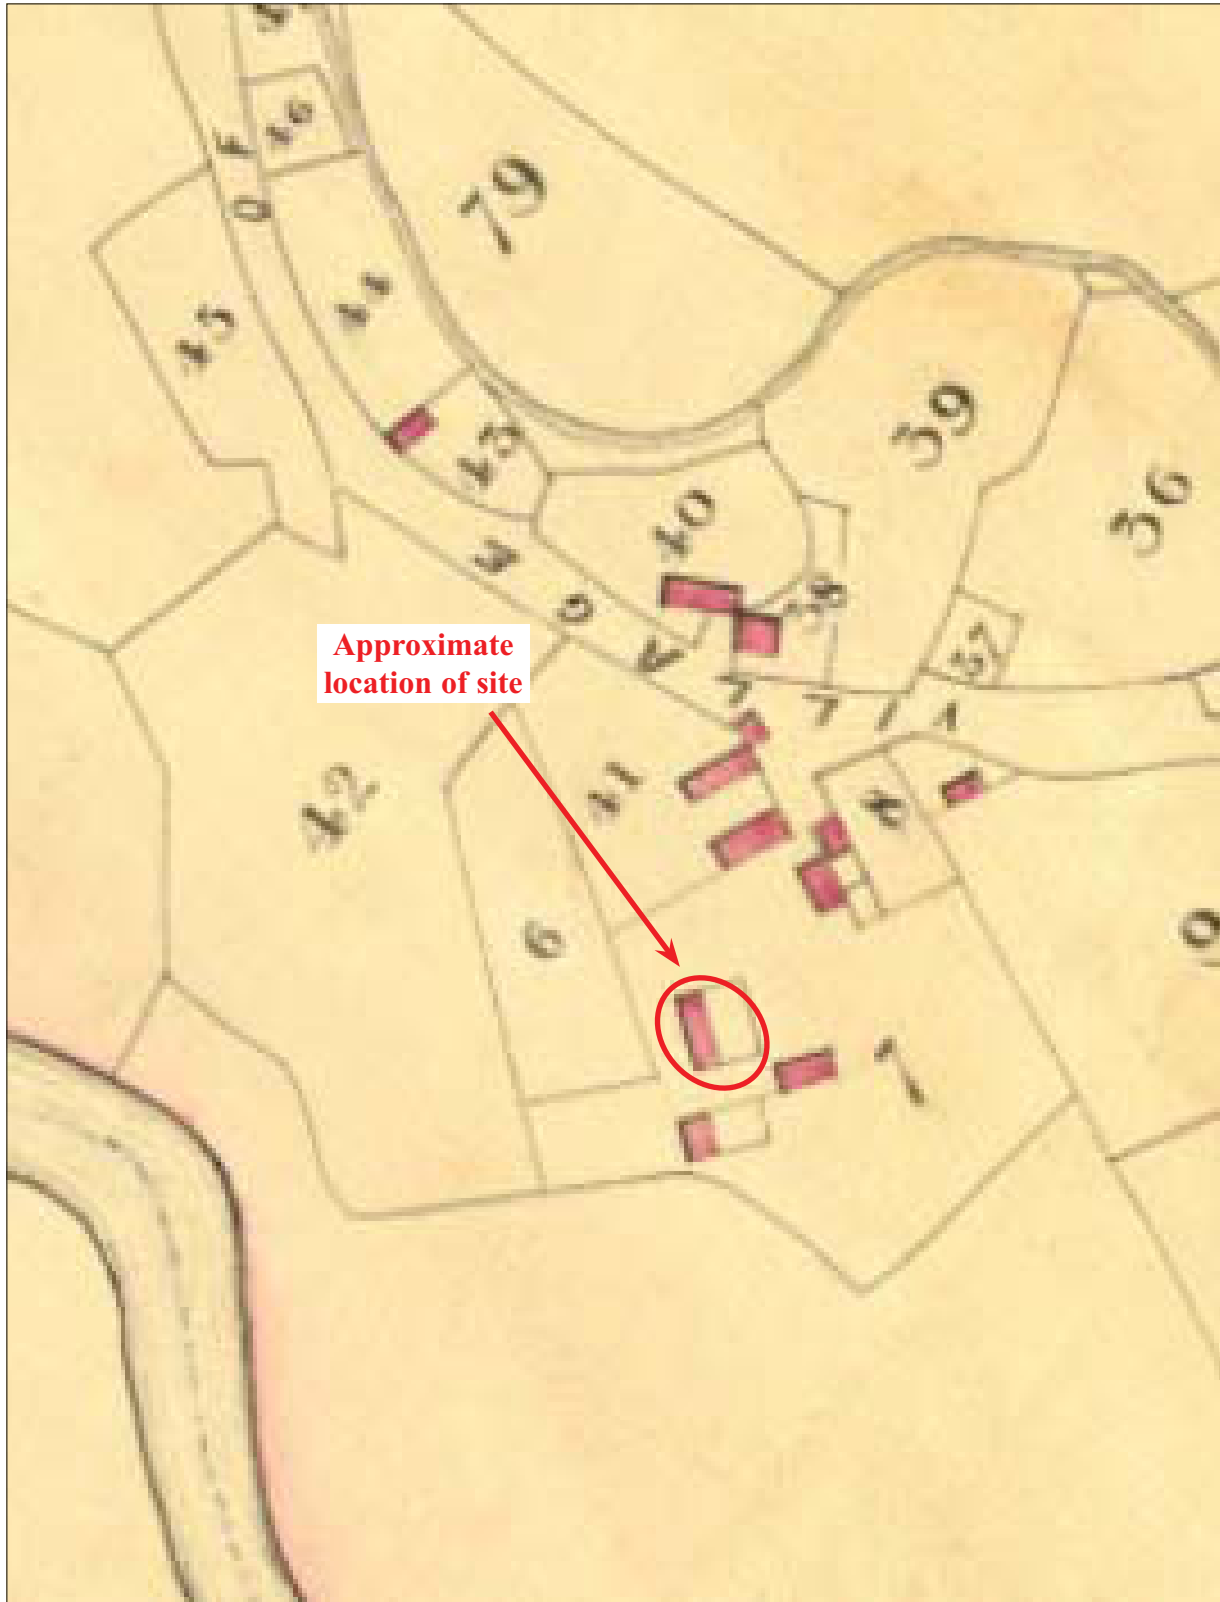
A range of Ordnance Survey and other historical maps of the area were consulted online in order to ascertain the development of the building throughout the site’s later history. The Ellerton tithe map of 1839 is the first available map to show the area in detail (Fig. 3). The manor house stands within a parcel of land numbered ‘7’ which contains three rectangular buildings; two of which appear to have a small yard associated with them. The accompanying apportionment records the owner as John Deaval Carpenter, Earl of Tyrconnel and the occupier as John Earl, with the parcel of land labelled as ‘Homestead and Garth.’ The location of the buildings does not make it easy to match up with the earliest Ordnance Survey maps, but it is likely that the tithe map shows part of the eastern range of the Manor House as identified on later maps.

**Ellerton Manor, Ellerton On Swale,  
Richmond, North Yorkshire, 2023  
Building Recording**  
Figure 3. Ellerton Tithe Map, 1839.

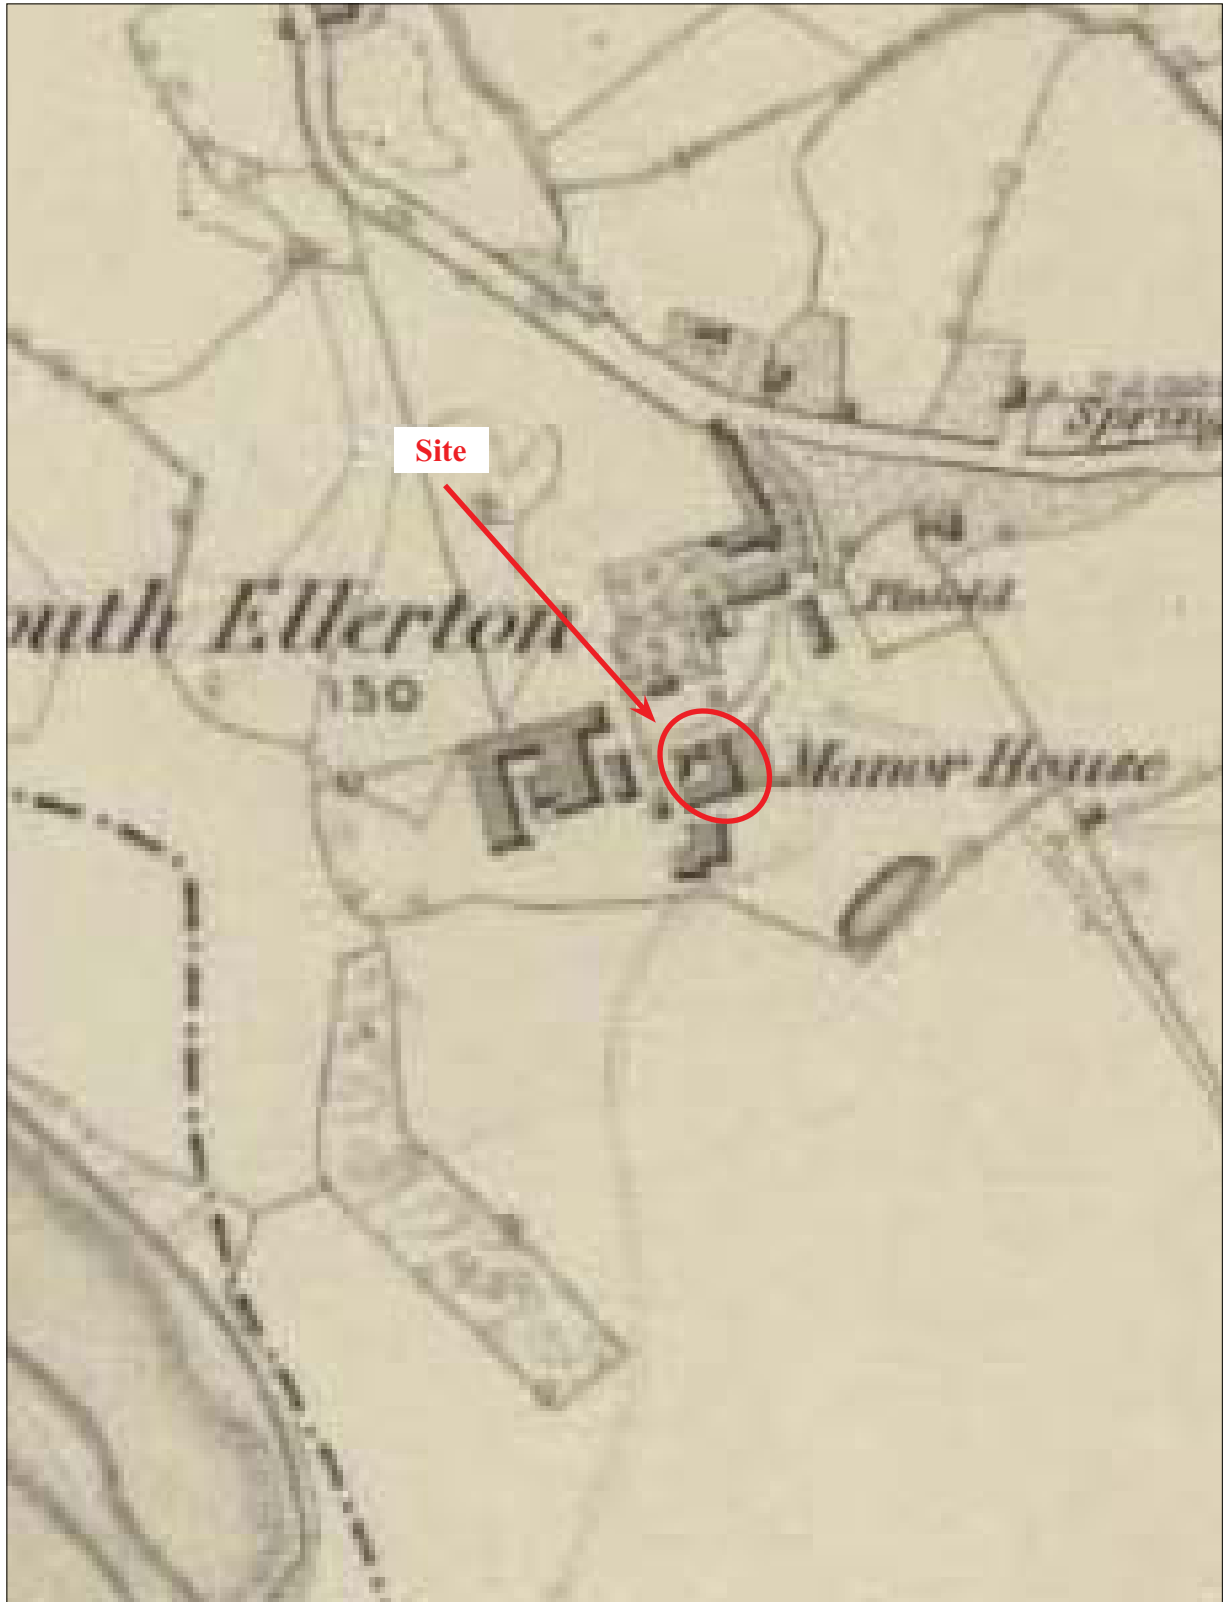
The first Ordnance Survey map to show the Manor House in detail dates to 1854. It shows the House prior to incorporation of a set of outbuildings in the north-west corner of the site (Fig. 4). The main building consists of an ‘L-shaped’ building with ranges along the southern and eastern sides of the site to form a small courtyard to the west. This has clearly undergone significant change since the tithe map of 1839 and in the intervening 15 years the house has either been extended to the west and the associated farm significantly increased in size or the older buildings demolished and rebuilt.

**Ellerton Manor, Ellerton On Swale,  
Richmond, North Yorkshire, 2017  
Building Recording**  
Figure 4. Ordnance Survey, 1854.

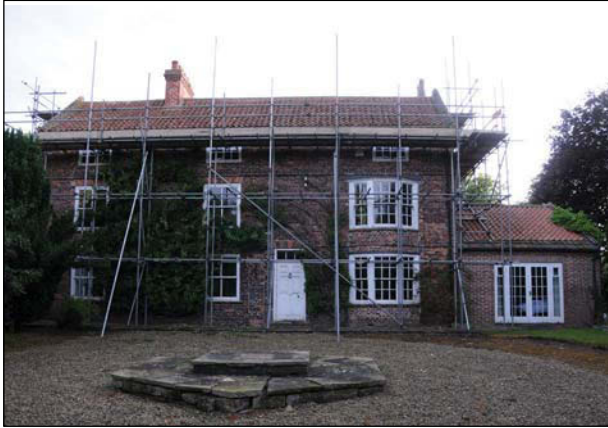
In general the frontage of the building (east elevation) is three bays wide with a cross passage, and two and a half storeys high, brick built with a gable end roof covered in pantiles and stone slates along the eaves (Pl. 1). The bricks are predominantly laid in stretcher bond and are brown-orange in colour. Each floor has three windows; two at the southern end of the elevation and one at the northern end. On the ground floor the door is located between the southern and northern windows and on the ground and first floor the northern window has been replaced with a bay window. Above the ground and first floor windows are flat arches and a string course. The flat arch above the door cuts through the string course. To the rear of the building, in its earlier form is a turret which houses the staircase.

Plate 1. Exterior, house frontage, looking west.

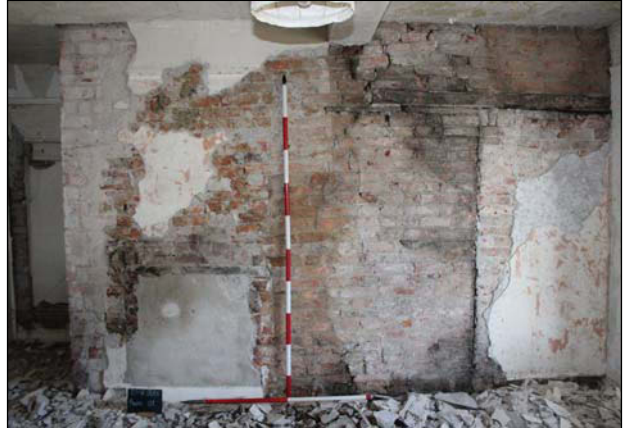
Within bay 1 of the first-floor plaster had been removed from the chimney breast to reveal the underlying structure (Pl. 2). This consisted of a brick chimney breast, with the bricks laid in stretcher bond. Towards the western end of the chimney breast is the opening for the fireplace; now infilled with concrete (Pl. 3). Above the opening is a narrow timber lintel above which is a brick arch with the bricks laid in rowlock bond. Either side of the arch is a wooden block, possibly where a previous fireplace was attached to the chimney breast. An imprint

Plate 2. Looking north at the blocked up fireplace and opening on the first floor, Scales: 2m and 1m.

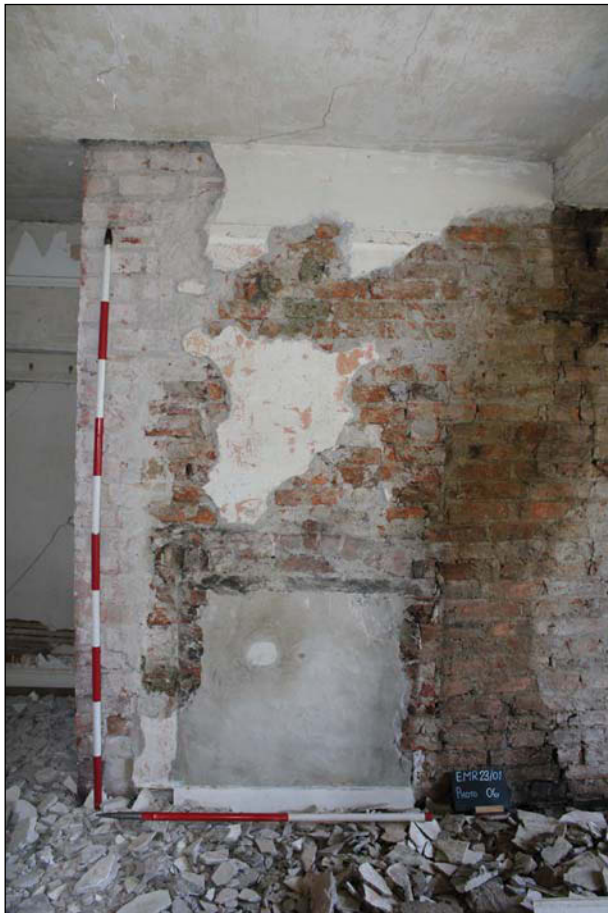
within the bricks to the right of the opening may be trace remains of the former fireplace surround. The imprint appears to extend part way up above the opening and perhaps suggests a former fireplace with an over-mantle. At the eastern end of the chimney breast is a blocked opening to bay 2 (Pl. 4). Above the former opening is a timber lintel that extends beyond the width of the doorway.

Plate 3. Looking north at the blocked up fireplace on the first floor, Scales: 2m and 1m.

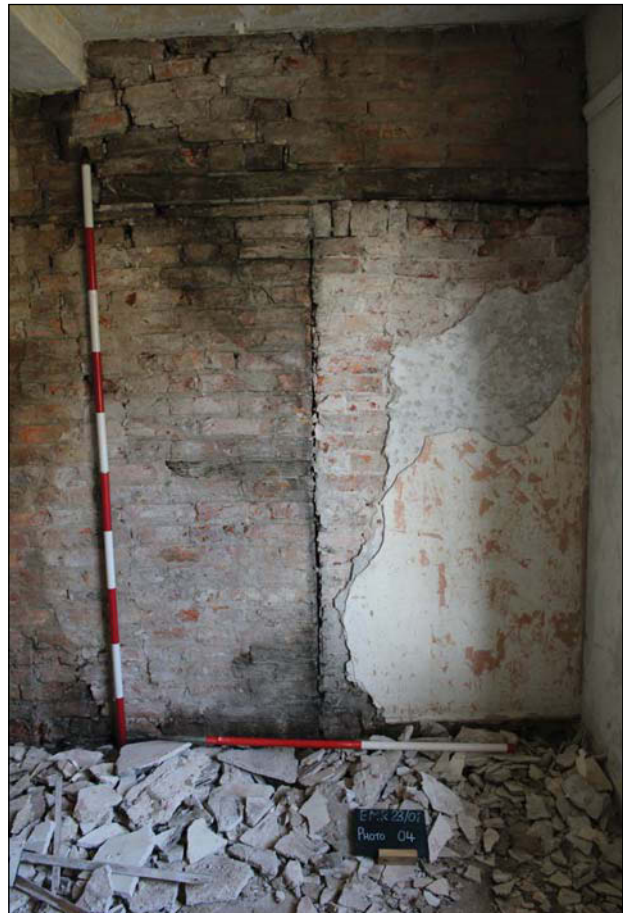
Plate 4. Looking north at the blocked up door on the first floor, Scales: 2m and 1m.

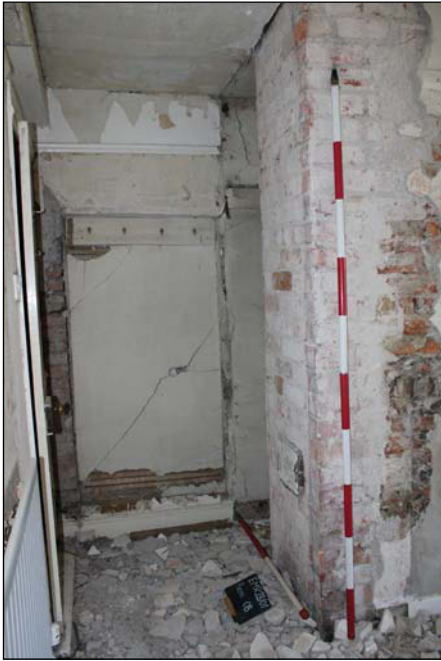
To the left of the chimney breast within the dividing wall is an area of lath and plaster suggesting a second opening between the two bays (Pl. 5). The height of the former opening is not clear due to the presence of the plaster but the area of brickwork remaining suggests the presence of a door.

Plate 5. Looking north at the blocked up opening to the side of the chimney on the first floor, Scales: 2m and 1m.

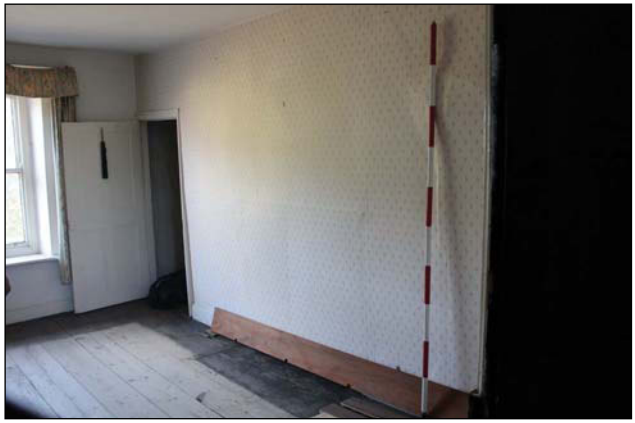
The decorative finish had not been removed in bay 2 though it was possible to see evidence of the former opening within the chimney breast and the heath stone within the floor (Pl. 6).

Plate 6. Looking SE, view of wallpapered wall and door to storage on the first floor, Scales: 2m.

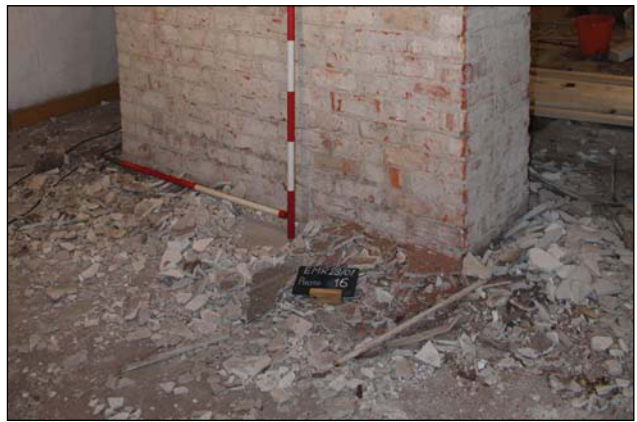
Within bay 1 of the second floor the plaster had been removed revealing the underlying structure (Pl. 7). This consisted of a brick chimney breast with the bricks predominantly laid in stretcher bond with some headers interspaced. There are no features within this section of the chimney breast. Within this section the brick coursing is fairly level and consistent unlike that in the room below. This construction continued round the eastern side of the stack extending up into the roof space. Where the chimney had not been covered in plaster the bricks could be seen to be orange-red in colour. The bricks were consistent in size, measuring 228mm x 76mm.

Plate 7. Looking south at the wall on the second floor, Scales: 2m and 1m.

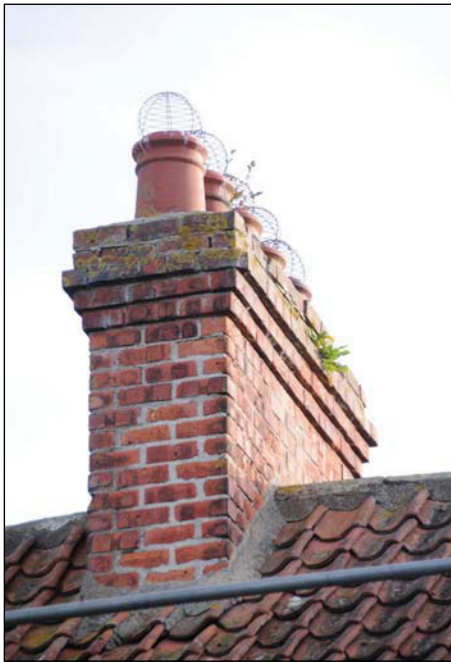
Plate 9. External chimney detail, looking west.

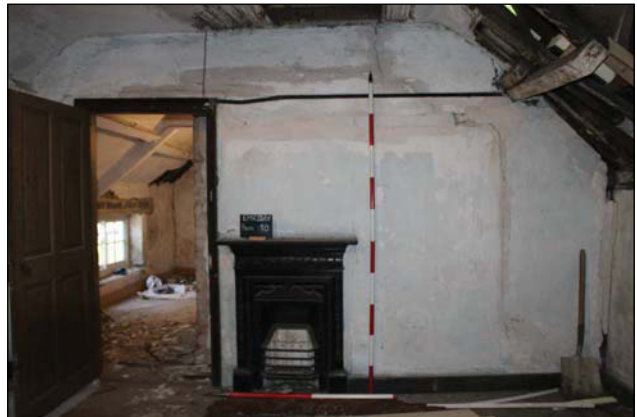
The plaster had not been removed within bay 2. A single piece cast-iron fireplace was still present within bay 2 of the second floor typical of the late 19th century (Pl. 8).

Historically the western end of the chimney breast has been extended or rebuilt at the same time as the second floor. The chimney breast within the second floor and rising up to the stack above the roofline is a later rebuild, perhaps dating to the cast iron fireplace within bay 2 of the second floor. Such a fireplace is indicative of a late 19th-century date.

Plate 8. Looking north at the fireplace and door on the second floor, Scales: 2m and 1m.
