**A 19th Century Brick Kiln on land between 19 and 73,
The Hill, Blunham, Bedfordshire**

Archaeological Excavation

Site Code: THB18/127

May 2023

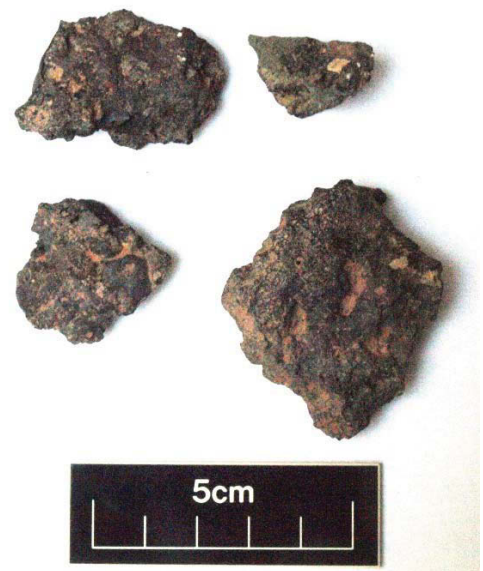
Plate 2: Black vitreous material (possibly non-diagnostic ironworking slag) from context [321]/(359)

The material from robber cut 321 (359) comprises small fragments of black vitreous material (86g) (Pl. 2) and a large fragment of metallic iron (258g). The black vitreous material appears to be identical to that from context 325: it has a similarly low density, and similar inclusions (quartz/ceramic?). The metallic iron appears to be a deliberately fashioned but incomplete object; corrosion obscures much of the object.

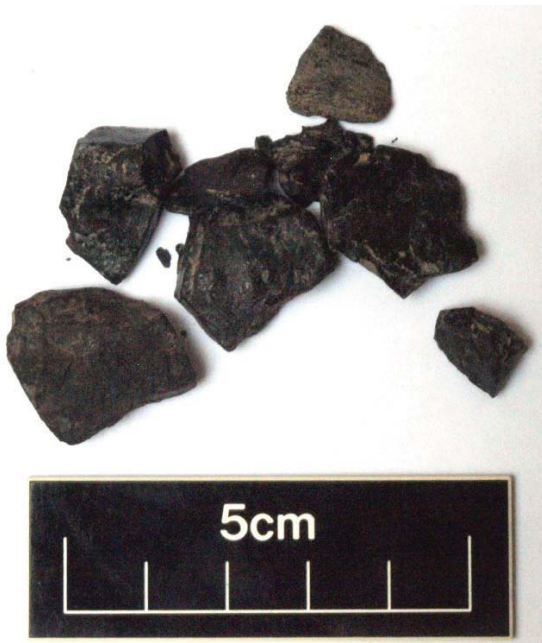
Plate 5: Unburnt coal from context 326/466 <4>

The material from context foundation 326 (466, sample 4) can be divided into three categories: some black vitreous material (229g, similar to above, Pl. 3), some partially burnt coal (6g, Pl. 4), and some unburnt coal (8g, Pl 5).

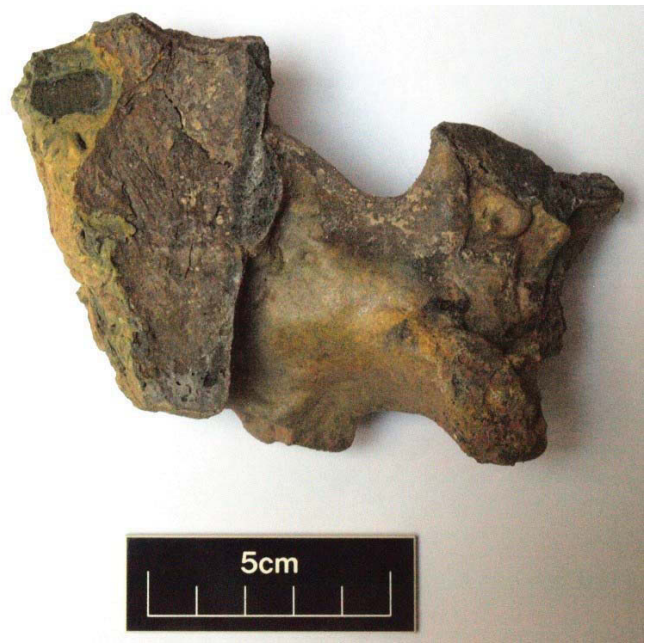
Plate 6: Brick waster from context (459)

The material from levelling layer 459 comprises waste from the (failed?) production of bricks (Pl. 6). The material is fairly light weight ($2.1\text{--}2.5\text{g/cm}^3$) and displays some original and some fracture surfaces. The original surfaces tend to be smooth and suggest some slumping/flow of the material when hot. The material (both original and fracture surfaces) is mostly grey in colour but this varies with some areas rather yellowish. The fracture surfaces reveal that the material has two components: fragments of grey ceramic with right angles (these appear to be fragments of bricks) completely embedded in a slumped vitreous material (the latter probably derived from melted bricks).

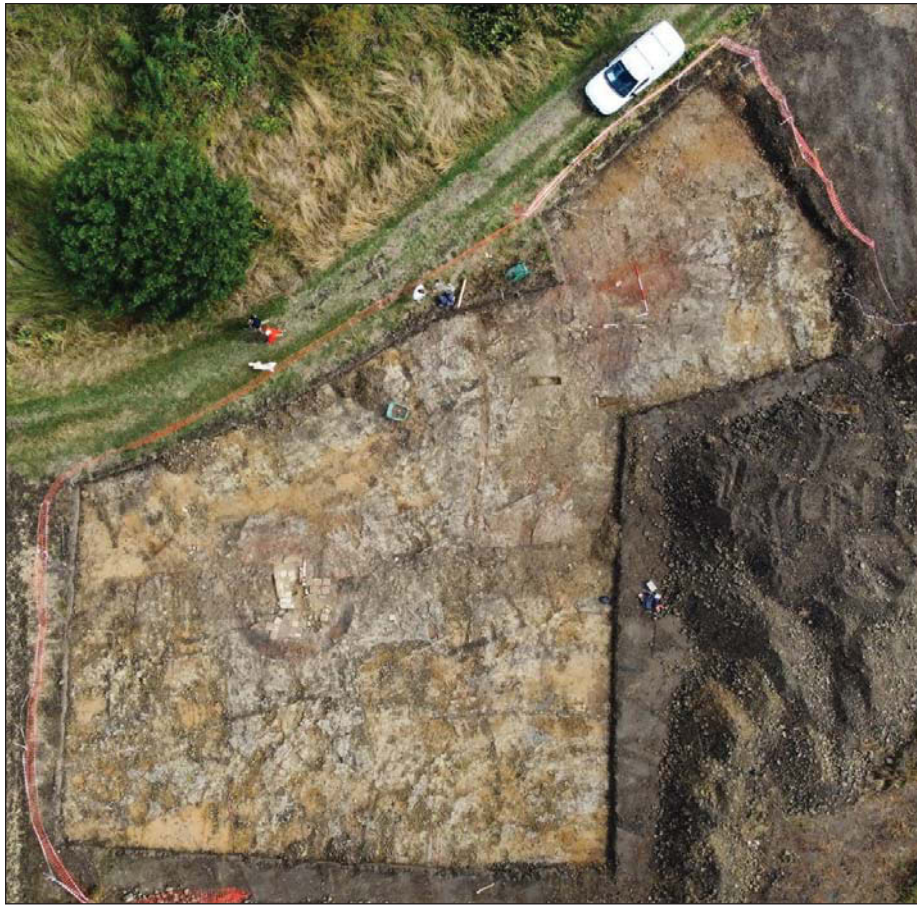
Plate 7. Drone view of the site.

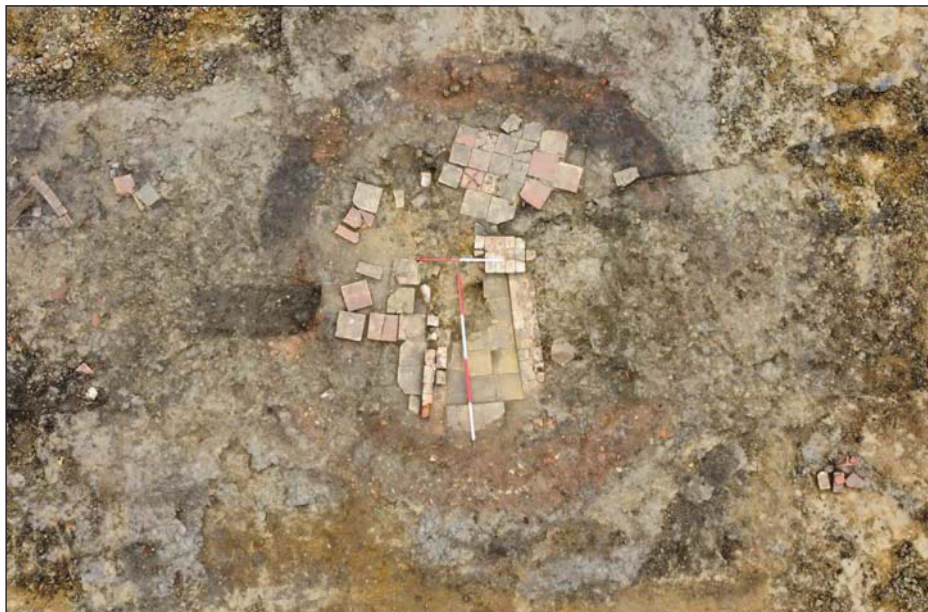
Plate 8. Drone view of brick kiln 1000.

The remains of a circular brick kiln were recorded in the northern part of the excavation area. These remains showed it was a circular downdraught kiln. Parts of this structure had been previously identified in evaluation

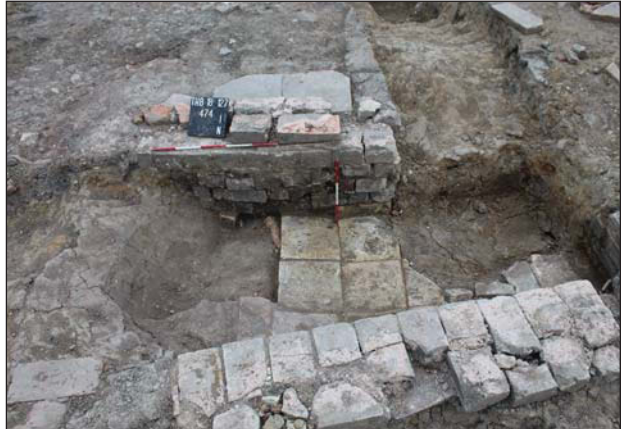
Plate 10. Showing downdraught pipes, looking south, Scales: 0.5m and 0.3m.

The chamber's tiled floor, 472 (Pl. 11) overlay a T-shaped series of ceramic pipes within cuts 327 and 330, which had been laid before the construction of the chamber walls (Pls 9 and 10). These pipes at one time were used as part of a downdraft system which enabled the hot gases generated from fires in the fire chambers of the kiln to circulate within the interior of the kiln and thus fire the bricks. The fire chambers would have been built into/around the kiln walls. The hot gases from burning coal and coke in the fire chambers would rise and hit the domed roof of the kiln then the vacuum caused by an exterior chimney would draw these gases down through the kiln then out of it via the pipes to a chimney. Ceramic pipe 478 in cut 327 and 401 was seen to be laid below wall 474/394 and led beyond the circular walls southwards, likely to a chimney, but no evidence this structure was recorded, it being completely robbed away.

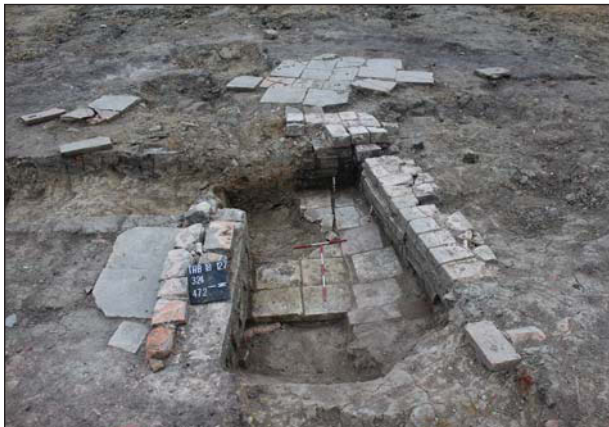
Plate 11. Lower floor level within kiln 1000, looking west, Scales: 0.5m, 0.3m and 2 x 0.1m.

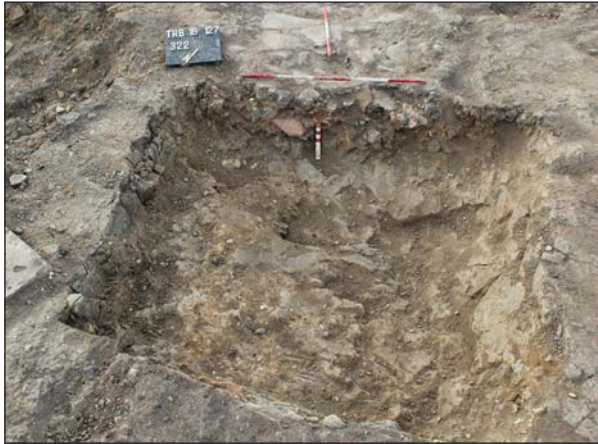
Plate 13 Foundation 322, looking south-east.
Scales: 0.5m, 0.3m, 0.1m

The outer circular brick walls and domed/vaulted roof of the brick kiln had been thoroughly robbed after the kiln went out of use, so that no trace of these survived. The foundations of the circular wall had also been partly robbed (robber cut 321) and only the lower elements of the circular foundations survived. The surviving foundations (322, 325 and 326) were shown to surround an internal space with a diameter just a shade under 4m, giving an area of *c.*12.4 sq m (Pls 13, 14 and 17). They were seen to be between 0.60m and 0.80m wide and 0.14m and 0.20m deep with shallow concave sides and slightly rounded or irregular base and were filled with brick and tile fragments together with possible non diagnostic iron working slag, pieces of unburnt coal and brick wasters.

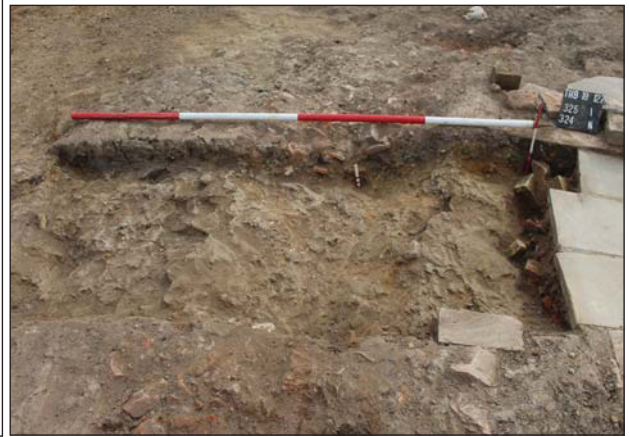
Plate 14. Foundation cuts 324 and 325, looking south,
Scales: 2m, 0.3m and 0.1m.

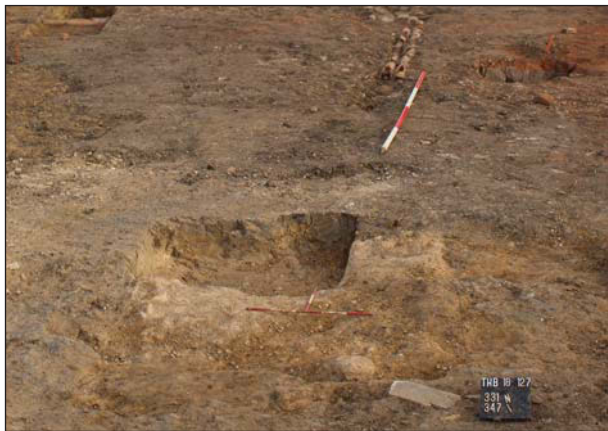
Plate 15. Mortar mixing pit 347, looking north,
Scale: 2m.

This was rectangular with near vertical sides, 1.40m by 1.10m and over 0.18m deep. It truncated layer 398. It was filled with a compact yellowish red sand (389) which overlay hardened lime mortar (390). It was truncated by a later land drain (402).

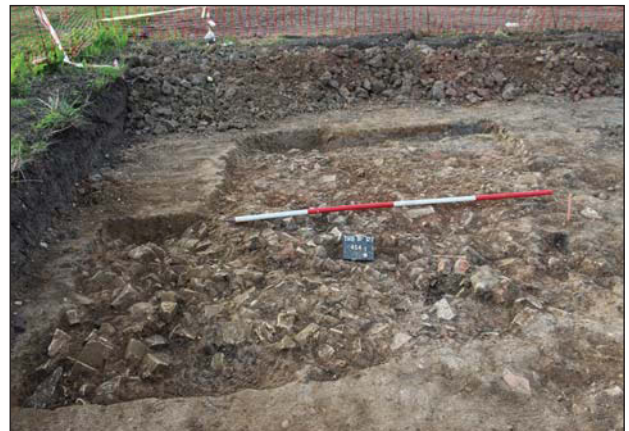
Plate 16. Metalled surface 454 looking south,
Scale: 2m.

In the far SE corner of the site a metalled surface, 454, was recorded (Pl. 16). This comprised broken brick fragments (red and yellow) in a grey clayey silt matrix. This was seen to be continuing beneath the southern and eastern edge of the excavation and in the excavation area was recorded as a rectangle 2.60m by 3.00m and 0.20m deep. It overlay a dark grey brown sandy clay layer (471) with brick dust and charcoal which was 0.17m deep. This was overlying the natural geology. This surface is likely an area of hard standing on which carts were loaded with ceramic products and mortar to be carted off site.

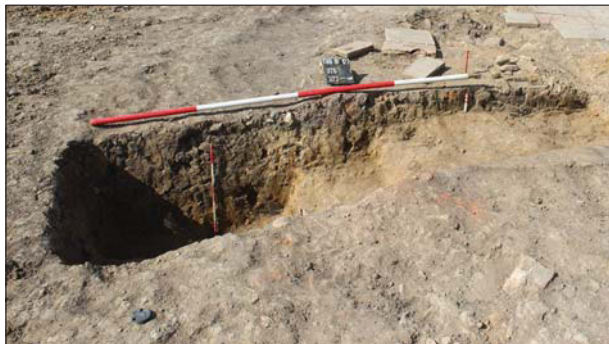
Plate 17. Pit 323 and kiln foundation 326, looking west,
Scales: 2m, 0.5m and 0.1m.

This was seen in a box slot and was seen to be over 0.80m wide and 1.00m in length. It was not bottomed as excavation ceased at 0.60m below the stripped surface. It contained two fills (468 and 469) and four fragments of a small dish or a lid from a rhubarb forcing pot of probable Victorian date were recovered from fill (469).
