**Land at Farnham Sewage Treatment Works,
Water Lane, Farnham, Surrey**

Archaeological Evaluation

**An Archaeological Evaluation
for Trinzic Operations Limited**

Report 20/153b

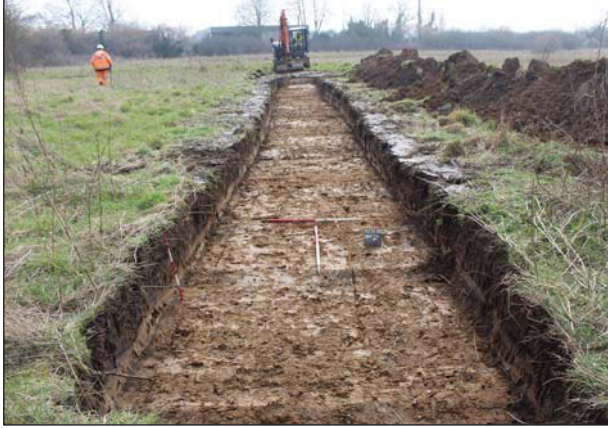
Trench 2 was aligned NW - SE and was 25m long and 0.50m deep. The stratigraphy consisted of 0.35m of topsoil and 0.15m of subsoil overlying natural geology. No archaeological feature was seen and no finds were recovered.

Plate 1. Trench 2, looking South East;
Scales: 2x1m and 0.5m.

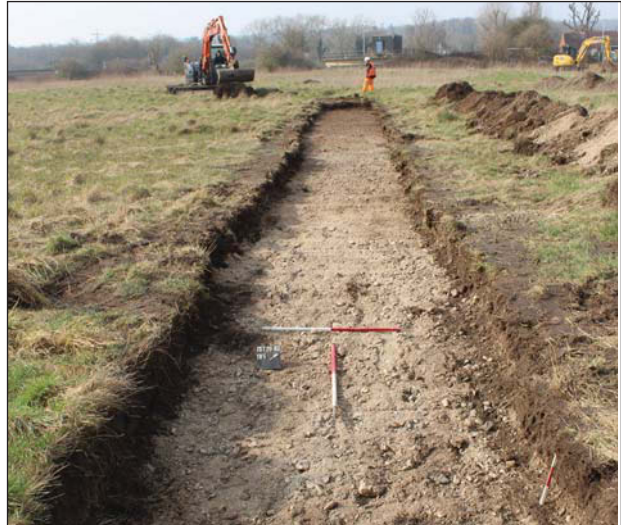
Trench 5 was aligned SE - NW and was 25.6m long. It was 0.35m deep. The stratigraphy consisted of 0.24m of topsoil overlying natural geology. Some ploughmarks were visible. No archaeological feature was seen and no finds were recovered.

Plate 2. Trench 5, looking North West;
Scales: 2x1m and 0.3m.

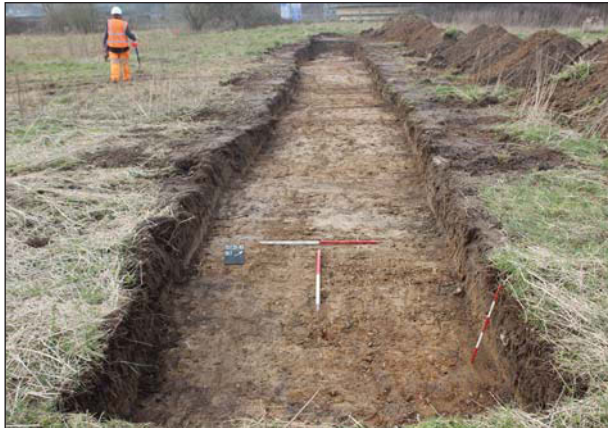
Trench 7 was aligned ESE - WNW and was 25m long. It was 0.30m deep on the western end and 0.50m on the eastern side. At its thickest part, the stratigraphy consisted of 0.25m of topsoil and 0.21m of subsoil overlying

natural geology. A modern ditch was present between 3.20m to 4.10m from the ESE end. No archaeological feature was seen and no finds were recovered.

Plate 3. Trench 7, looking North West;
Scales: 2x1m and 0.5m.

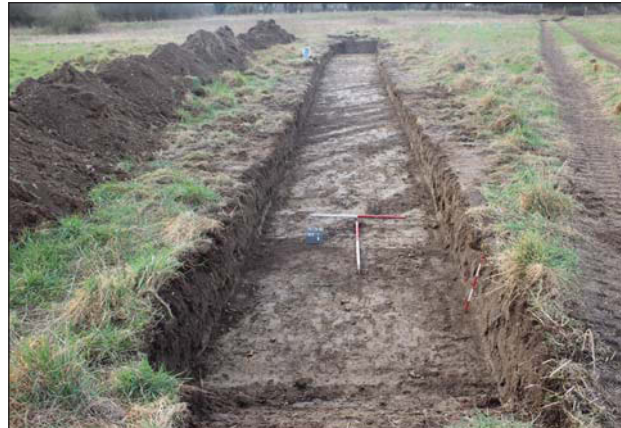
Trench 9 was aligned S - N and was 26.10m long. It was 0.3-0.5m deep. The stratigraphy consisted of 0.20m of topsoil and 0.30m of subsoil overlying natural geology. Several ploughmarks were noted. From 20.3–21.6m from the north end a massive modern truncation was present. A 1m deep test pit was made but did not bottom this presumed quarry pit, also seen in trenches 11 and 15. No archaeological feature was seen but a worked flint was recovered from subsoil.

Plate 4. Trench 9, looking South;
Scales: 2x1m and 0.5m.

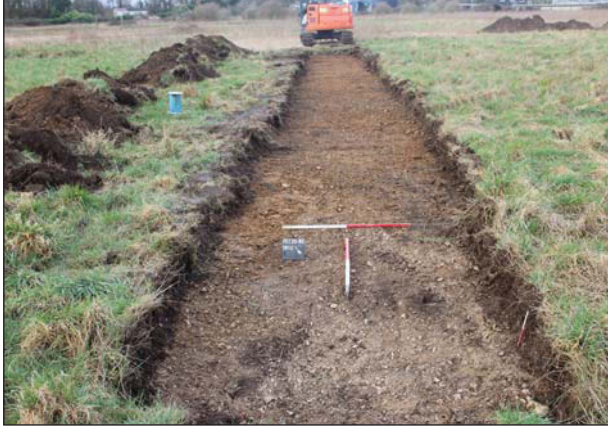
Trench 10 was aligned WSW - ENE and was 20m long. It was 0.20m deep. The stratigraphy consisted of 0.20m of topsoil overlying natural geology. No archaeological feature was seen and no finds were recovered.

Plate 5. Trench 10, looking South West;
Scales: 2x1m and 0.3m.

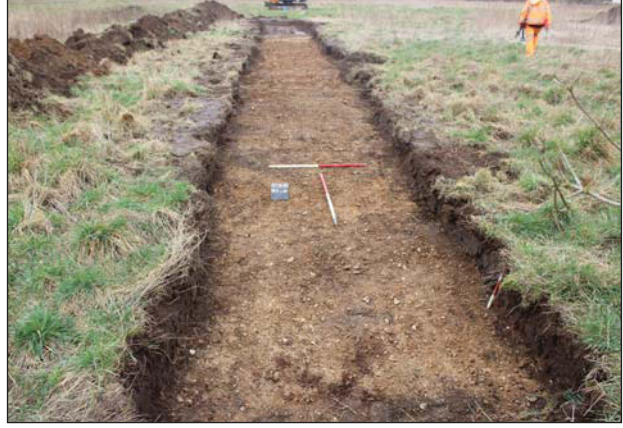
Trench 11 was aligned ESE - WNW and was 25.5m long. It was 0.33m deep. The stratigraphy consisted of 0.30m of topsoil overlying natural geology. No archaeological feature was seen and no finds were recovered. At 17.9m from the east end there was the edge of another massive modern truncation until the end of the trench, likely the same as seen in trenches 9 and 15.

Plate 6. Trench 11, looking North West;
Scales: 2x1m and 0.3m.

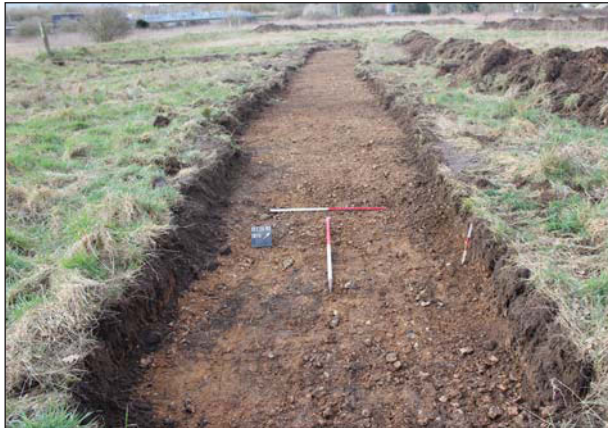
Trench 16 was aligned NW - SE and was 25m long. It was 0.30-0.35m deep. The stratigraphy consisted of 0.18-0.30m of topsoil overlying natural geology. No archaeological feature was seen and no finds were recovered.

Plate 7. Trench 16, looking North West;
Scales: 2x1m and 0.3m.

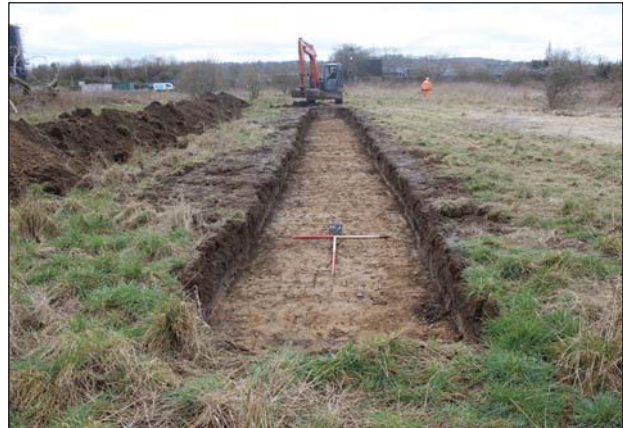
Trench 21 was aligned SE - NW and was 25m long. It was 0.40-0.50m deep. The stratigraphy consisted of 0.20m of topsoil and 0.10m of subsoil overlying natural geology. The subsoil, more akin to a dirty natural geology, thickens towards NW up to 0.20m. No archaeological feature was seen and no finds were recovered.

Plate 8. Trench 21, looking North West;
Scales: 2x1m

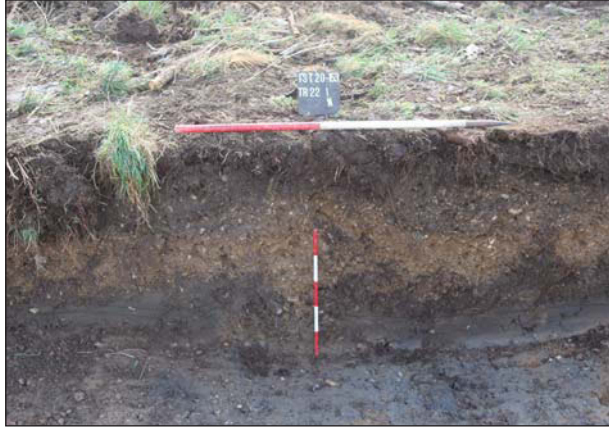
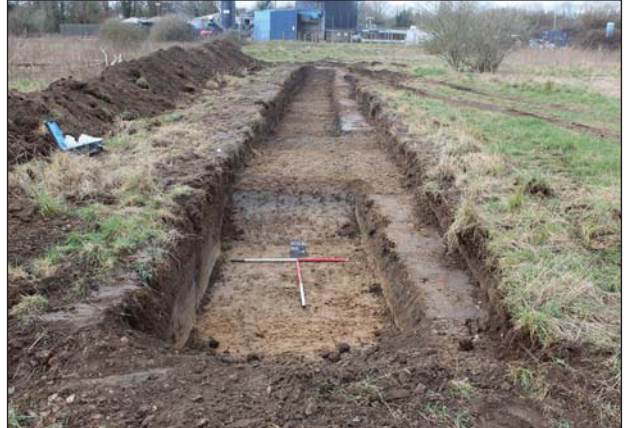
Trench 22 was aligned E - W and was 25.4m long. It was up to 0.75m deep. The stratigraphy consisted of 0.20m of topsoil, 0.10m of redeposited gravels (53) and 0.34m of a buried topsoil, a dark grey silty sand with rare gravels and yielding late 19th/20th century finds (not retained) overlying natural geology. No archaeological feature was seen and no finds were recovered.

Plate 9. Trench 22, looking South;
Scales: 1m and 0.5m.

Plate 10. Trench 22, looking West;
Scales: 2x1m.

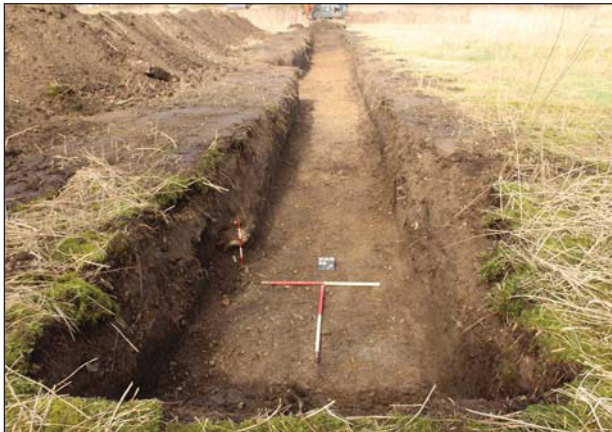
Trench 26 was aligned SE - NW and was 25.20m long. It was 0.90-1.10m deep. The stratigraphy consisted of 0.15m of topsoil overlying a thick modern backfill, not bottomed at SE and incorporating common modern rubbish. The base of that deposit rose up gradually after 5m and natural geology was observed at 0.80m below ground level afterwards. No archaeological features were seen.

Plate 11. Trench 26, looking North West;
Scales: 2x1m and 0.5m.

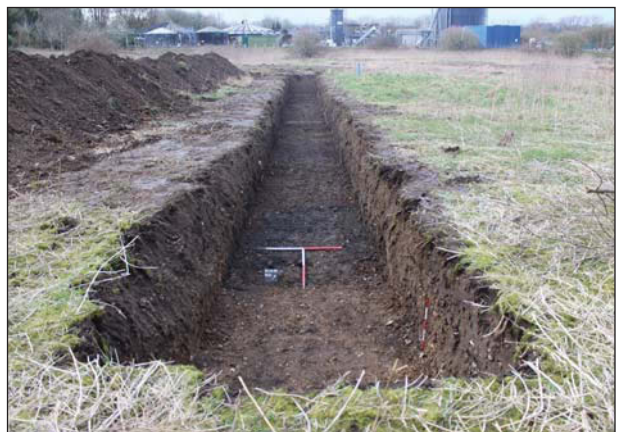
Trench 28 was aligned ESE - WNW and was 25.30m long. It was 1.10m deep. The stratigraphy consisted of 0.32m of topsoil and 0.78m of modern infill. The natural geology might have been reached only at the eastern end, for in the first couple of metres, at 1.10m deep. Elsewhere the modern landfill (58) was not bottomed. No archaeological feature was seen.

Plate 12. Trench 28, looking North West;
Scales: 2x1m and 0.5m.
