**St Mary's Church, Church Lane,
Hartley Wintney, Hampshire**

An Archaeological Watching Brief

Site Code SWH 09/02

January 2009

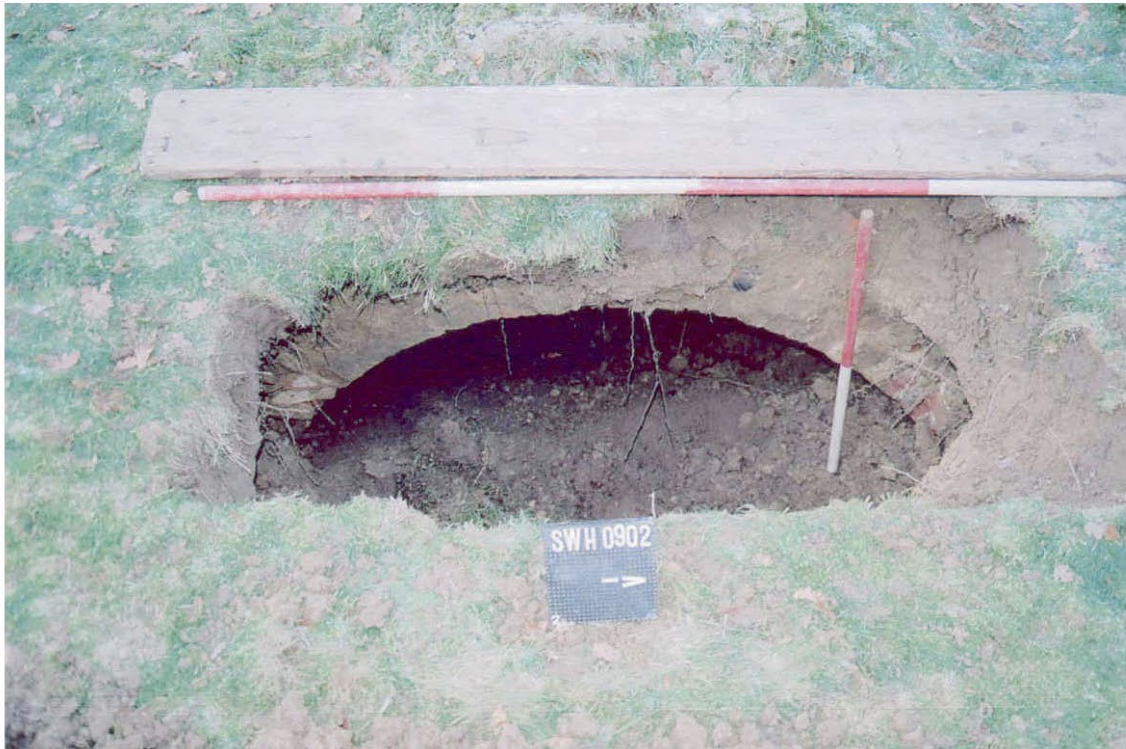
The existing void was expanded by hand to 2.50m by 0.90m and *c.* 2.40m in depth, where a brick-built barrel vault was exposed (Fig. 3 and Pl. 1). The crypt measured 2.10m by 1.97m and was in good condition except for the east end wall which had collapsed causing the void to open up in the churchyard, the western internal wall of the crypt was intact and showed evidence of a blocked doorway for entrance into the crypt. The wall of the vault was made of a double skin of brick with a whitish yellow mortar, as was the lower part of the wall of the crypt. The collapsed section of wall was only single skinned (Pl. 2). All the bricks measured 220mm x 110mm by 71mm. Bricks rarely reached depths of 70mm ($2\frac{5}{8}$ inch) before the middle of the 18th century; this size of brick would have been on the large side, but not abnormally so, for the second half of the 18th or first half of the 19th century, but is also that specified in 20th century standards. The base of the crypt was a brown silty clay which may be the natural geology.

Plate 1. Crypt as exposed looking west, horizontal scale 2m, vertical scale 1m.

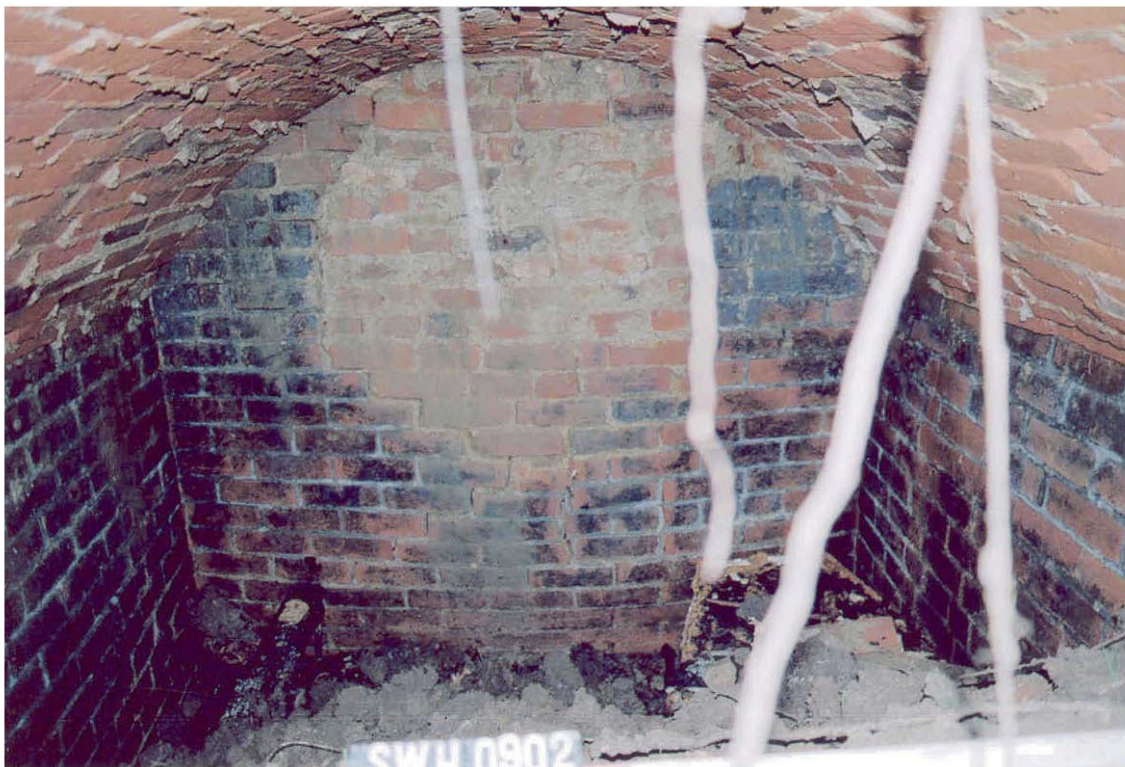
Plate 2. Crypt interior, showing wall repair and new vault.
