**Upminster Court, Hall Lane, Upminster,  
London Borough of Havering**

**An Historic Building Appraisal**

**Site Code: UPC09**

**Report 09/89b**

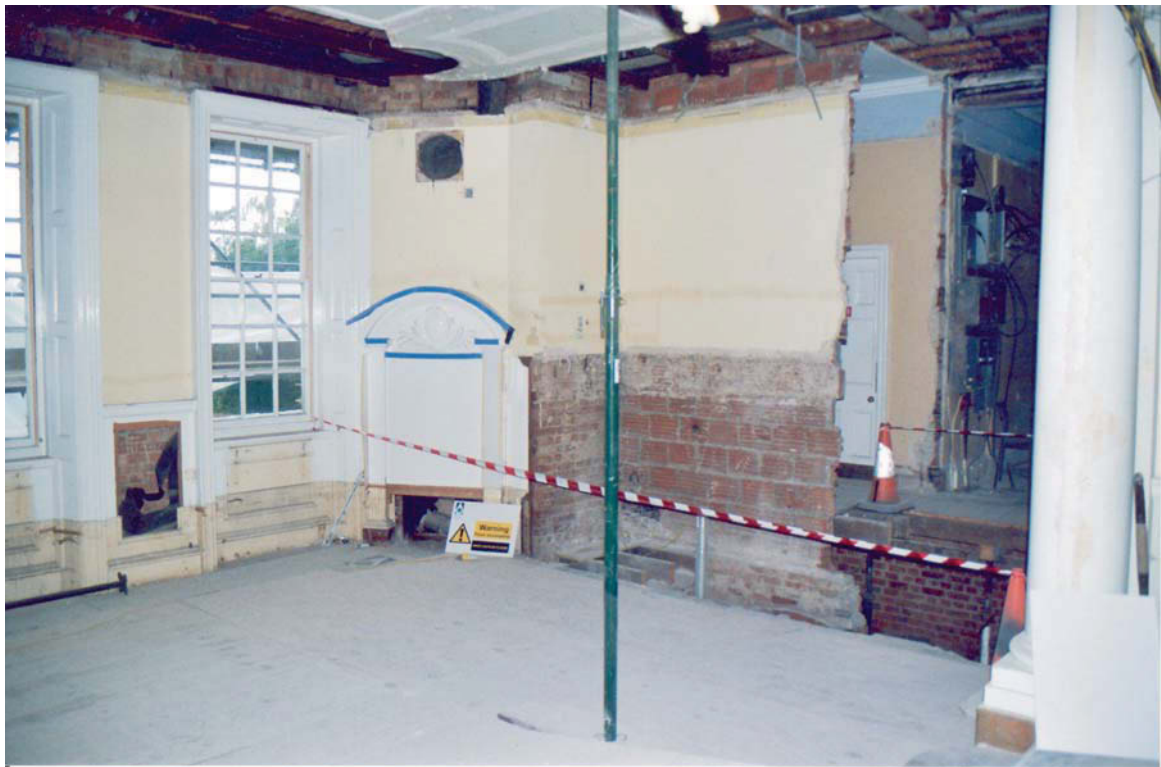
Plate 2. Room G3 looking north.

Room G3 (the original drawing room) is also accessed from the main lobby (G2), with the doorway between them retaining its original timber surround [5] (Pl. 2). Recent work, undertaken for Health and Safety reasons, such as to remove asbestos, has had the effect of restoring the room to its original size, as a number of later partition walls had divided it into three smaller rooms, a corridor and a lobby for the lift. In addition to the lift and partition walls being removed, a number of false ceilings have also been taken down, thus restoring the room to its full height and exposing the finely moulded cornices and original decorated ceiling [6]. The original ceiling is intact except in the north-east corner of the room, where it was truncated by the insertion of the lift. Traces of an earlier colour scheme can be seen where the later partition walls have been removed. Much of the original character of the room survives, including a fireplace in the north-west corner, although the east wall has been affected by the construction of the lift shaft, and by the insertion of a later narrow doorway into room G1.

As mentioned above, this doorway is no longer required, and will be fully blocked. The drawing room has a south facing bay, with three full length windows, and there are two further full length windows [7] overlooking the terrace and gardens to the west. All these windows still have their original timber surrounds.

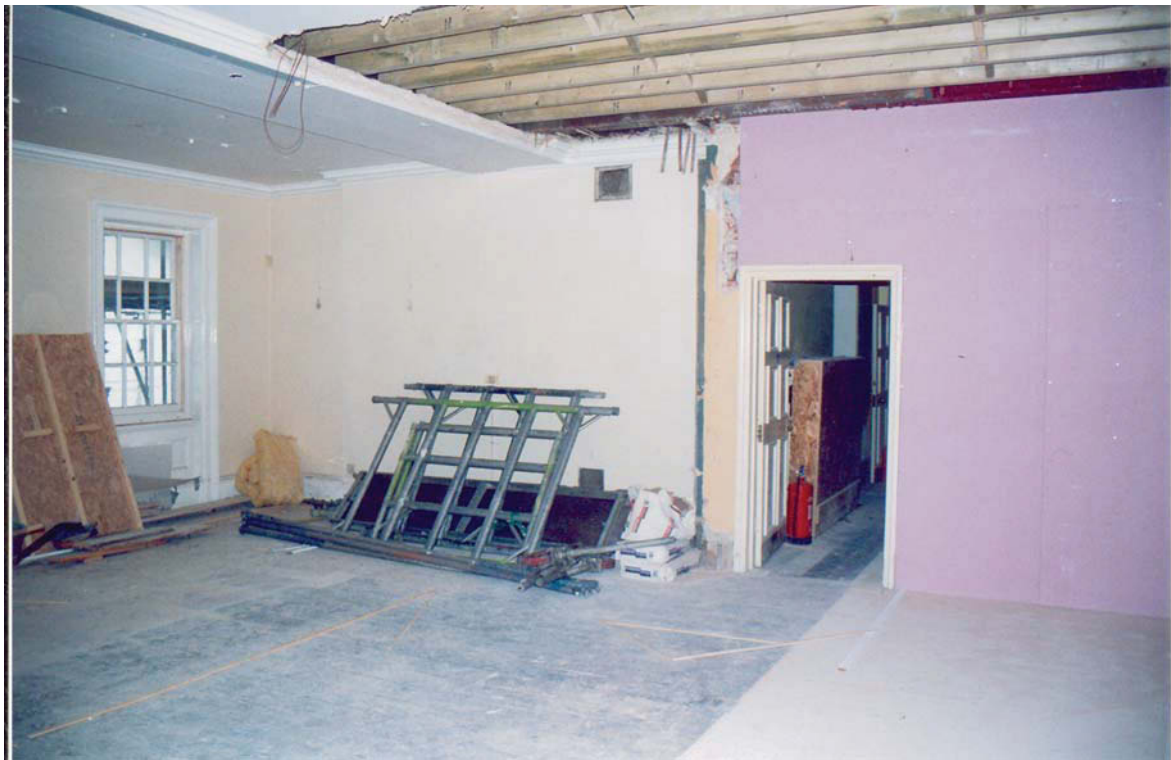
Plate 6. Room G14 looking south.

the doorway leading outside from room G14 appears to have been altered. As part of the proposed development, it is proposed to block the existing doorway, and construct a new entrance to the north. This will provide access to the new refectory. New partition walls in the north-east corner of room G14 will be built to create a small vestibule area for the new entrance. These will be roughly in the same position as one of the original storerooms. Room G13 still has its modern false ceiling [26] (Pl. 6).

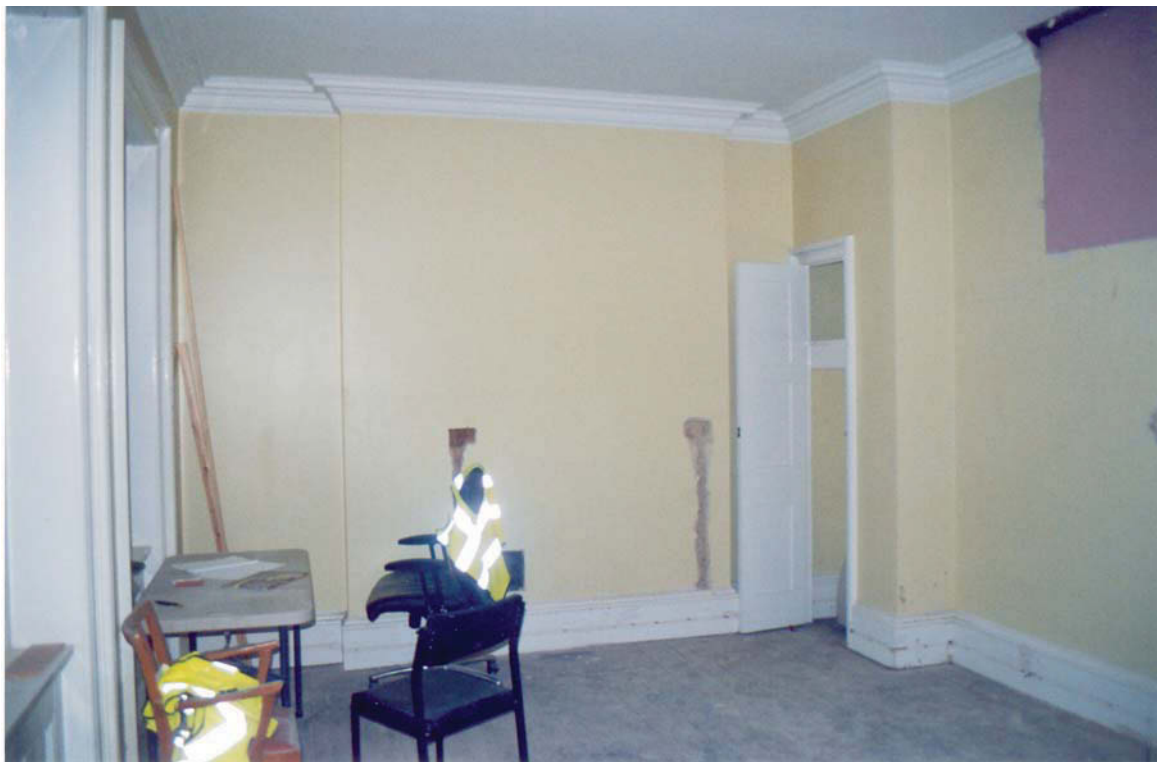
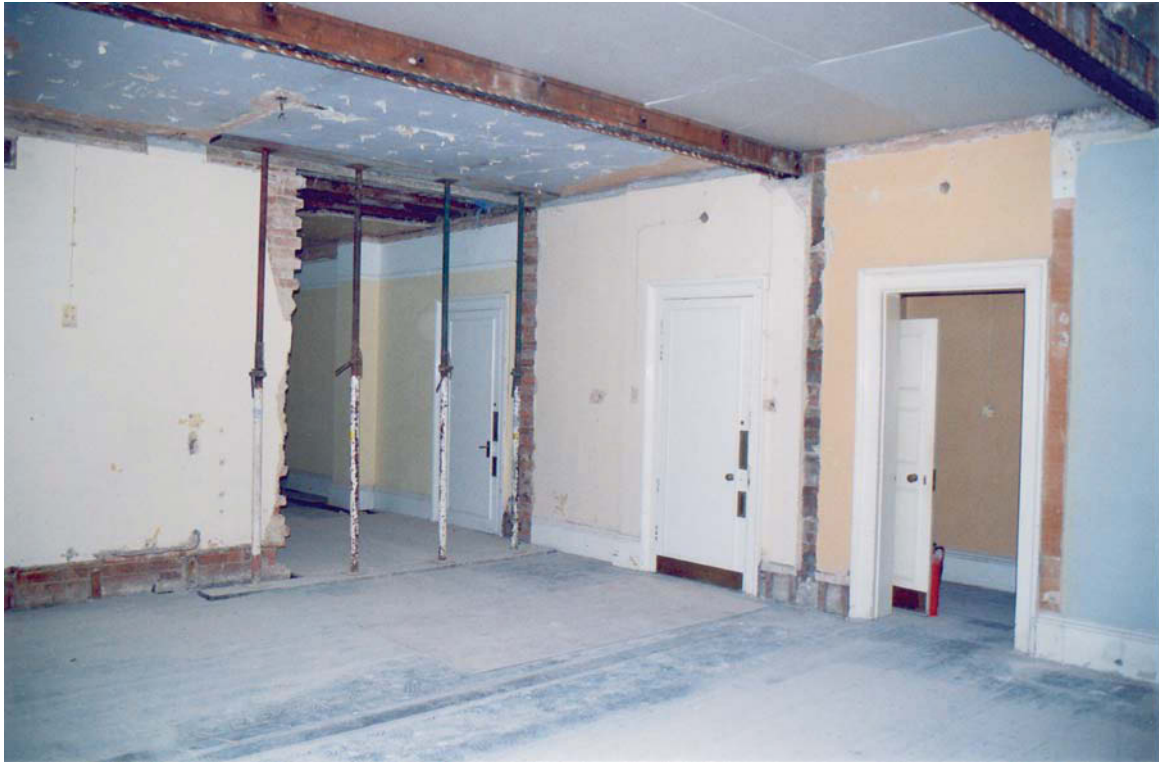
Plate 7. Room F1 looking west from staircase.

The present room F2 has been created by the removal of the lift and a number of partition walls [38, 40, 41] (Pls 7, 8). Although the room has a number of original windows, the fireplace in the north-west corner has been

removed and blocked up. Due to the alterations which have been made since 1905, it was impossible to tell how the room would originally have been divided into separate bedrooms. As mentioned above, there was originally a door leading into room F3, which has subsequently been blocked, although the door frame is still present [39].

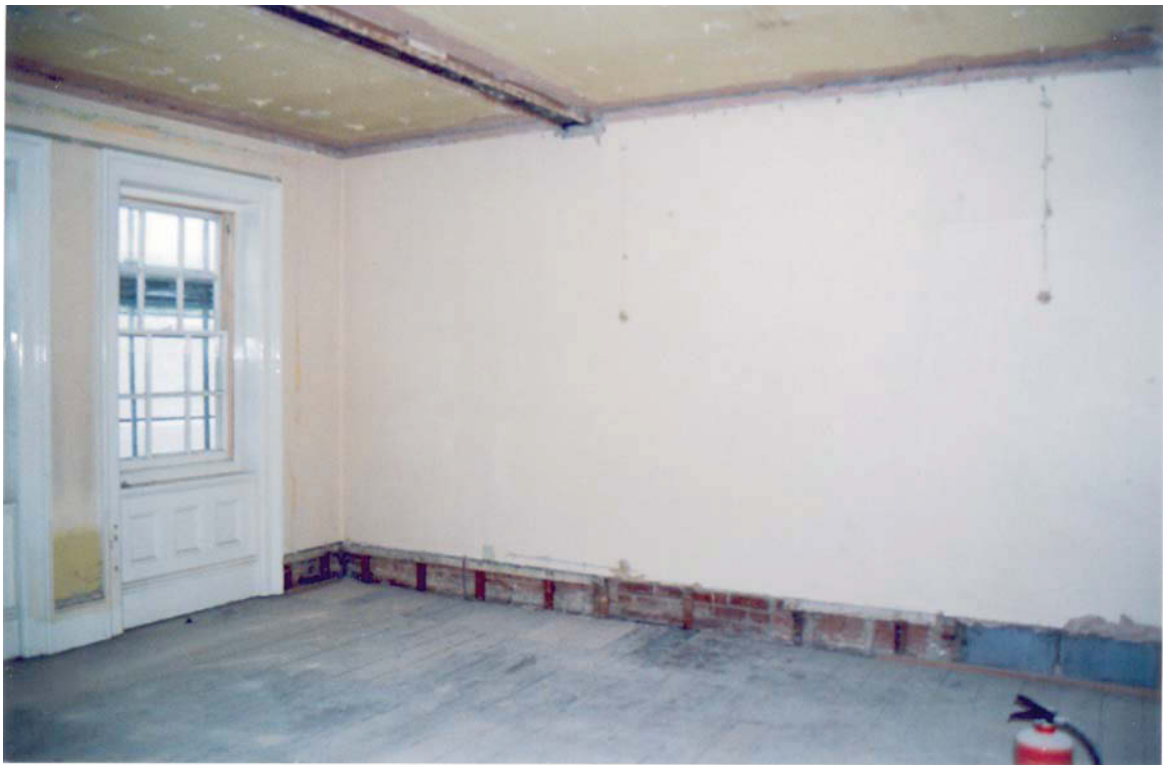
Plate 10. Room F9 looking south-east.

Moving north from landing F1, the main first floor corridor (F10) passes a staircase to the second floor [48, 49]. A small room behind this staircase (F20) previously contained a WC which has recently been removed [61], along with parts of the ceiling [62]. The next room along the corridor, on the west side, is F8, which has three original windows. A number of partition walls have recently been removed from this area, along with the original cornices [44]. In addition, preparatory work in respect of the new lift has resulted in the demolition of part of the wall between rooms F8 and F9 [45] (Pl. 9). The fireplaces which presumably occupied the south-west and north-west corners of room F8 appear to have been removed or blocked-up. However, this appears to have been done a number of years ago. Whilst some of the partition walls which were recently removed may have been later additions, it is likely that the east-west partition wall may have been an original feature, as the space created by its subsequent demolition (F8) now has two doorways onto corridor F10 [46] (Pl. 10).

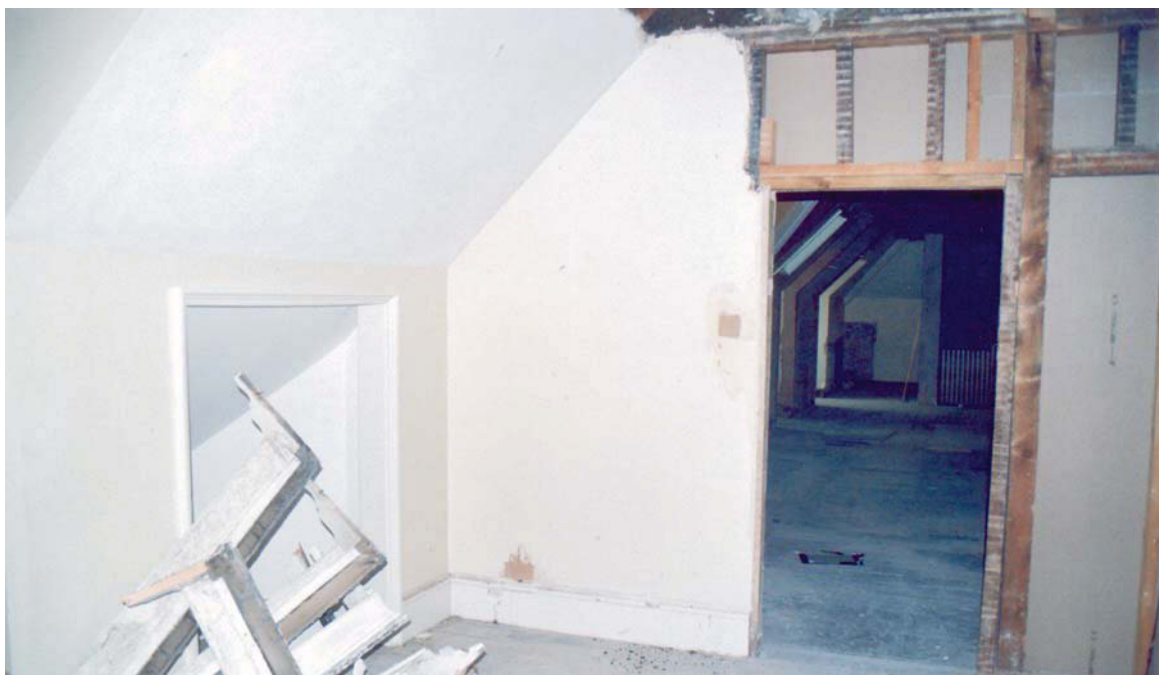
Plate 13. Room S3 looking east.

A number of partition walls have recently been removed from what is now room S3 (Pl. 13). The area now covered by this room previously consisted of three rooms with associated corridors and stair landings [71]. Apart from the windows [72] and remaining doors, the only original feature recorded during the site visit was a fireplace in the south-west corner of room S3 [78]. Several new partition walls will be constructed to convert this area into two bedrooms, separated by the new lift, with a north-south corridor running down their east side. Further walls will be inserted within the new bedrooms to provide en-suite bathrooms. The present staircase at the far north end of the room will be little affected by the refurbishment.

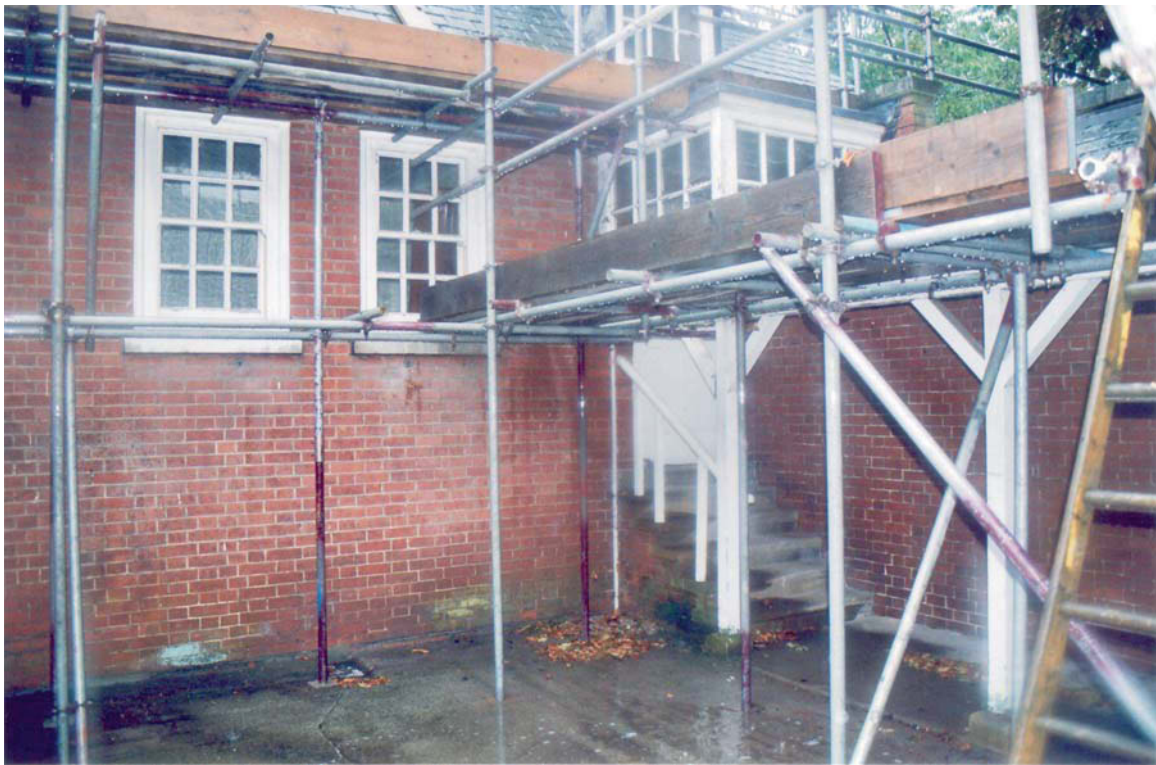
Plate 15. Kitchen courtyard looking south-west towards main house.

There are currently two entrances into the larger courtyard. The main entrance through the eastern brick wall appears to have been modified on at least two separate occasions, based on differences in the brickwork. A secondary, northern, entrance is located to the west of building C, via a short flight of steps. At the time of the site visit, the courtyard was rather unremarkable, although it was noted that an outbuilding previously adjoining the service wing of the main house had recently been demolished. It is planned to build a new refectory within the courtyard, with herb garden patio to the south. The new building will mostly utilise the existing courtyard walls, along with the south wall of building C. The proposed alterations will include repairs, underpinning and alterations to the walls around the courtyard, the construction of a new entrance into the main house (Pl. 15), and a new fire-door in the area between buildings C and D. The refectory will also have a new wall separating it from the proposed herb garden patio, to the south, which will primarily be constructed with glass panels. It is planned to create a new opening in the curved section of the wall at the southern end of the courtyard, which will be built to mirror that into the walled garden further south. The original plan of the house shows an entrance in this position, although it is not clear from the brickwork whether it ever existed. A new set of steps will be built to provide access to the main house, in the area formerly occupied by the small outbuilding which has recently been demolished. The existing entrance will be blocked-up, and a new doorway created.

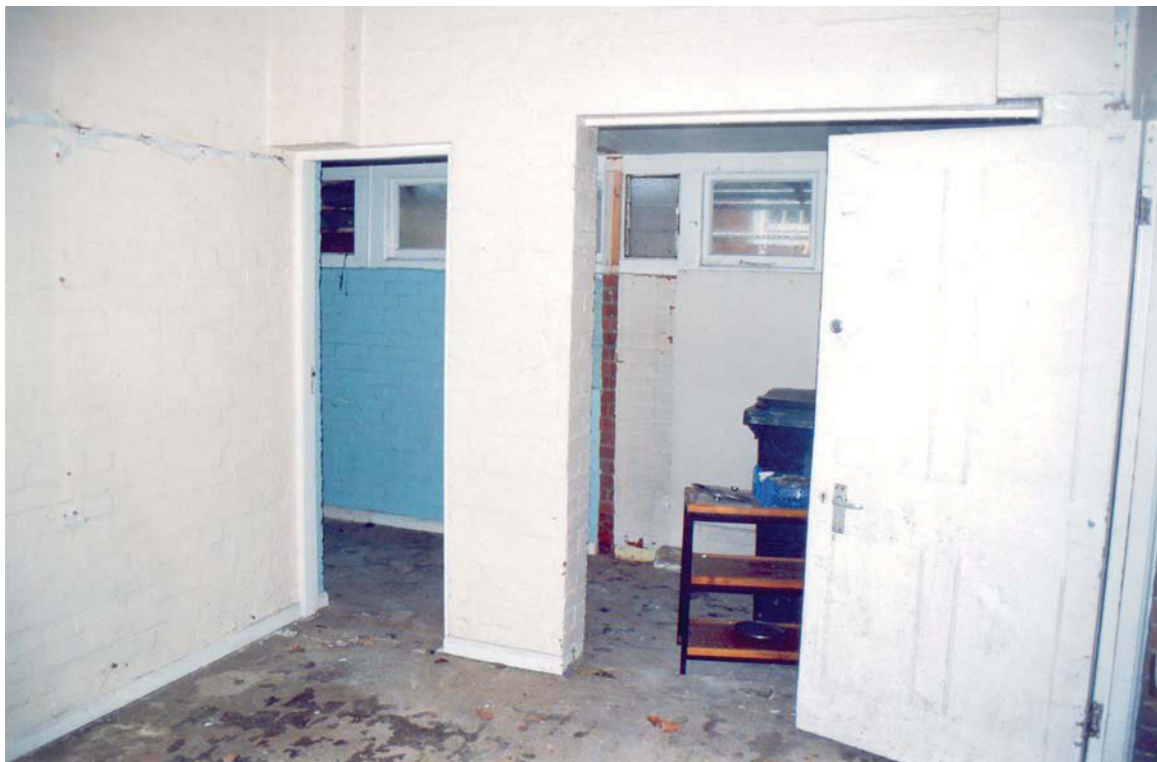
Plate 16. Interior of building D looking south.

S6	Apart from the insertion of an en-suite bathroom the north-east corner of the room, no major changes are planned.	Some redecoration and the insertion of pipework needed	Minor
S7	The partition walls and WC in the north-west corner of the room will be replaced by a new en-suite bathroom.	The WC is not original. Some redecoration and the insertion of pipework needed	Minor
Kitchen Courtyard (B)	A new refectory and herb garden patio to be built within courtyard. This will involve repairs, underpinning and alterations to the surrounding walls. A new entrance into the house will be created.	Whilst the surroundings walls are original, they do appear to have been modified on at least two occasions since 1905.	Minor <b>[Pl. 15]</b>
Building C	Building will be converted into toilets and a storeroom.	This will involve the removal of original partition walls.	Moderate
Building D	Building to be converted into a bar and storeroom, following removal of existing partition walls.	The building appears to have been modified internally in the past, therefore the proposed changes will not have a significant impact of its historical fabric.	Minor <b>[Pl. 16]</b>
