**St Nicholas's Church, Ickford,
Buckinghamshire**

Archaeological Watching Brief

**An Archaeological Watching Brief
For St Nicholas's Parochial Church Council**

Report 10/12

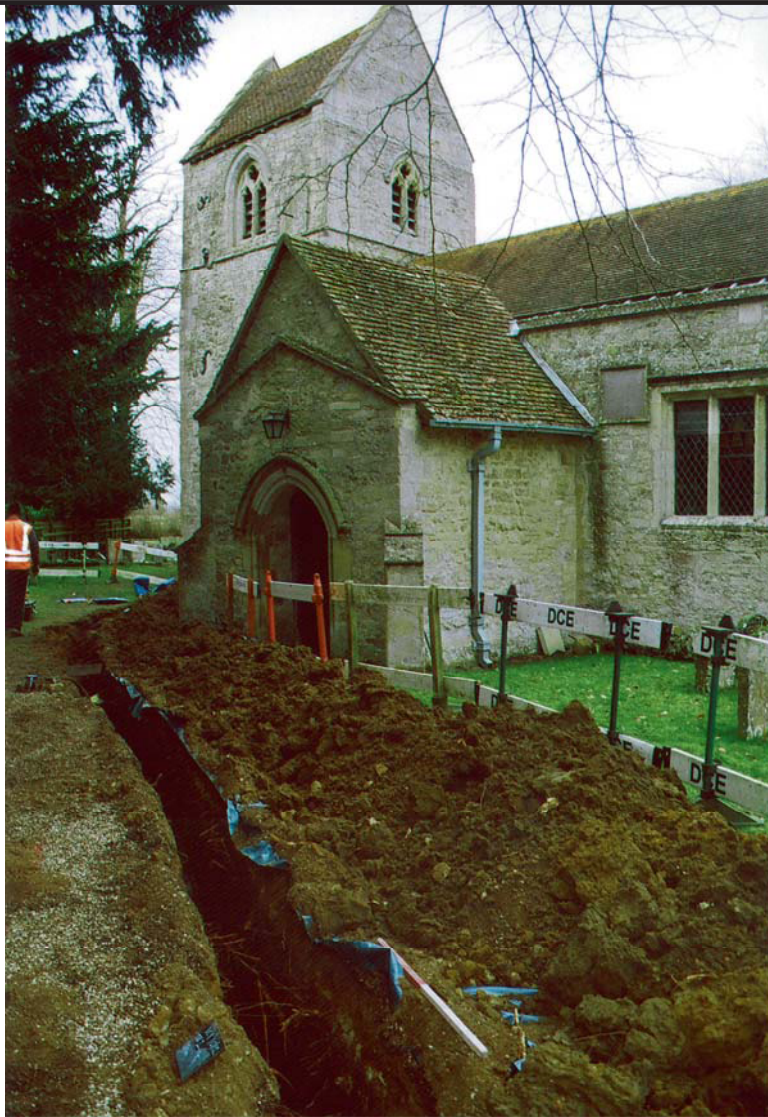
The sewer trench was dug over the course of two days. The trench was 0.3m wide and 0.5m deep at the western end, falling to 1.4m at the eastern extent of the site where the sewer joins with existing service trenches (Pl. 1). The trench measured 40m to the edge of the site (Fig. 3). The stratigraphy encountered generally comprised 0.2m of turf and topsoil above 0.5m of mid grey/brown silty clay subsoil/grave-earth above mottled yellow/brown clay down to the base of the trench (Fig. 4). The water table was observed at depth of 0.9m at the eastern end of the trench.

Far less disturbance was observed as the trench moved further away from the church (Pl. 1). No other features of archaeological interest were observed during the excavation of the trench.

Plate 1. Sewer trench looking north-west, scale: 1m

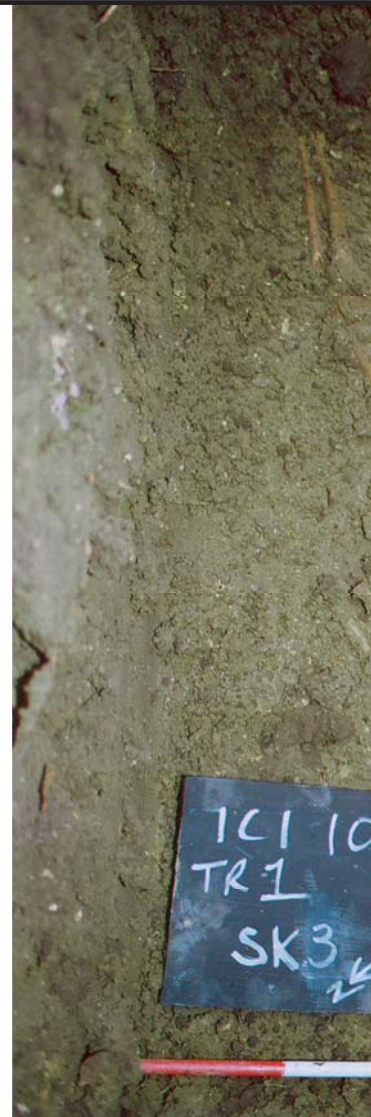
The burials, apart from the fourth skeleton, were aligned across the trench, therefore only partial remains were recorded and removed. The revealed bones of skeleton 1 and 3 were the leg and feet bones only (Pl. 2), whilst the skull, ribs, vertebra and humerus were recovered from skeleton 2. The final skeleton appeared to be aligned more closely with the path of the trench, although as it was decided to step the trench up, only the leg bones had been recorded.

Plate 2. Sewer trench, skeleton
