**The Paddocks, School Lane,
Castle Eaton, Swindon, Wiltshire**

Archaeological Evaluation

Site Code: SLC10/52

(SU 1462 9565)

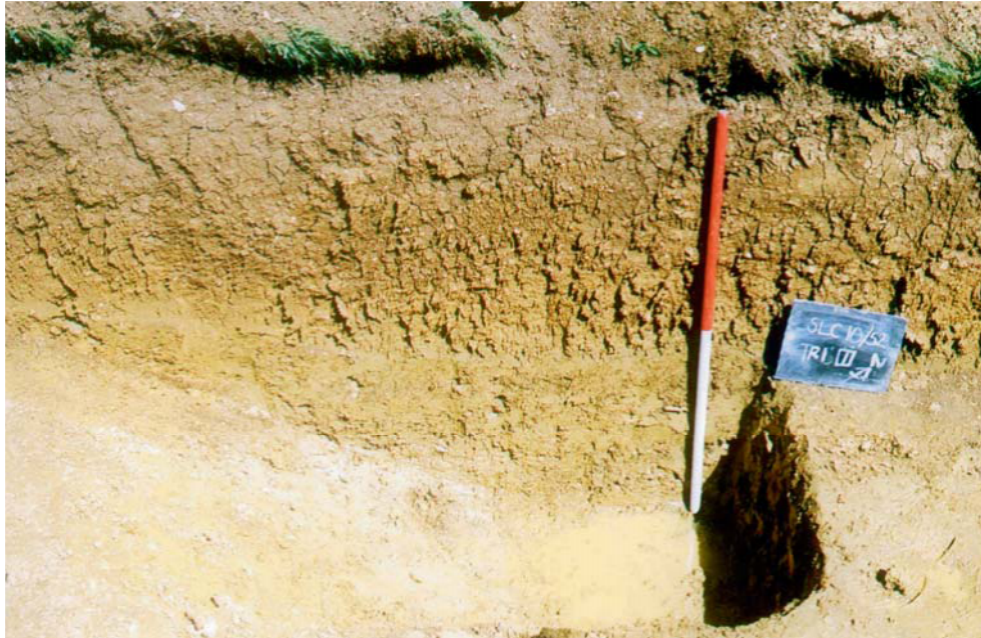
Beneath the subsoil and cut into hard yellow gravel natural geology was Ditch 1 which was orientated SE - NW and was 3.10m wide and 0.56m deep with sides that sloped approximately 30° and what appeared to a flat base, however the water table was encountered at 0.38m deep within the ditch. Ditch 1 was filled with (52) a mid yellow/brown sandy clay with occasional gravel (Fig. 4). A section was excavated though the ditch to the mid point and then extended across the remainder of the ditch for finds retrieval; just three pieces of animal bone weighing 14g were recovered.

Plate 1. Trench 1, section of ditch 1, looking north west, scale 1m.

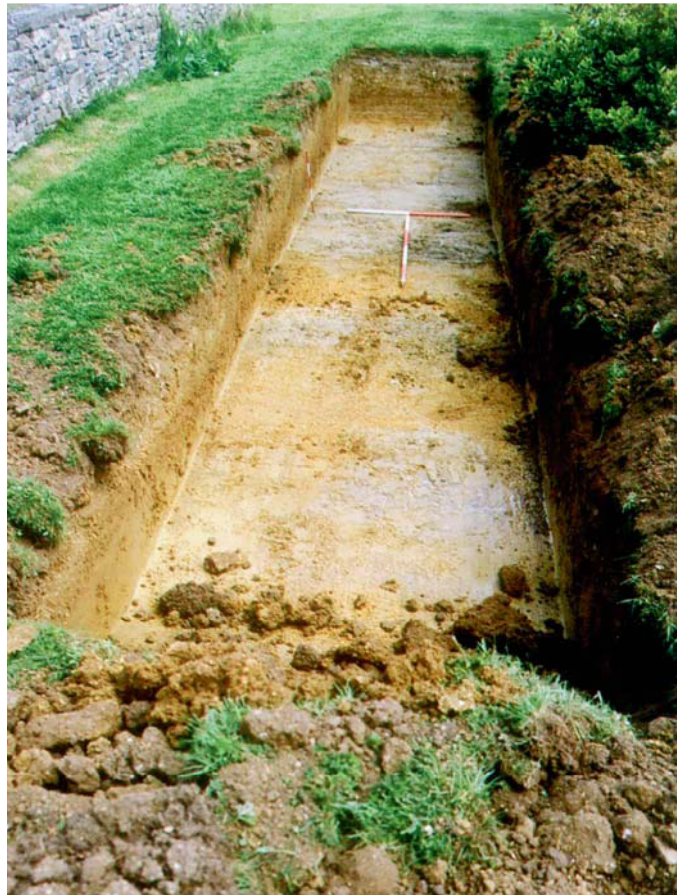
Trench 3 was aligned SW–NE and was 9.8m long and a maximum of 0.80m deep. The stratigraphy comprised topsoil to a depth of 0.20m over silty clay with gravel subsoil to a depth of 0.35m. Beneath the subsoil was palaeochannel (3) which had an uneven irregular shape in plan irregular and undercut edges though the base was not seen. A hand dug sondage was excavated though the fill of the palaeochannel, which was filled with mottled red/brown to blue/grey sandy clay with lens of yellow and red brown sandy gravel (53). The sondage was excavated to a depth of 1.10m below topsoil after which it was augured to a depth of 1.8m with no change in

Plate 2. Trench 3, looking north east, horizontal scales 1m and 2m, vertical 0.5m

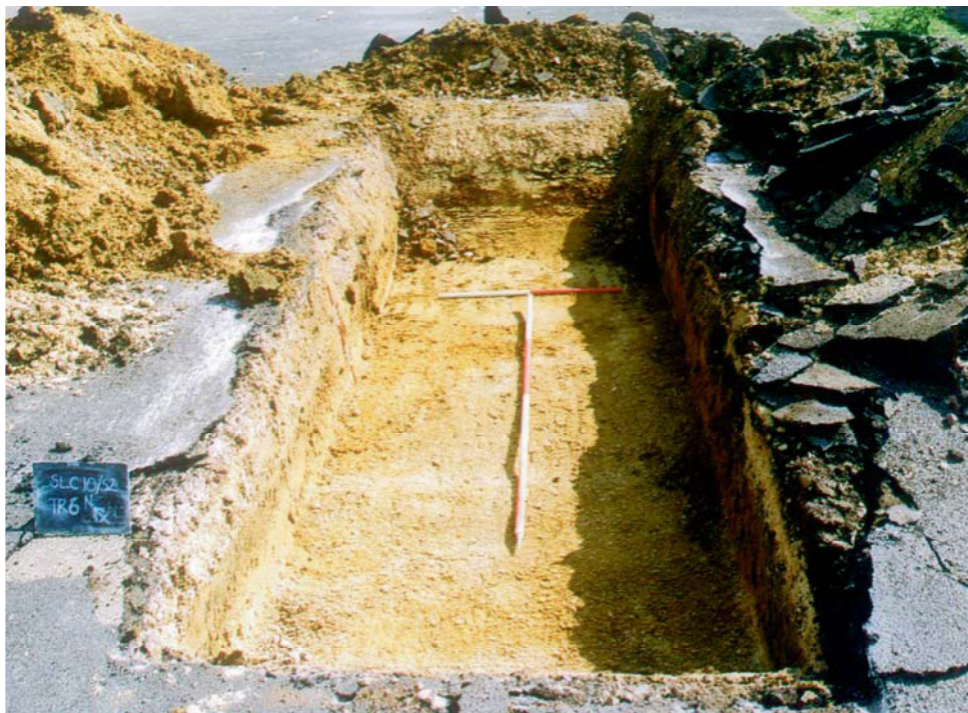
Trench 6 was aligned SW–NE and was 5.2m long and a maximum of 0.7m deep. The stratigraphy comprised Tarmac to a depth of 0.05m; beneath the Tarmac was 0.10m of clean loose yellow gravel made ground. Beneath this was 0.10m of mixed red brown silty clay with modern brick and concrete made ground. Beneath this layer of made ground was 0.20m of mixed red brown and yellow brown clay with modern concrete. Beneath the clay was 0.18m of mid red brown silty clay with gravel subsoil. Finally beneath the subsoil was hard yellow gravel natural geology. No archaeological features were present within Trench 6 nor were any artefacts recovered from it.

Plate 4. Trench 6, looking north east, horizontal scales 2m and 1m, vertical scales 0.5m.
