**Brick Kiln Copse Moat,
Semley, Wiltshire**

Archaeological Watching Brief

New Drainage Trench, Brick Kiln Copse Moat, Semley, Wiltshire

Site Code BSW 10/20

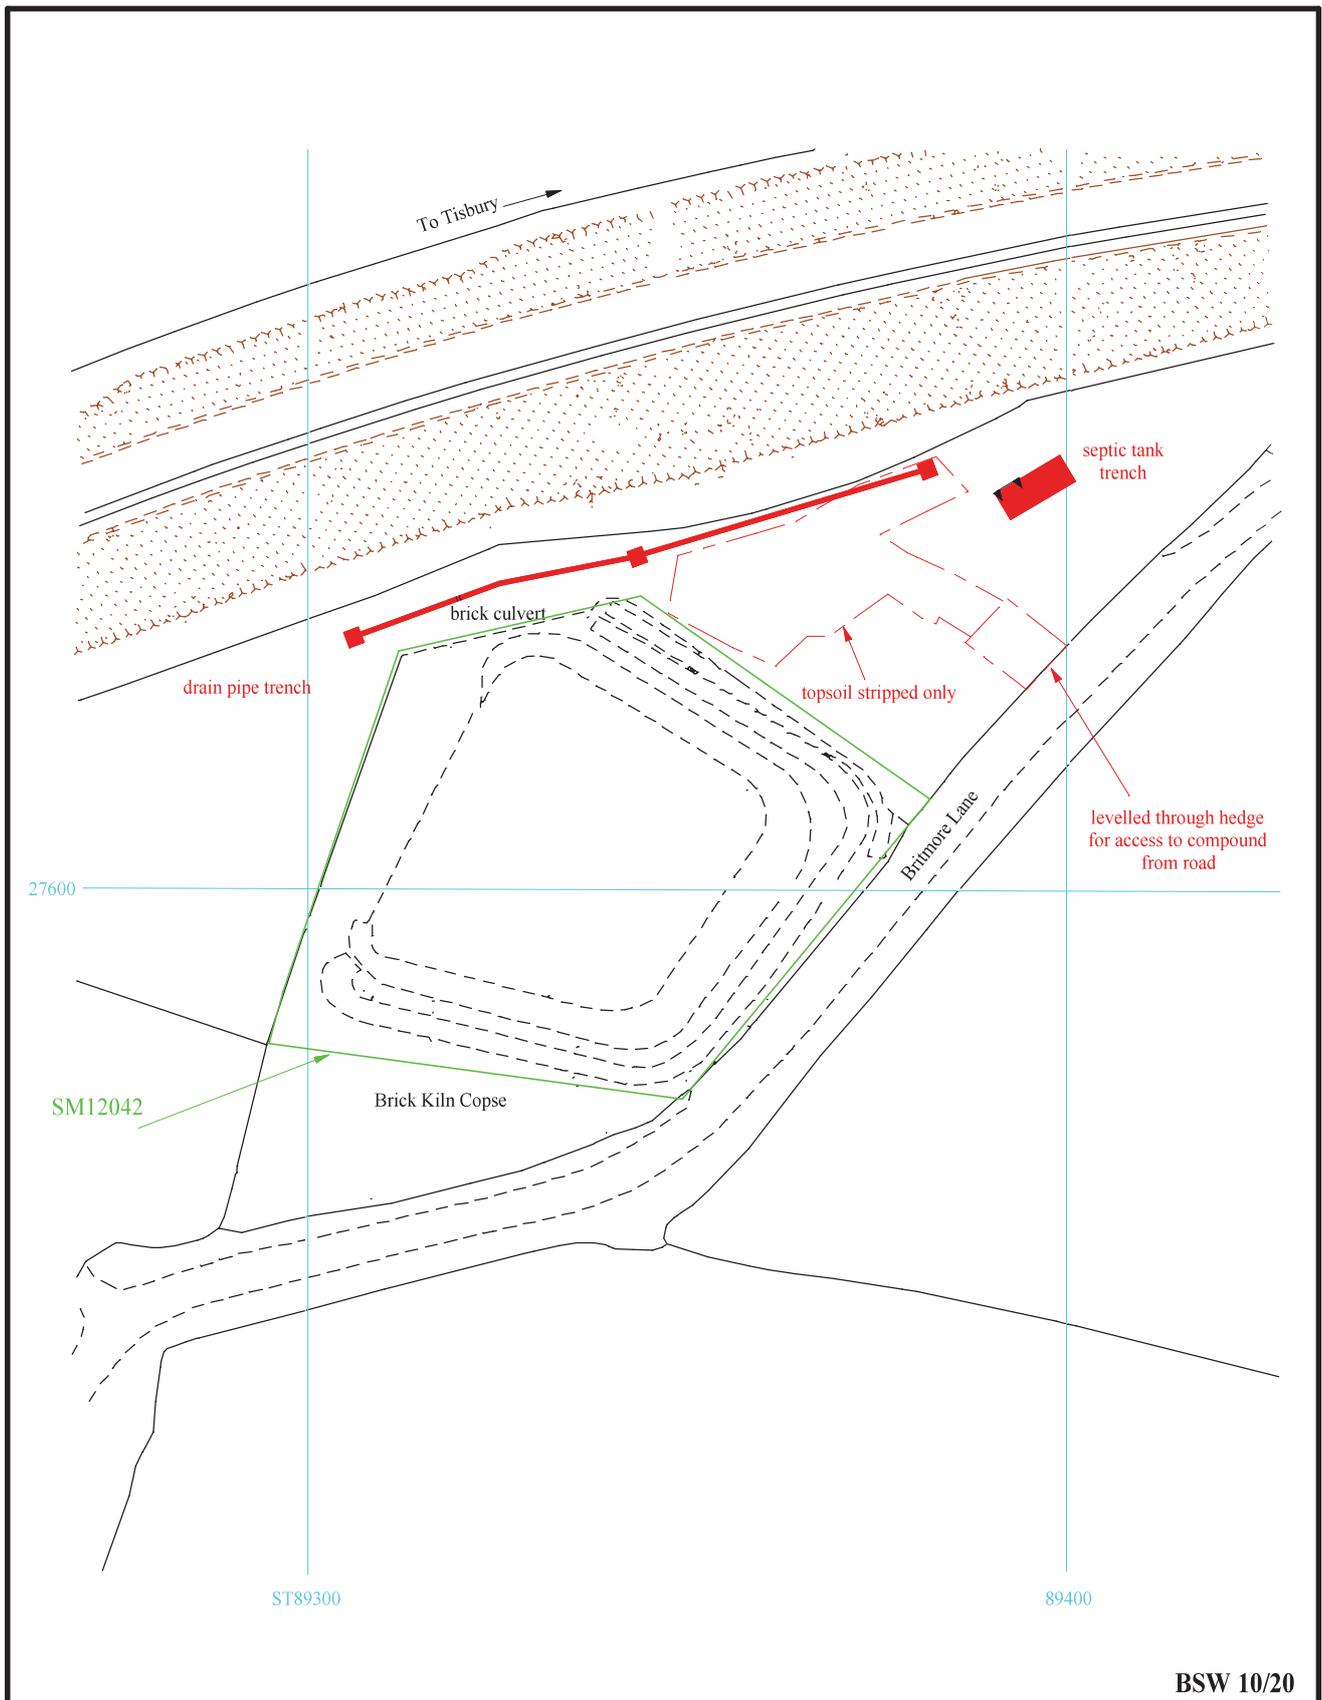
Figure 2. Location of areas observed during watching brief.

The purpose of the watching brief was to excavate and record any archaeological deposits threatened by the groundworks. This was expected to involve examination of a drainage trench and the compound entrance of Britmore Lane (Fig. 2). Which would include overburden stripping. Some areas to be excavated lay in previously disturbed areas (the cutting slope) or were shallow (topsoil disturbance only) with mitigation measures in place to minimize deep disturbance. All areas were excavated under supervision by an archaeologist at all times, using a bladed grading bucket on a 360° mechanical excavator.

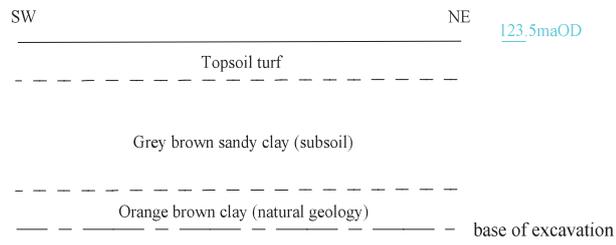
Septic tank trench

A septic tank trench 8m by 4m was excavated to the east of the compound area to a depth of 0.5m. This revealed c. 0.15m of topsoil above 0.15m of grey brown sandy clay subsoil above the natural clay. No archaeological deposits were observed.

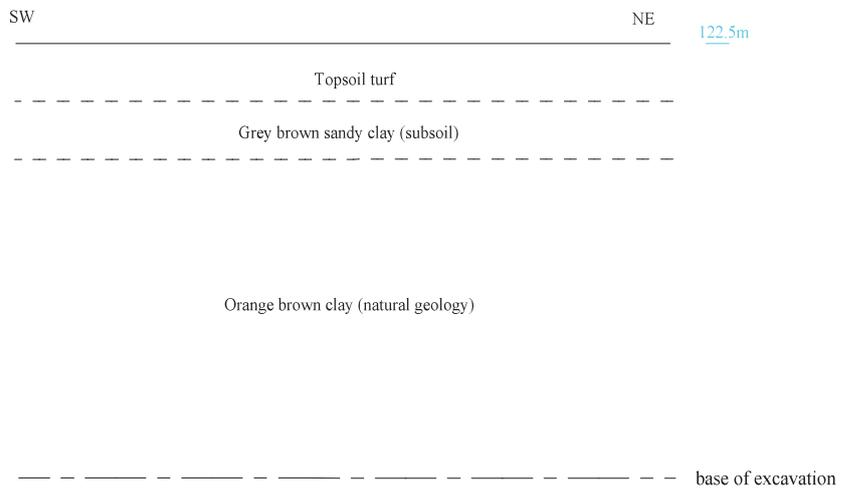
Drainage trench

This drainage trench was c.75m in length, 0.6m wide and was excavated to a depth of between 1.1m to 1.8m deep. This generally uncovered undisturbed stratigraphy, though a brick culvert was noted to cross the trench perpendicularly at a depth of 1.1m deep, 15.5m from the west end of the trench. This was modern in date, seen to be cut through the subsoil, and thought to be associated with drainage from the moat. It is also noted that this may well have been associated with the ground instability on the railway cutting. Due to its location it was thought that this would have been running from the base of the moat ditch outside its course. No clear cut for the

moat (which is not visible as an earthwork at this point) was noted in the drainage sections. No archaeological deposits were identified with the trench.

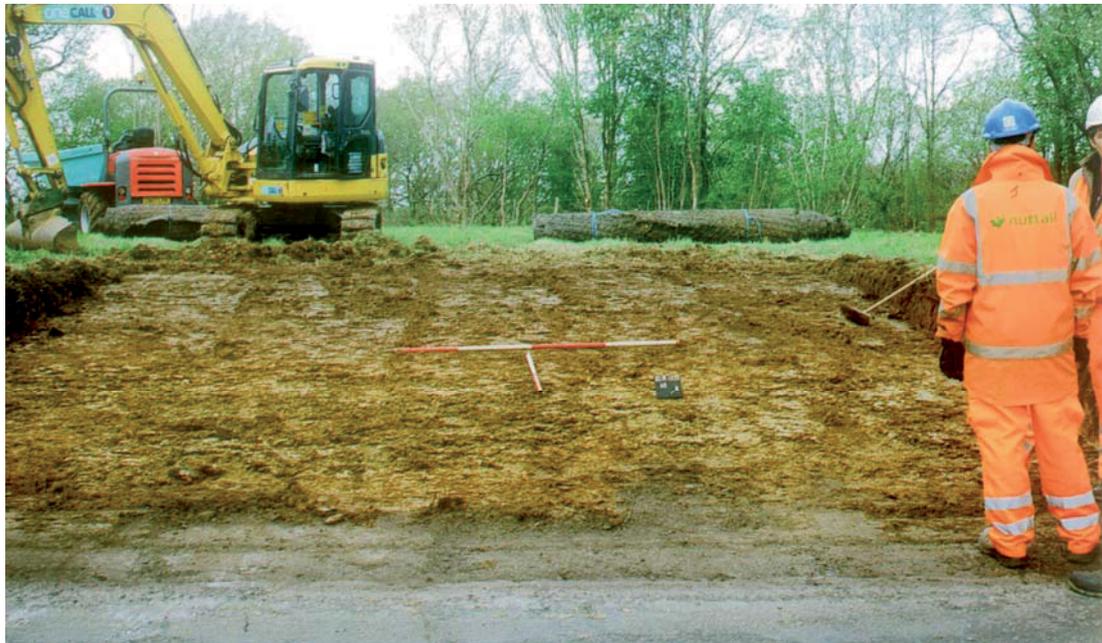
An access ramp was cut through the hedgerow off Britmore Lane 8m wide and roughly 10m in length (Plate 1). At its deepest point the access cutting was 1m. The topsoil comprised a thin layer (0.20m) of dark grey brown sandy silt directly overlying the natural geology. A sondage 1m square was dug adjacent to the carriageway to search for a service pipe, but this was not revealed. No archaeological deposits were observed.

Plate 1. Access trench, looking north west, scales 2m and 1m.

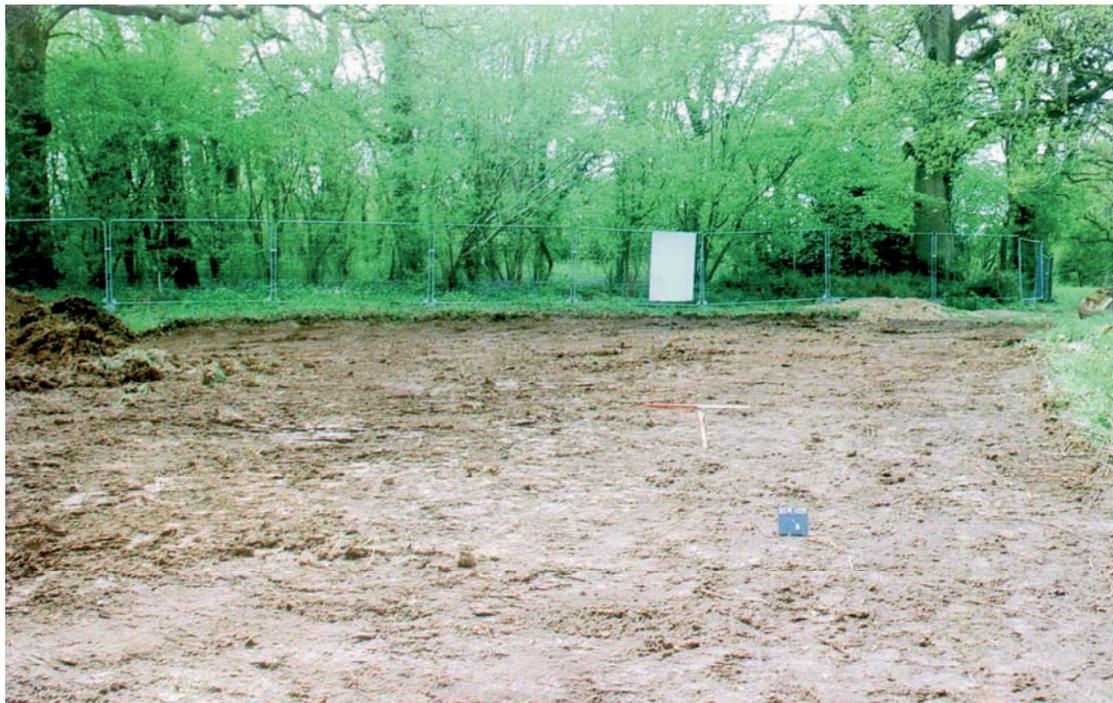
Further topsoil stripping occurred, to a depth of 0.1m to 0.2m, over an area of c.14m by 4m wide to the east of the moated site prior to the laying of geotextile and formation of a compound surface. The overburden stripping was not deep enough to expose the archaeologically relevant level and no archaeological deposits were observed (Plate 2).

Plate 2. Compound topsoil only strip, looking south west, scales 1m and 2m
