Summerhill, Camden Hill, Sissinghurst, Cranbrook, Kent

Archaeological Watching Brief

Site Code: SCK10/63

Report 10/63

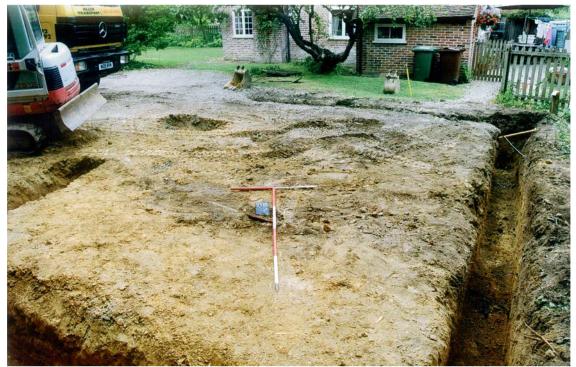
Plate 1. General view of the site, looking northwest. Horizontal scale 1m, vertical scale 2m.

The foundation trenches were dug in the form of a rectangle with two openings in the western side (Fig. 3, Pl. 1). One archaeological feature was recorded in the sides of the foundation trench in the south-western corner of the footprint (Fig. 3). This consisted of a shallow cut, possibly a pit, 0.06m deep, 2.06m in length and 0.49m wide (1) (Fig. 4, Pl. 2) which was filled with a dark orange sand containing frequent small and medium fragments of ironstone (51). The fill of this feature yielded many fragments of roughly-made sandy brick and a few smaller pieces of tile. The whole feature was unclear in plan as it was completely covered by a layer of mottled orange and pale yellow clayey sand 0.54m deep (50). This matched the local natural geology and contained no artefacts, which suggests that it was excavated and then immediately used to level the site or build up the bank that previously covered that area of the site.

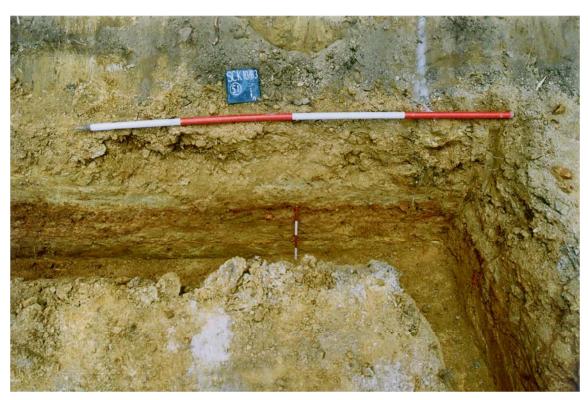
Plate 2. Cut 1, looking south. Horizontal scale 2m, vertical scale 0.4m.
