**Stonor Arms Hotel, Henley Road,  
Stonor, Oxfordshire**

**Archaeological Watching Brief**

**Site Code: SAO09/83**

# **Stonor Arms Hotel, Henley Road, Stonor, Oxfordshire An Archaeological Watching Brief**

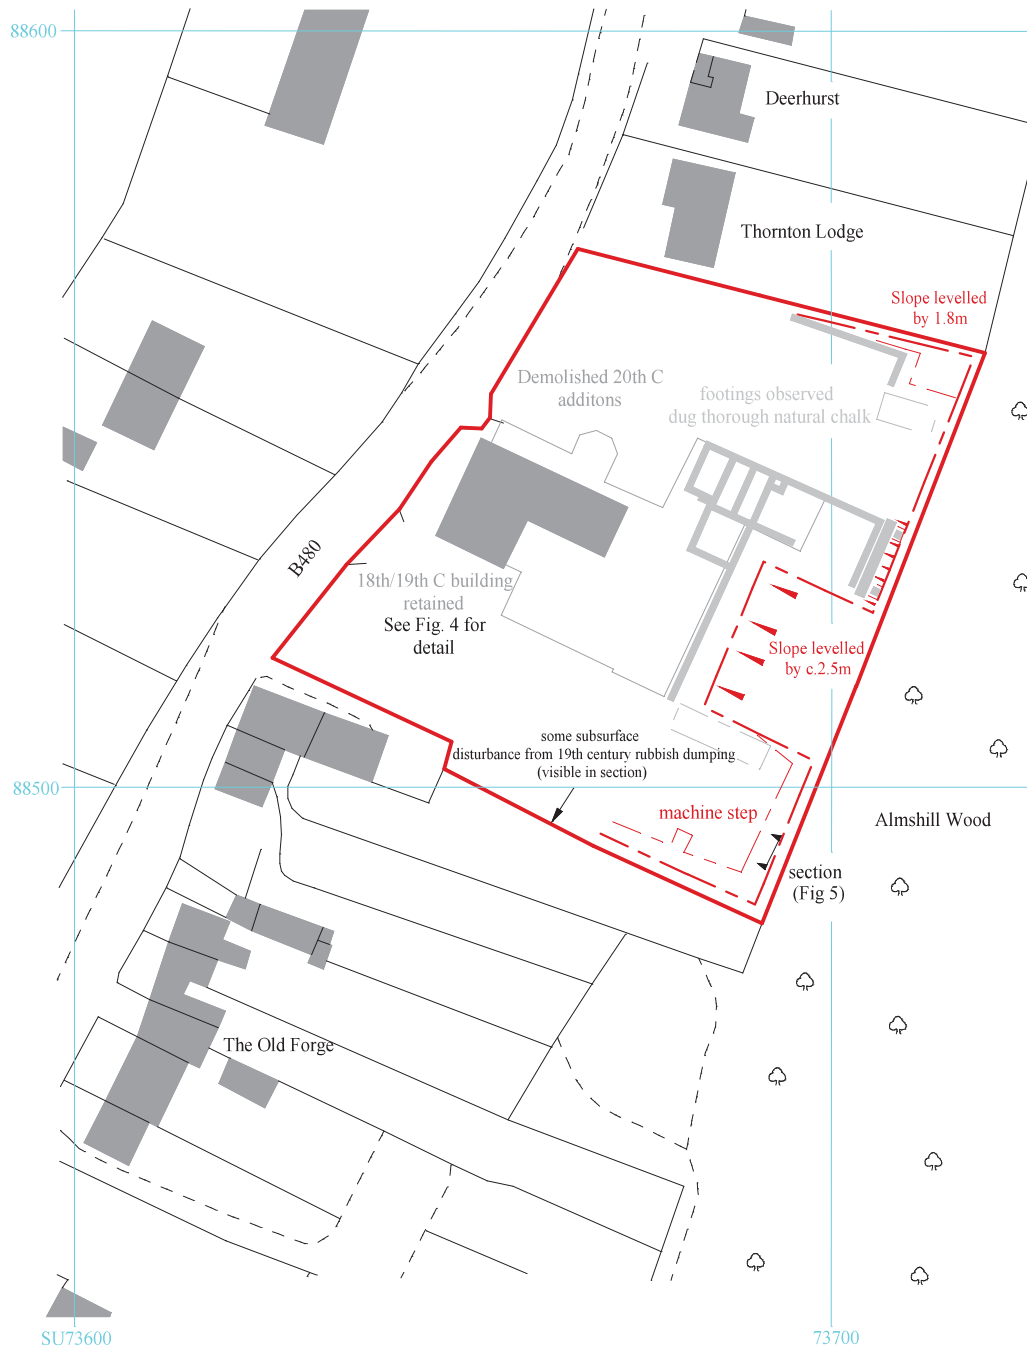
Figure 3. Detail of areas observed for watching brief.

The ground was observed during and after machine excavation to the rear of the Hotel grounds (Fig. 3). A common stratigraphy was noted across most of these works. Undisturbed deposits of topsoil overlying chalk natural geology were seen through all sections, and the topsoil and subsoil at its deepest seem to be only c. 0.6m thick. After topsoil and subsoil removal, up to 4m of the chalk natural geology was removed to level the site to that where the retained building stands. Some 19th-century dumping of rubbish was noted in a large feature on

this southern boundary. This might have been associated with other contemporary sub-surface landscaping of ground which was also seen here to a depth of 0.84m.

Once the level on this eastern side of the site had been matched to the west, only natural chalk deposits remained across all exposed surfaces but subsequently buried by a mat of crushed rubble to form a stable base for further machining. All footings were dug through previously undisturbed natural chalk deposits. No finds or deposits pre-dating the 19th century were noted during any of the groundworks.

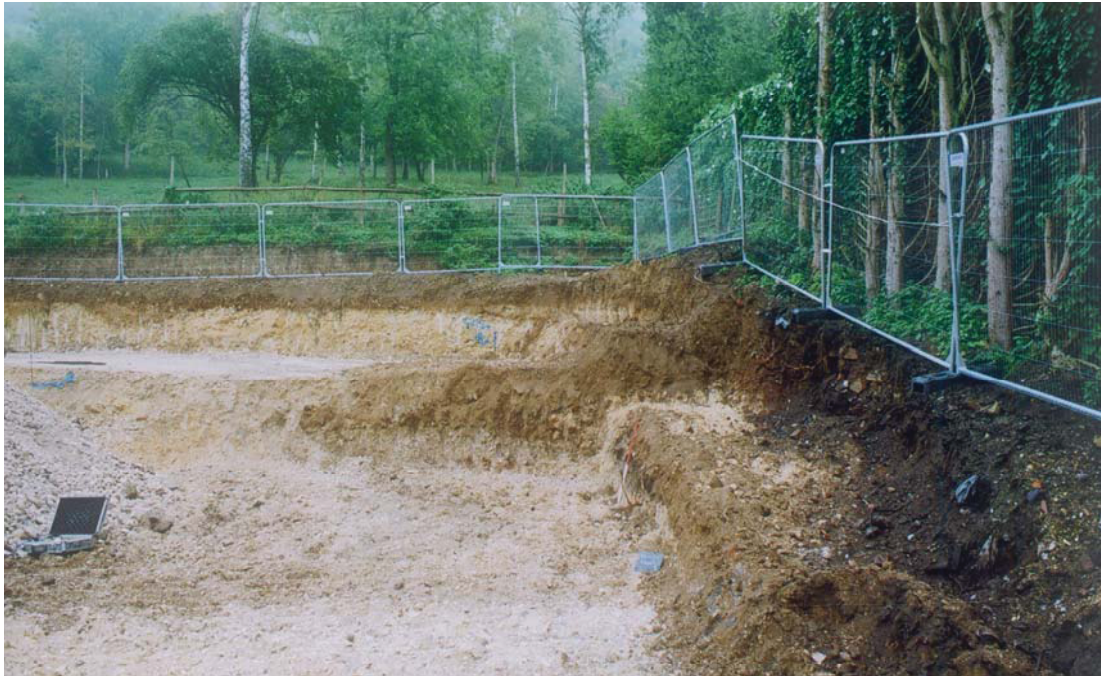
Plate 1. General view of south eastern margins of the site.

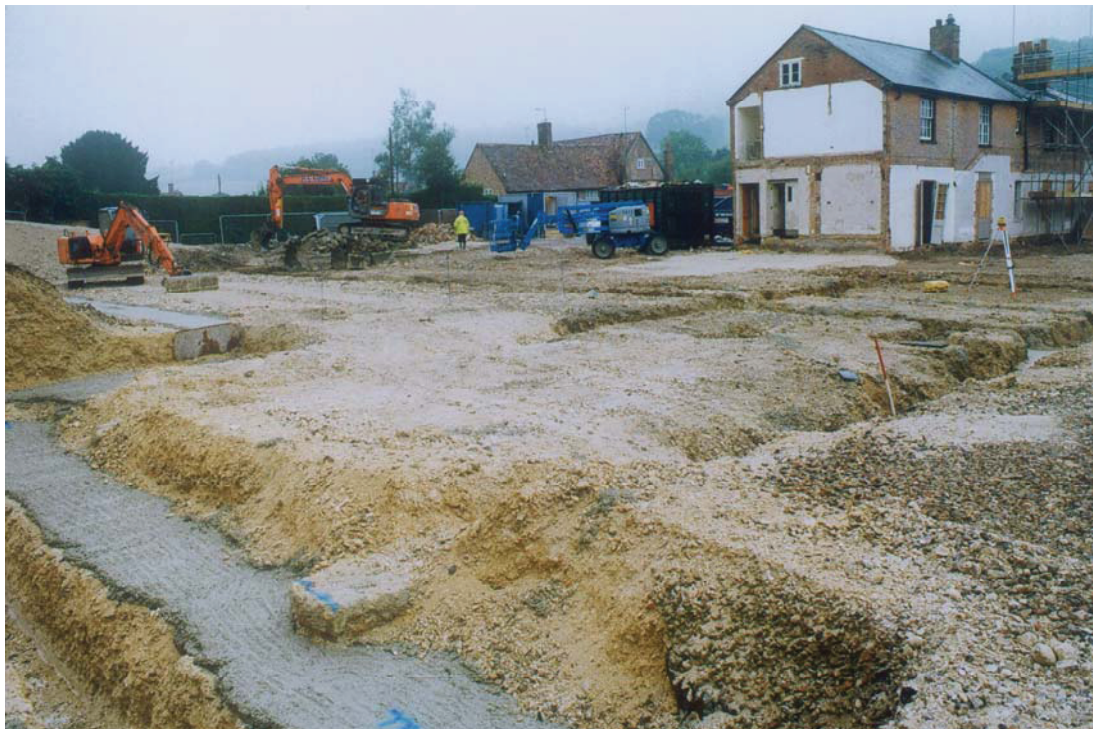
Plate 2. General view over new footings, with 19th century northern addition (rear) visible in the background.
