**Church of St Mary Magdalene, Shabbington,
Buckinghamshire**

Archaeological Watching Brief

Site Code: CMS10/115

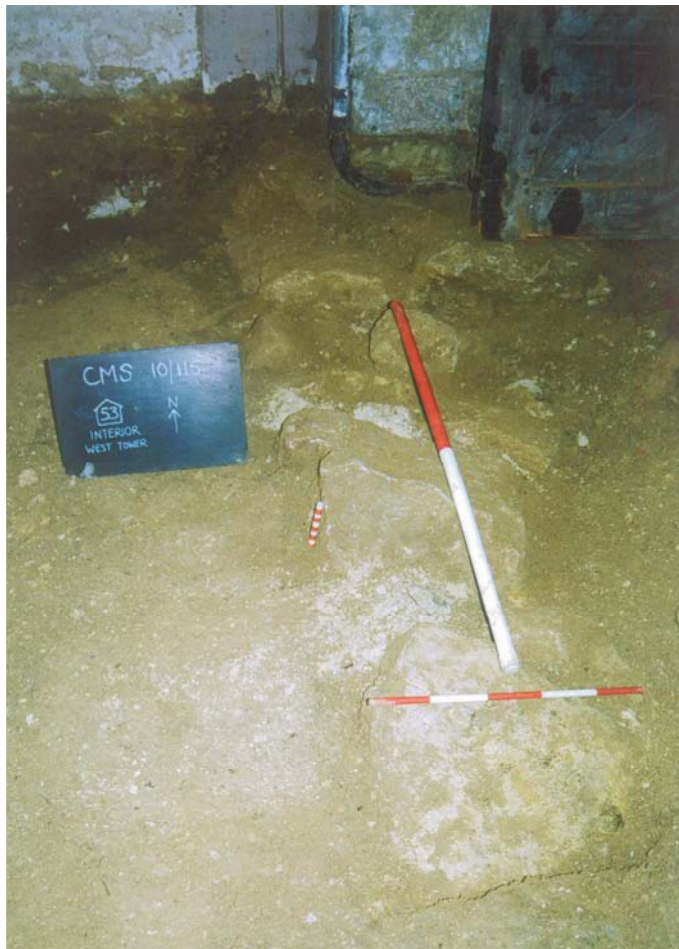
The existing floor of the West Tower was removed and the ground reduced by 0.40m, the stratigraphy comprising 0.12m stone flooring slabs above 0.24m light brown grey sand with occasional limestone, brick and tile (52) overlying dark grey silty clay with occasional limestone and charcoal (54). A stone-built wall (53) was recorded across the eastern end of the tower (Plate 1). This wall was 0.50m wide and 0.14m of the wall in height was exposed in the reduced area. The wall was made of large irregular blocks of limestone with rough faces, up to 0.50m across; no visible bond was observed between the blocks. The wall is likely to be the remains of the original end of the nave prior to the tower being built in the 15th century which would suggest a date of the 12th century for the construction of the wall.

Plate 1. Interior of West Tower, looking north, scales: 1.0m, 0.5m and 0.1m

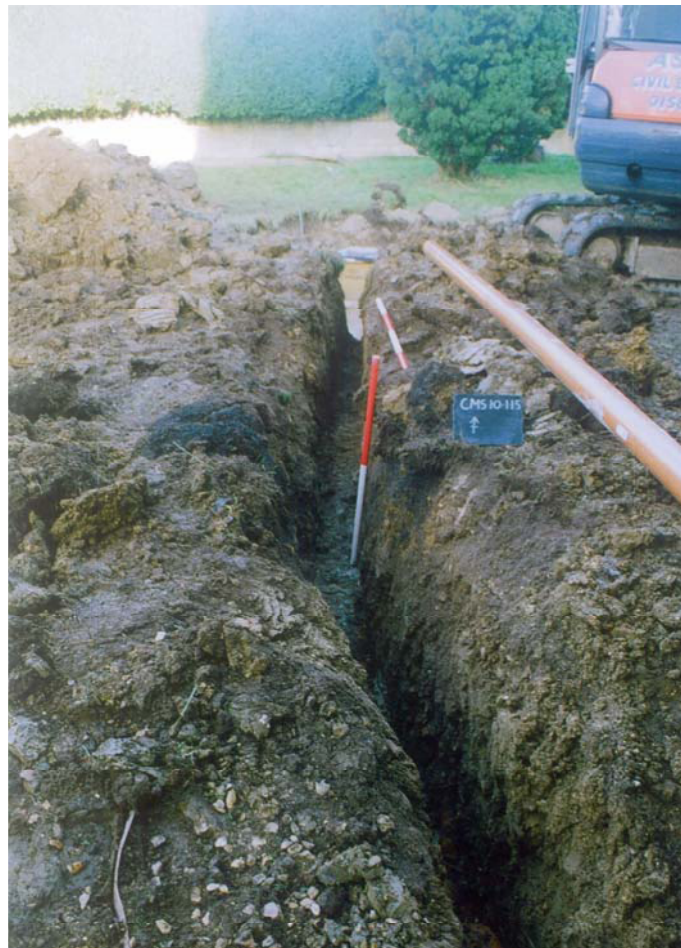
A service trench was dug through the churchyard measuring 74m long and 0.5m wide (Fig. 3). It was 0.35m deep (near the church) and up to 0.80m closer to Mill Road (Plate 4). The stratigraphy was similar of that seen in the cess pit and further disarticulated bones were recovered from the deeper parts of the service trench at the northern end of the trench. At the northern most end of the trench the tops of two sections of limestone built wall

(58 and 59) were observed, the walls were 0.50m wide and two courses amounting to 0.25m were exposed in the trench. The walls were made of irregular limestone blocks similar to those of wall 56 with no mortar present either, it is possible that they form part of the same structure due to their alignment, but unlikely to be directly associated with wall 56 to the south-west.

Plate 4. Service Trench, looking north, Scales: 1.0m and 1.0m
